NIOSH HEALTH HAZARD EVALUATION REPORT

**HETA # 2003-0346-2969
Salvation Army Harbor Light Center
St. Louis, Missouri**

May 2005

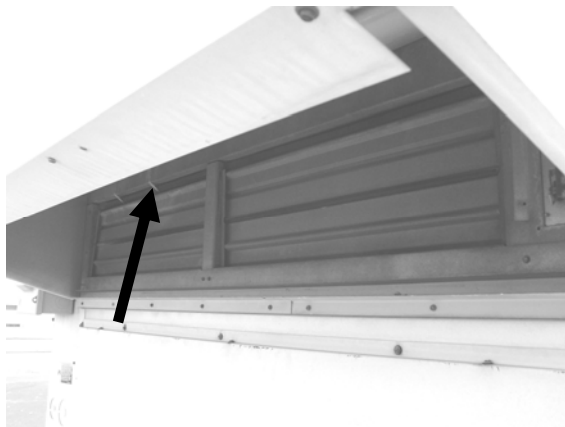
The ventilation systems in both buildings needed complete testing and balancing to assure optimal distribution of air within the shelter. The annex AHUs, while generally in good working order, had the outside air dampers screwed shut, severely limiting fresh air supply to that part of the shelter. The units in the main building clearly needed maintenance and repair and were extremely dirty, limiting airflows in the main building. Also, the MERV 7 filters that had been used in the AHUs are only about 25% efficient at filtering 1.0-3.0 μm particles, and would therefore allow most of the infectious droplet nuclei associated with *M. tuberculosis* transmission to pass through the filters, even under the best circumstances.

Figure 6. Outside air damper of annex AHU. Arrow is pointing to screws holding damper closed.

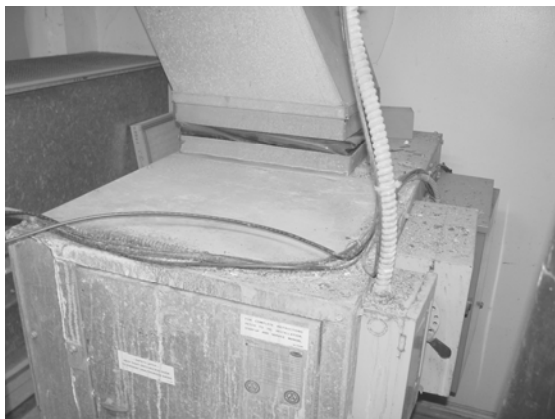
Table 2 provides the locations and general information on all 18 AHUs in the main building. Locations of the six AHUs serving the first floor of the main building are shown in Figure 3. These units were generally in need of cleaning, maintenance, and repair. They were typically installed inside small mechanical rooms that were also used for general storage (files, holiday decorations, extra ventilation filters, etc.). The outside surfaces of most AHUs in the main building were covered with dust and debris (Figure 7). Likewise, the inside surfaces were also covered with heavy layers of dirt and debris (Figure 8) and many had debris collected on the heating/cooling coils (Figure 9). Another common problem was stagnant, dirty water in clogged drain pans or drain pans having inoperable pumps (Figure 10). In some cases, it was evident that leaking or overflowing drain

Figure 7. AHU in main building covered with dust and debris.

Based on the visual inspection, we recommended a combination of improved maintenance, cleaning, and enhanced filtration as detailed in Interim Report I (Appendix A). Major recommendations included:

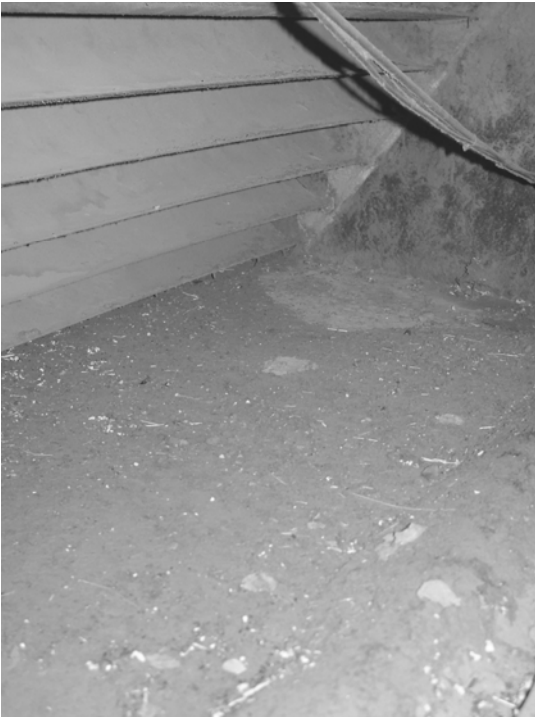
Figure 8. AHU in main building showing thick layer of dust and debris inside.

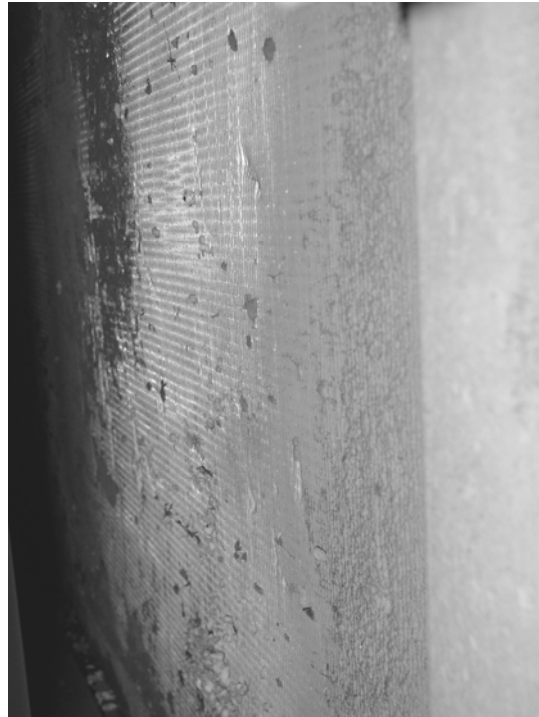
Figure 9. AHU in main building showing dust and debris built up on heating/cooling coils.

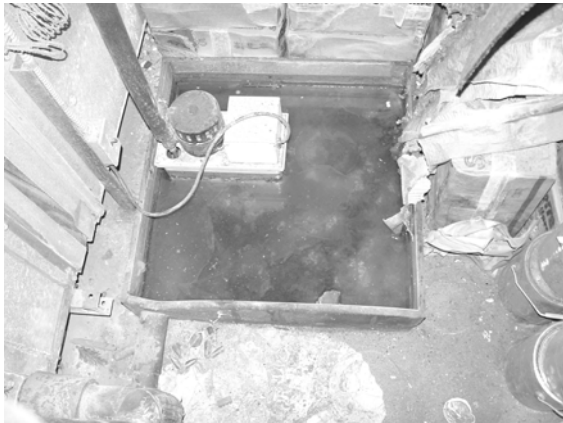
Figure 10. Condensate pan for AHU in main building having inoperable pump. The pan is full of stagnant, dirty water.

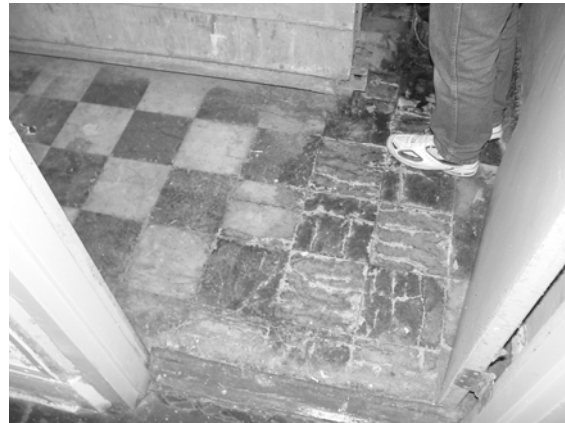
pans had caused floor damage (Figure 11). Other common problems included damaged pneumatic and/or electronic sensors and controllers, damaged outside air dampers, and loose fan belts.

Figure 11. Damage to tile floor where a condensate pan leaked or overflowed.

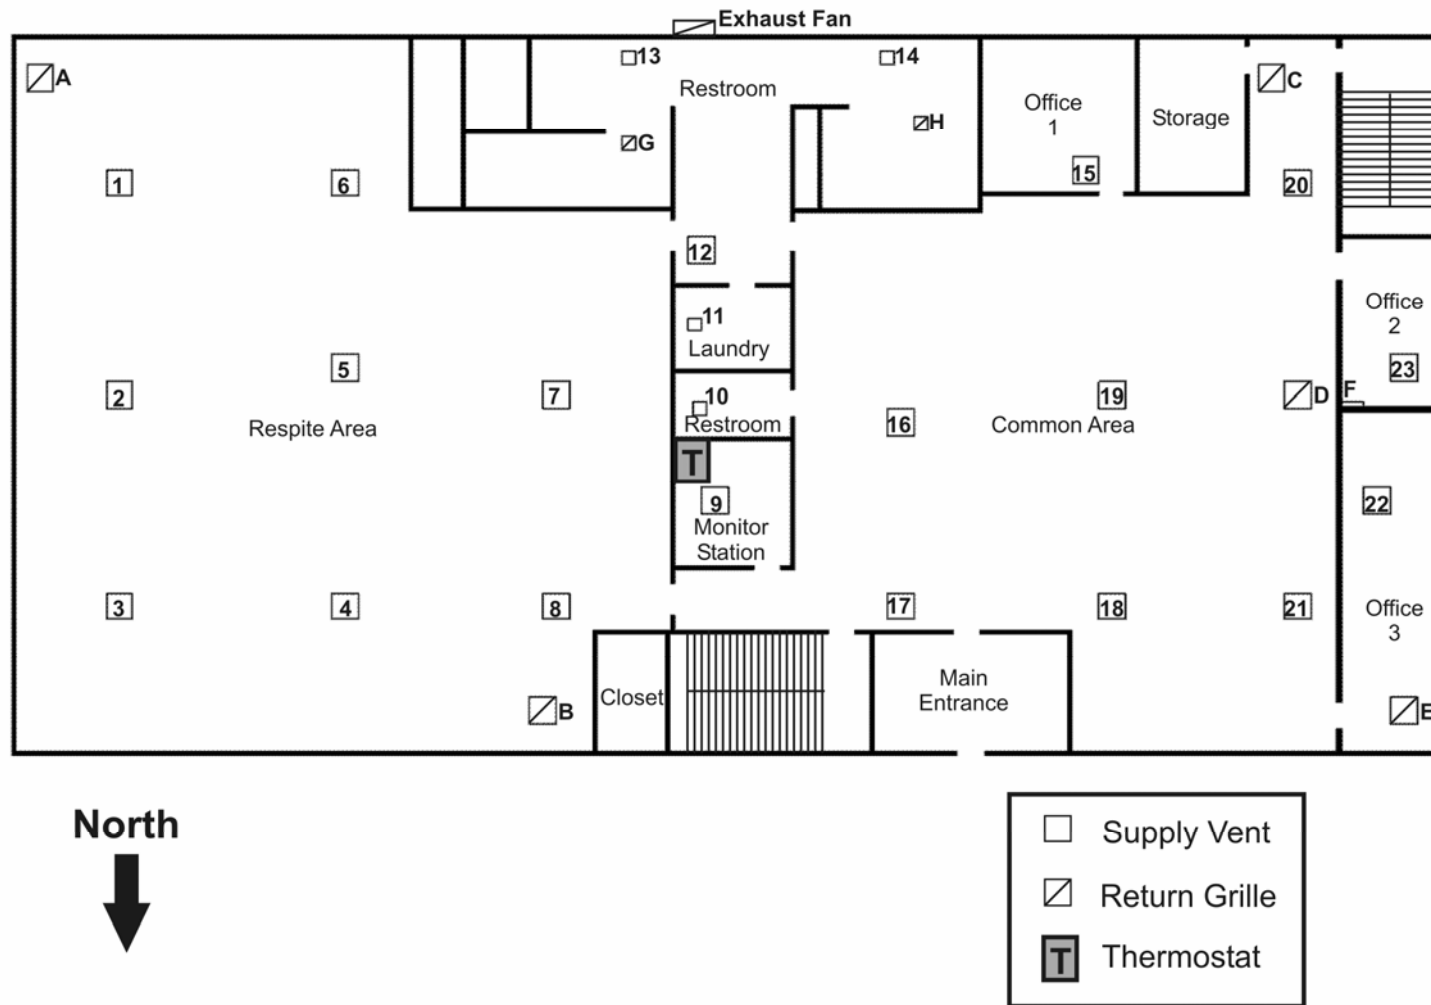
Figure 12. Supply vent and return grille locations on the annex first floor.

The data presented in Tables 5 and 6 show several oddities. There were supply vents serving as air returns (e.g., vents 10, 11, and 15 on the first floor in July), and returns that were supplying air (e.g., grilles D, E, F, and H on the first floor in April). There were also many zero readings. We had recommended testing and balancing (TAB) of the HVAC systems after our first visit in September 2003, but TAB was never completed during the time we conducted evaluations at the shelter. Thus, our readings in January, April, and July were taken with the building "as is." In October, we inspected all of the flex duct connections in the four main client areas in an attempt to explain the conditions mentioned above. In most cases, the flex duct was cracked or completely separated from the supply vent, causing supply air to leak directly into the return air plenum. In some cases, the end of the flex duct was several feet from the supply vent to which it should have been connected. Every supply vent was partially or totally disconnected in the respite area, and all but two were disconnected in the common area. The second floor Level 1 area and the VA area each had two disconnected supply vents. Prior to taking the October ventilation measurements, we reconnected the flex duct to all of the supply vents. Thus, the measurements taken in October are more realistic of actual ventilation system performance, and were the only set where all of the supplies functioned as supplies and all but

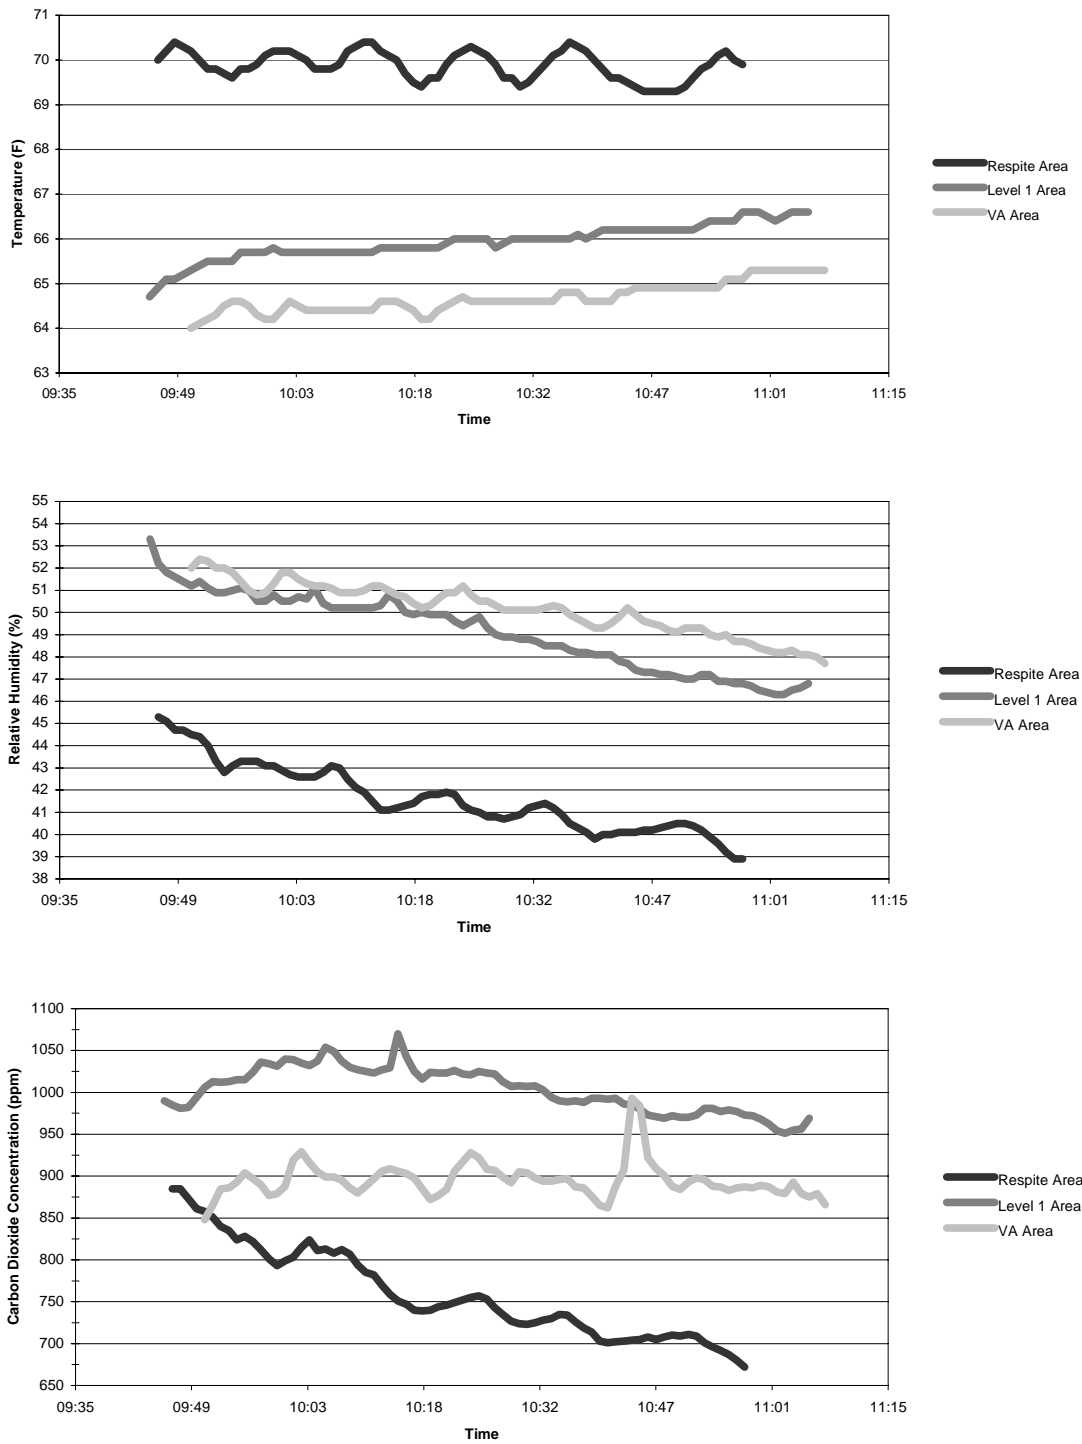
In the annex, IEQ data were recorded in the respite area, Level 1 area, and VA area on October 15, 2004 (during tracer Tests 4 and 5). The results from Test 4 (Figure 26) show that the temperature in the Level 1 and VA areas was below the ASHRAE recommendations. The temperature in the respite area met the recommendations. The RH was between 30% and 60% in all three areas. CO₂ concentrations were below 1050 ppm in the respite area and VA area throughout the test. Two short duration peaks that exceeded the 1050 ppm level were seen in the Level 1 area.

Figure 26. IEQ parameters in the annex on October 15, 2004 (tracer gas Test 4). ASHRAE recommends winter temperatures between 68°F and 76°F and relative humidity between 30% and 60%. Carbon dioxide concentrations should be below 700 ppm above the ambient concentration (approximately 1050 ppm total).

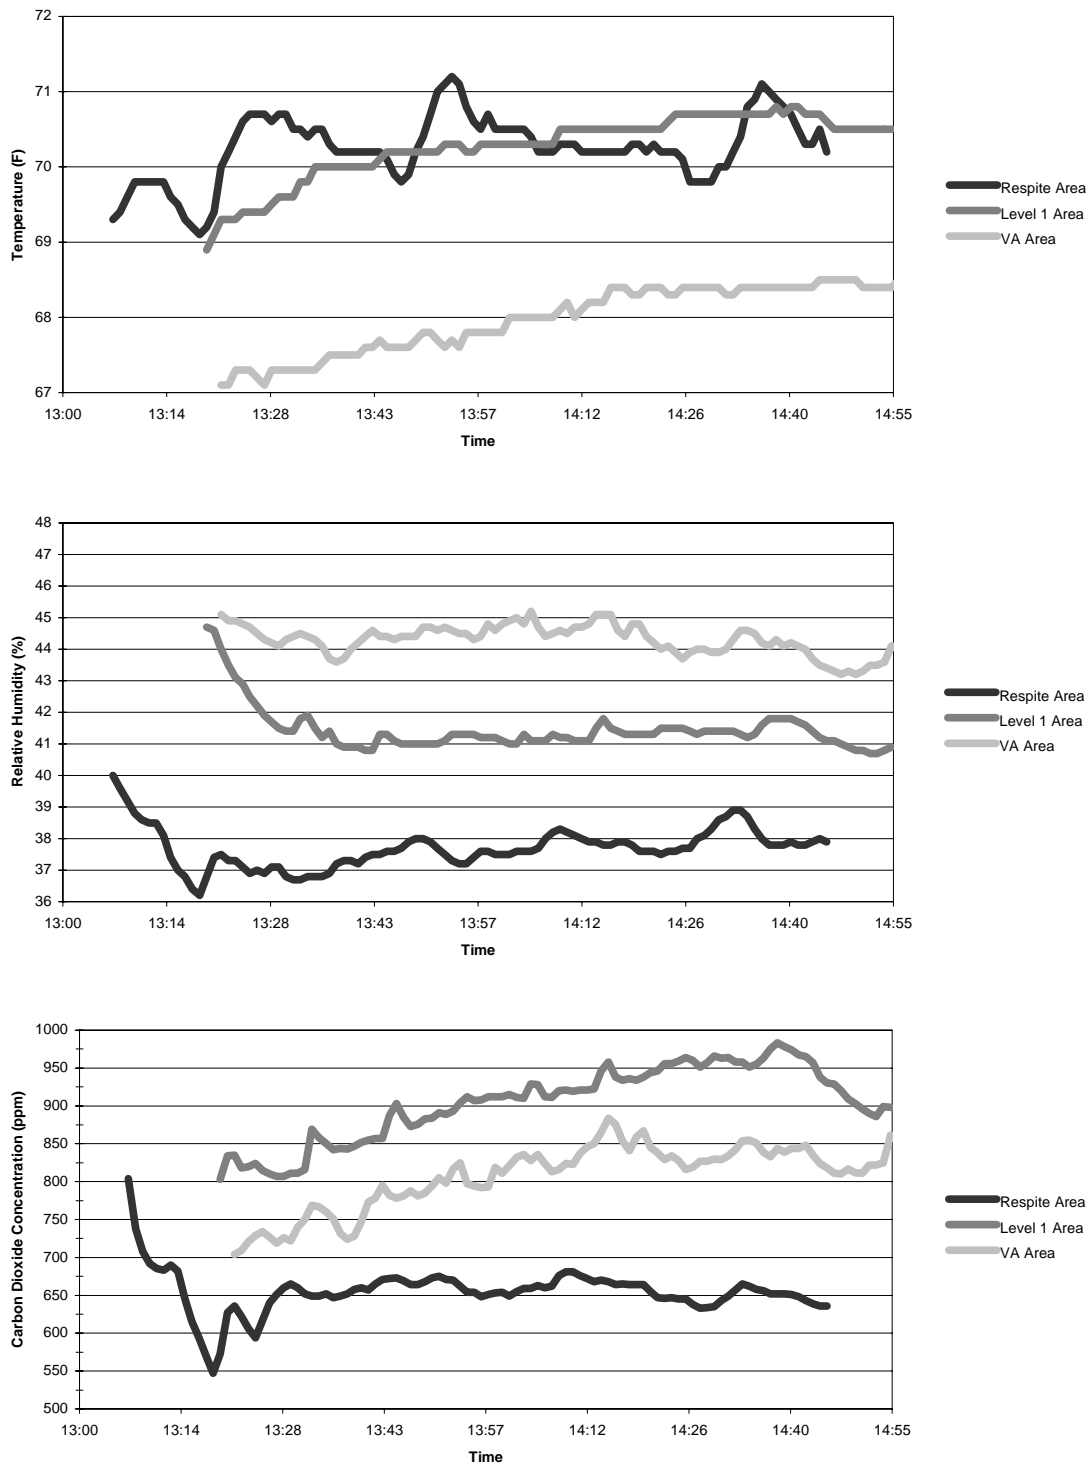
Figure 27 shows the IEQ results from the annex during tracer Test 5. All three parameters were within the recommended ranges in all three areas, except for the temperature in the VA area, which started out slightly below the 68°F minimum for winter months.

Figure 27. IEQ parameters in the annex on October 15, 2004 (tracer gas Test 5). ASHRAE recommends winter temperatures between 68°F and 76°F and relative humidity between 30% and 60%. Carbon dioxide concentrations should be below 700 ppm above the ambient concentration (approximately 1050 ppm total).

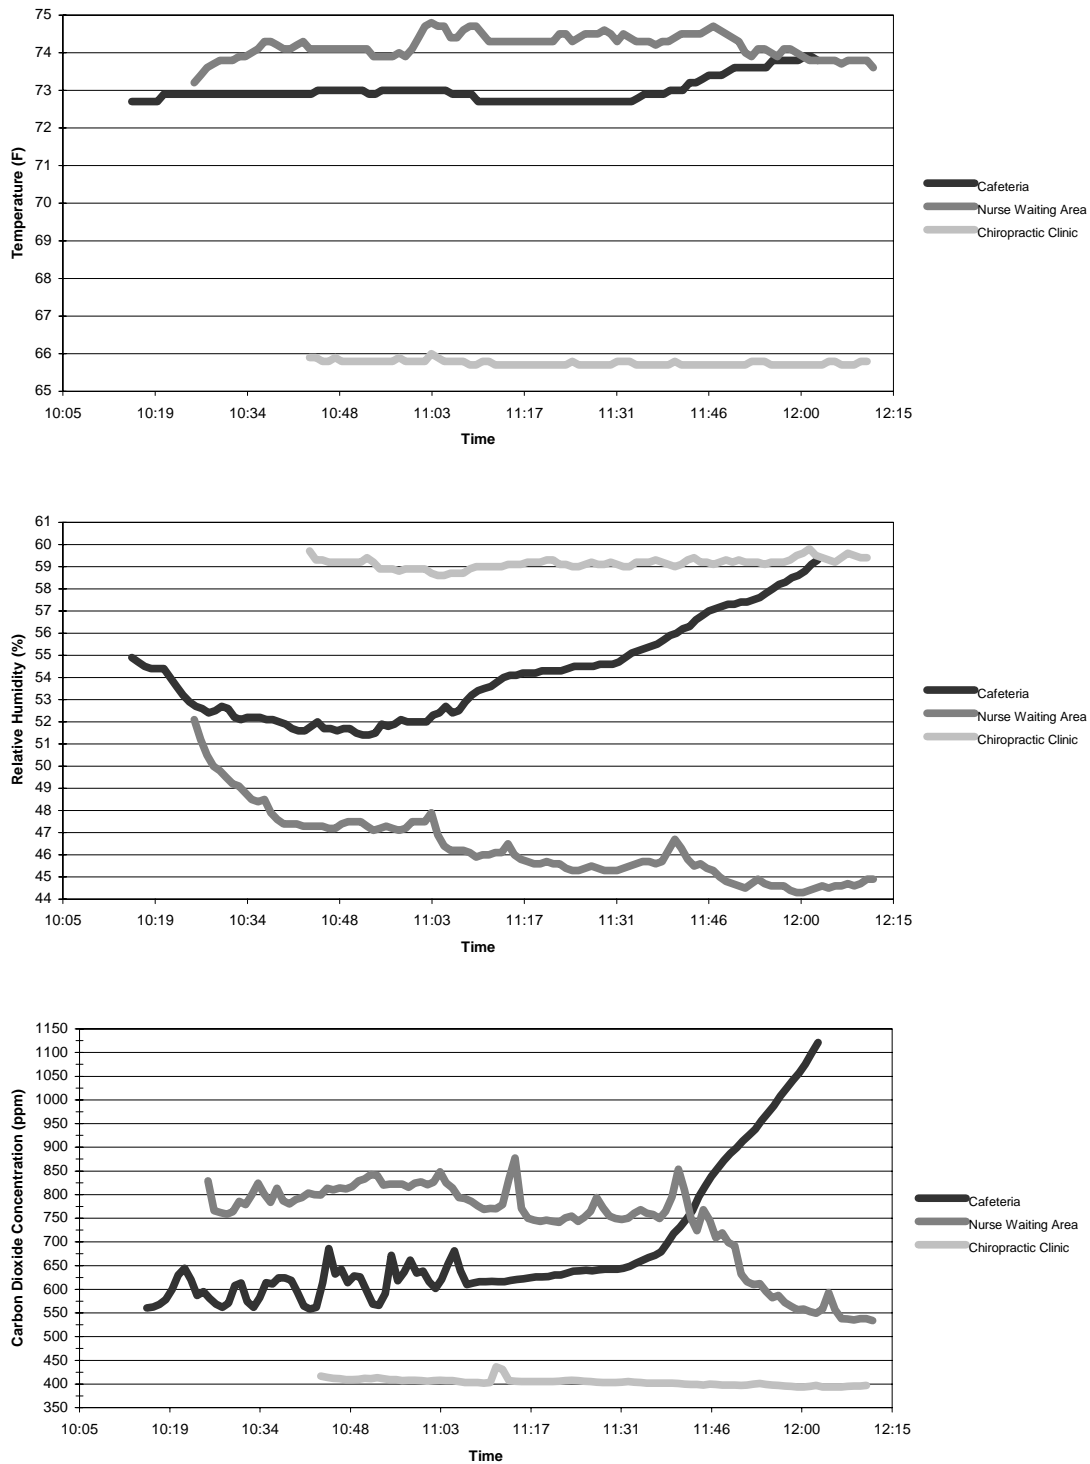
During tracer Tests 6 and 7 (conducted on October 19 and 20, respectively) on the first floor of the main building, IEQ parameters were monitored in the cafeteria, the nurse waiting area, and the chiropractic clinic. On October 19 (Figure 28), the temperature in the cafeteria and nurse waiting area was within the recommended ranges. The chiropractic clinic was a couple of degrees lower than the 68°F minimum for winter

Figure 28. IEQ parameters in the main building on October 19, 2004 (tracer gas Test 6). ASHRAE recommends winter temperatures between 68°F and 76°F and relative humidity between 30% and 60%. Carbon dioxide concentrations should be below 700 ppm above the ambient concentration (approximately 1050 ppm total).

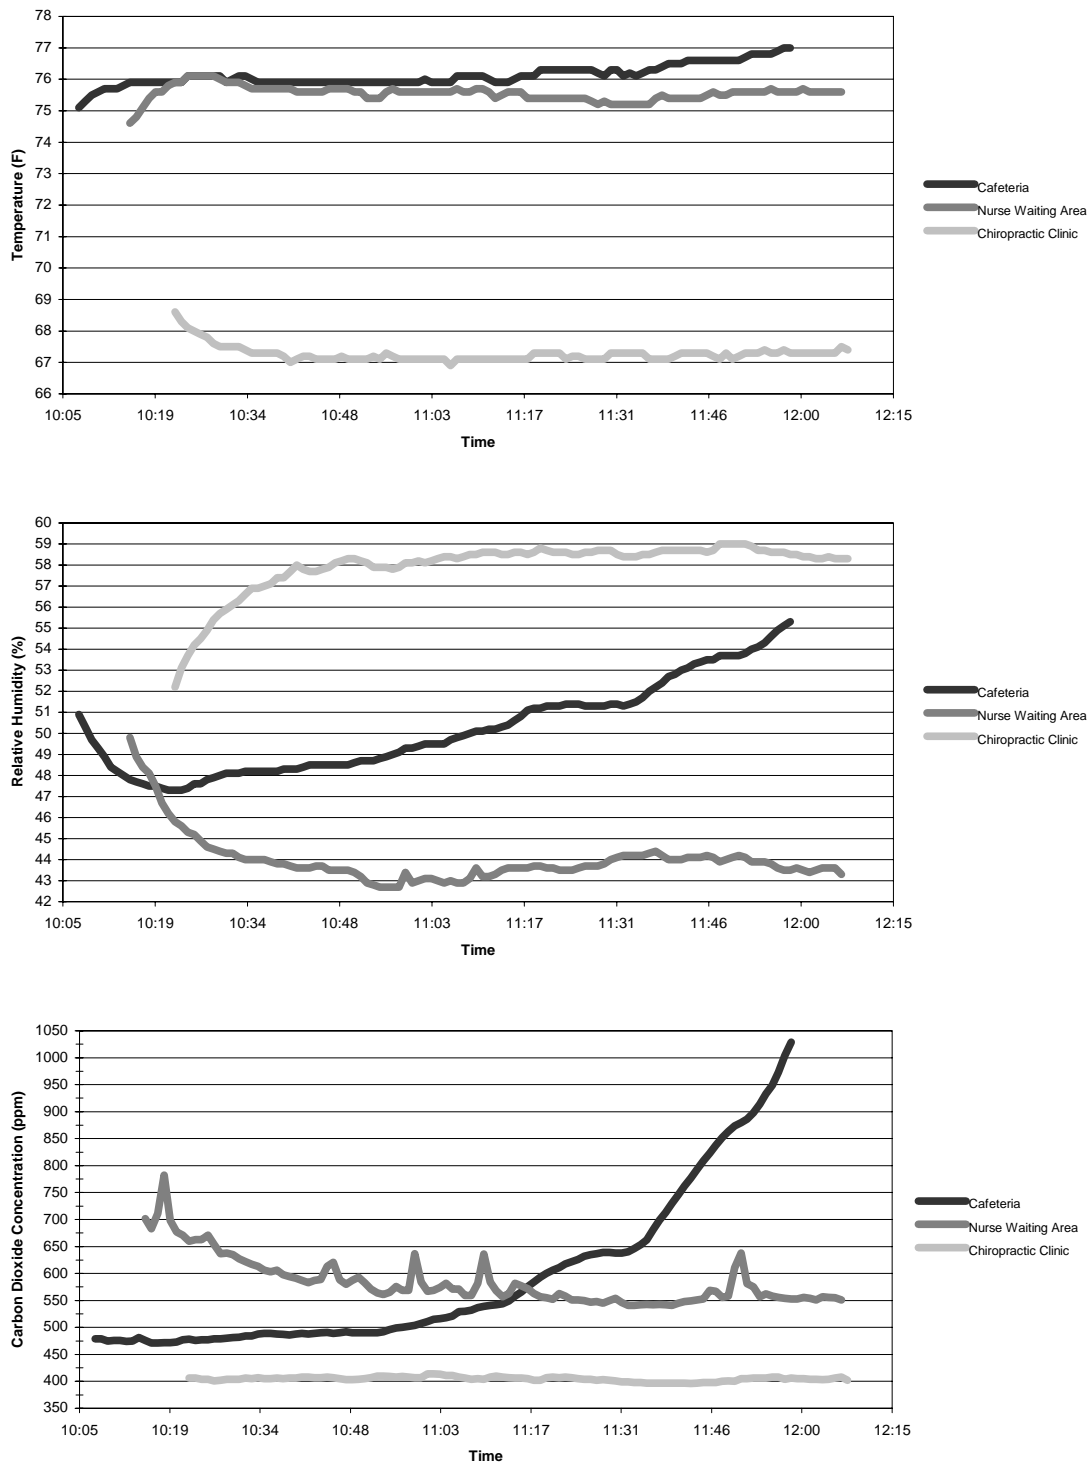
Figure 29 shows the IEQ results for October 20. Again, the unoccupied chiropractic clinic was below the 68°F minimum for winter months. Also, during lunch, the temperature in the cafeteria exceeded the 76°F maximum temperature recommendation. All three areas met the RH criteria and all three areas showed CO₂ levels below 1050 ppm, though CO₂ levels in the cafeteria were rapidly increasing after the doors were opened for lunch at around 11:30 am. Again, because the Q-Trak was turned off at about noon, the eventual maximum CO₂ concentration remains unknown.

Figure 29. IEQ parameters in the main building on October 20, 2004 (tracer gas Test 7). ASHRAE recommends winter temperatures between 68°F and 76°F and relative humidity between 30% and 60%. Carbon dioxide concentrations should be below 700 ppm above the ambient concentration (approximately 1050 ppm total).

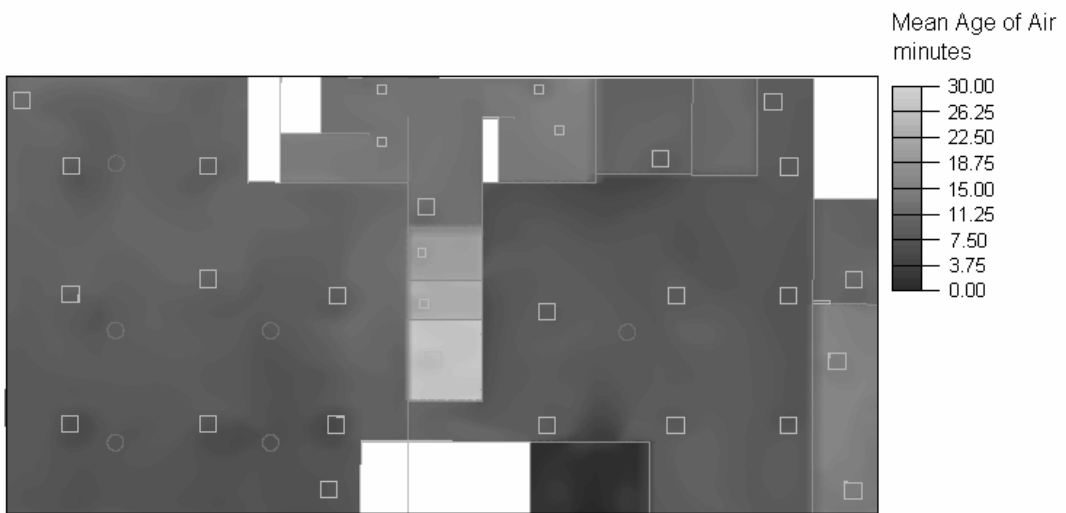
The same model was solved using ventilation measurements from October (Figure 31). All of the flexible duct connections had been repaired and all of the UVGI fixtures were installed in October, and the ventilation associated with these improvements are included in the model. Compared with Figure 30, Figure 31 shows a dramatic improvement in the mean age of air for the respite area dropping from around 30 minutes in January to about 10 minutes in October. The model also shows that the air mixing in the respite area is fairly uniform with the SAM units operational. The mean age of air in the common area stayed about the same, at around 10 minutes. However, there were improvements in all other areas of the first floor,

Figure 31. CFD modeling results showing mean age of air (in minutes) at three feet off the floor for the annex first floor in October 2004.
