## **NIOSH HEALTH HAZARD EVALUATION REPORT**

**HETA #2003-0383-2942**  
**Alstom Power, Inc.**  
**Chattanooga, Tennessee**

**July 2004**

### Evaluation of Jobs in a Power Equipment Manufacturer

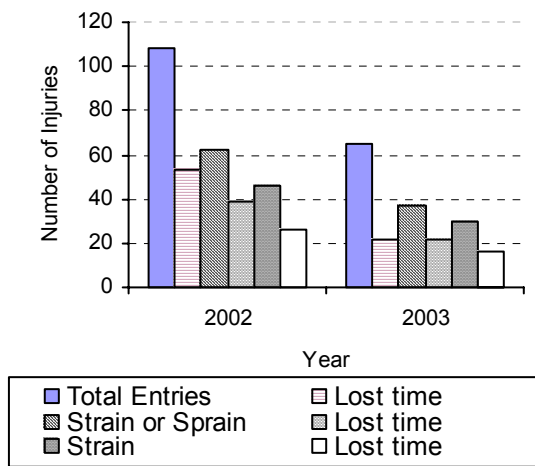
**Figure 1: Injury and Illness Entries**

For the year 2002, there were 108 entries, 53 with lost time. The number of lost days was 2500. Of these, 62 (57%), were classified as “strains or sprains”, 39 with lost time. Forty six (43%) were categorized just as “strain”, which were thought by the company to most likely be musculoskeletal disorders. Of these 46 strains, 26 resulted in lost time. Through October 2003, there were 65 entries, 39 with lost time. The number of lost days was 2015. Of the 65 entries, 37 (57%) were classified as “strains or sprains”, 22 having lost days. There were 30 entries (46%) classified just as strains, 16 with lost days (see Figure 1). The percent of injuries attributable to strains or sprains was comparable for both years, and 2003 was on a pace to result in almost the same number of total lost days as 2002.
