Major Maintenance Report

Tillamook North and South Jetties

Garibaldi, Oregon

December 2003

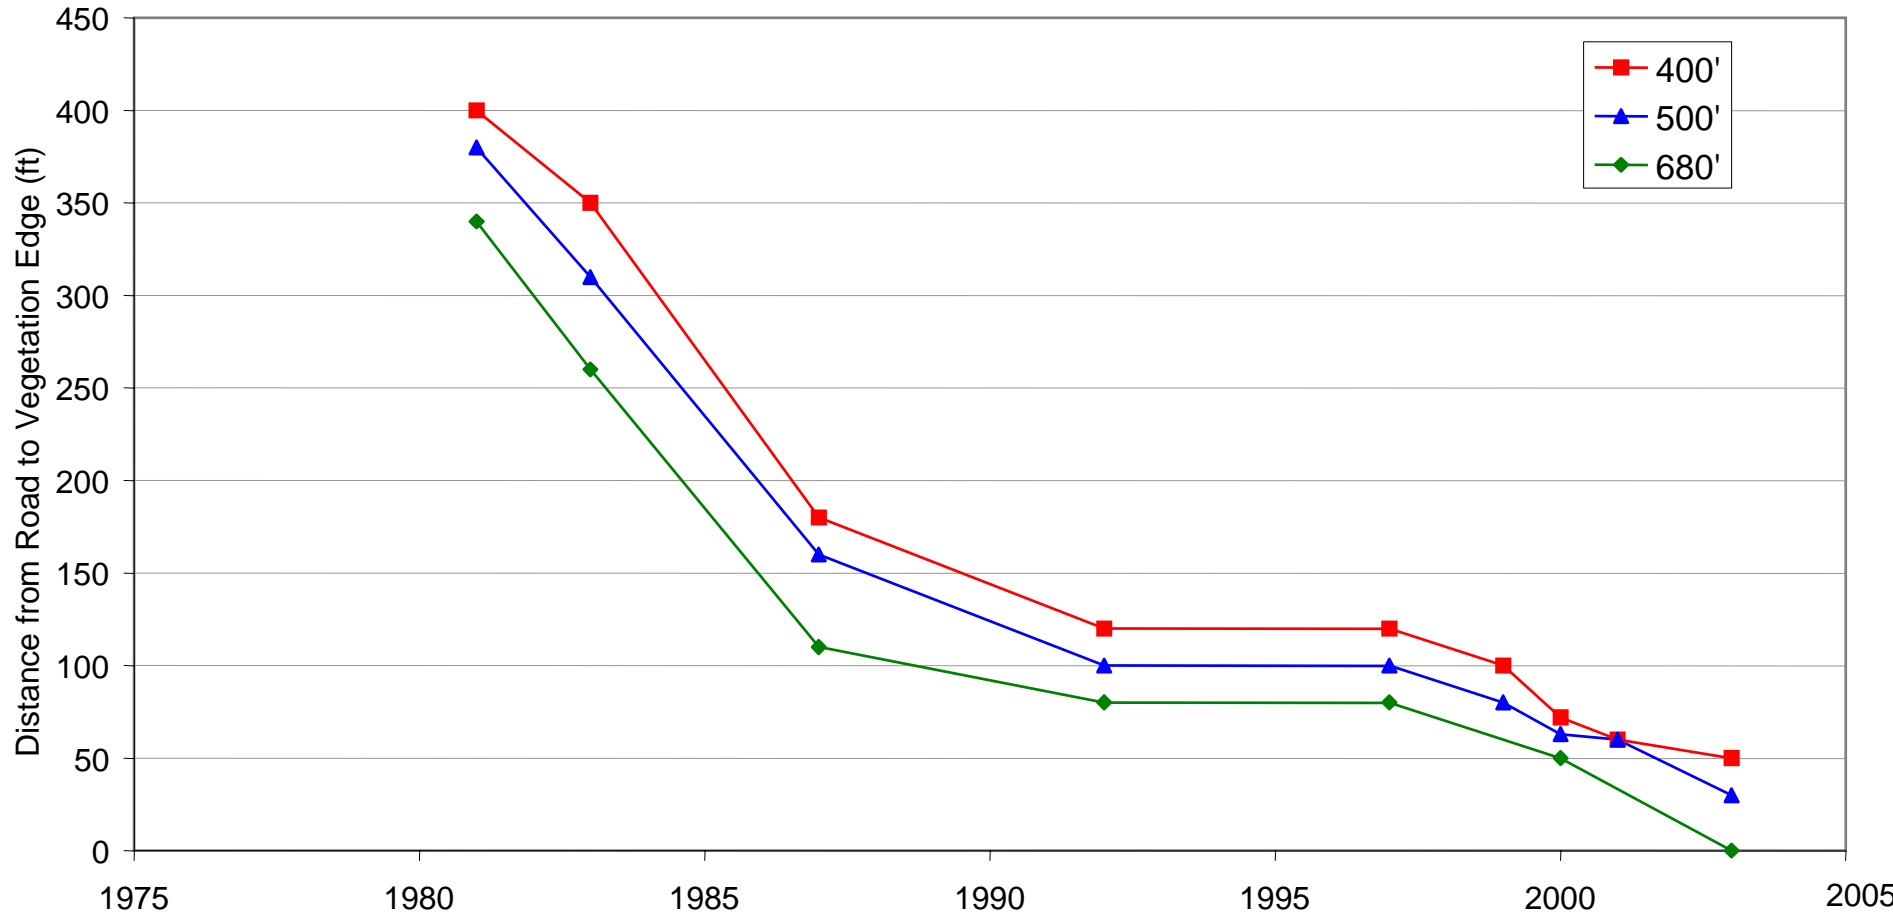
Tillamook North Jetty

Figure 2-1 Recession of the Vegetation Line north of the North Jetty

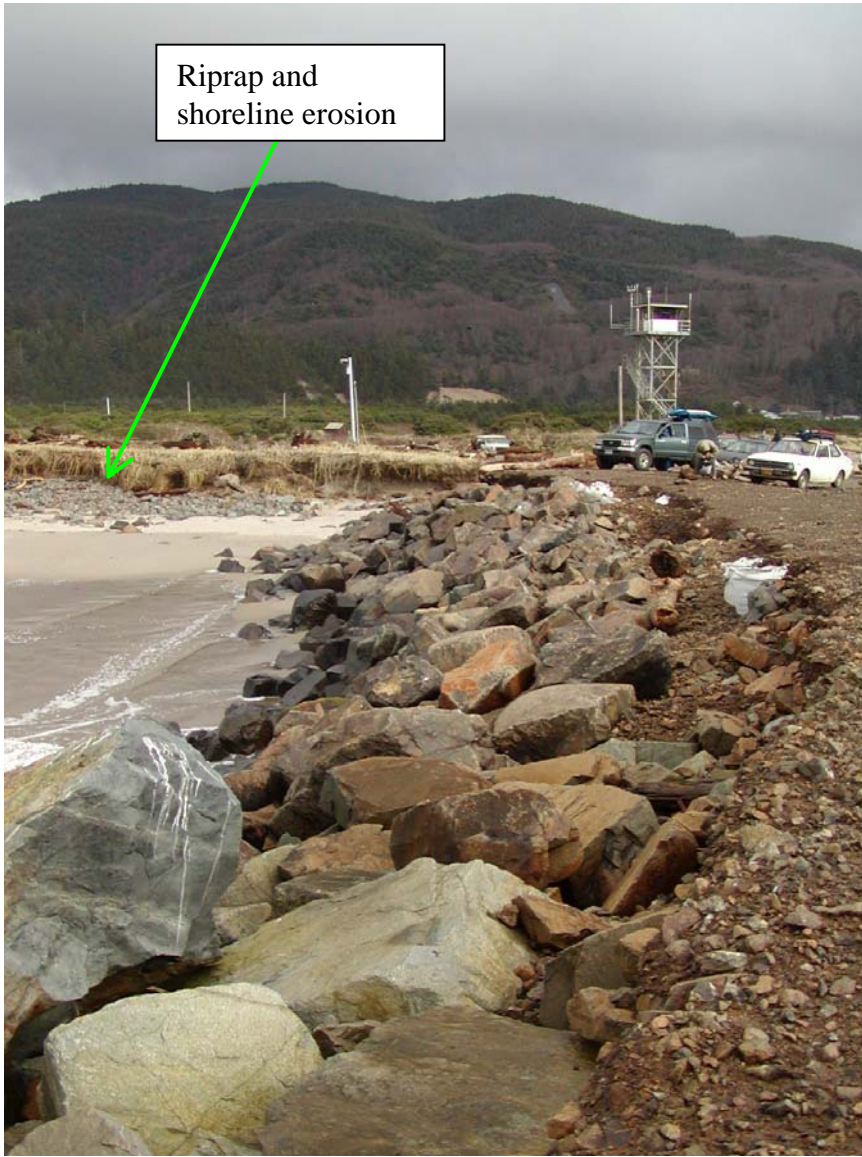
Figure 2-2 North Jetty shoreline erosion and riprap placed winter 2001. Photo 1/18/2002

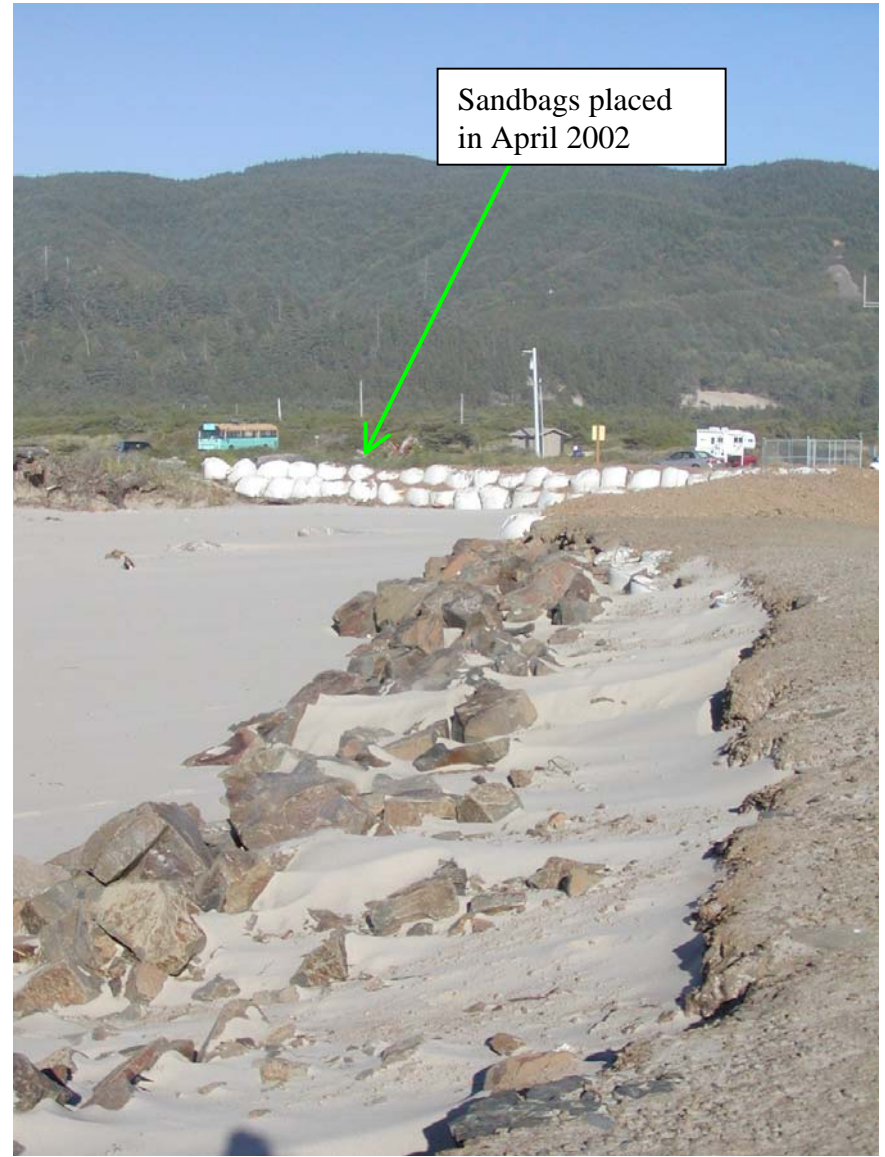
Figure 2-3 North Jetty shoreline erosion and sandbags placed in April 2002. Photo 9/23/2002

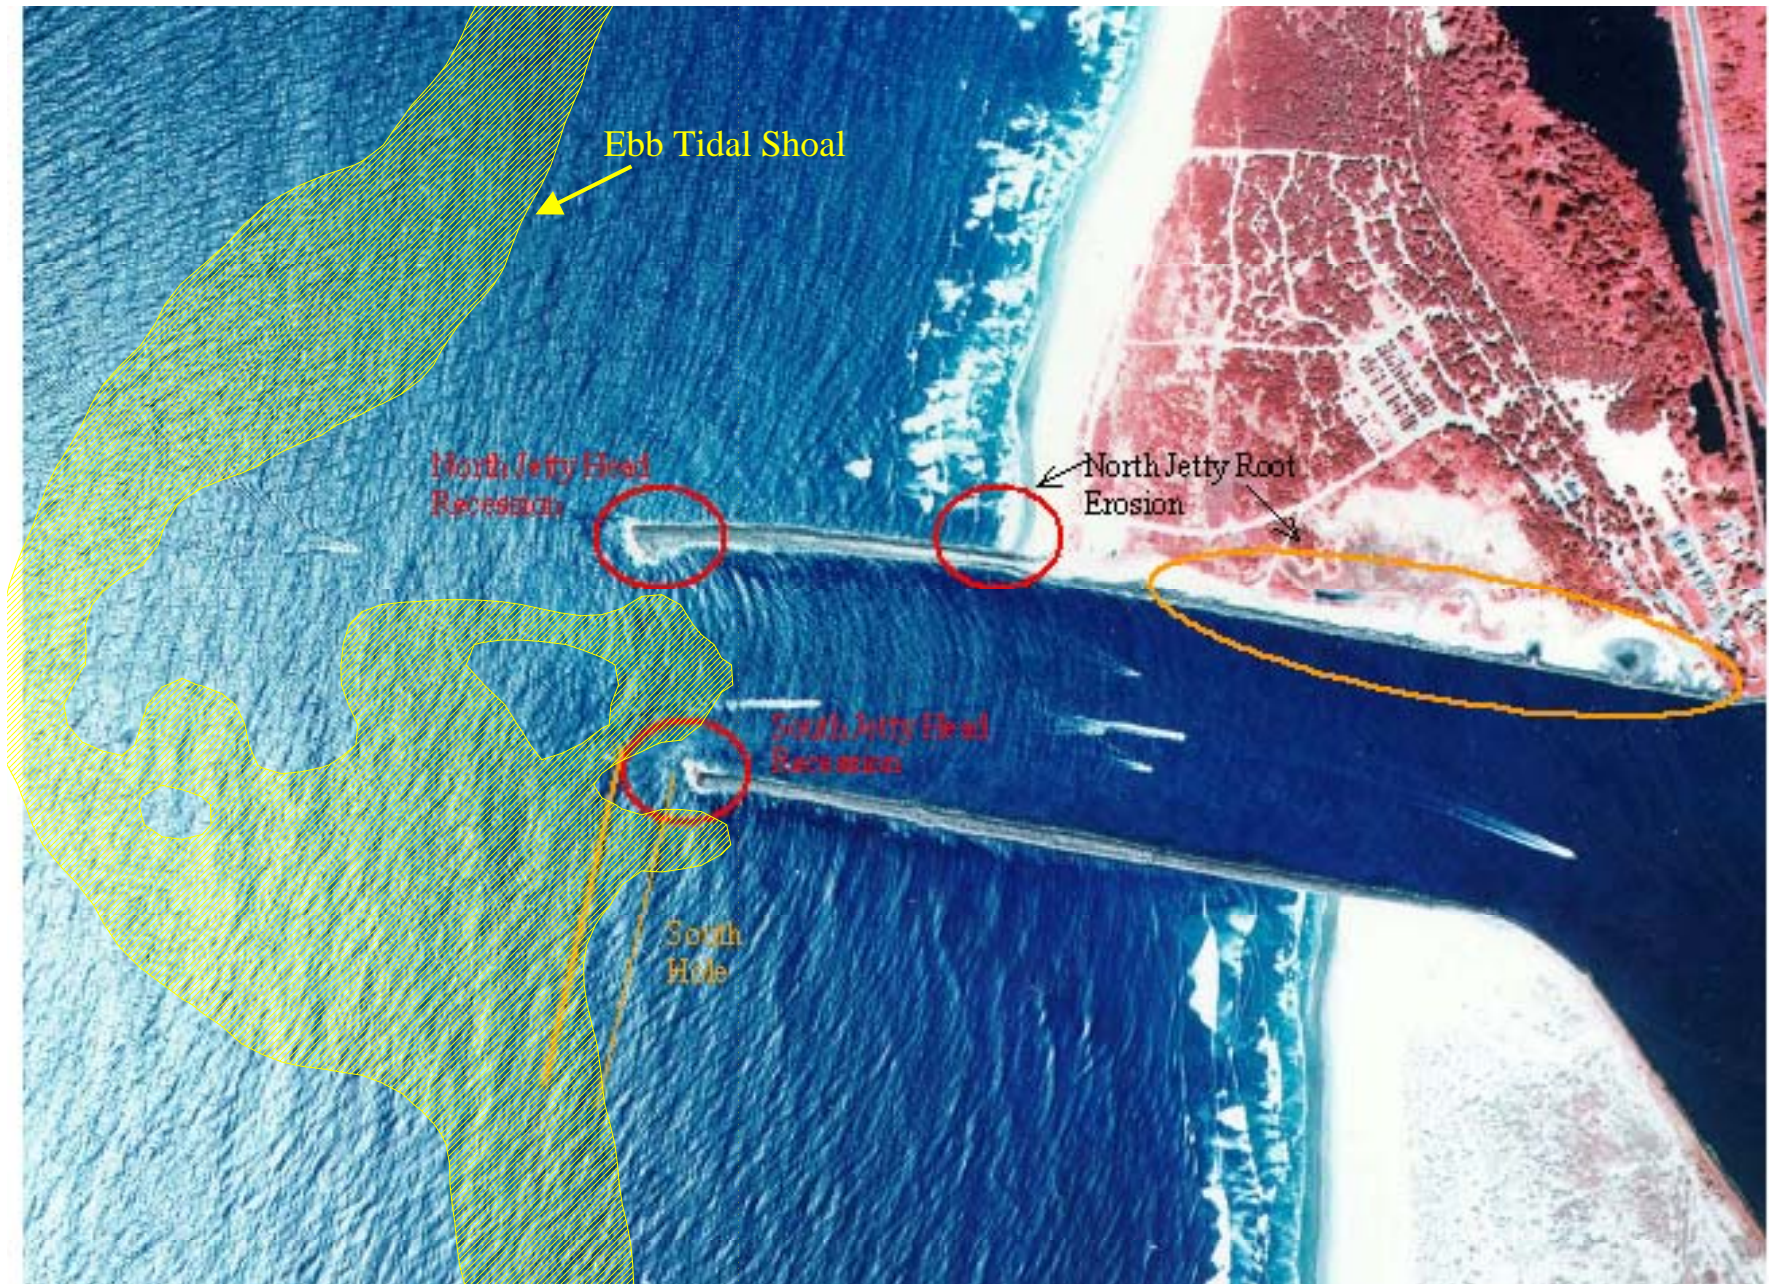
Figure 2-7 Problem Areas Map

Deterioration of the north and south jetty heads, as well as other locations along the structures, has caused concern for navigability through the channel and for overall stability of the jetties. Figure 2-7 shows an aerial view of the areas of concern. The severity of the jetty deterioration was analyzed along the entire length of both jetties. Damage areas were evaluated to determine the type and severity of damage evident at the various sections. Several severe damage areas were identified along the trunks of both jetties. Figures 2-8 and 2-9 show the damage areas along both jetties. Based on FY 2000 structure surveys, the north jetty exhibits 2,884 ft of damage along the structure, 2,500 ft damage along the trunk, and currently has 384 ft of submerged jetty head. An additional 2000 feet of the north jetty is also damaged based on visual inspection and aerial photography. Survey data for this portion of the jetty between stations 0+00 and 20+00 is not yet available; therefore, the exact amount of damage is unclear. Except for the head damage areas, damage areas are found on the channelside, oceanside toe, and crest primarily. Of the damage areas noted along the north jetty, severe/moderate/minor damages were assessed at (20/76/4) %, respectively. The south jetty exhibits 3,866 ft of damage along the structure, 3,200 ft damage along the trunk, and currently has 666 ft of submerged jetty head. The south jetty has not been repaired since its original construction. Damage areas were characterized by comparing the current jetty cross-sections to the constructed cross-sections, including the existing foundation. Of the damage areas noted along the south jetty, severe/moderate/minor damages were assessed at (51.5/47/1.5)%, respectively.

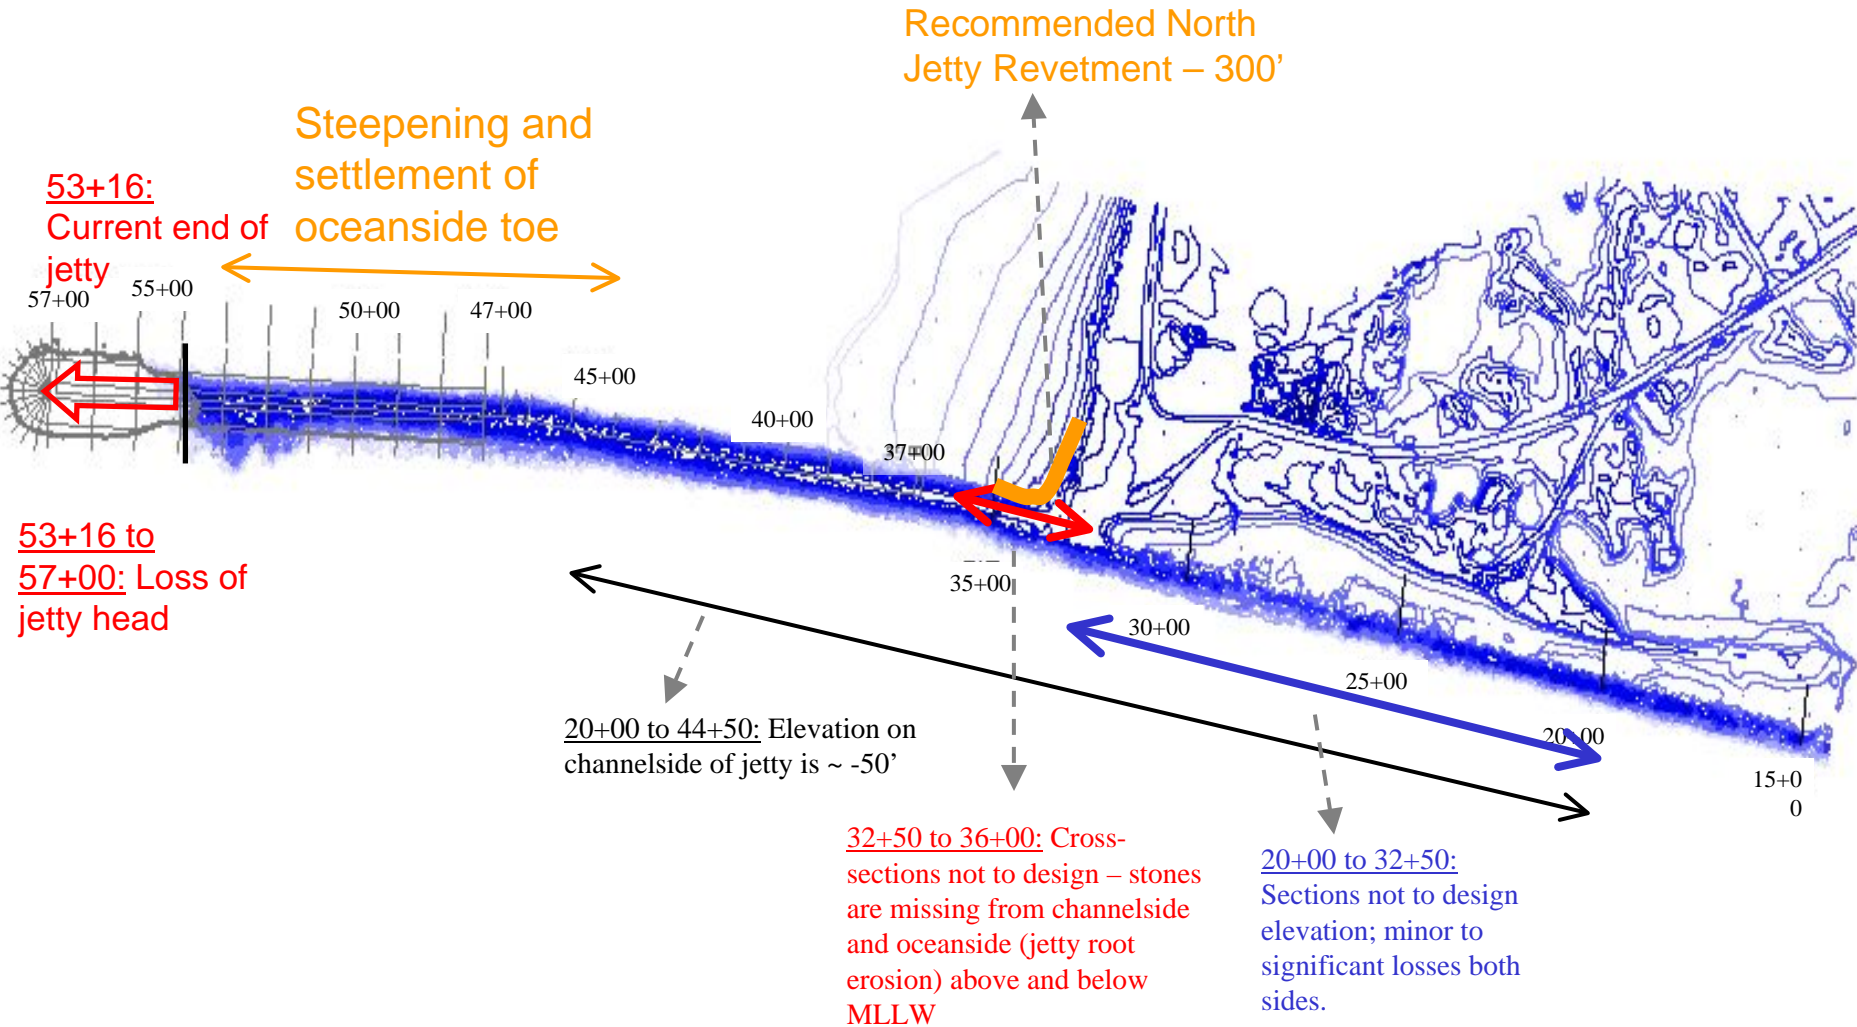
Figure 2-8 North Jetty Damage Areas

- a. Assessment of North Jetty Condition in 2003. The head of the jetty has suffered extensive damage. The end of the jetty continues to erode, with the current end station at 53+16, 384 ft shorter than the authorized station of 57+00. The head that was constructed in 1991 has been destroyed. There appears to be wrapping of stone around the end of the jetty into the channel side. This is creating a notch at the end of the jetty, about 100 ft seaward of a pre-existing notch near the end of the jetty that has been apparent since about 1987.

A large portion of the outer, channel side lower slopes were displaced prior to the previous repair and are present at low tide as a flattened slope that extends toward the channel. Small scallops have been observed at several locations along the channel side. The seaward side appears to be in good condition with stones still retaining good interlocking and placement.

The area adjacent to the shoreline and extending landward, STA 22+00 to 37+00, is in need of repair. The jetty between STA 22+00 and 29+50 exhibits damage on the north sideslope above MLLW, and damage along the crest, mainly on the seaside. The worst

damage area extends from STA 29+50 to 37+00 with severe damage along the crest and damage to the south sideslope above and below MLLW.

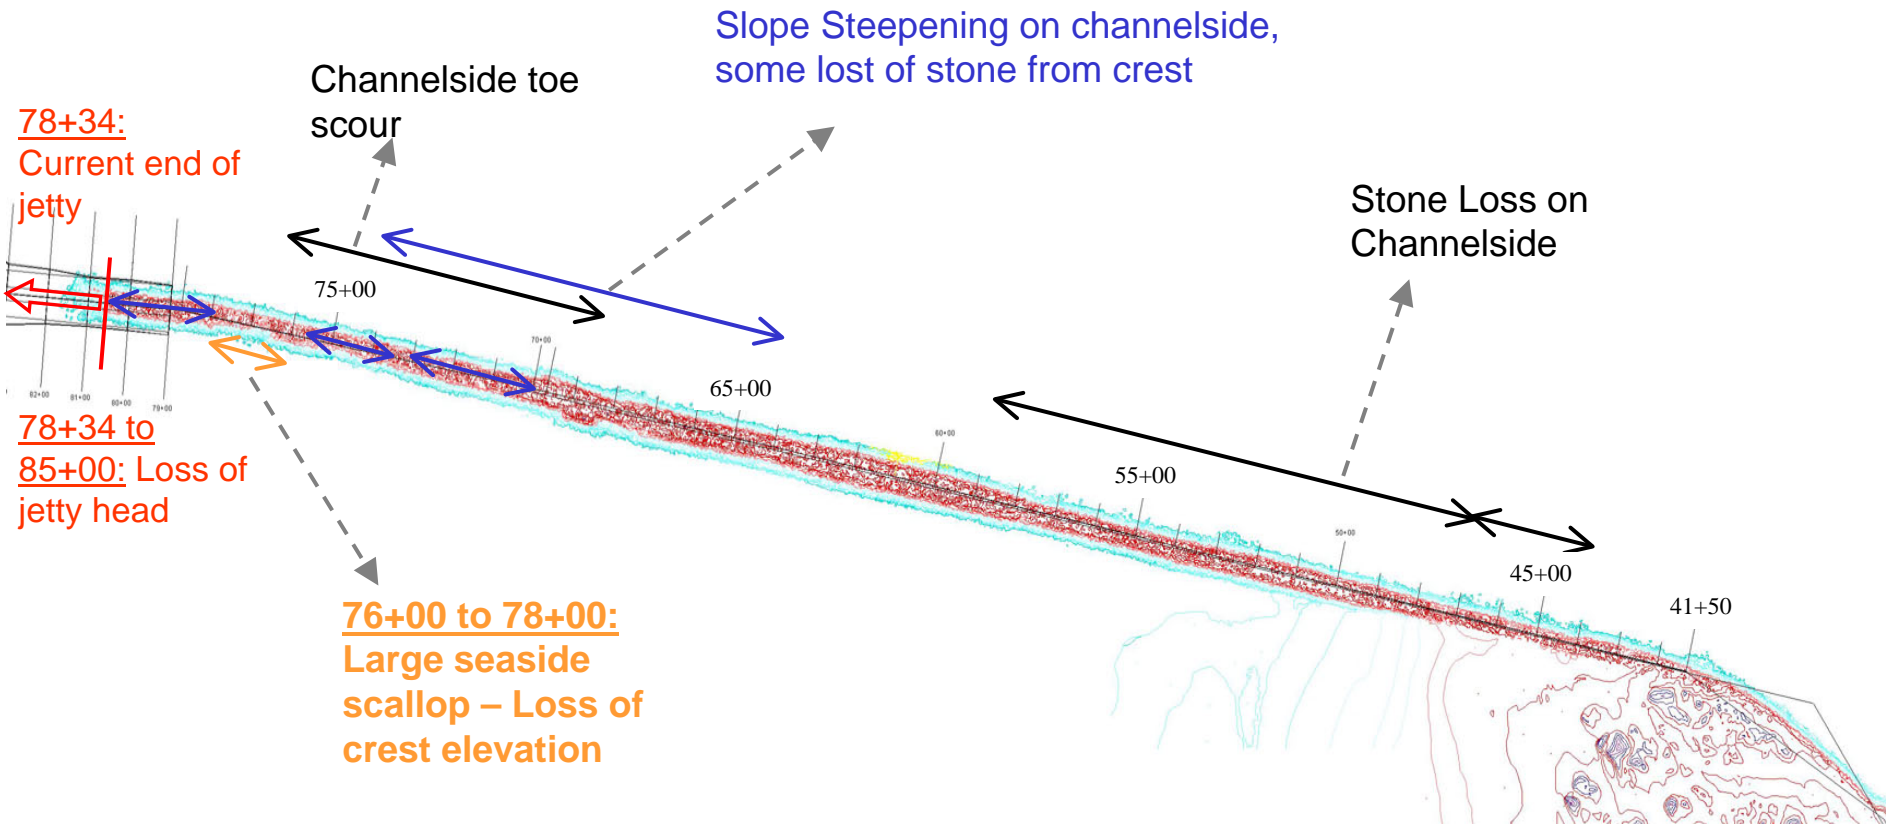
Figure 2-9 South Jetty Damage Areas

The area adjacent to the shoreline and extending seaward, STA 44+00 to 58+00, is in need of repair. The jetty exhibits damage along the north sideslope above and below MLLW and also along the north side of the crest.

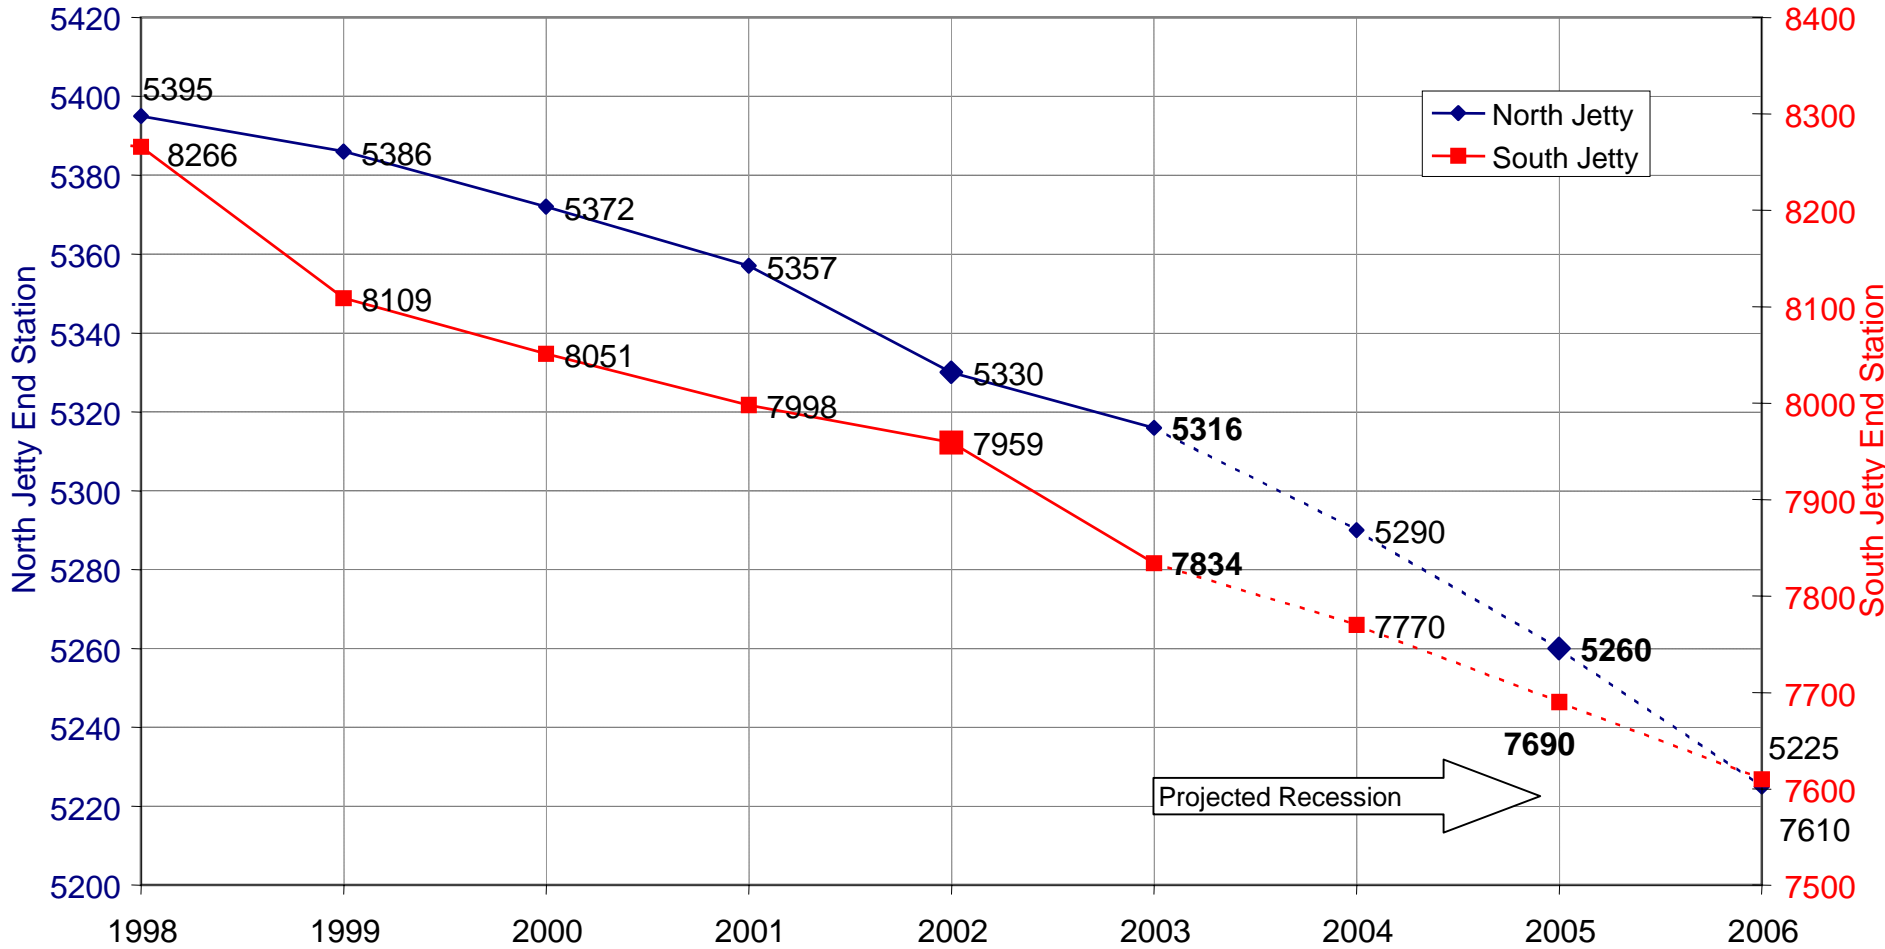
Figure 2-10 Projected Jetty End Stations

Severe damage areas occur at the seaward ends, where there is substantial deterioration evidenced by the submerged jetty heads. If repairs to the jetty heads are not conducted, figure 2-10 shows the projected recession of the ends of the jetties, based on historical recession rates through 2003. At historical jetty head recession rates, by 2005, the north jetty will be 201 ft shorter than the 1991 head location, 440 ft shorter than the authorized length. The south jetty will be 810 ft shorter than the authorized length. The 2005 jetty end station was chosen because that is the earliest possible construction year that work on the jetty heads could be started.
