Tillamook Major Maintenance

July 26, 2004

Existing Project Condition

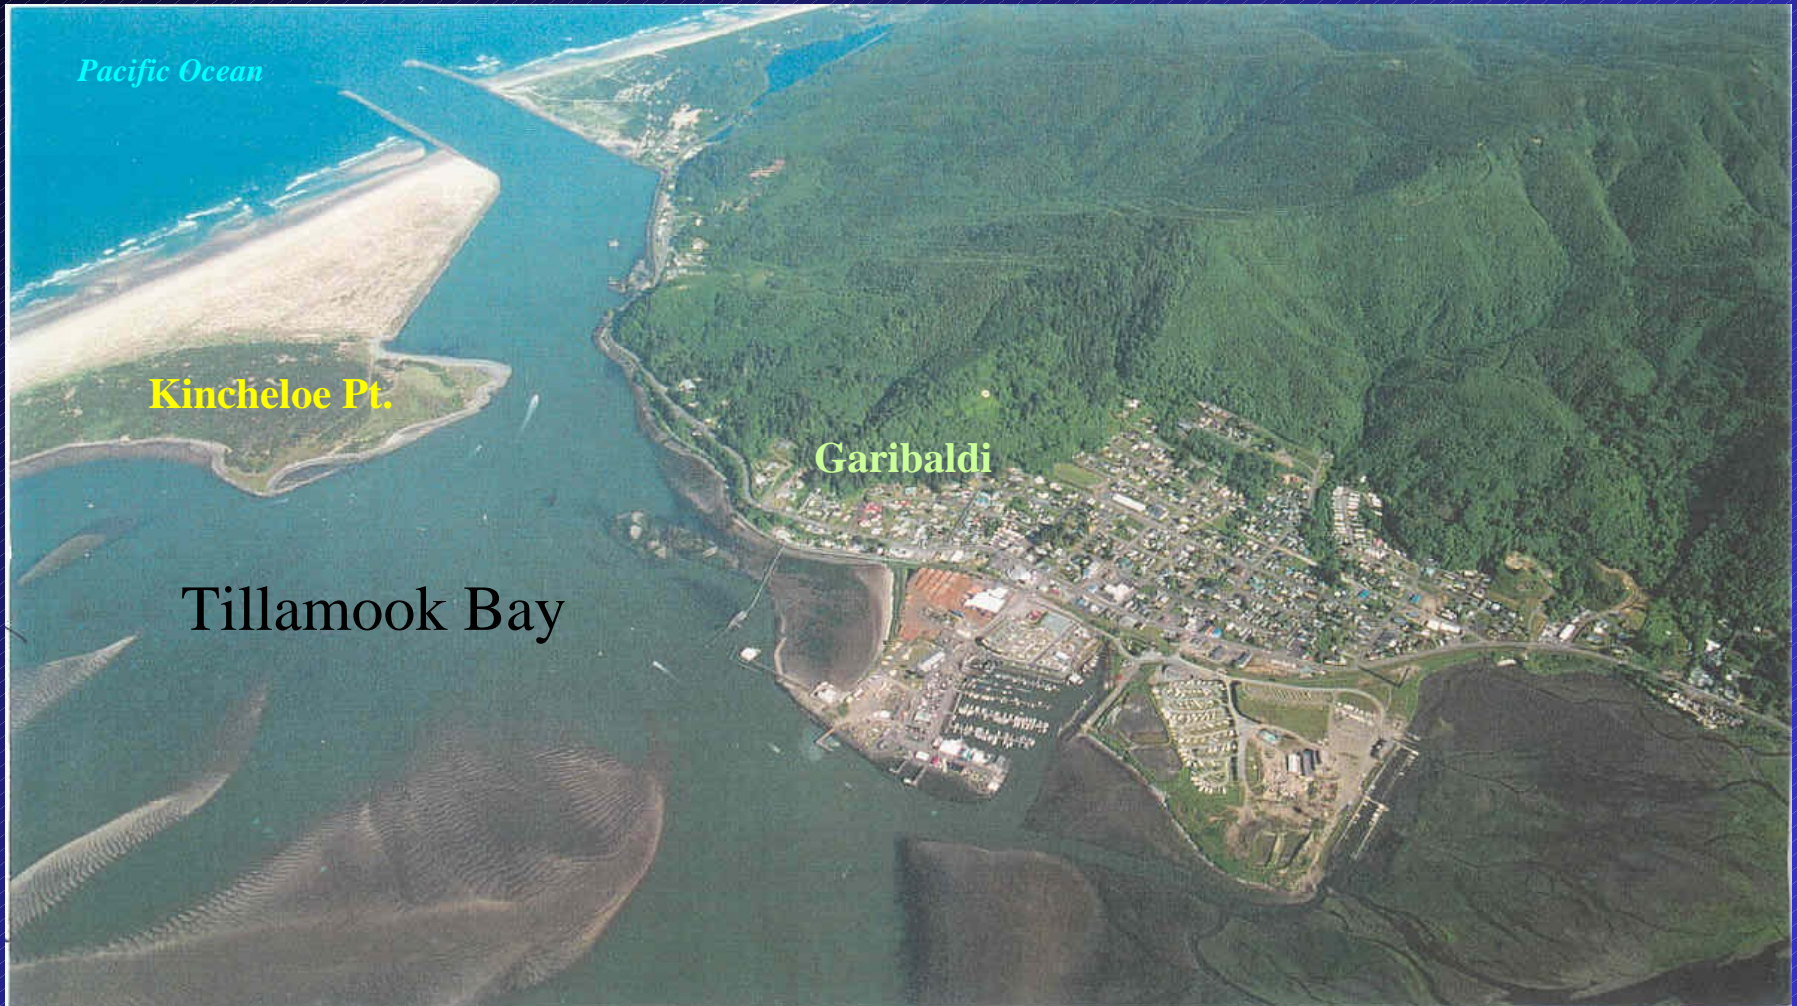
400' of submerged
North Jetty

Root
Erosion

Weakened North
Jetty along Root

730' of submerged
South Jetty

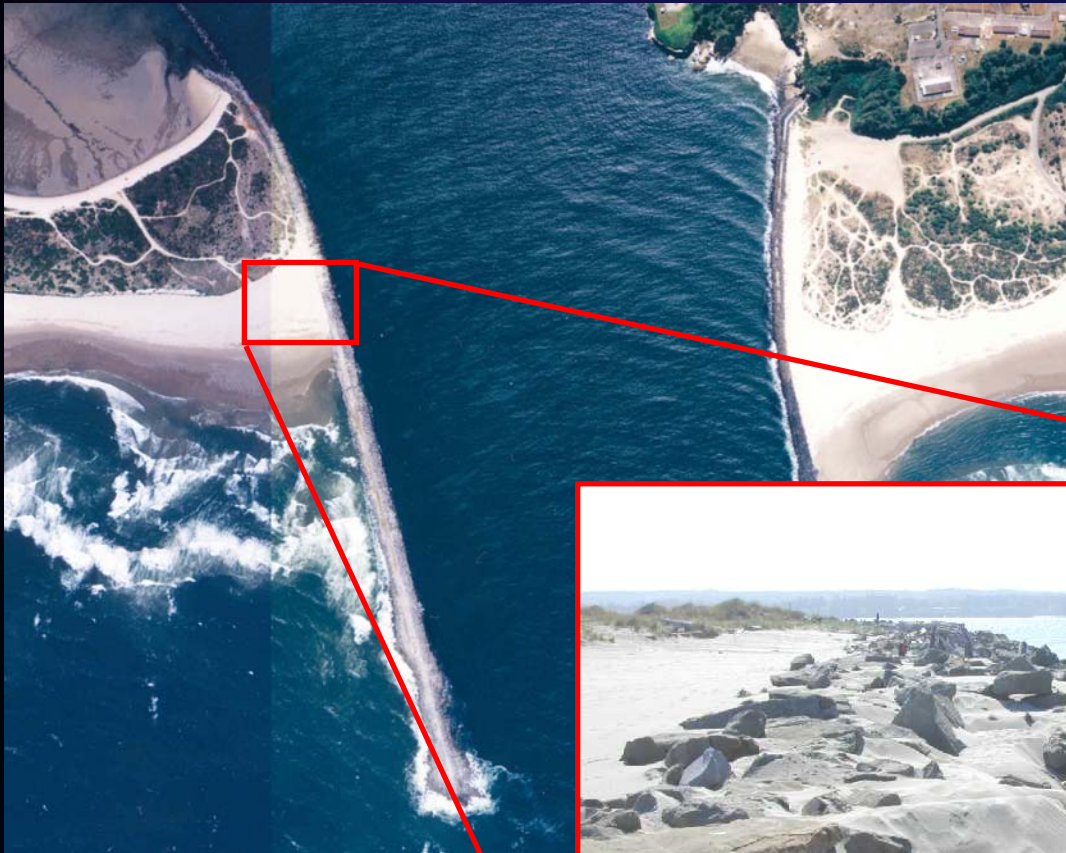
Prior to emergency repair,
North Jetty root was last
repaired in 1939 with a crest
elevation 9 ft lower than the
rest of the structure \Rightarrow allowed
windblown sand to erode and
move into the channel

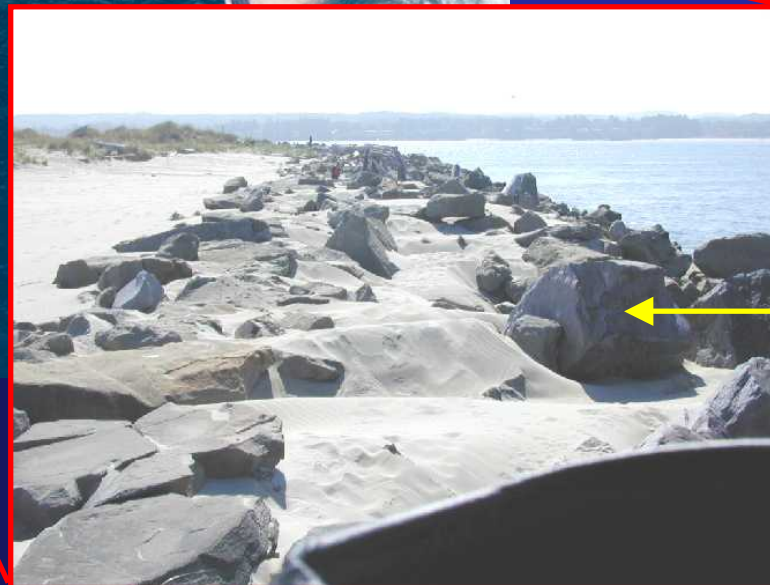
Rock used for
1939 repair was
sandstone, not
very durable
stone

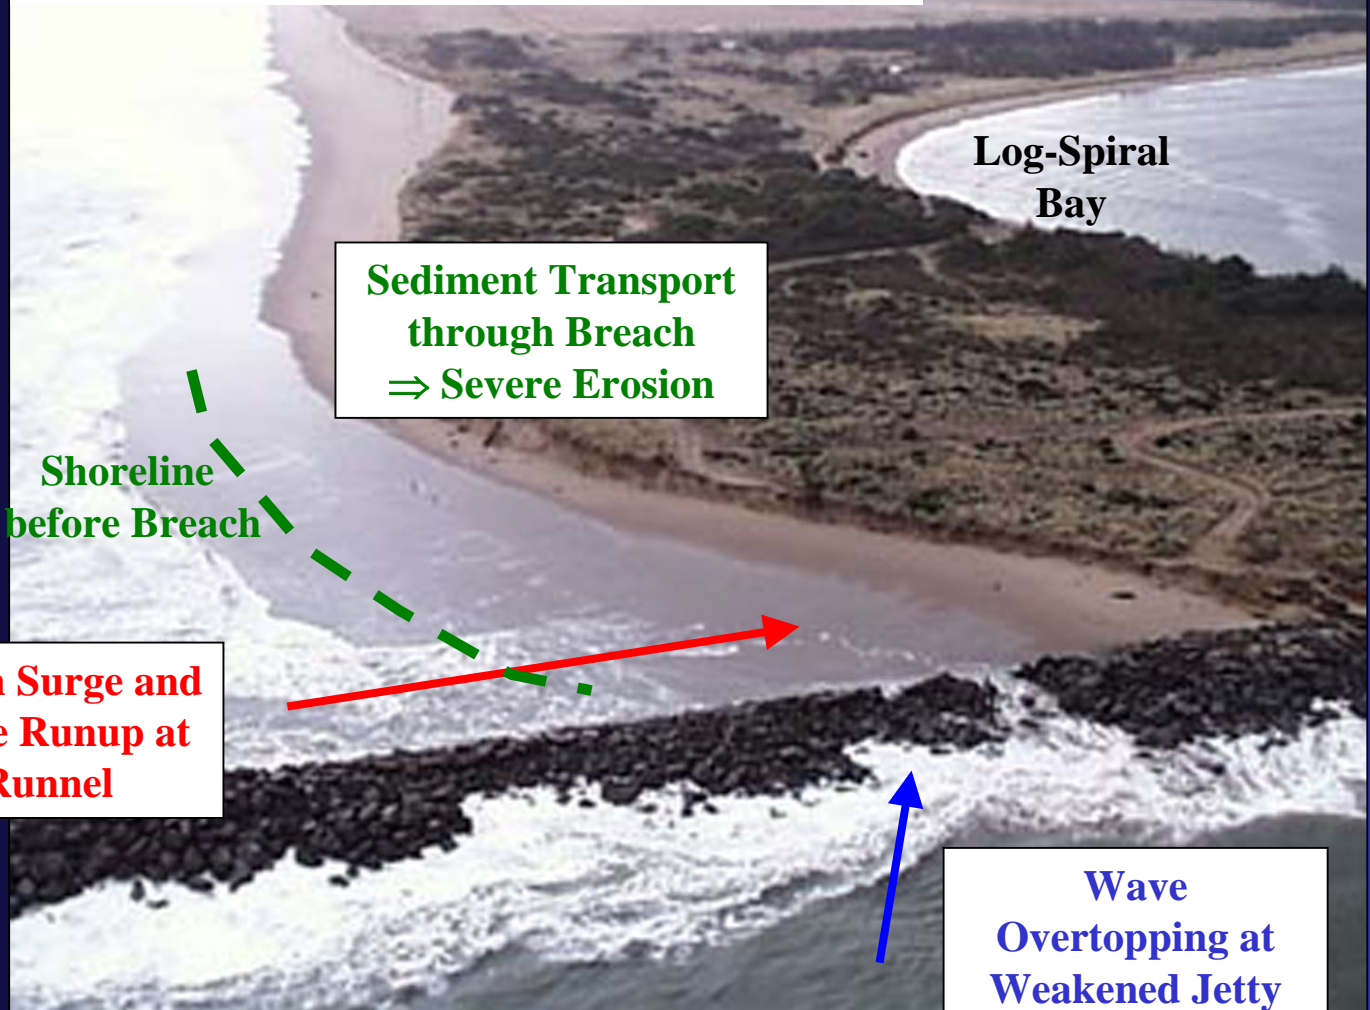
November 8, 2002 North Jetty Breach

Sediment Transport
through Breach
⇒ Severe Erosion

Storm Surge and
Wave Runup at
Runnel

Wave
Overtopping at
Weakened Jetty
Root

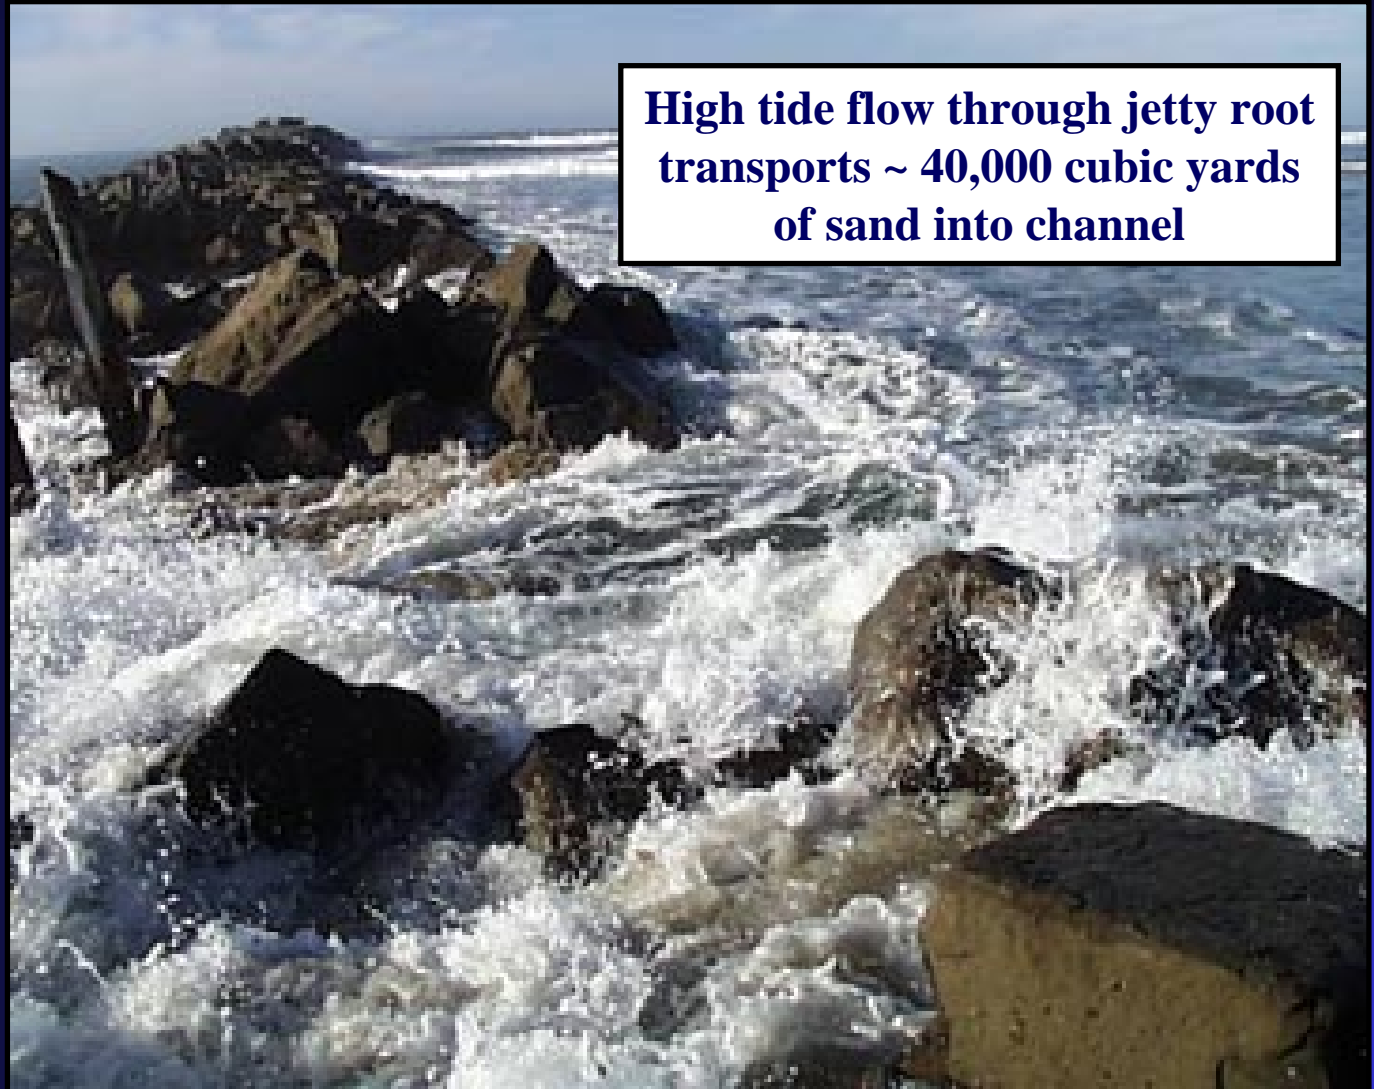
**High tide flow through jetty root
transports ~ 40,000 cubic yards
of sand into channel**

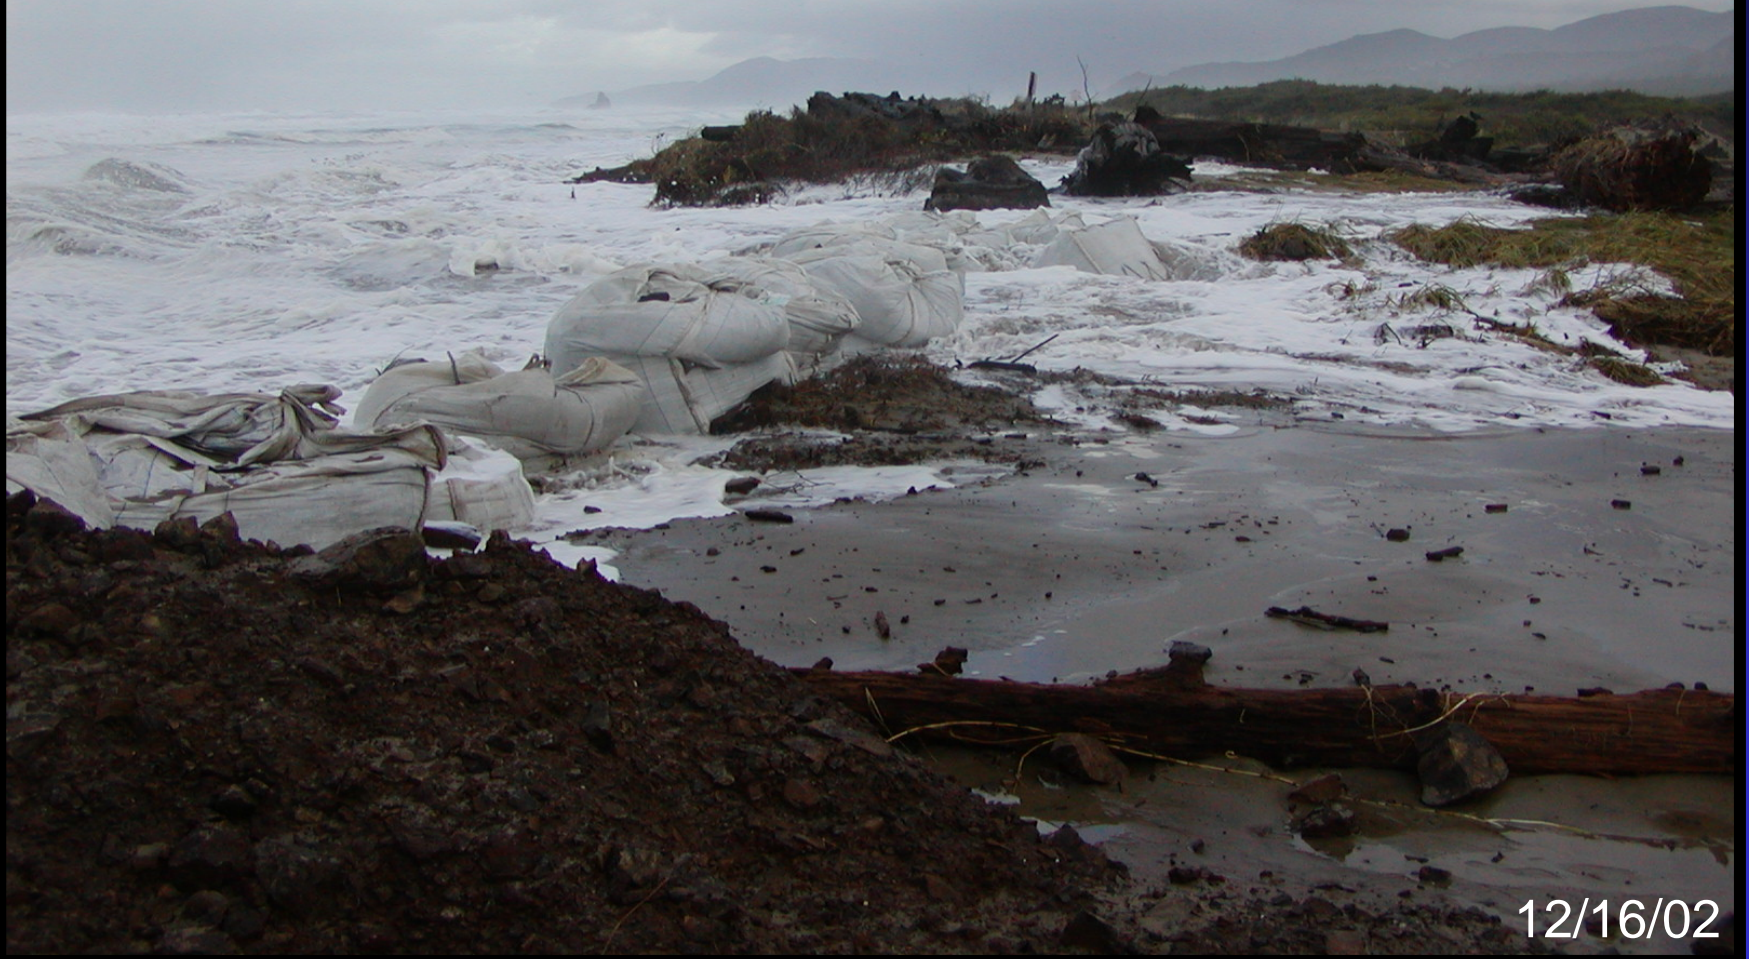
12/16/02

If this narrow section of beach is breached, the north jetty root will likely fail soon afterward

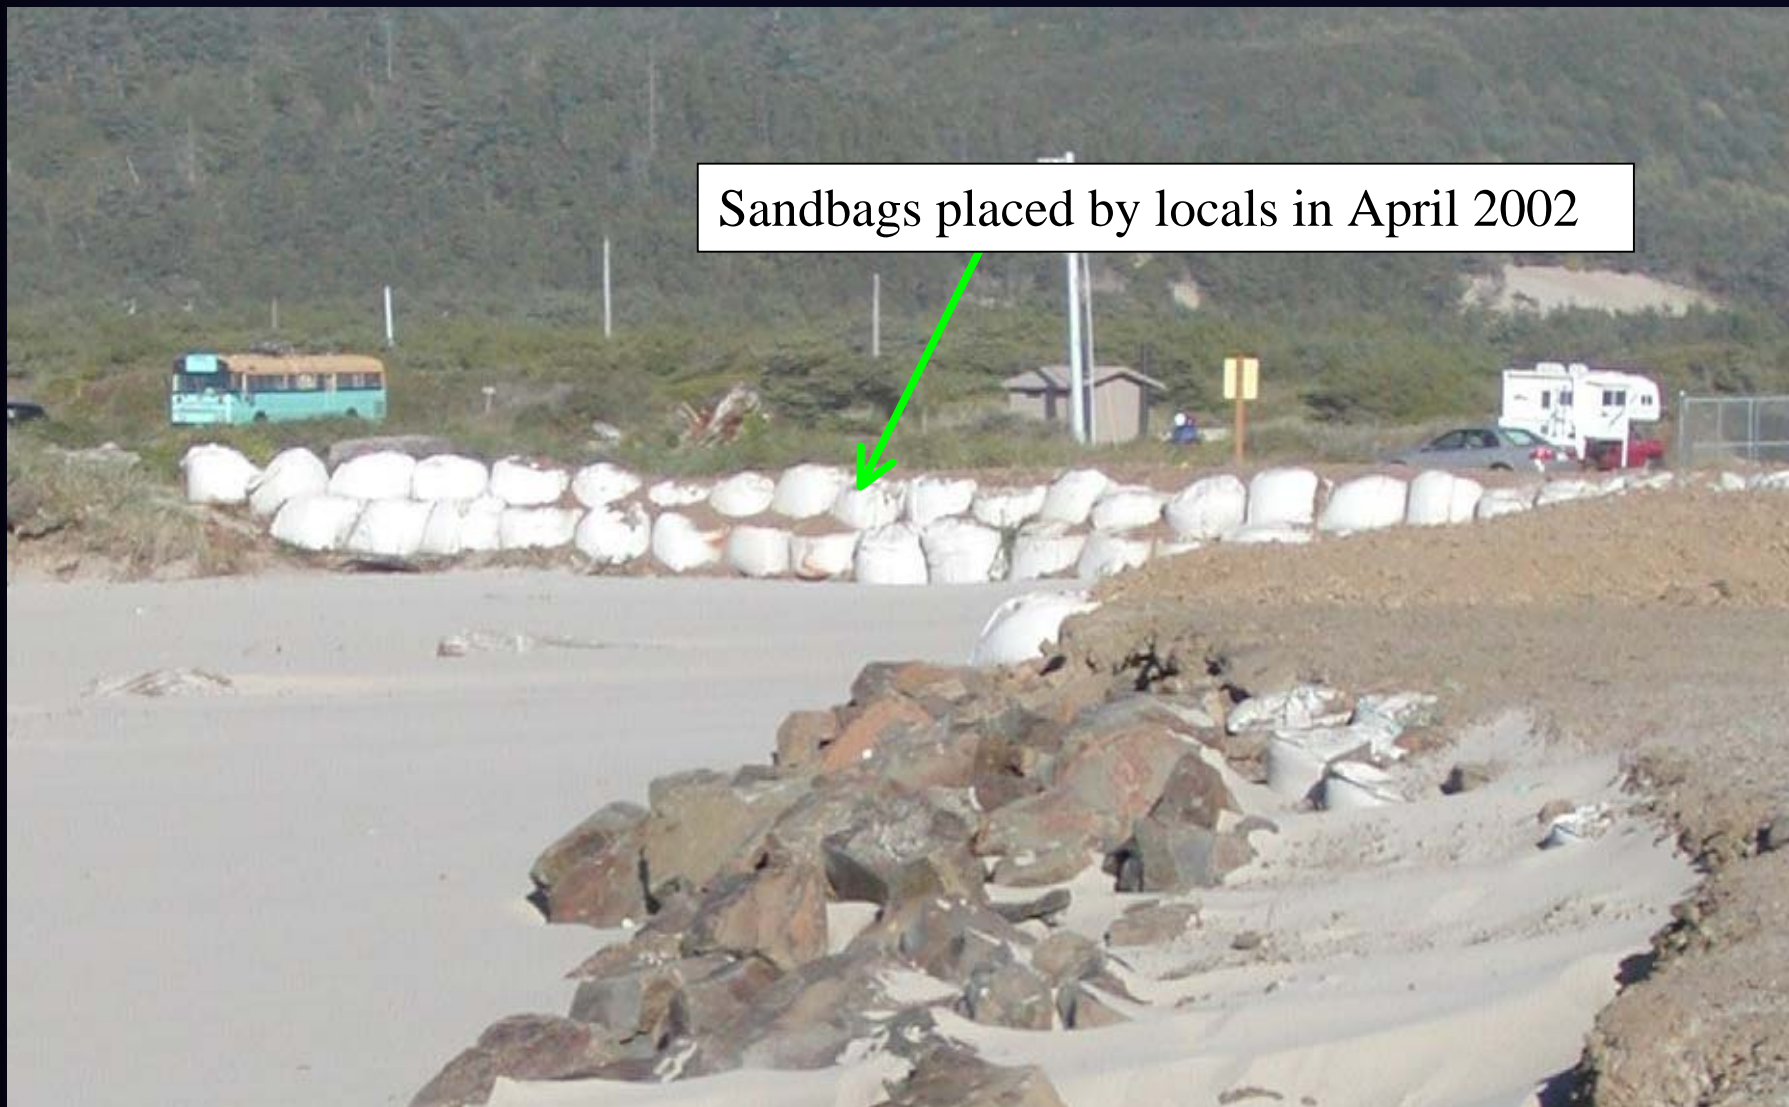
Sandbags placed by locals in April 2002

**Figure 2-3 North Jetty shoreline erosion and sandbags placed in April 2002.
Photo 9/23/2002**
