## **FACE 82-02: Fall from a Scaffold Involving a Construction Foreman**

### **INTRODUCTION**

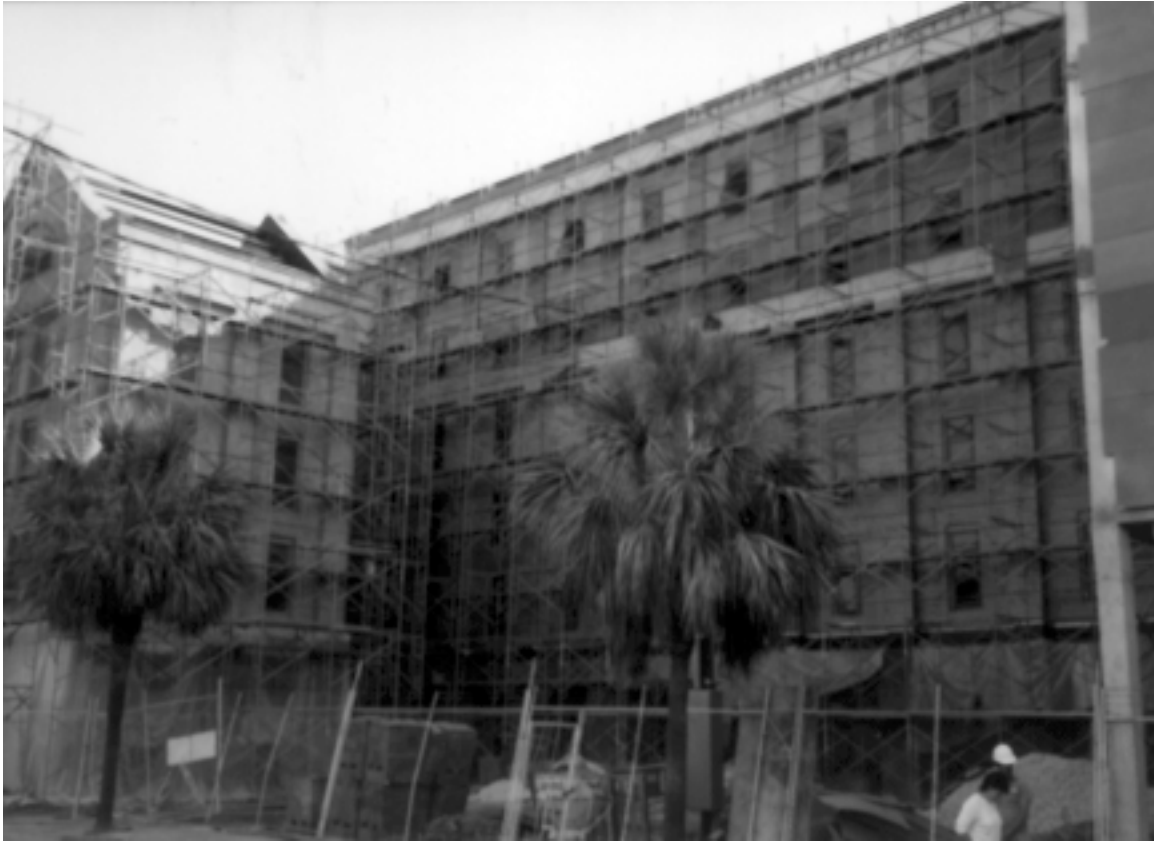
been loosely secured or not secured at all to the scaffolding uprights, gave way allowing the victim to fall approximately 48 feet to the ground. Another employee saw the victim strike the scaffold planking at the first level before he struck the ground (see Figure).

**Figure.** *The victim fell from the fifth-floor level of the scaffolding shown here, when he either stood on or fell against the guardrail causing it to give way. The victim was not wearing any fall protection equipment.*

The loose or unsecured guardrail may have been identified and corrected had proper installation, initial inspection, and/or periodic inspection procedures been used.

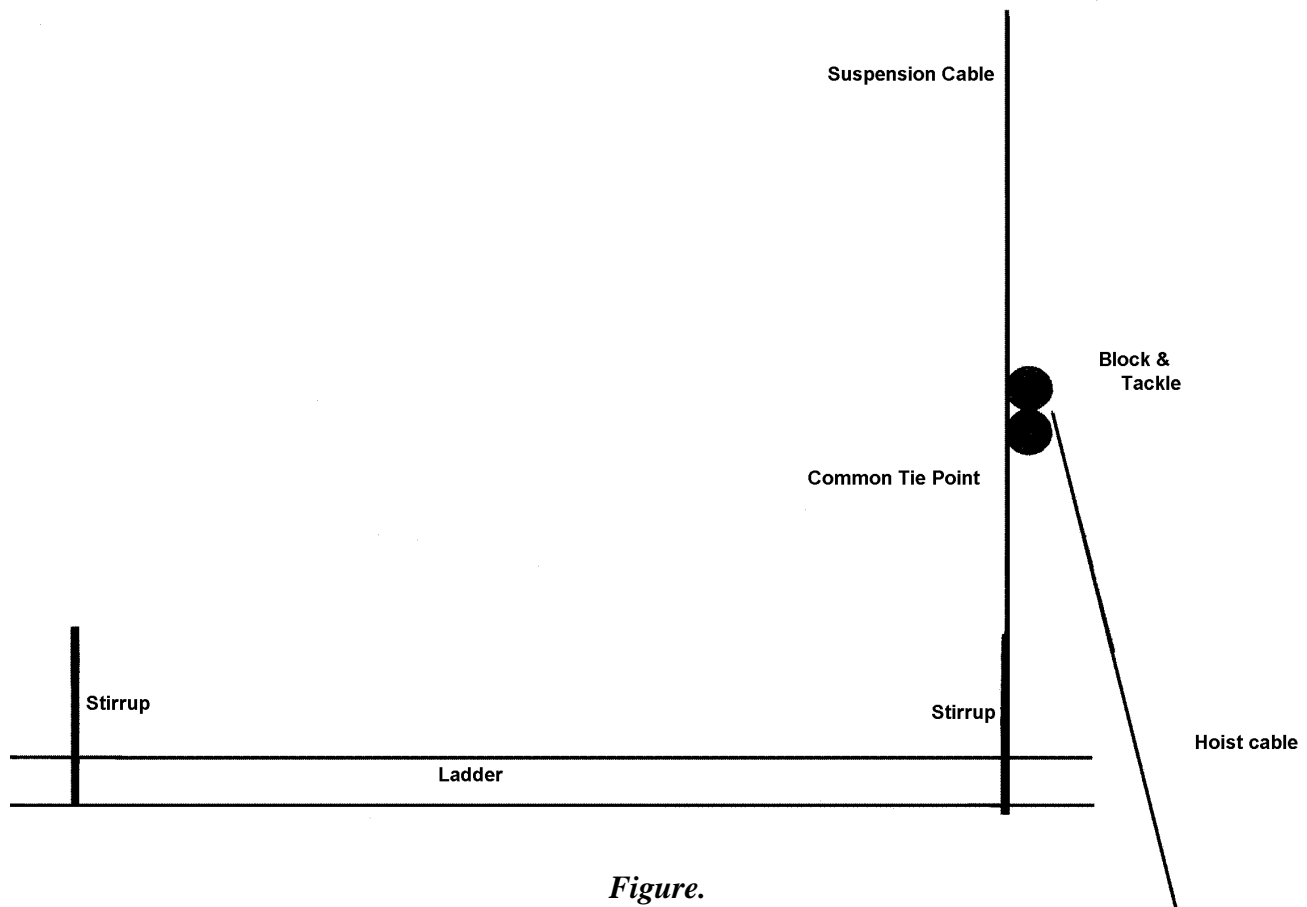
***Figure.***

Discussion: The "scaffold platform" in this incident was a simple aluminum ladder. This ladder was designed to support a load in a vertical position but was being utilized to support a load while in a horizontal position. While this did not directly contribute to this incident, the potential for a failure of the ladder while being used in this manner was certainly present.

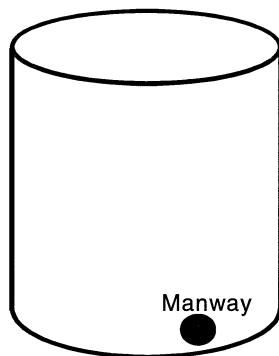
Exterior of 40-foot-diameter by 40-foot-high water tank.

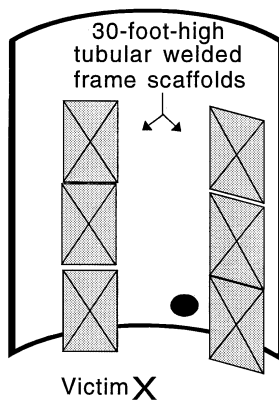
Interior, including scaffolding arrangement and location of victim inside water tank.
