# THE DALLES HYDROELECTRIC PROJECT

## NORTH AND EAST FISH LADDER RELIABILITY ASSESSMENT REPORT

**The Dalles Dam North Fish Ladder  
Inspection Report**

**The Dalles Dam East Fish Ladder  
Inspection Report**

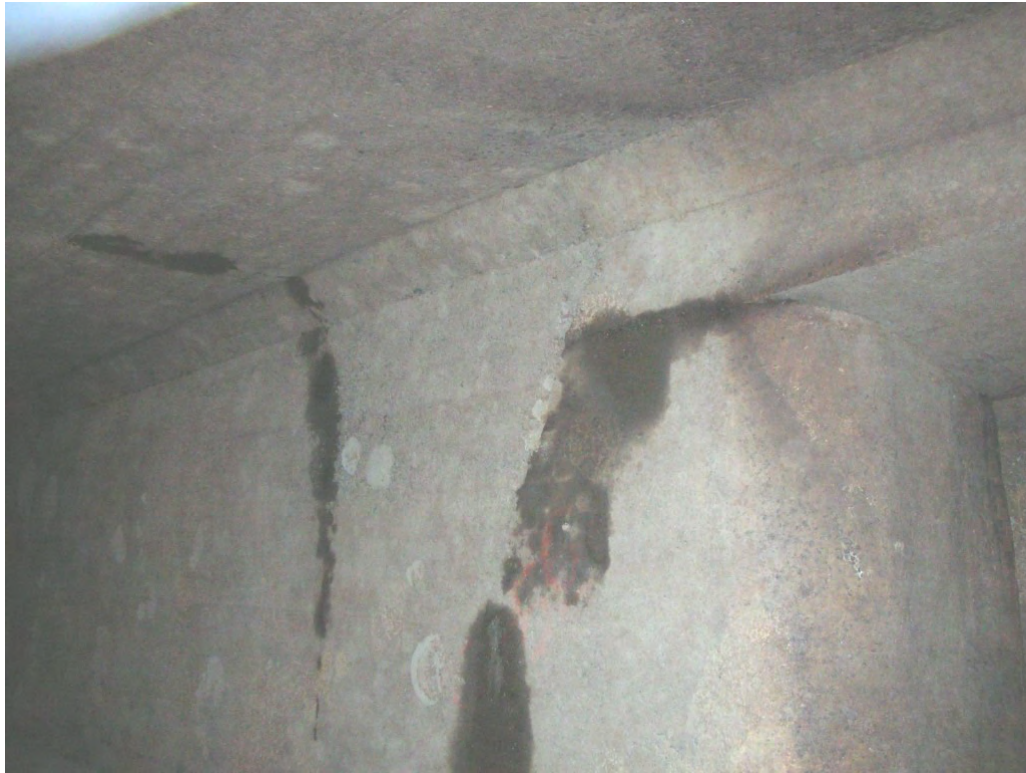
CS-1 Concrete Crack

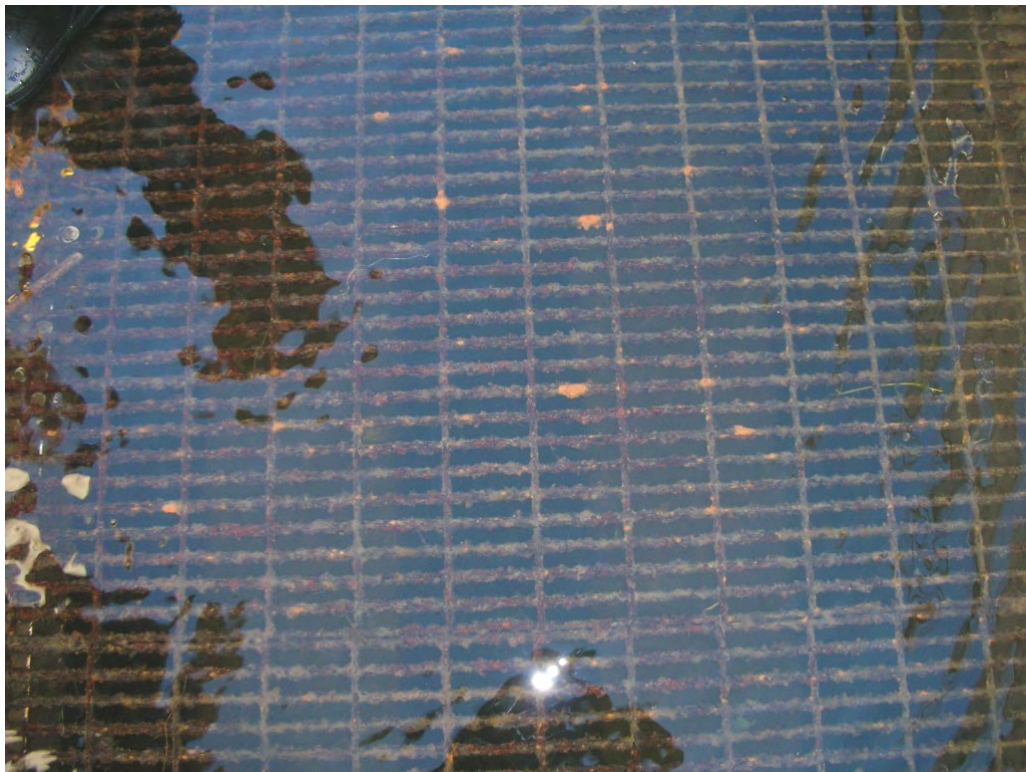
CS-2 Diffuser Grating

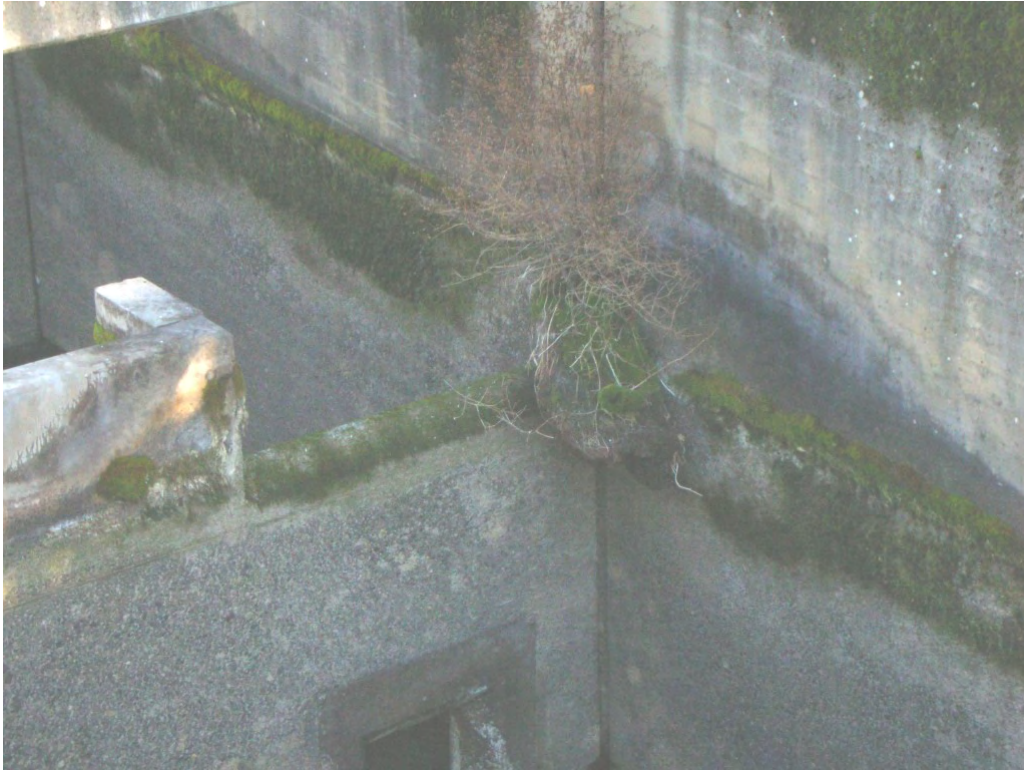
H-15 Root Ball in Channel

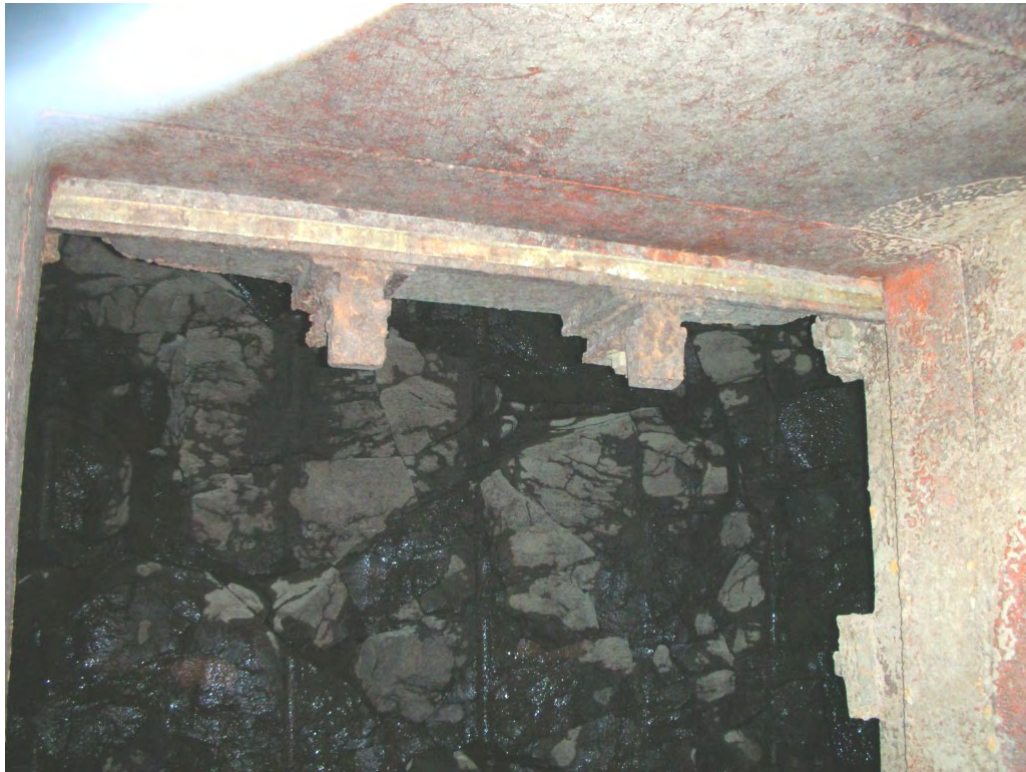
M-2 Diffuser Gate Corrosion

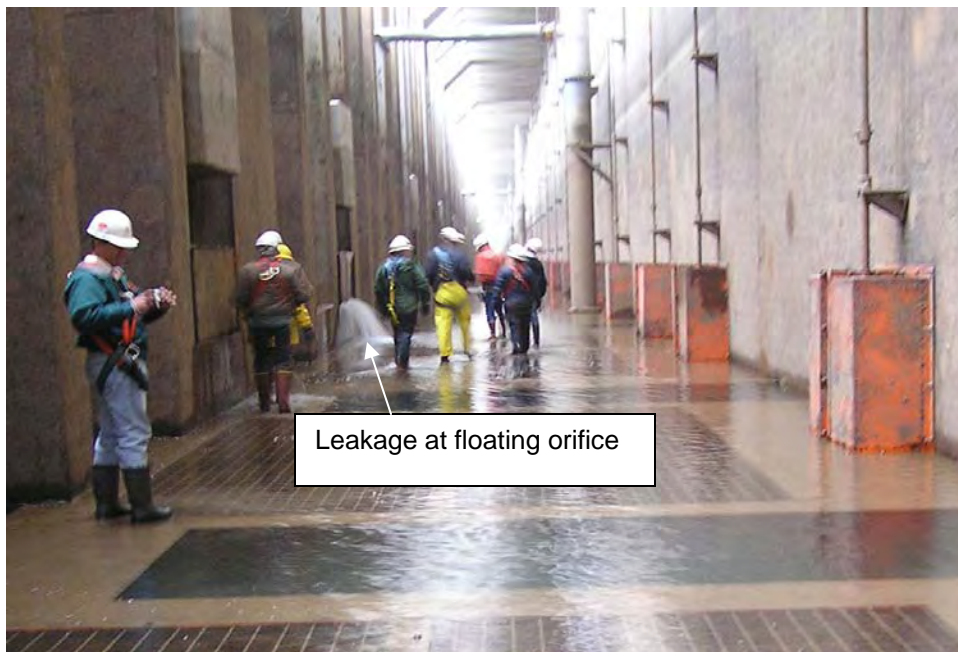
Photo CS- 2 Collection Channel. Note leakage at one floating orifice.

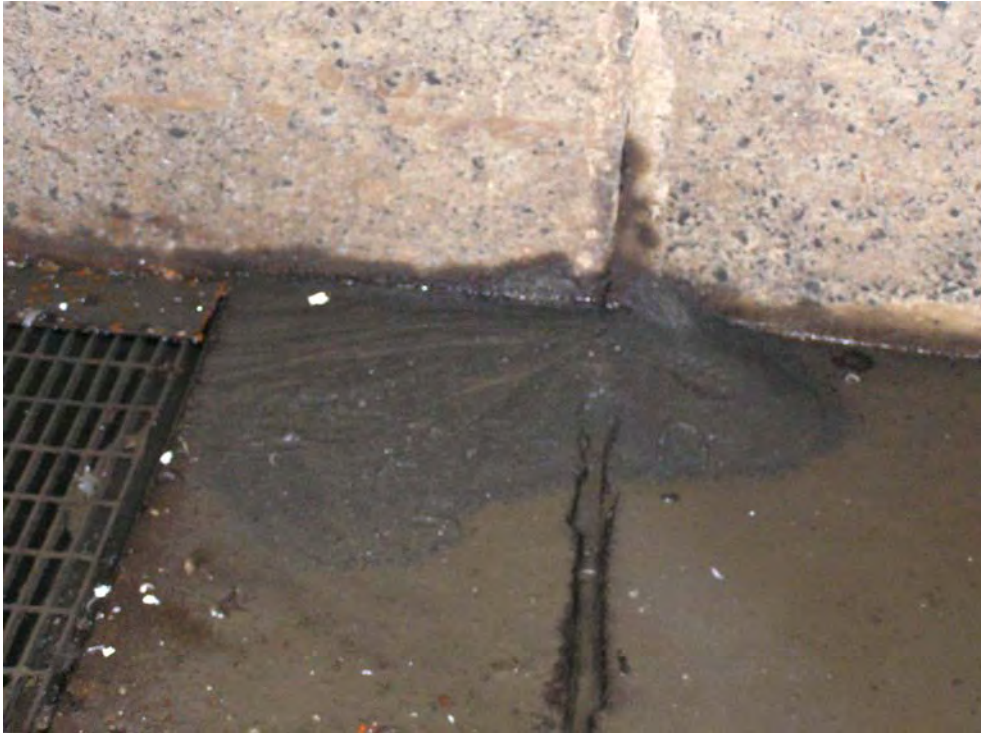
Photo CS-3 Sand accumulated from seepage at joint between concrete sections in Transportation Channel

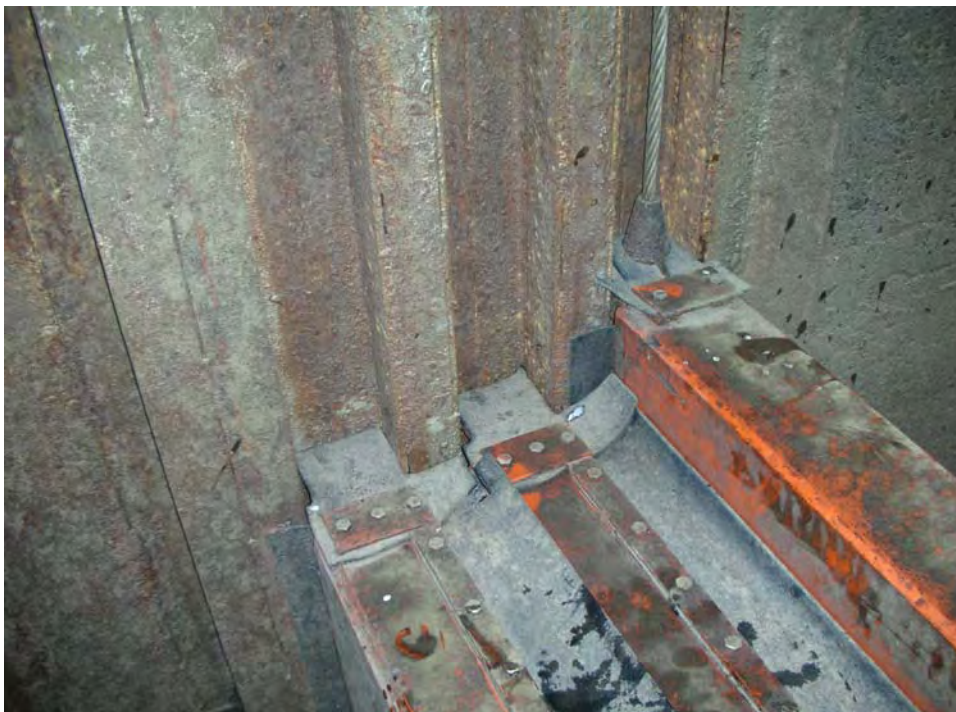
Photo ME-2 Leaf seals on the southernmost weir at East Entrance

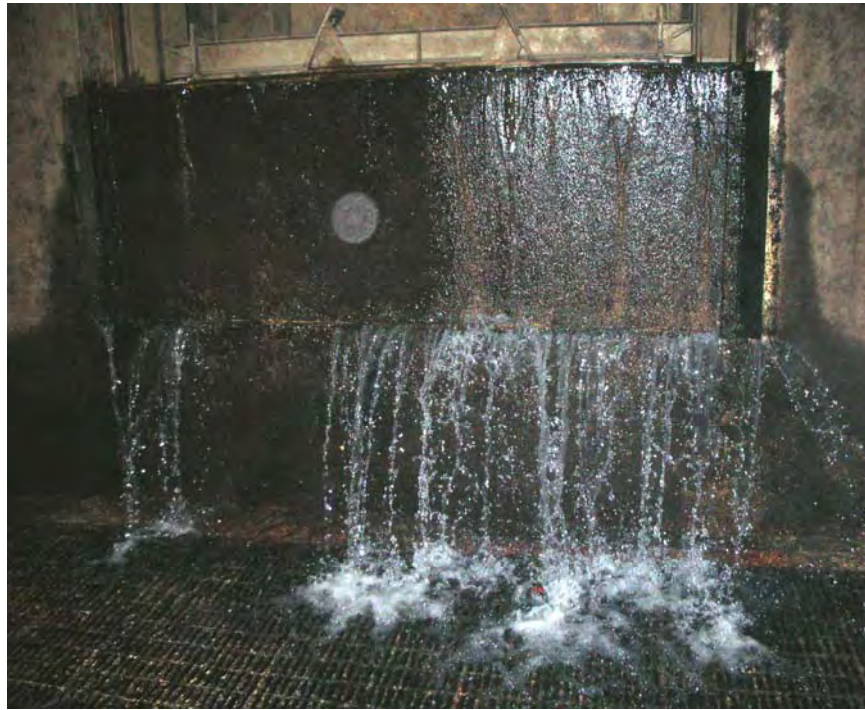
Photo ME-5 Water leaking past downstream bulkhead in collection channel

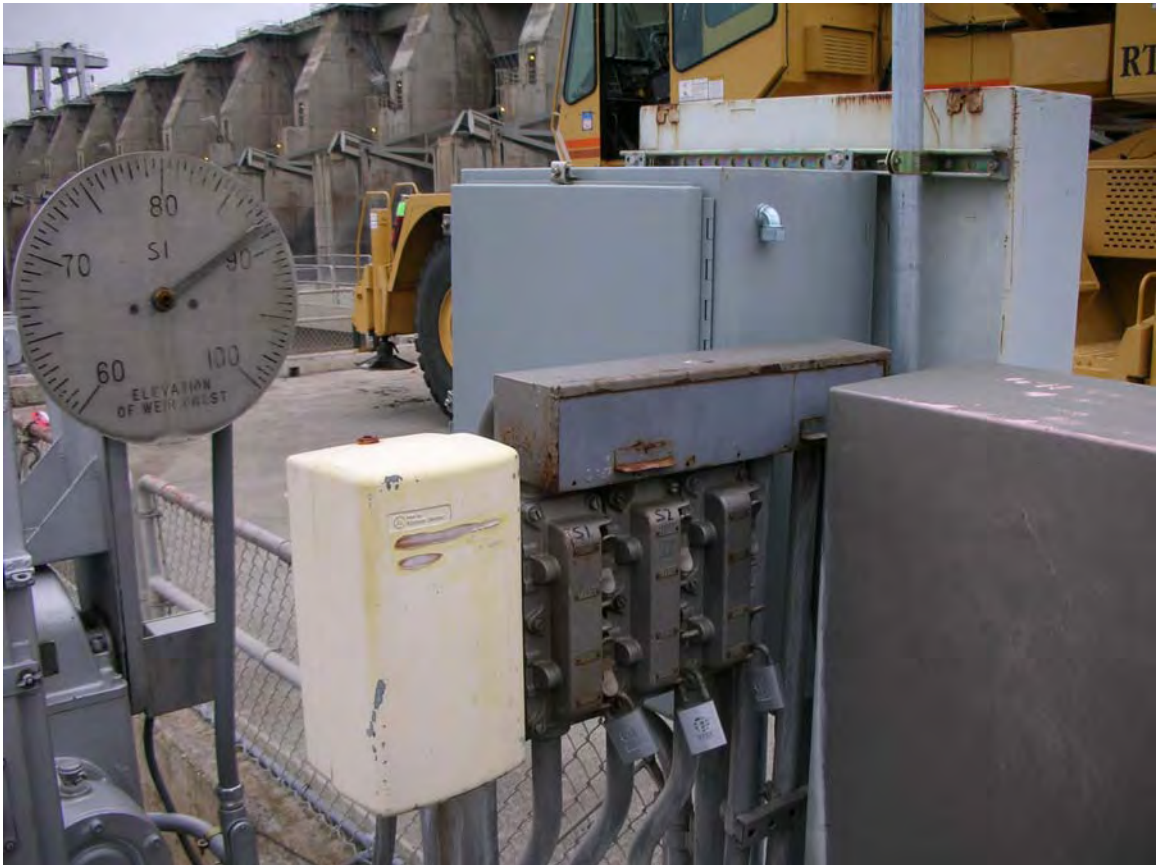
Photo ME-11 Hoist electrical controls at South Entrance showing older condition

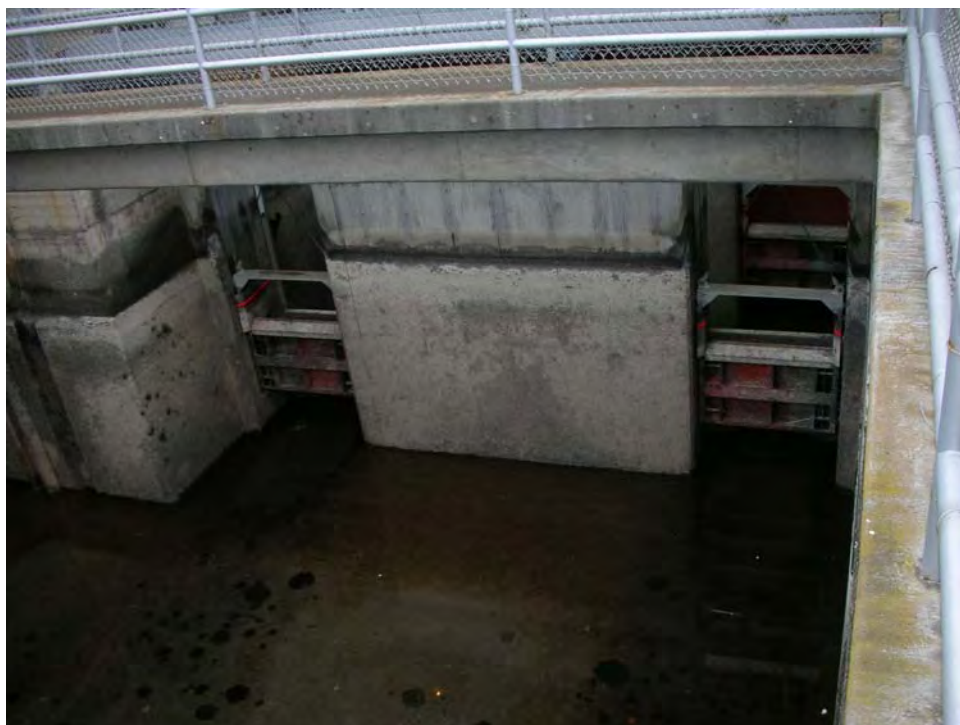
Photo ME-20 Weirs fabricated from a former single weir

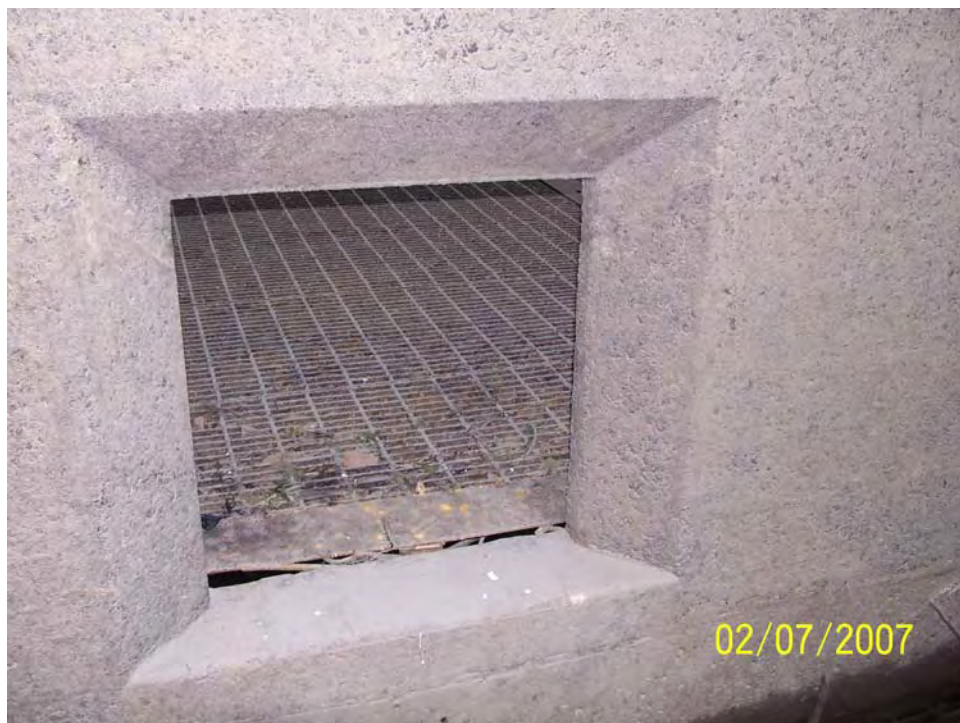
Photo H-4 Debris between diffuser grating and orifice

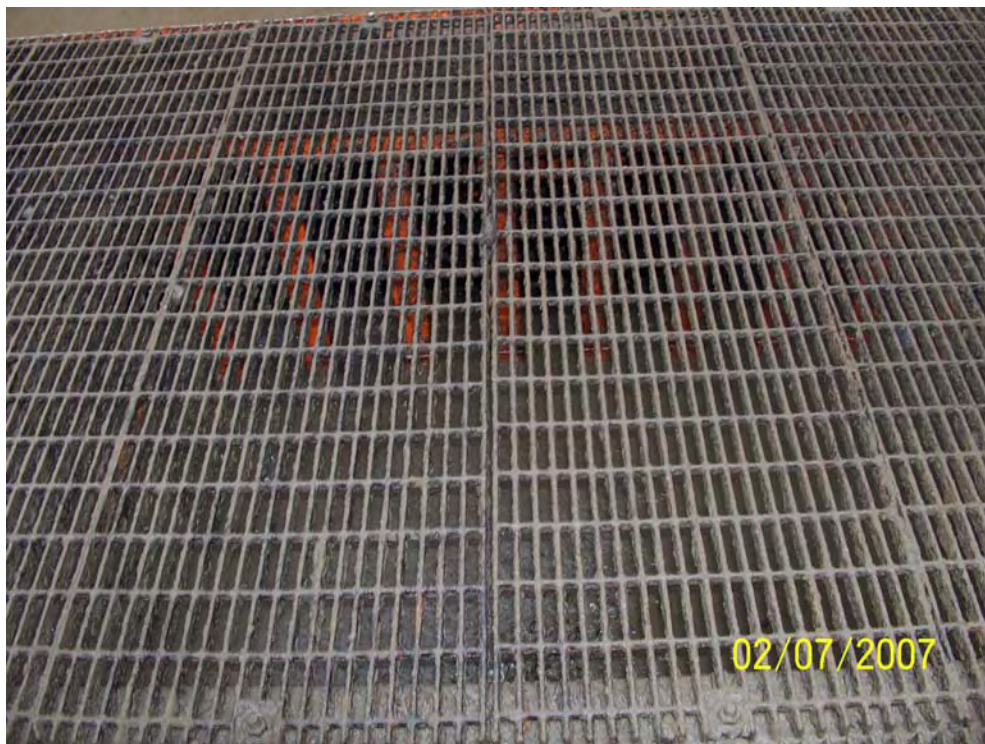
Photo H-8 Sediment on diffuser grating
