**October 3, 2006**  
FIRNGHELAB 2006-0005

## Subcontractor electrician triggers 480V arc flash

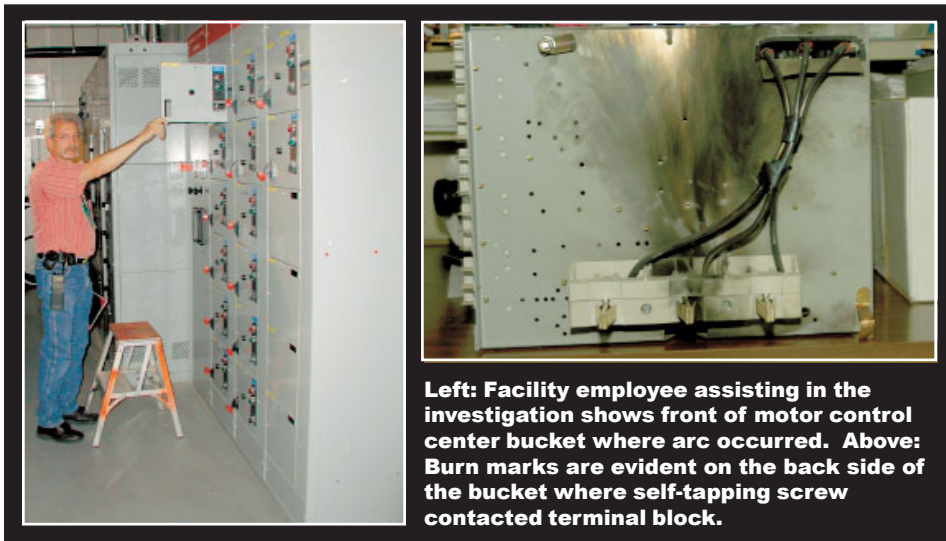
**Left: Facility employee assisting in the investigation shows front of motor control center bucket where arc occurred. Above: Burn marks are evident on the back side of the bucket where self-tapping screw contacted terminal block.**

480V power feeding the MCC. After determining a suitable location for the relay within the bucket, the employee used a cordless drill with a Phillips bit to drive the first of two one-half inch self-tapping screws into the rear surface of the bucket. After the screw penetrated the steel rear panel of the bucket, it came into contact with the 'B' phase on the terminal block carrying 480V power to the bucket. The contact with the energized lead within the terminal block caused an arc flash and tripped the breaker that supplies primary electrical service to the entire building.

Investigators report that ACS was working under subcontract to KSL Services using an existing blanket work order. The work was covered by a valid Integrated Work Document (IWD) provided by KSL, but the IWD did not cover specifics of tasks such as the location and voltage of the MCC. Investigators noted that the IWD required that lock out/tag out (LO/TO) equivalent to LANL standards be employed, but the ACS employee did not

utilize LO/TO when he attempted to add the relay to the MCC bucket. According to investigators, the employee had safety glasses with him but there were indications he was not wearing them at the time of the event, and he was not wearing other personal protective equipment (PPE) intended for electrical safety.

- Managers and supervisors must ensure that employees have taken required training as specified in IWDs and Statement of Work agreements prior to authorizing employees to begin work.

- Persons in Charge (PICs) must be trained, and they must ensure the IWD they are using is complete.
- Within IWDs, unique process must be described with sufficient detail to ensure that the work can be accomplished with all hazards and associated controls identified. Controls should be specific and not simply reference another document.

- Design drawings for work involving modifications to electrical systems should identify tie-in points on the electrical interface drawings, and these drawings should be reviewed by a systems engineer.

- When the scope or magnitude of the work significantly exceeds the original estimate, workers should stop and verify that the existing IWD and supporting work documents still adequately describe the work, identify the hazards, and prescribe specific and effective controls.
