Taum Sauk Upper Reservoir Breached

Taum Sauk Reservoir

14 December 2005 Dam Rupture - Lesterville, MO

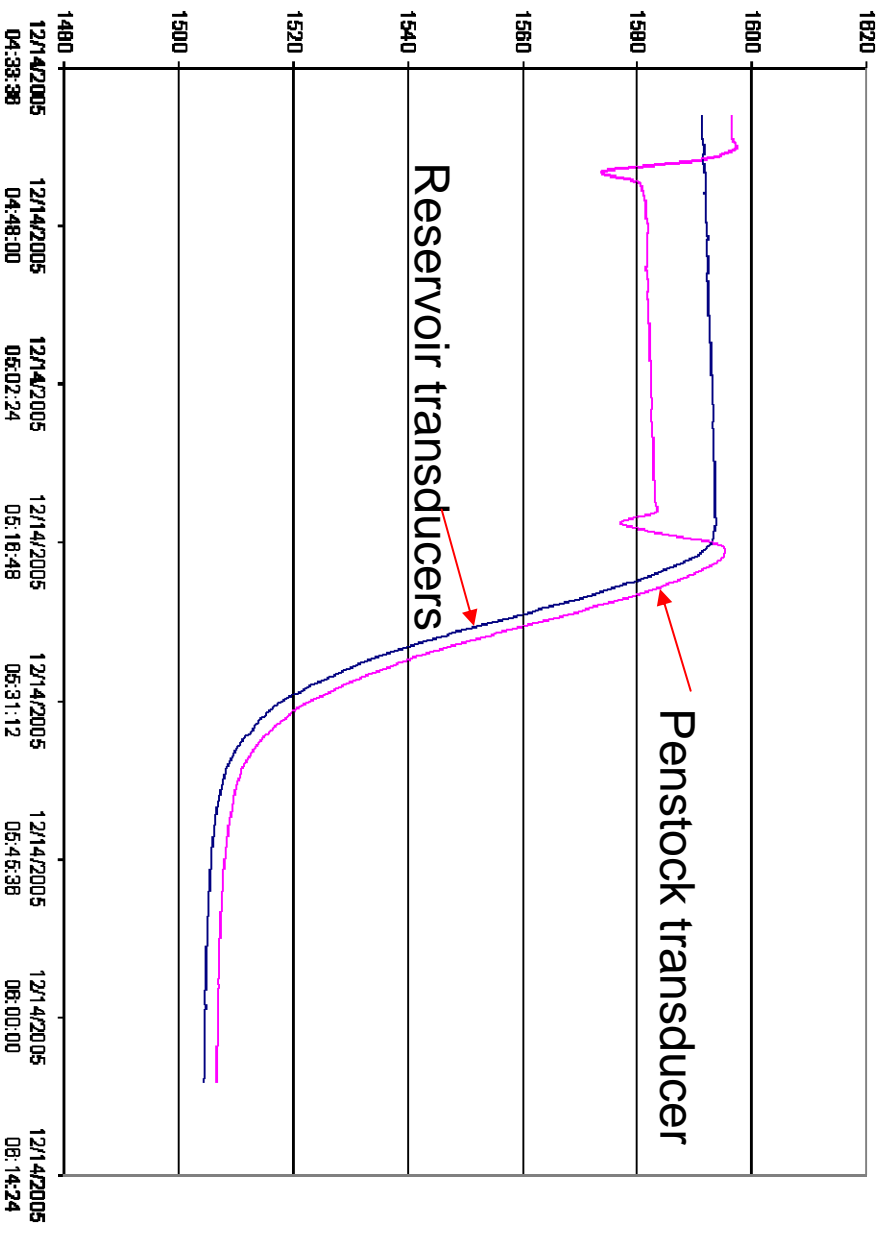
Figure 6-3

Dec. 14th breach.

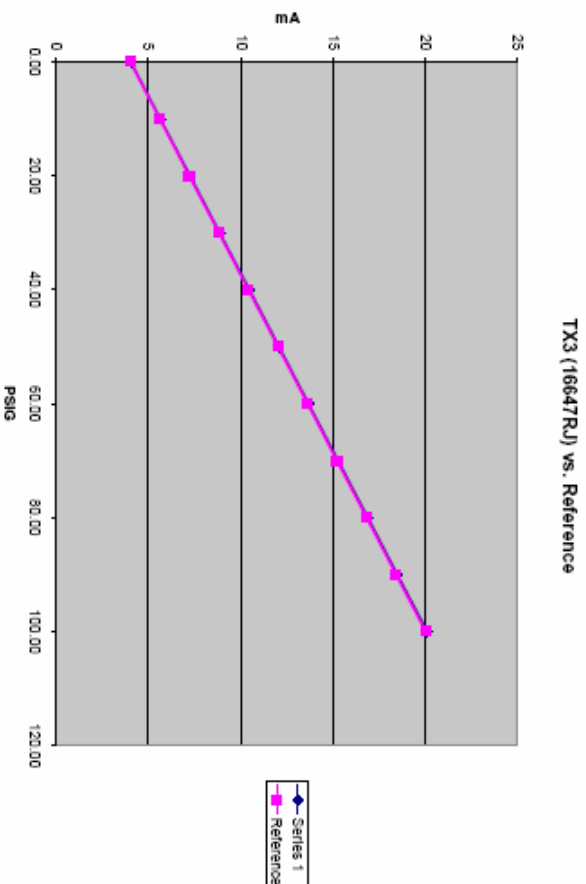
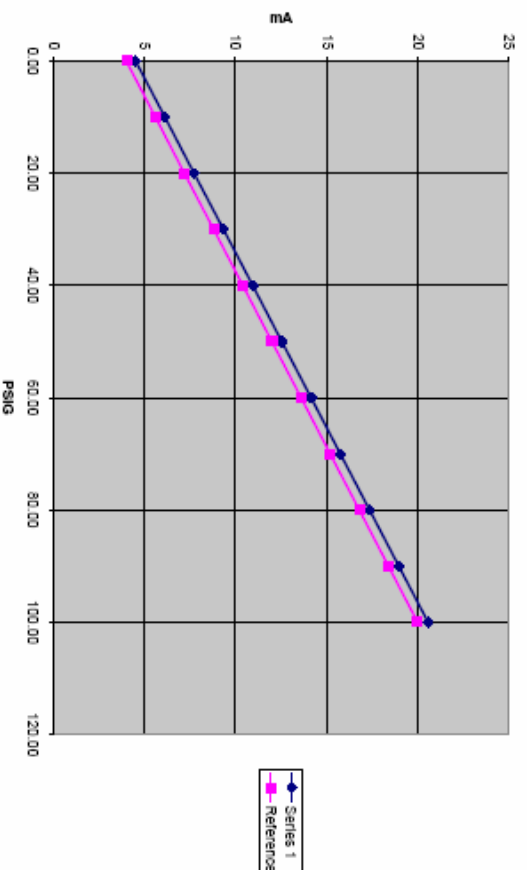
Figure 7-1

Pressure Transducers TX2 and TX3 Compared to Reference Transducer (TX2 reads average of 7.86 feet high and TX3 reads average of 0.85 feet high)

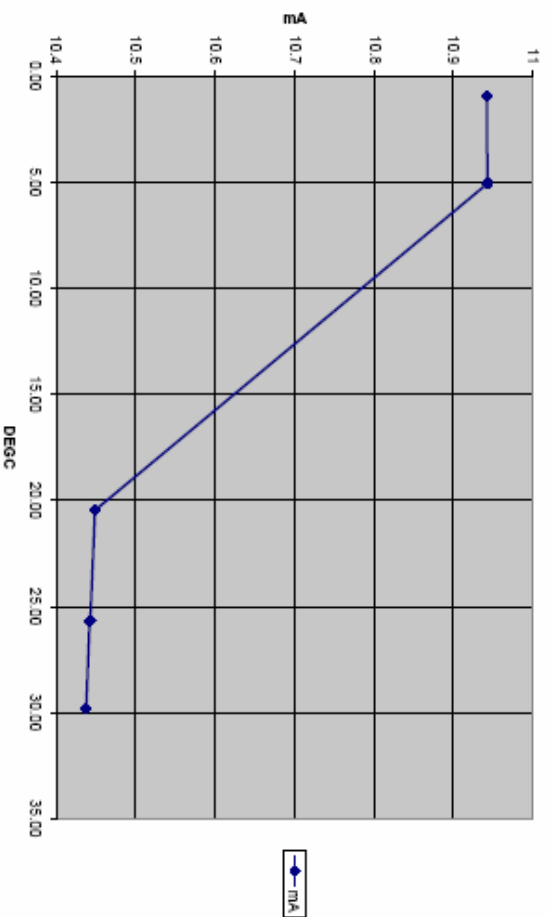
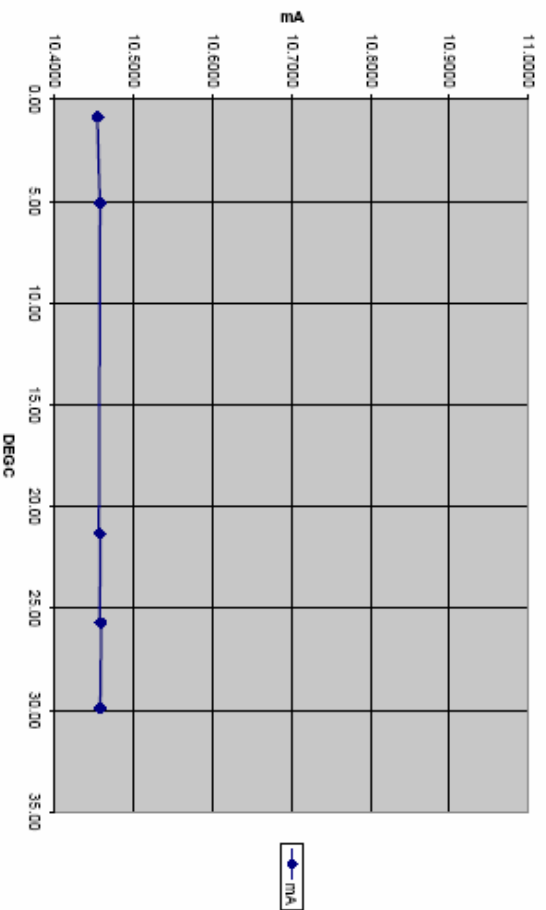
Figure 7-2

**Pressure Transducer Temperature Sensitivity
(TX2 Output Shift Represents +7.11 Ft. of Water Level
at 5 degrees compared to 20 degrees)**

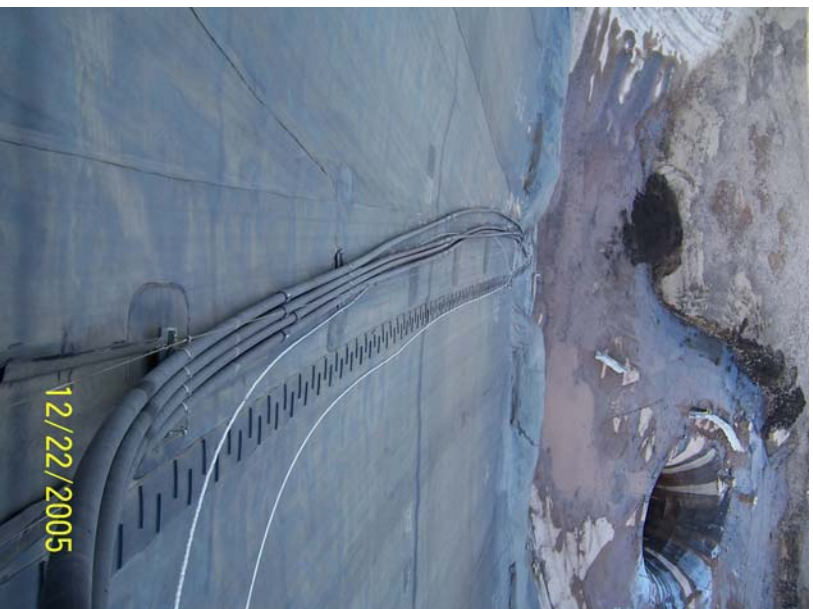
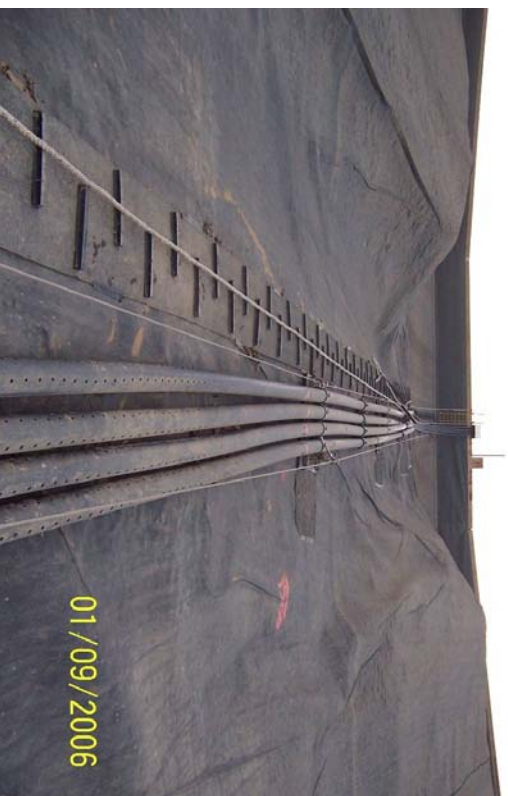
Figure 7-5

Note, straightening of protective pipes between dates of above photos.

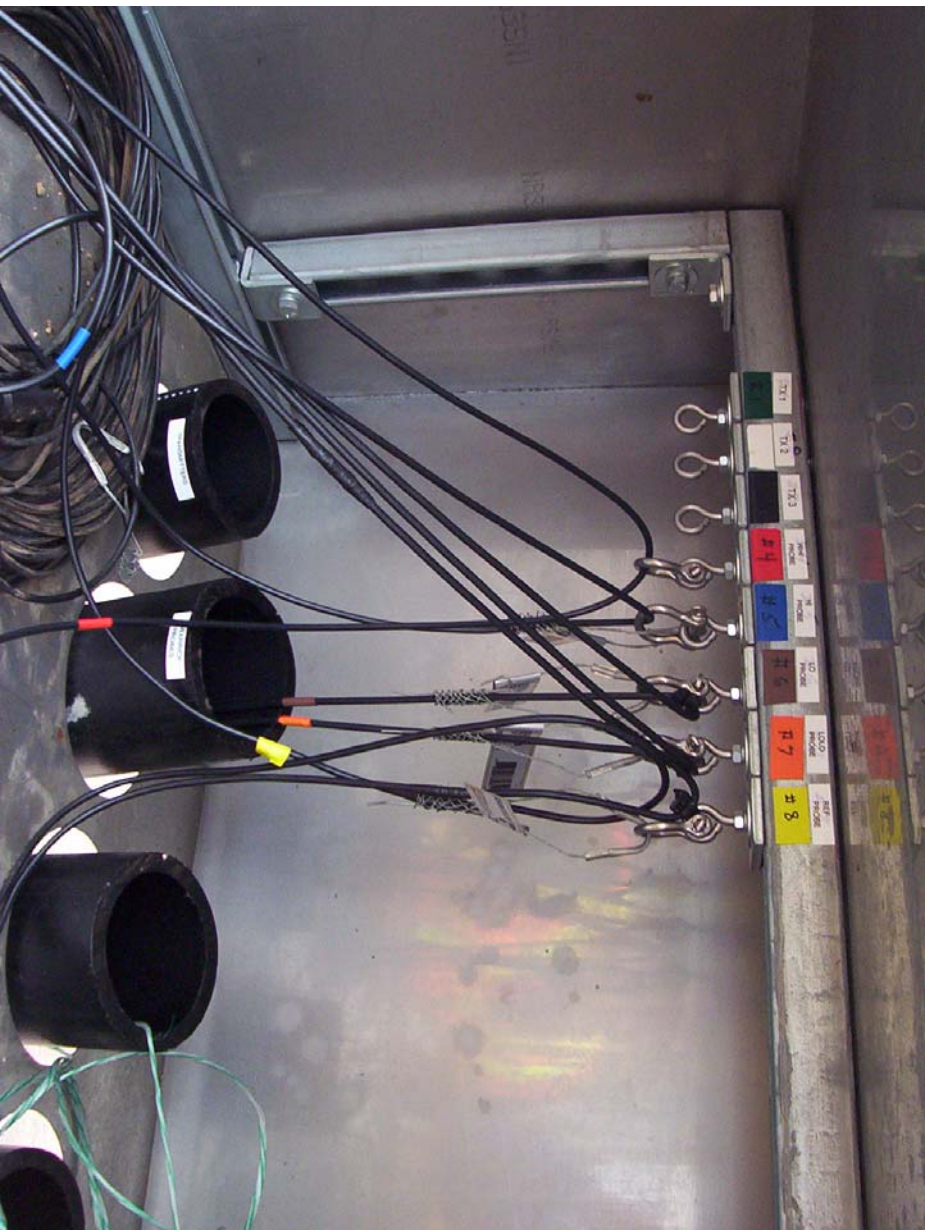
Figure 7-6

**Upper ends of protective pipes
with instrument cables in enclosure on parapet.
Pressure transducers use left pipe
and conductivity probes use the second pipe from left.**

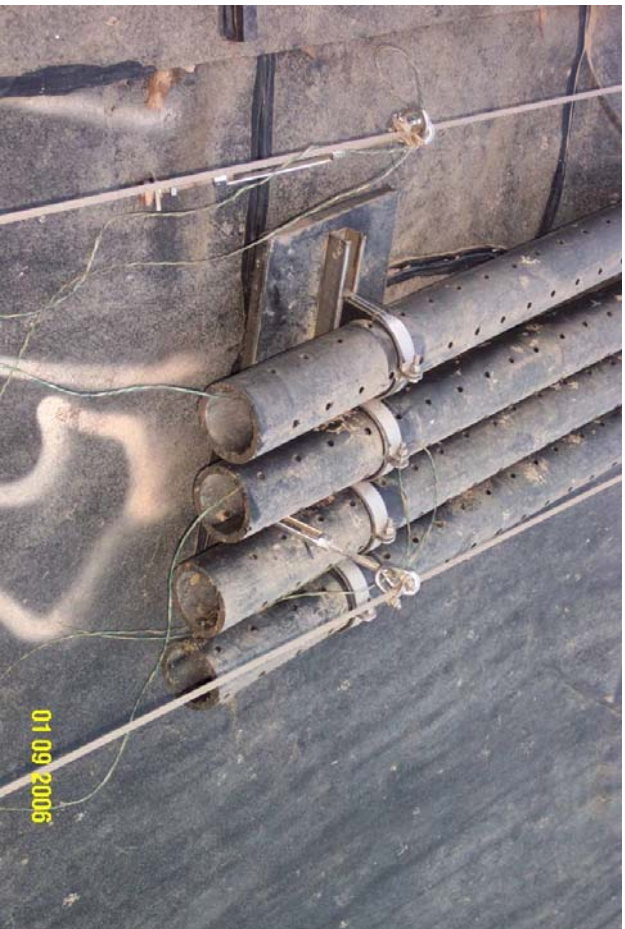
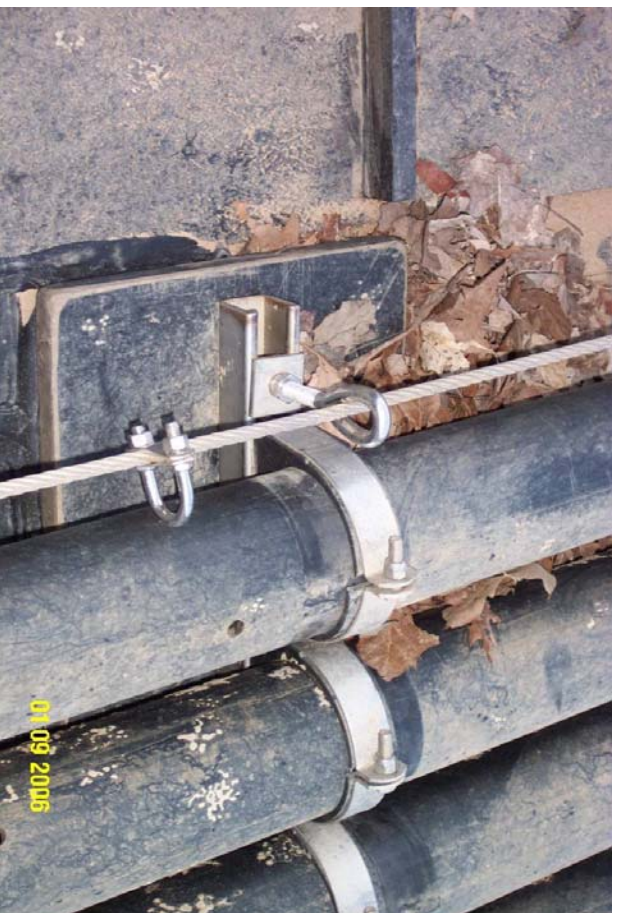
Figure 7-7

Protective pipe base plates are not anchored to reservoir.
Left guy cable has come loose from base plate in top photo.

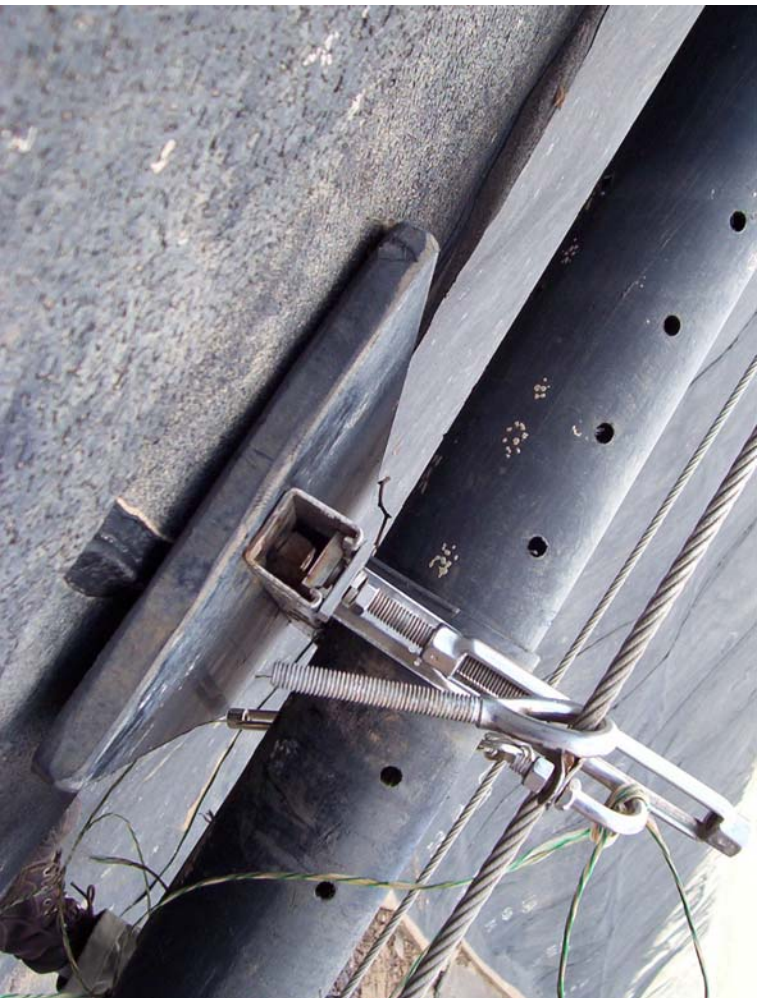
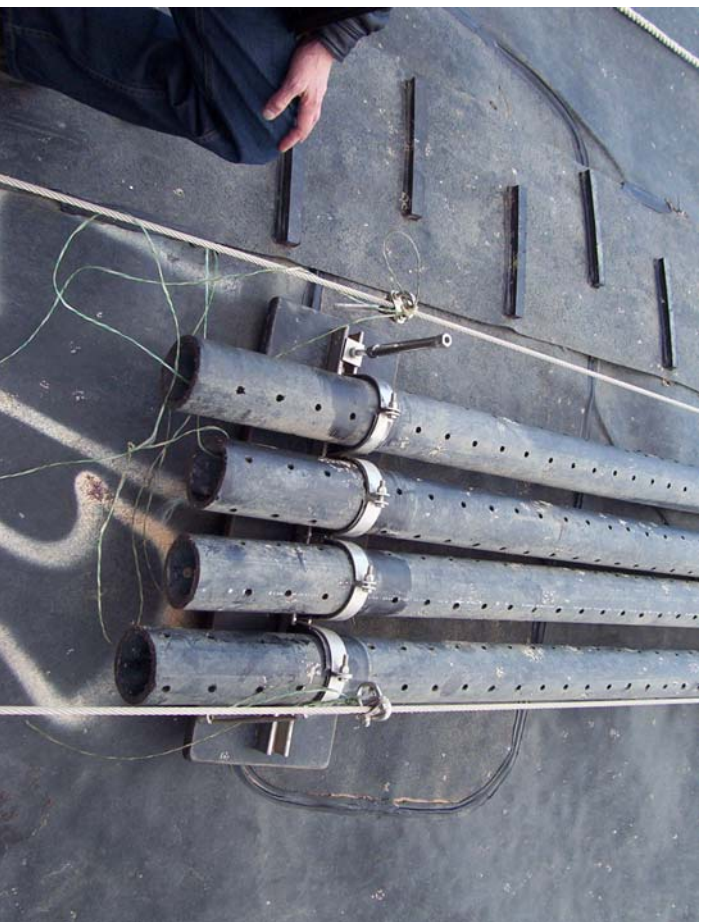
Figure 7-8

Protective pipe support system as found. Note eye bolt unthreaded from turnbuckle. Also note lock washer in place at connection to U channel but lack of lock washer at turnbuckle.

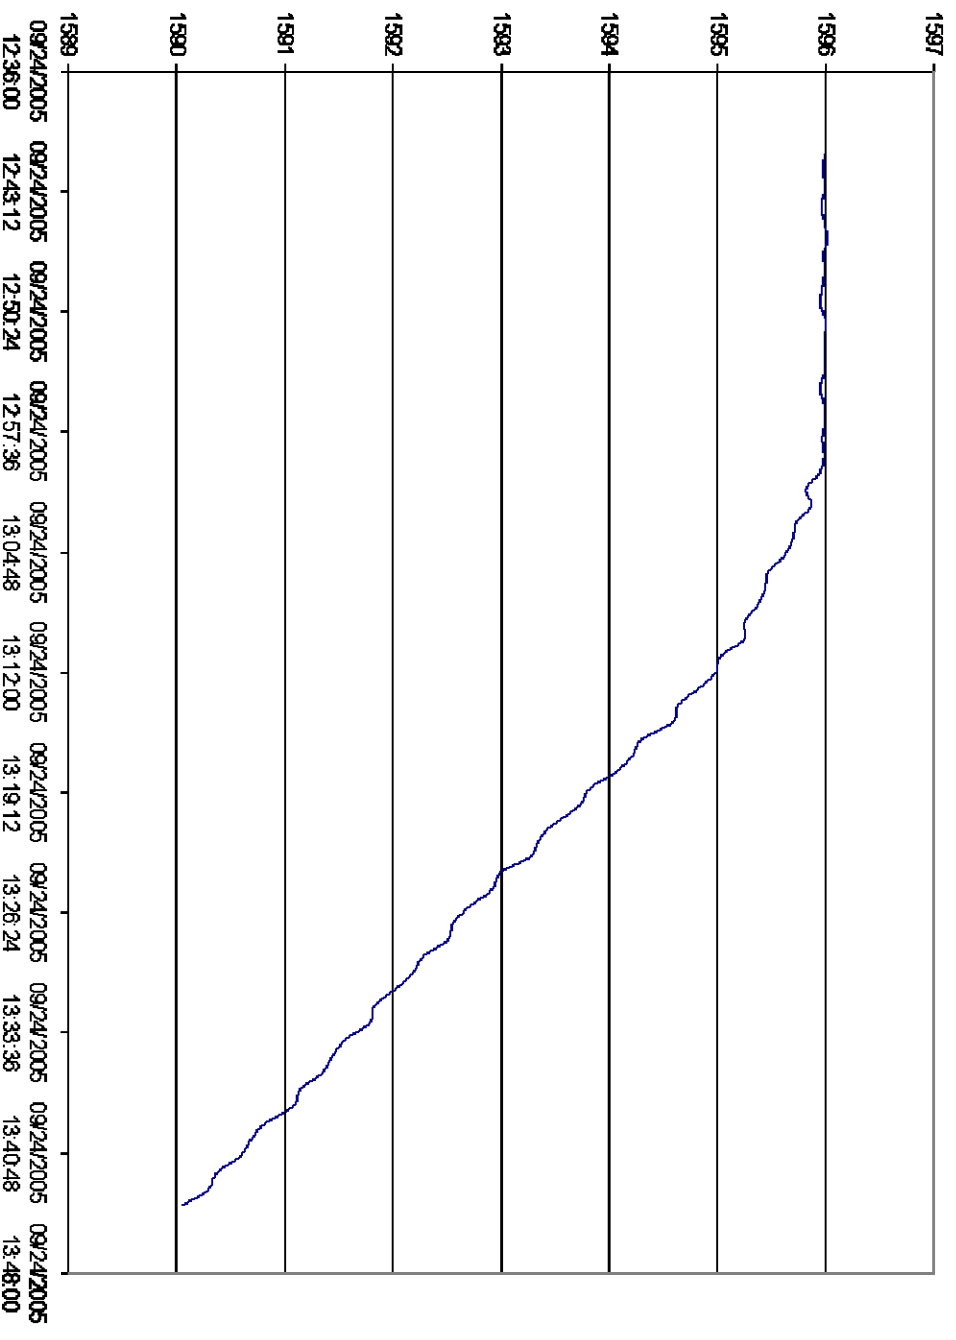
Figure 7-11

Generation start on day prior to Hurricane Rita. Note smaller level variations compared to next day.

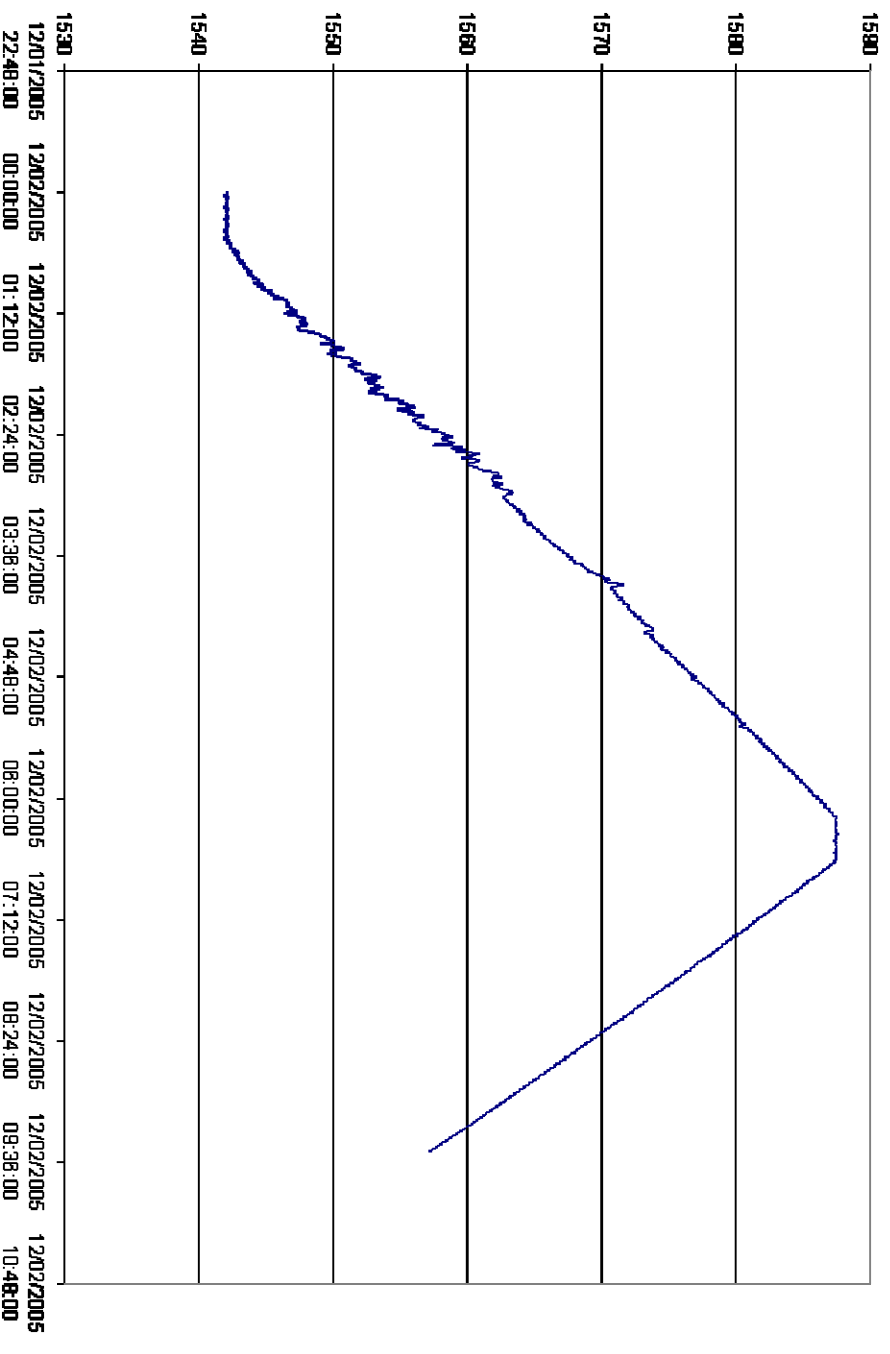
Figure 7-14

Dec. 2nd. Note erratic behavior on rising and lower level compared to falling level.

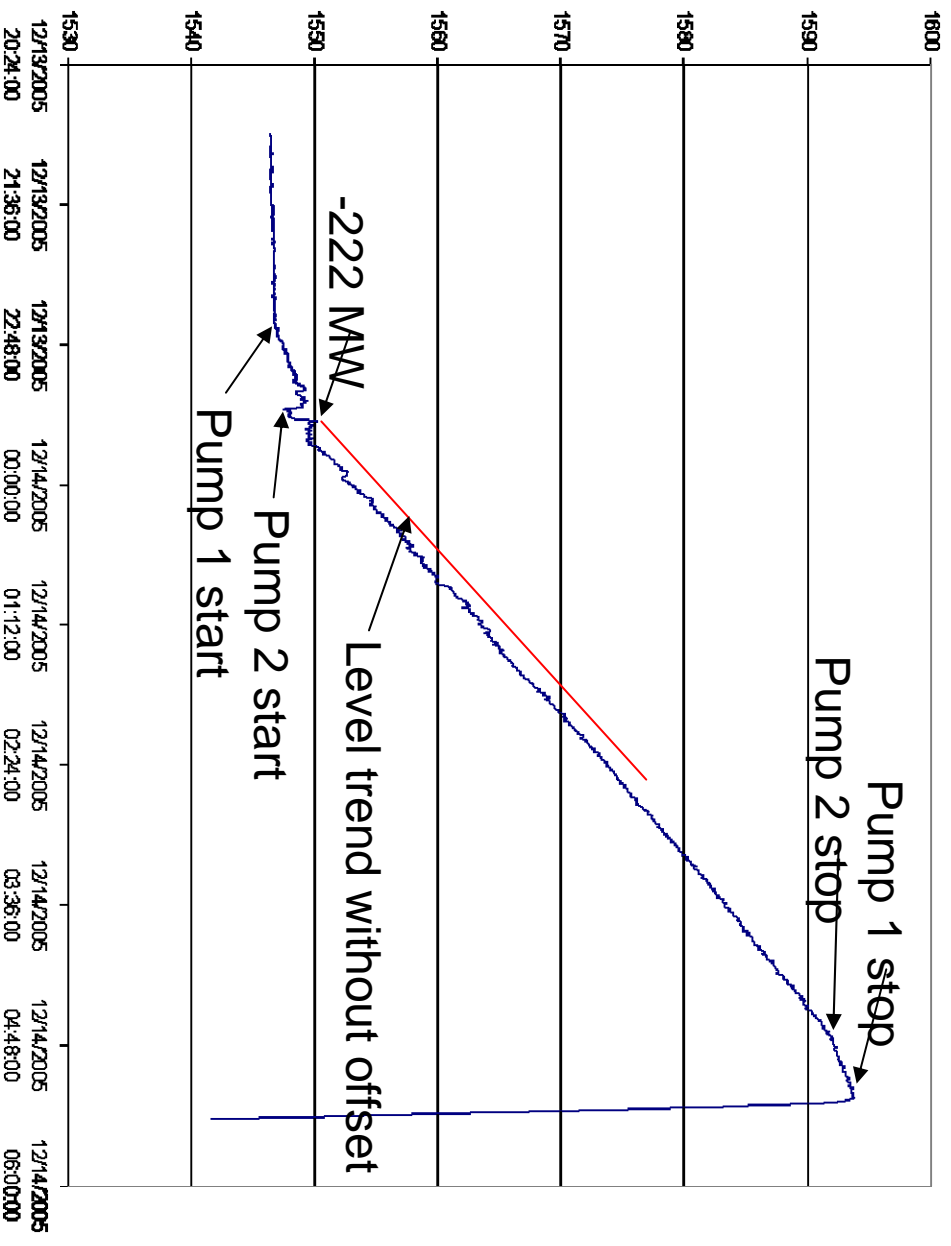
Figure 7-24

**Level indications after pump 2 start shows an offset.
-222 MW = Completion of pump 2 start sequence.**

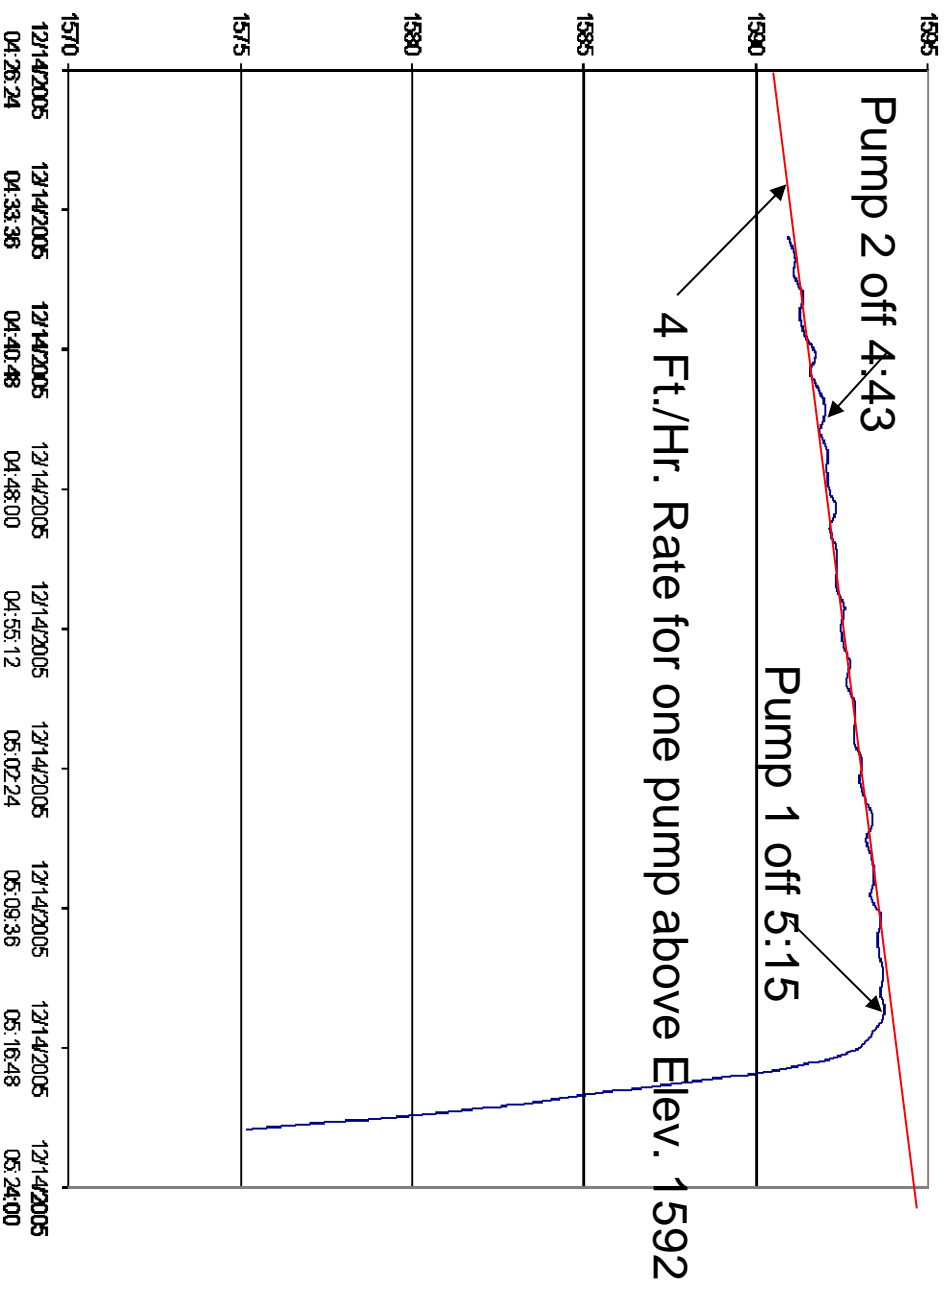
Figure 7-25

Water level indications at breach event.

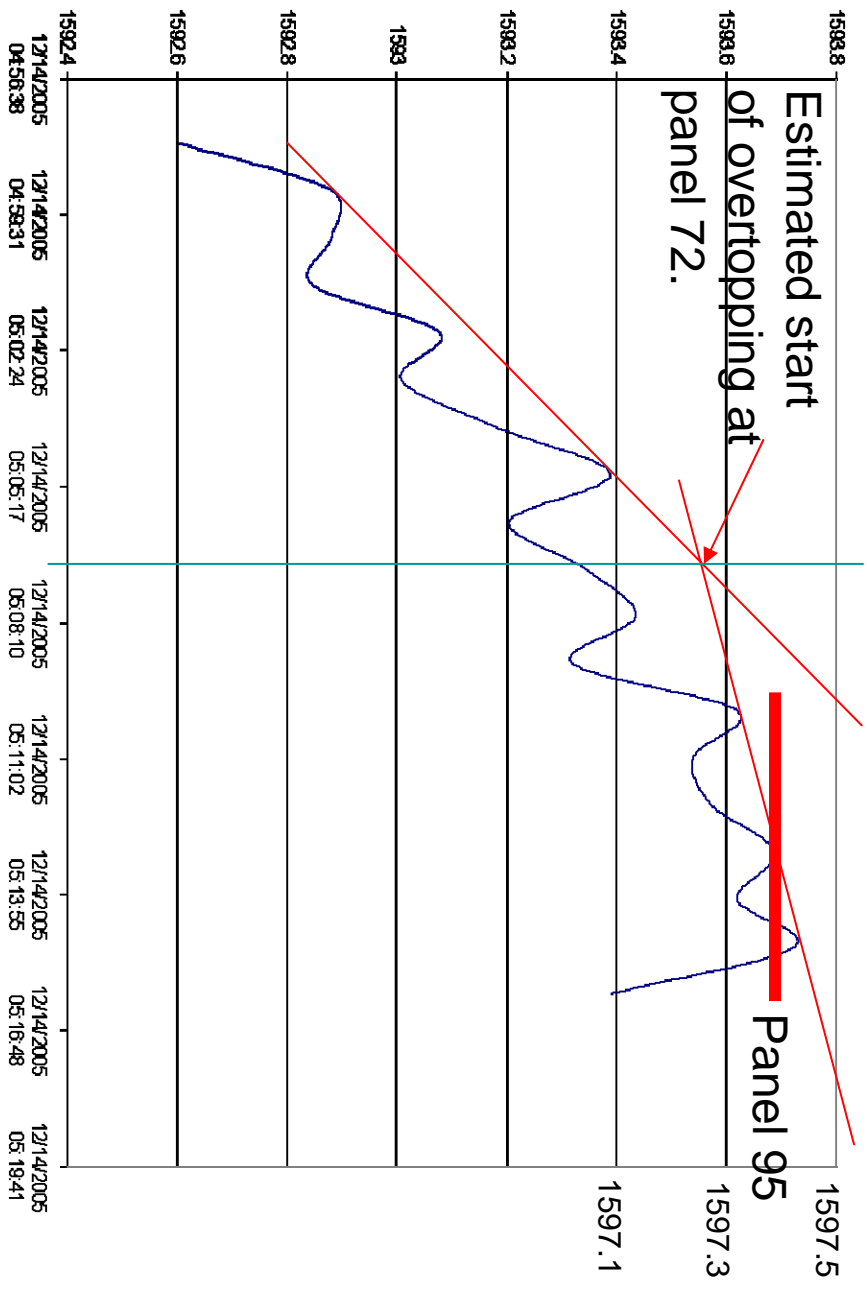
Figure 7-26

Water level indications (left scale)
and adjusted (right scale) prior to breach event.

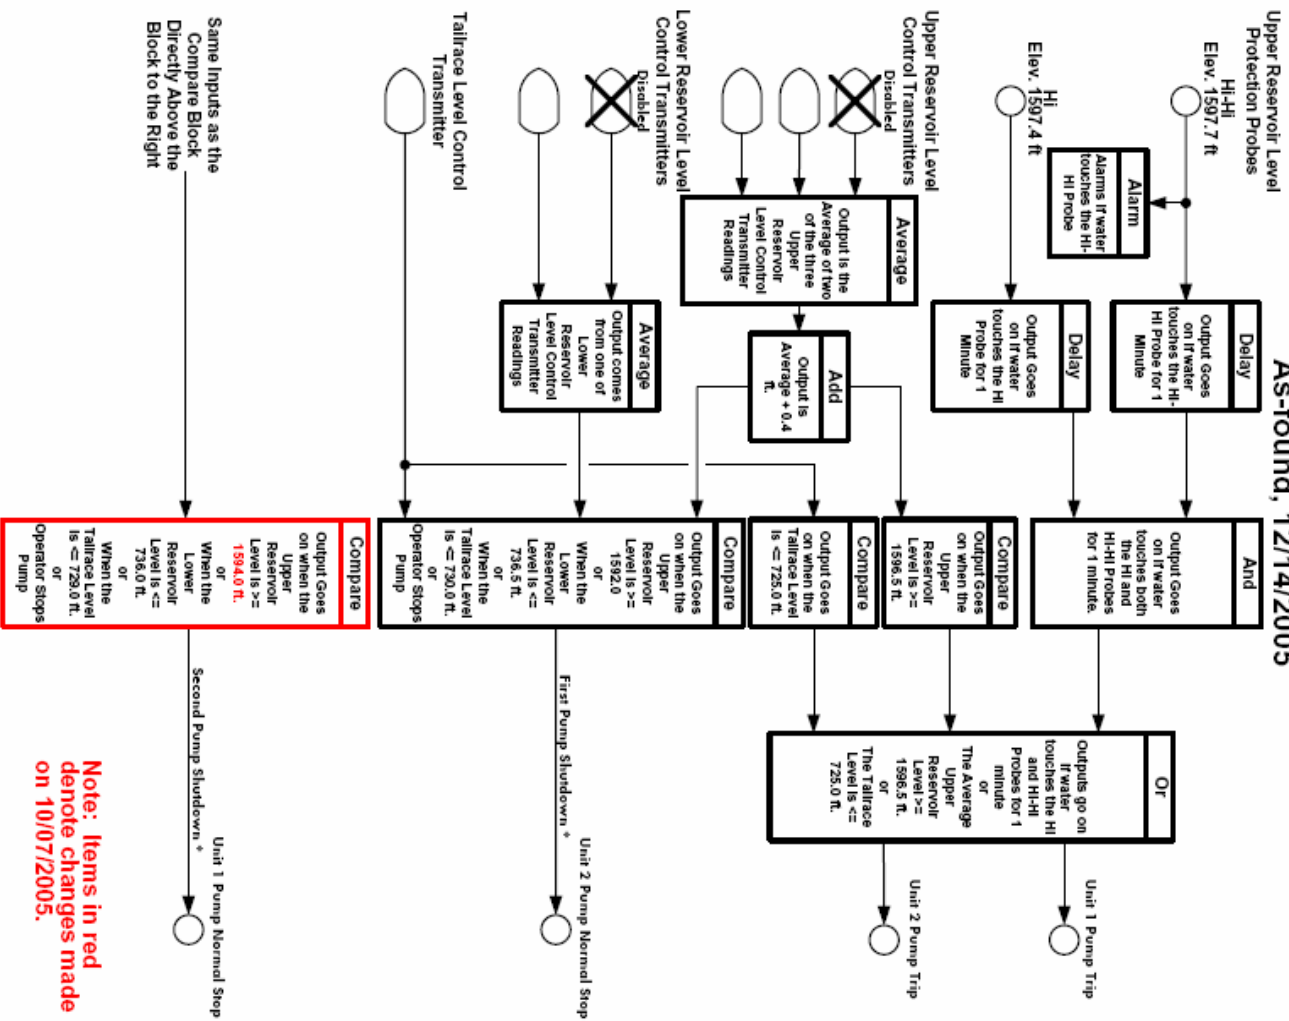
Figure 7-31

Note: Due to programming error made on Sept. 16, 2005, Unit 2 pump shutdown due to level protection probe response was disabled.
