Limited Scope Accident Investigation

**April 7, 2005 South Gate Active Vehicle Barrier Incident
at the DOE Germantown Complex
Germantown, Maryland**

June 2005

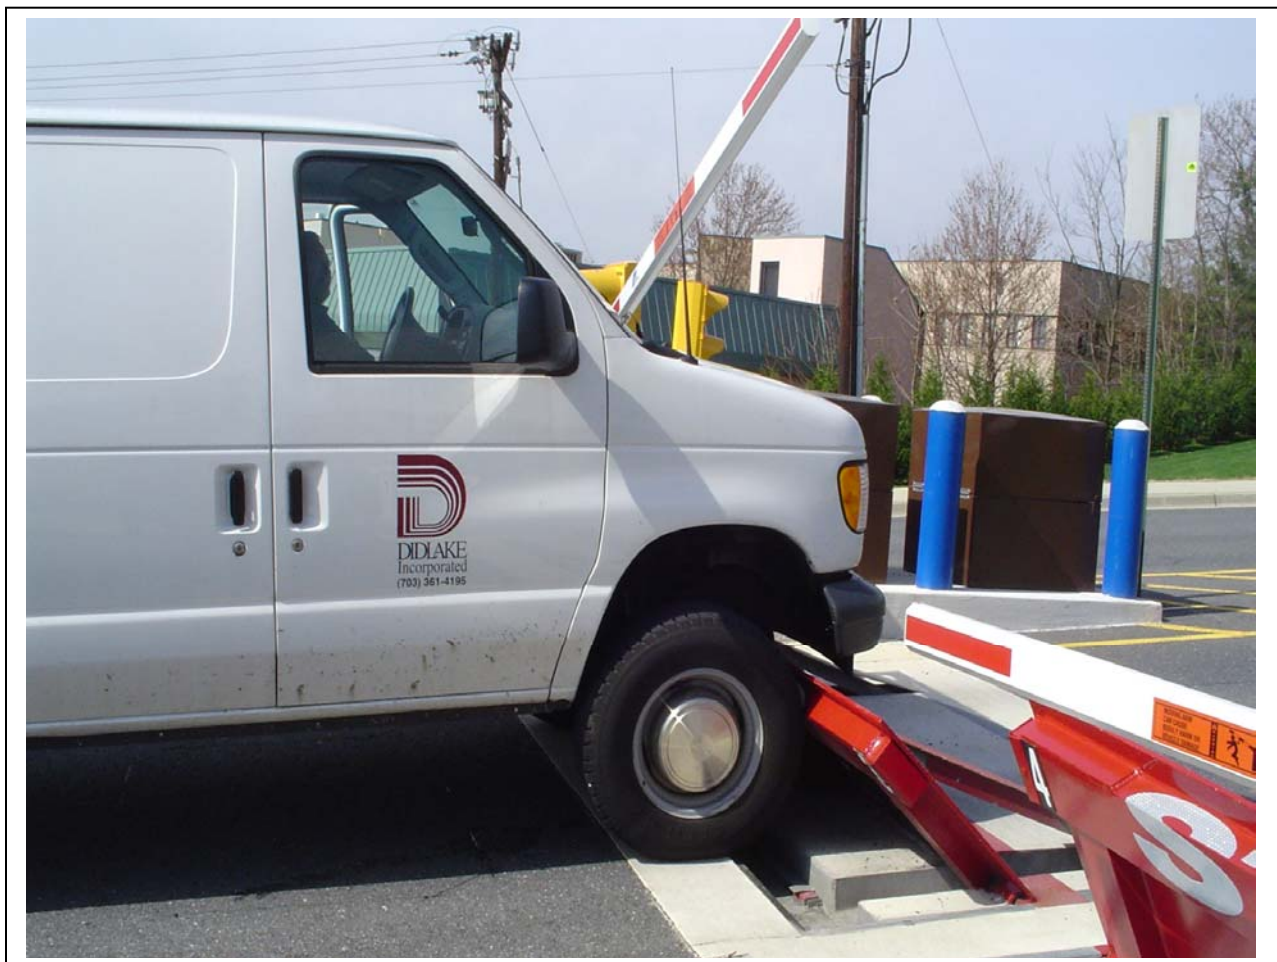
Figure 2-1. Positioning of the Vehicle Immediately Following the Accident

On April 7, 2005, around 10:15 am a commercial van driven by a contractor employee was granted access by the guard at the South entrance to the DOE Germantown facility after badge verification. As the driver proceeded, the vehicle impacted the AVB and the vehicle barrier arm came down striking the windshield of the van. As a result of the impact, the driver hit his head on the steering wheel, causing a slight cut on his forehead. The van sustained front end damage. An IST technician responded to the accident and found that the “up” or “closed” indicator light for the barrier #3 was illuminated on the control box inside the guard booth. The removal of the van from the barrier required a hydraulic jack.
