# TYPE A ACCIDENT INVESTIGATION OF THE MARCH 16, 2000 PLUTONIUM-238 MULTIPLE INTAKE EVENT AT THE PLUTONIUM FACILITY LOS ALAMOS NATIONAL LABORATORY NEW MEXICO

July 2000  
Prepared by  
Office of Oversight  
Office of Environment, Safety and Health  
U.S. Department of Energy

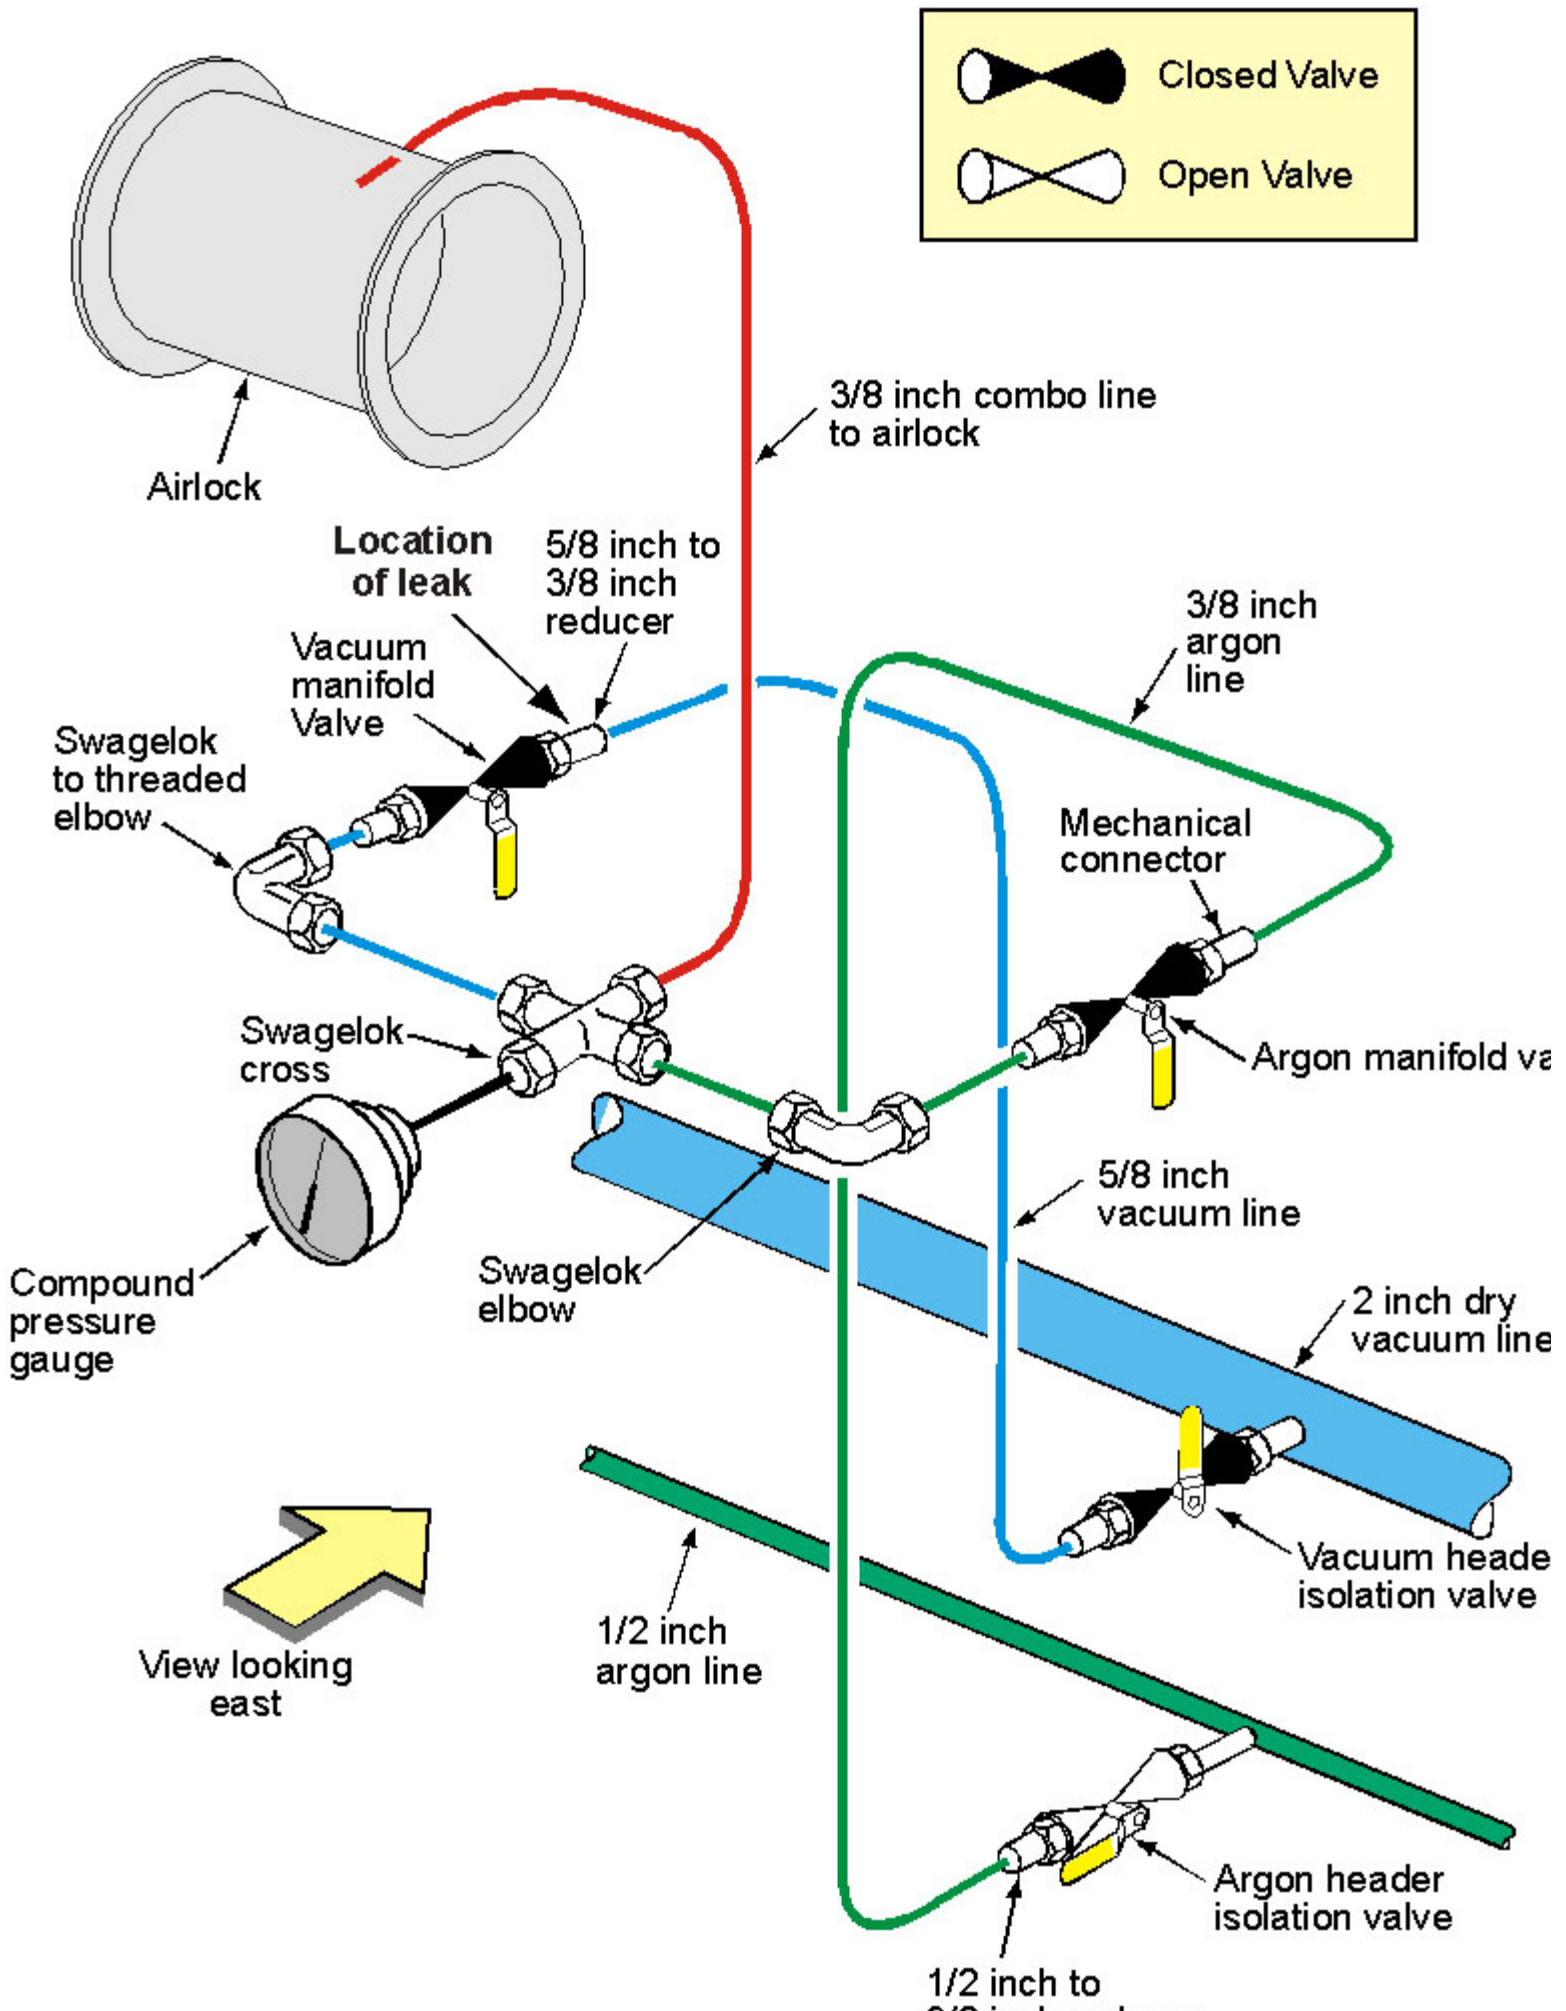
**Figure 2-2. Airlock Manifold Piping Diagram**

The accident investigation board determined that the direct cause of the accident was a release of airborne contamination from a leaking compression fitting in an inadvertently pressurized dry vacuum line. The vacuum line serves an airlock between the glovebox and an adjacent dropbox.

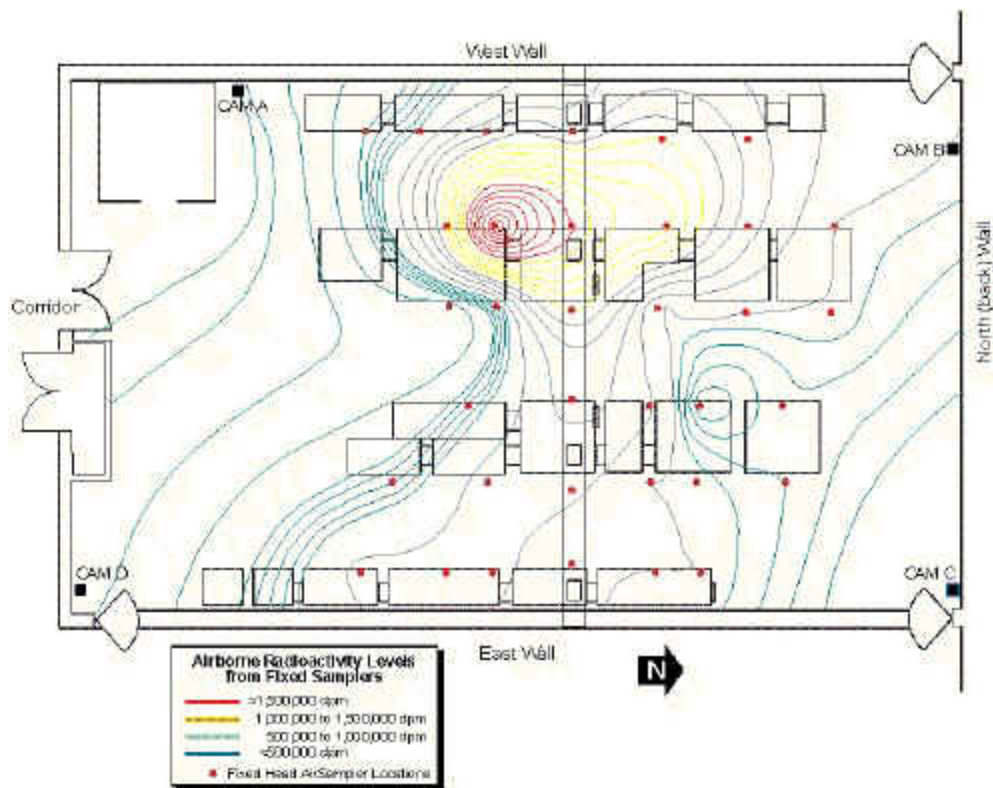
**Figure 2-3. Fixed-head Air Sampler Results in Room**

LANL and Lovelace Respiratory Research Institute (LRRI) estimate the particle size distribution of the release to be in the range of 1 to 5 micrometers activity medium aerodynamic diameter. The contamination evidence suggested that there was a significant amount of locally deposited material that may have caused the hand monitors to alarm. To assess this possibility, the Board had the probes of the hand monitors in the area surrounding the glovebox surveyed. It was found that the probe directly above the apparent release location was reading 17,000 dpm, and the probe on the dropbox north of the glovebox was reading 6000 dpm. The probe on the glovebox across the aisle and directly behind ET's task location was reading 11,000 dpm. All other probes were less than 1000 dpm (the hand monitors are set to alarm at 1000 dpm). The order in which the monitors alarmed can be inferred from the distances between the monitors and the location of the release. This inference suggests that the monitor directly above the release point alarmed first, followed by the monitor on the dropbox to the north, and finally by the monitor on the glovebox across the aisle to the west of the release point.

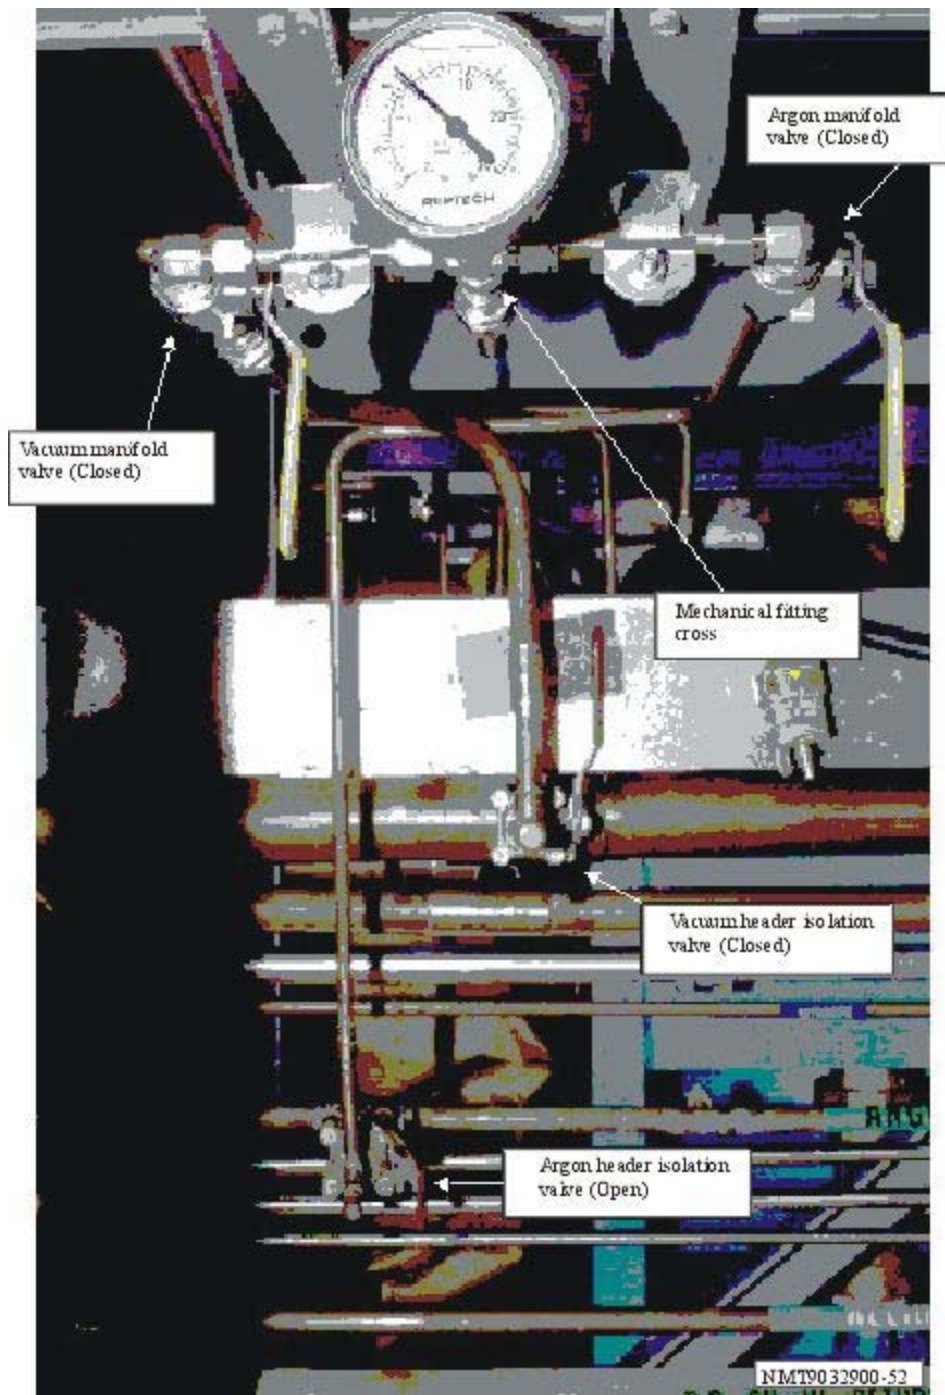
**Exhibit 2-3. Alignment of Valves in the Manifold Line after the Accident**

At the time of the first hand monitor alarm, ET was tracing the piping and valve alignment underneath the northwest corner of this glovebox, and stated that he had "shaken" the pipes to test joint integrity. Therefore, the Board directed significant attention toward measuring the contamination levels at this location. The floor under the glovebox was found to be measuring about 1,000,000 dpm. The service pipelines were found to be reading levels ranging from 20,000 dpm to 200,000 dpm, with several locations as high as 1,000,000 dpm. The manifold for the airlock argon purge system is also at this location (see [Exhibit 2-3](#) and [Figure 2-4](#)). On the line from the dry vacuum supply line to the manifold, near the vacuum manifold valve, there was also a reducer coupling for changing the size of the pipe. The argon manifold valve was not contaminated, and the piping to the airlock read about 10,000 dpm. The vacuum manifold valve read 100,000 dpm, but the reducer was contaminated to a level exceeding the range of the instrument at 2,000,000 dpm. This last measurement was taken at a distance of about two inches from the coupling, indicating that the contamination level was actually much higher than the recorded reading.

In the fourth scenario, the Board postulated that ET attempted to introduce argon flow into the glovebox by opening the argon manifold valve (believing it to be the glovebox supply valve) under the northwest side of the glovebox while kneeling in front of the open shield door and watching the photohelic gauge above the west side of the glovebox. Since the vacuum manifold valve was leaking and the vacuum header isolation valve was closed, this action would have sufficiently pressurized the vacuum line with argon to provide the motive force. The pressure vented through the finger-tight compression fitting and spread existing contamination into the room. When no change was observed on the photohelic gauge above the glovebox, ET closed the valve. At about this time the hand monitor alarmed, and ET stood up to investigate, pumping the glove at the same time.

While considering this scenario, the Board also evaluated the possibility that ET had inadvertently bumped the argon manifold valve while reaching under the glovebox. However, this was considered to be unlikely, as there was not a continuous release and the argon manifold valve was found to be fully closed after the event.

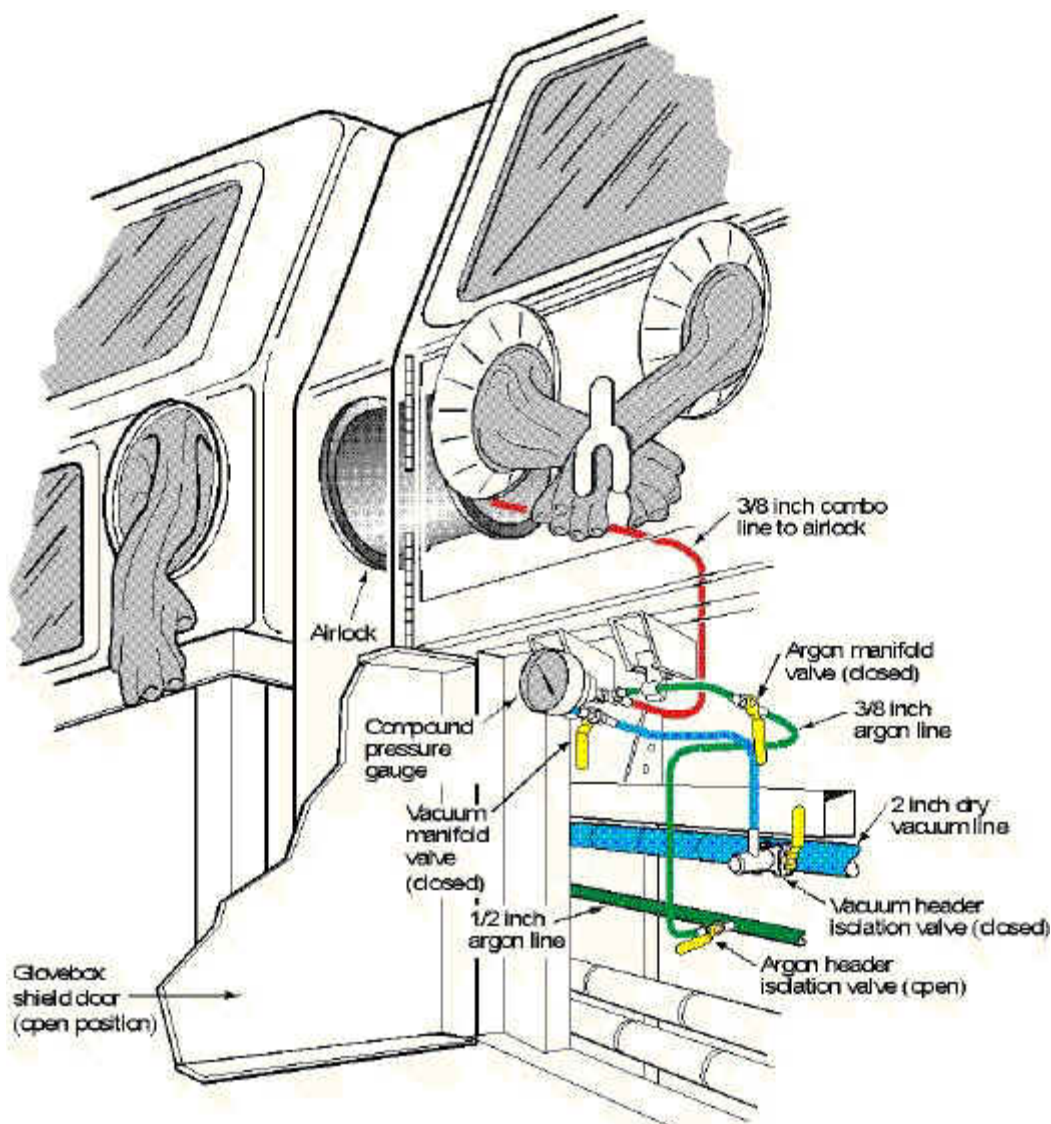
Figure 2-4. Northwest Corner of the Glovebox, Including the Argon and Dry Vacuum Lines

After the general conditions of the room were evaluated, the glovebox and ET's immediate task area were surveyed in detail. The gloves on the northwest side of the glovebox had contamination levels between 14,000 and 20,000 dpm. Some localized areas of contamination on the top of the glovebox and the top of the airlock were found to be as high as 200,000 dpm, but most areas were around 2,000 dpm. Measurements under the airlock indicated about 12,000 dpm.

The Board focused primary attention on the manifold under the northwest corner of the glovebox where the maximum contamination was found. This manifold is used for purging the airlock between the glovebox and the dropbox to its north. For the general layout of this location refer to [Exhibit 2-3](#).

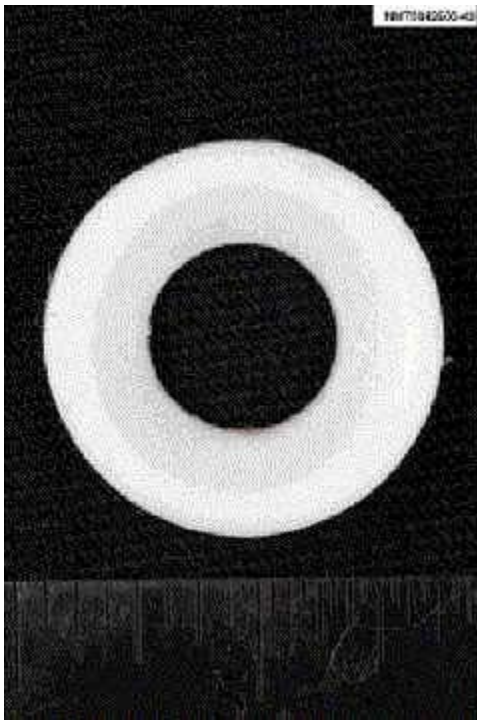
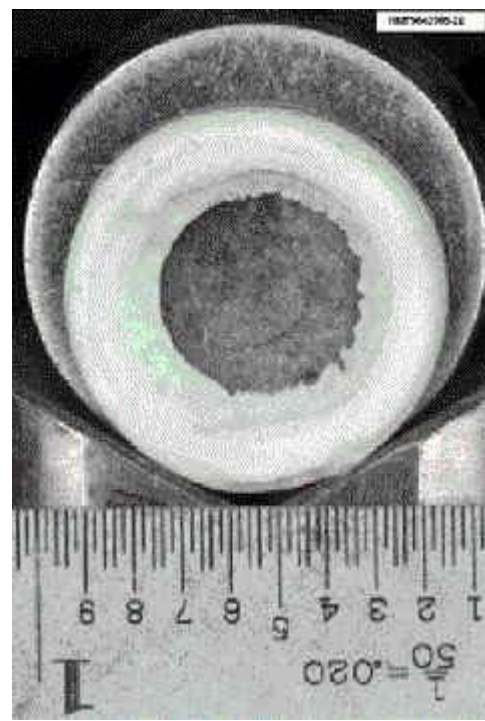
#### Exhibit 3-1. Teflon<sup>(r)</sup> Seat Degradation

Furthermore, the vacuum manifold valve was found to have a significant seat leakage and could not maintain a static pressure in the line. The cause of this leakage was found to be significant degradation of the Teflon(r) seats in the ball valve. The cause of this degradation will require further analysis, but it probably results from a combination of thermal, abrasion, and radiation damage from prolonged exposure to Pu-238. The Board concluded that further analysis of this

Teflon(r) degradation mechanism is warranted, and that DOE should evaluate the impact of this degradation at all similar plutonium facilities within the complex.

In addition to the use of Teflon<sup>(r)</sup> as the seat material in this valve, Teflon<sup>(r)</sup> tape is used to connect mechanical joints with pipe threads in this manifold. The Board concluded that Teflon<sup>(r)</sup> was an inappropriate design choice as a sealing material in an environment containing Pu-238.
