**Type A Accident
Investigation Report**

June 7, 2004

**Construction contractor
electrical accident at
double-circuit structure 38/1,
Watertown-Granite Falls
230-kV Transmission Line**

**East of Watertown,
South Dakota**

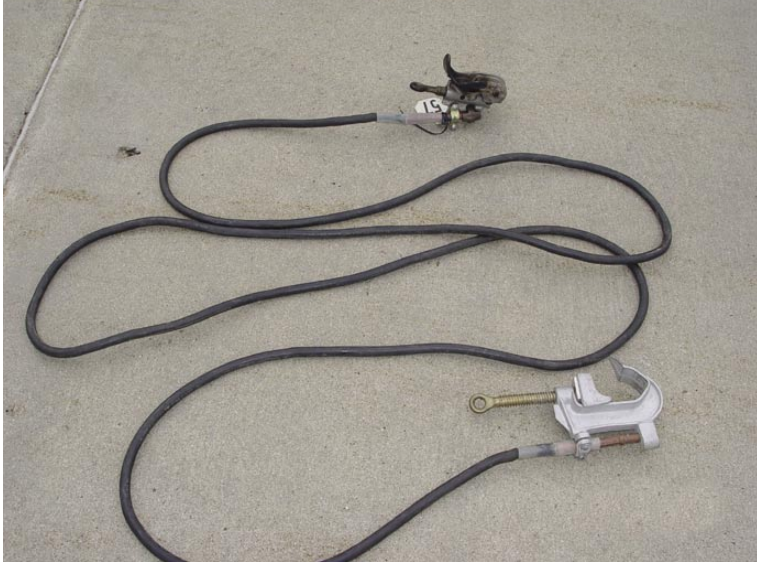
Figure 1: Ground lead (2/0 cable, 20 feet, 6 ½ inches long) that was connected between the A phase of the Watertown-Granite Falls 230-kV transmission line and the steel at Structure 38/1. At the time of the accident, the victim disconnected the “cold end” while the “hot end” was still connected to the A phase conductor. This type of grounding assembly is designed for bus-bar or phase-to-phase grounding applications.

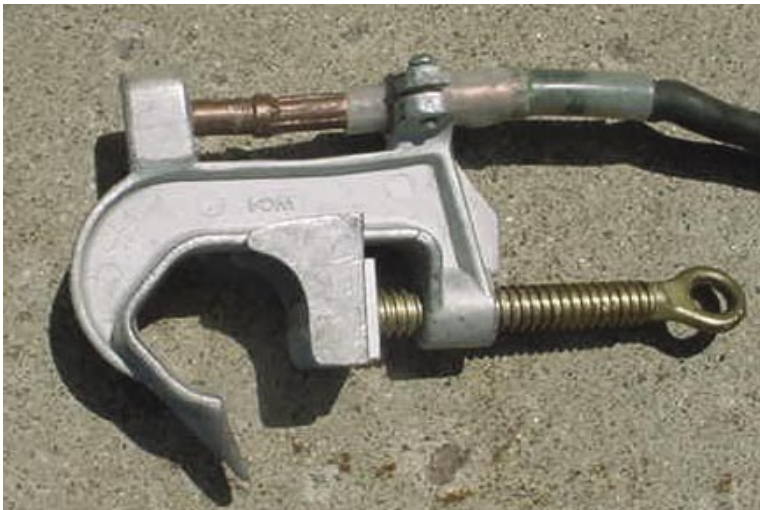
Figure 2: This clamp (bus type) was connected to the conductor (“hot end”).

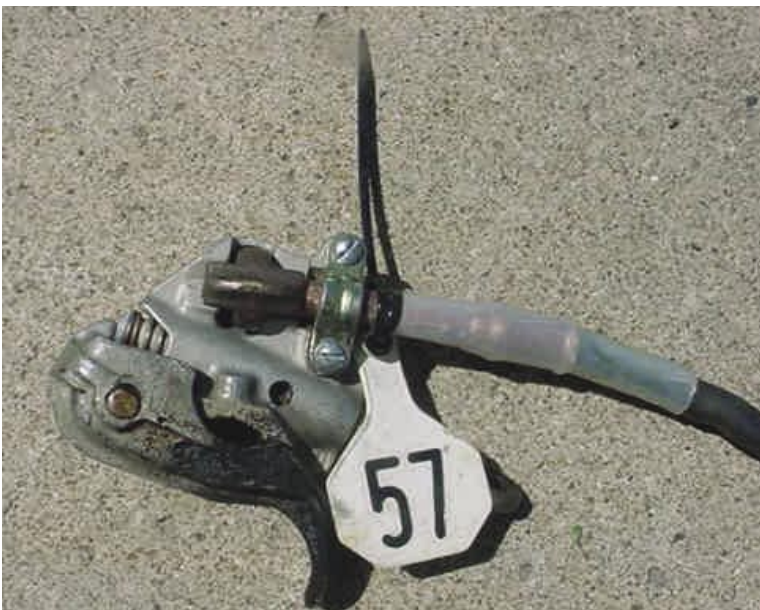
Figure 3: This clamp (duckbill type) was connected to the steel (“cold end”).

The Board determined that the direct cause of the accident was that the victim removed a personal protective ground end out of sequence, thereby leaving the "hot end" still connected to the A-phase conductor of the Watertown-Granite Falls 230-kV transmission line. This condition placed the victim in series with a circuit acutely energized by induction.

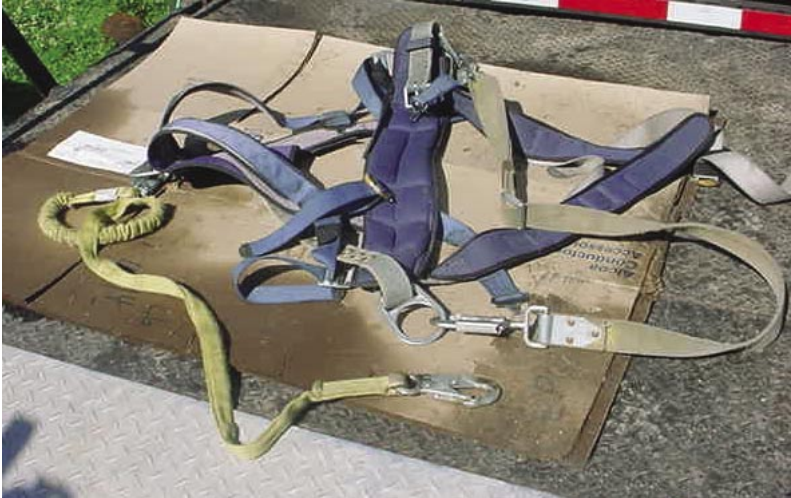
Figure 4: Harness, body belt and lanyard worn by victim at the time of accident.

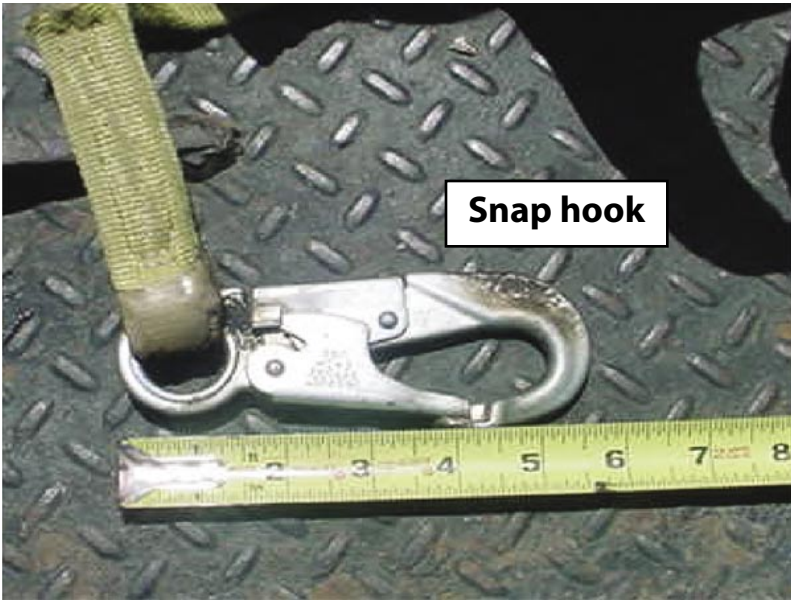
Figure 5: Lanyard snap hook used by the victim to loosen the “cold-end” clamp.

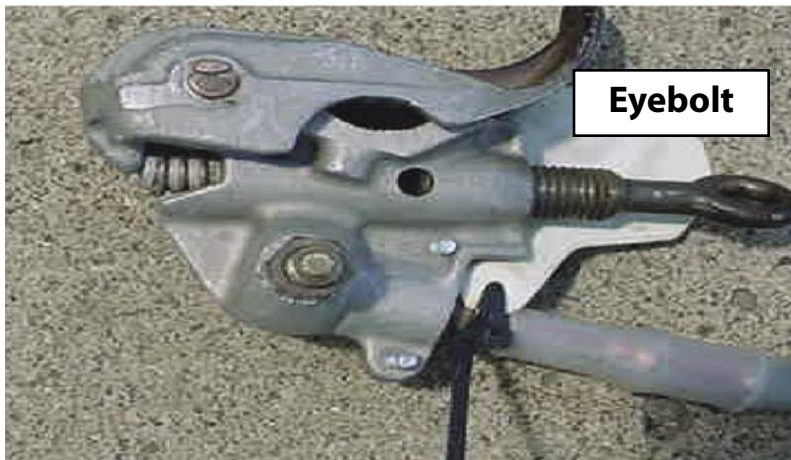
Figure 6: Eyebolt of “cold-end” clamp where victim attached the lanyard snap hook to loosen the ground connection.

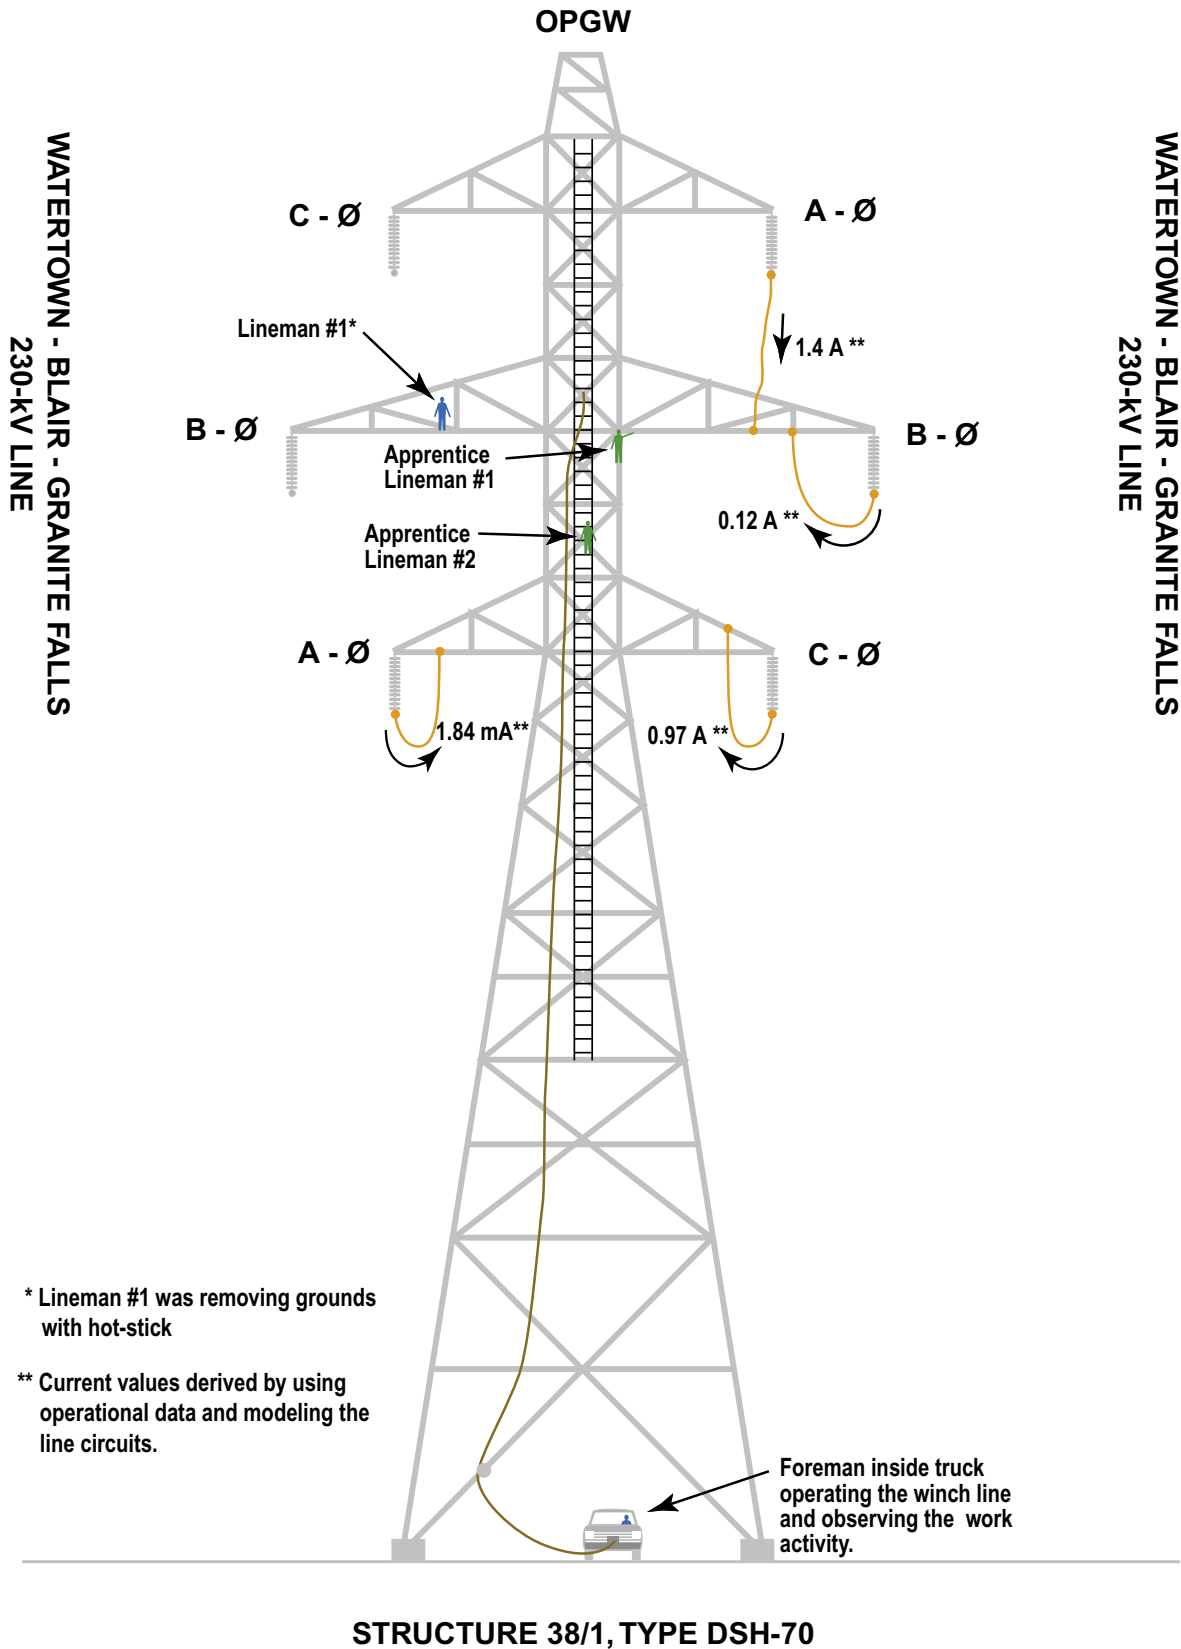
APPROXIMATE LOCATION OF GROUND LEADS AND PERSONNEL JUST PRIOR TO TIME OF WORK CREW CHANGE

* Lineman #1 was removing grounds with hot-stick
