Type A Accident
Investigation Board Report
of the
April 25, 1997
Contractor Fatality
on the
Olympia-White River #1
230 kV Line

B O N N E V I L L E
POWER ADMINISTRATION

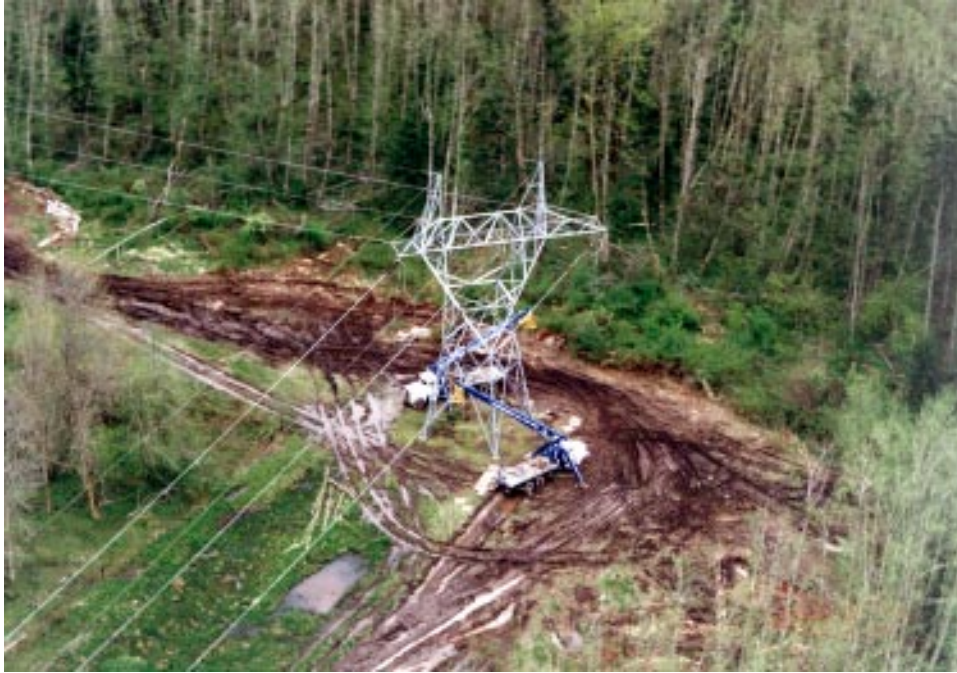
Exhibit 1 — Site Overview

Dead-ending was proceeding on both sides of the tower (See APPENDIX C, Exhibits 1 and 2 and Figure 1). Work-site conditions were extremely muddy from recent rains. Two Manitex M2592 Crane/Manlifts were dragged in by crawler and positioned beneath the lines, one on each side of the tower. Each crane has a 92-foot, noninsulated boom and a two-person basket attached to the end of the boom. The cranes are equipped with three sets of boom controls, one on each side of the crane cab and another in the basket.

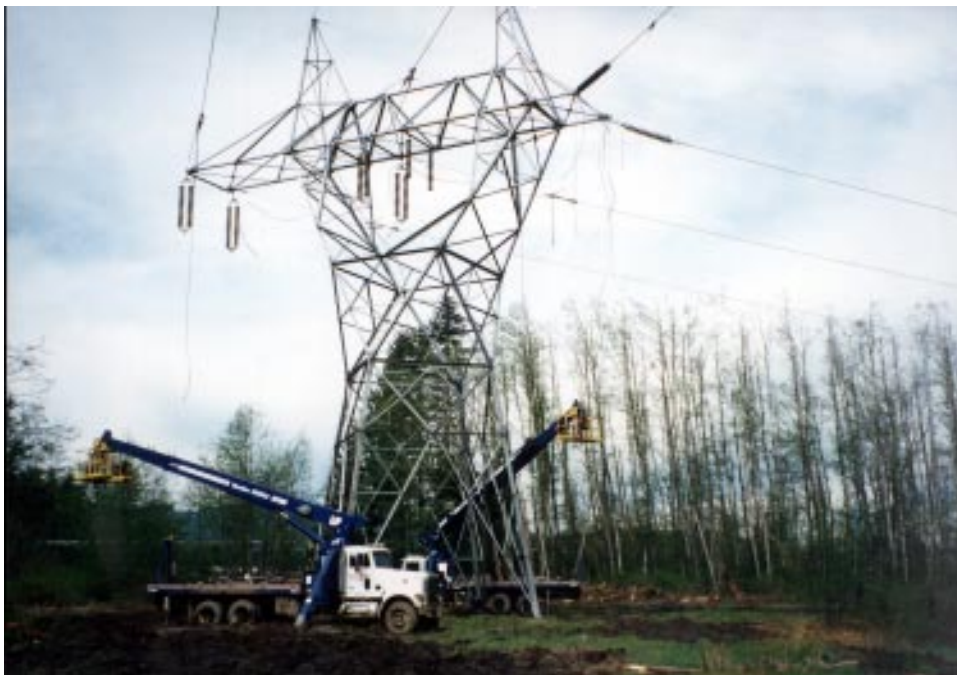
Exhibit 2 — Side View of Cranes Positioned Beneath Tower

Work conditions at the site were muddy, so the crane had to be dragged into position by a crawler. The crane was not tested for adequate boom extension and basket positioning. Apparently, that positioning did not allow adequate basket alignment, which required the victim and his coworker to overextend, utilizing the rails on the basket to reach the grip. It is possible that the victim had a such a tight grasp on the conductor because, since the basket was out of position, he needed more leverage to lift the 40-lb. grip.

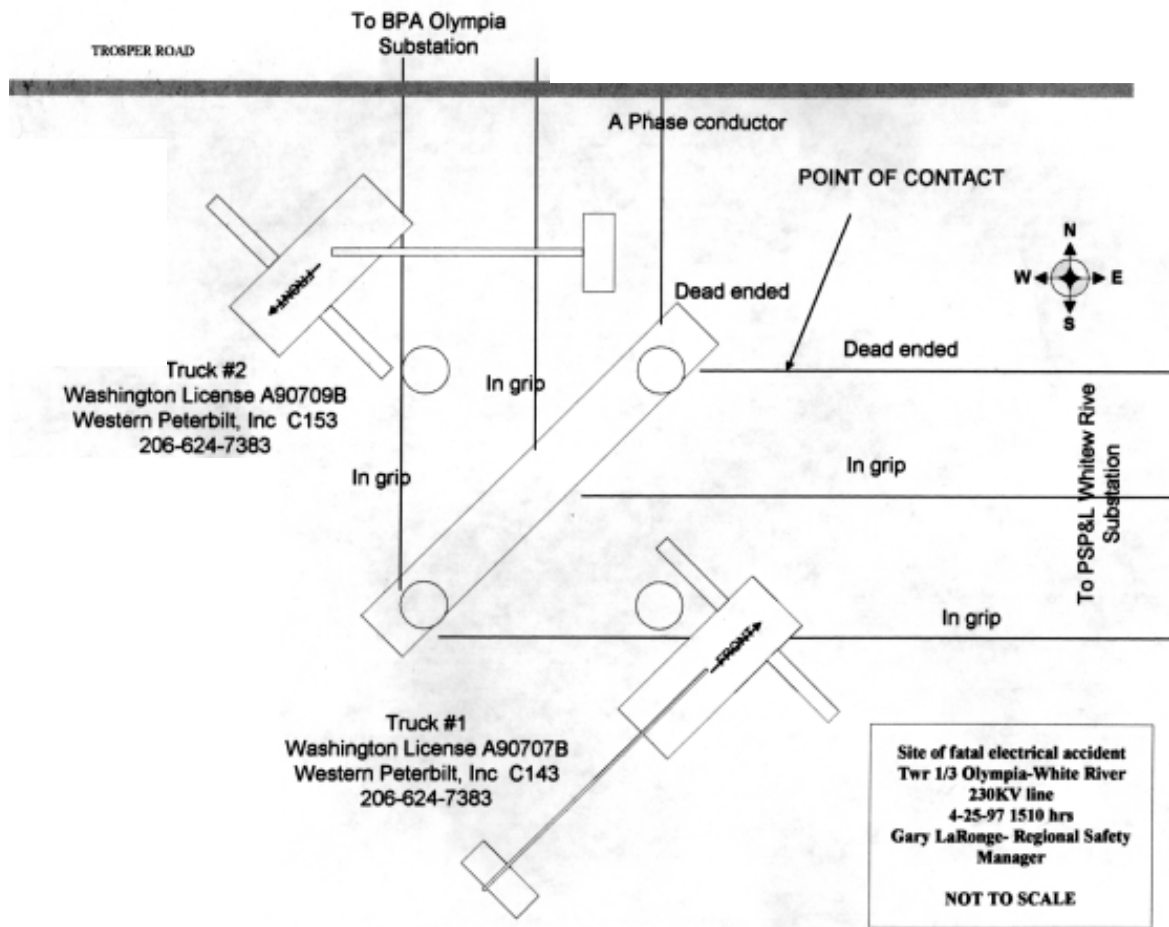
Figure 1 — “Site of Fatal Electrical Accident”

Eight Great Southwestern Construction crew members were on the job at tower 1/3. Two men were in the basket where the accident occurred; one man was operating the controls for that basket from the bed of the crane; the construction foreman and one additional worker were observing the proceedings from about 75 feet AHOL. Two crew members were in another aerial lift on the opposite side of the structure. One additional employee was working at ground level by the structure.

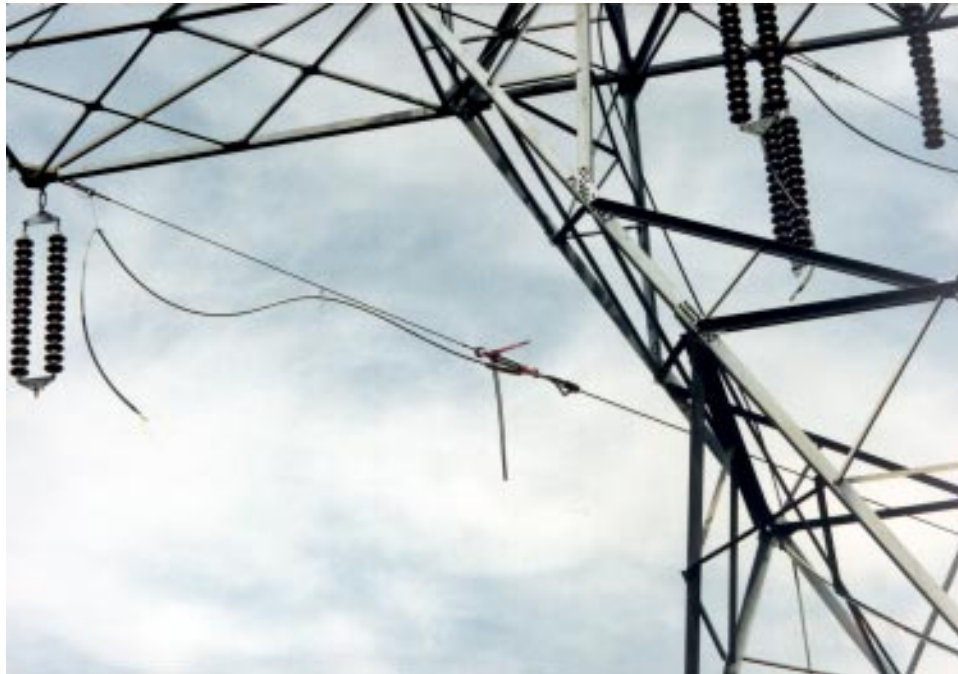
Exhibit 3 — Grip and Come-Along On Conductor at Scene of Accident

At the time of the accident, the work assignment on structure 1/3 was to connect the A-phase conductor to the dead-end tower insulator string. New conductor was being installed on both sides of the tower. Final connections were being made by the aerial basket crews. This procedure begins with rigging, or “catching off,” the conductor with rigging consisting of a hoist, or come-along, and wire-ropes sling assembly attached from the tower bridge arm to a conductor grip on the wire (See Exhibits 3, 5 and 6 and APPENDIX C). Then the conductor terminal end is made up with a compression-type fitting and attached to a string of insulators. The rigging is then slacked off to allow the tower arm to take the full tension of the conductor with the insulator assembly in place.

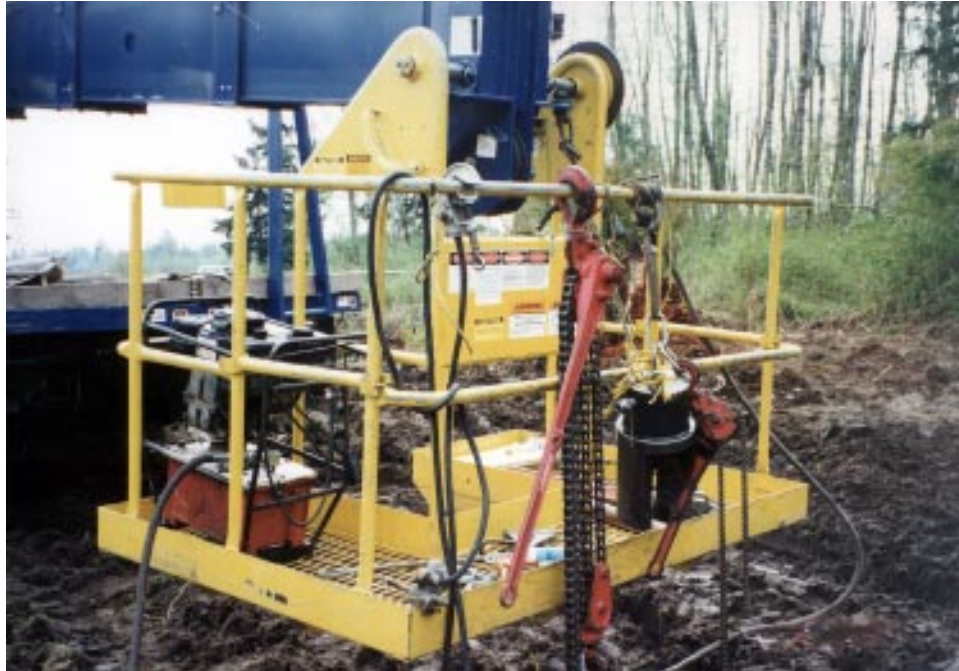
Exhibit 4 — Ungrounded Basket With Personal Ground Connections

The boom was then raised to the work location on the A-phase conductor AHOL. The boom was being operated by another employee, using the driver-side boom controls, because the sting-in and sting-out control operation (extension or retraction of boom sections) in the basket was malfunctioning. The front of the basket was located approximately at conductor level. The victim was located on the left side of the work basket, nearest the tower; the coworker was on the opposite end of the work basket (See Exhibit 4). According to coworker interview information, the victim connected the personal protective ground to the conductor by hand, between the grip and insulators, but was not observed tightening the ground clamp onto the conductor. The other end of the personal protective ground had been connected to the toe-board portion of the work basket, just under the right front corner, according to on-site observations and interviews (See Exhibit 4).

The BPA AIB cannot be sure of the exact conditions at the moment the victim was shocked. Crew members say that a personal ground was in place in the work area, but no one saw it being tightened down or otherwise secured. Subsequent statements by the crew members present cannot place the personal ground at any location after contact was made. No hotsticks, as prescribed in Great Western's Safety Plan, were reported being used, although standard utility practice is to use only fiberglass-insulated live-line tools to install or remove portable protective grounds.

The crane boom itself was used to break the victim's hold on the conductor, pulling him away as it came down. But the personal protective ground shows no evidence of having been ripped from the line (its other end was attached to the basket). After the accident, investigators found the conductor end of the personal ground attached to the rail from the inside, leading some to question if the ground had ever really been in place.

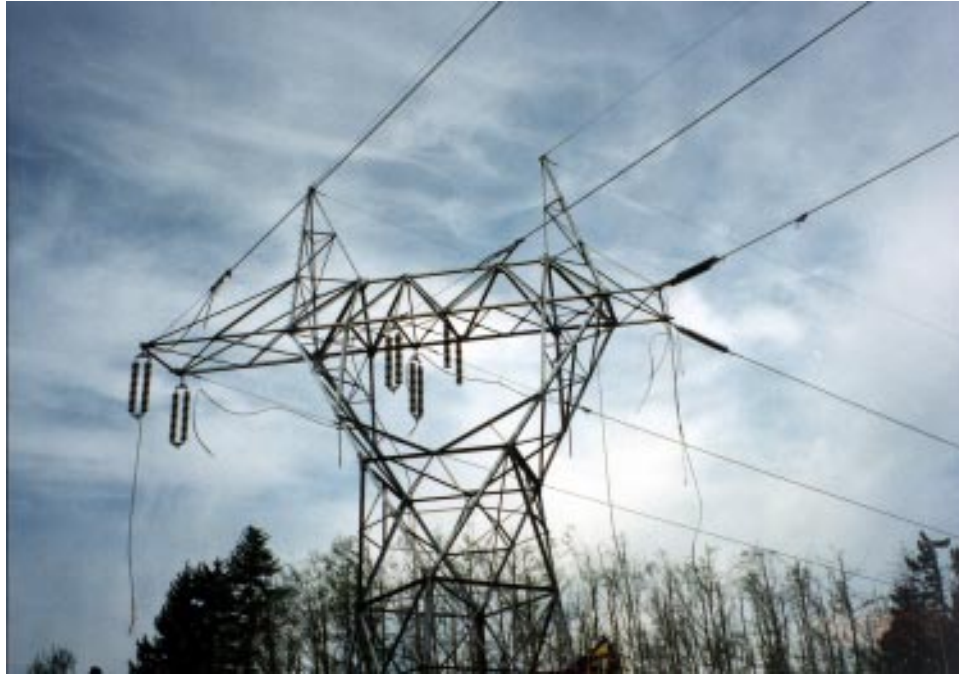
Exhibit 5 — Position of Grip on Conductor, Long Shot.

At the time of the electrical contact, the coworker was attempting to remove the grip from the conductor (See Exhibits 5 and 6 and APPENDIX C). This removal process required him to stand on the center work basket rail, allowing him to extend his reach. He needed to stand on the rail because the crane, which had been hauled into place as a result of the muddy conditions, was not positioned so that he could proceed normally from within the basket. As the coworker was moving the grip closer to the edge of the basket, the victim moved to assist in the removal process and grabbed the grip. Concurrently, the coworker let loose of the grip to reposition himself within the basket, leaving the victim holding onto the grip or conductor. Moments later, after repositioning himself in the basket, the coworker attempted to re-enter the work area to assist in removing the grip. In that brief time between the coworker letting loose of the grip, repositioning himself in the basket and attempting to assist in removing the grip, something had

Why was the victim injured and not his coworker, who also handled the grip? The AIB thinks the rigging used by the linemen formed an "incidental" ground that was broken when the rigging was disconnected. Grounding would still have been secure if the personal ground had remained attached.

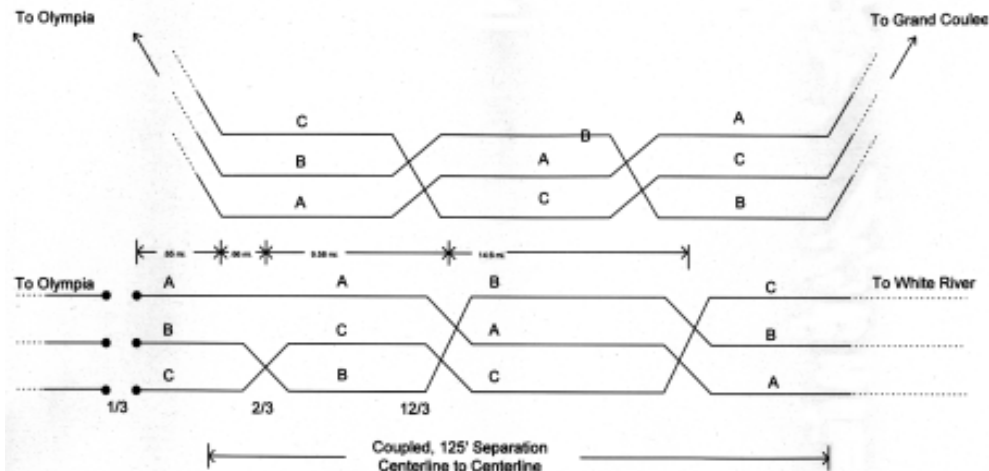
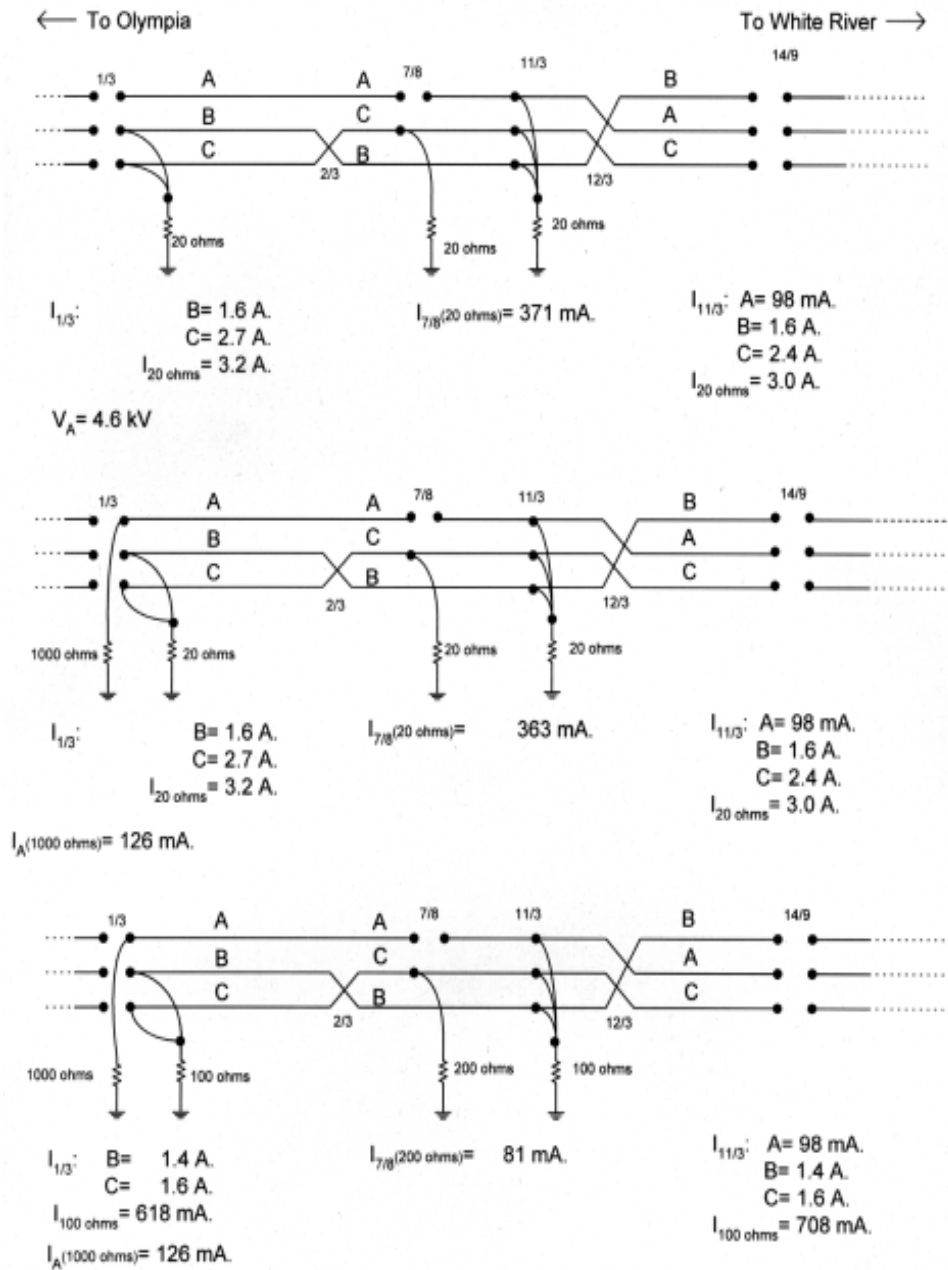
Figure 3. 3-Phase Schematic of Coupled Portion Between Olympia-White River (230 kV) & Olympia-Grand Coulee (287 kV)

The prevailing electrical conditions were examined at tower 1/3 to determine the source and magnitude of the electrical energy that caused the fatal accident. Figure 3 shows those conditions.

The Olympia-Coulee 287-kV line, 125 feet north of and running parallel to the Olympia-White River circuit, was operating at 300 kV at the time of the accident.

APPENDIX E shows the effects of current on the human body. As noted, time exposed and current magnitude are the crucial factors. The AIB concluded that 125 ma passed through the victim’s heart region as it crossed his body, from its entrance point on his left hand to its exit point below his right knee.
