**Type A Accident
Investigation Board Report
on the June 20, 1997,
Construction Fatality
at the
Brookhaven National Laboratory
Upton, New York**

July 1997

**Office of Oversight
Environment, Safety and Health
U.S. Department of Energy**

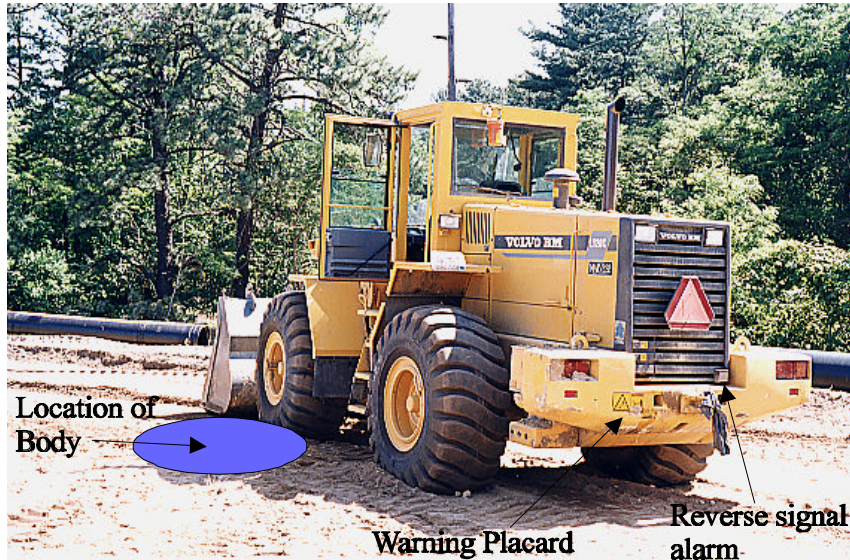
Exhibit 2-1. Wheel Loader

Based on the above information, the Board concluded that there was no equipment defect that contributed to the accident.

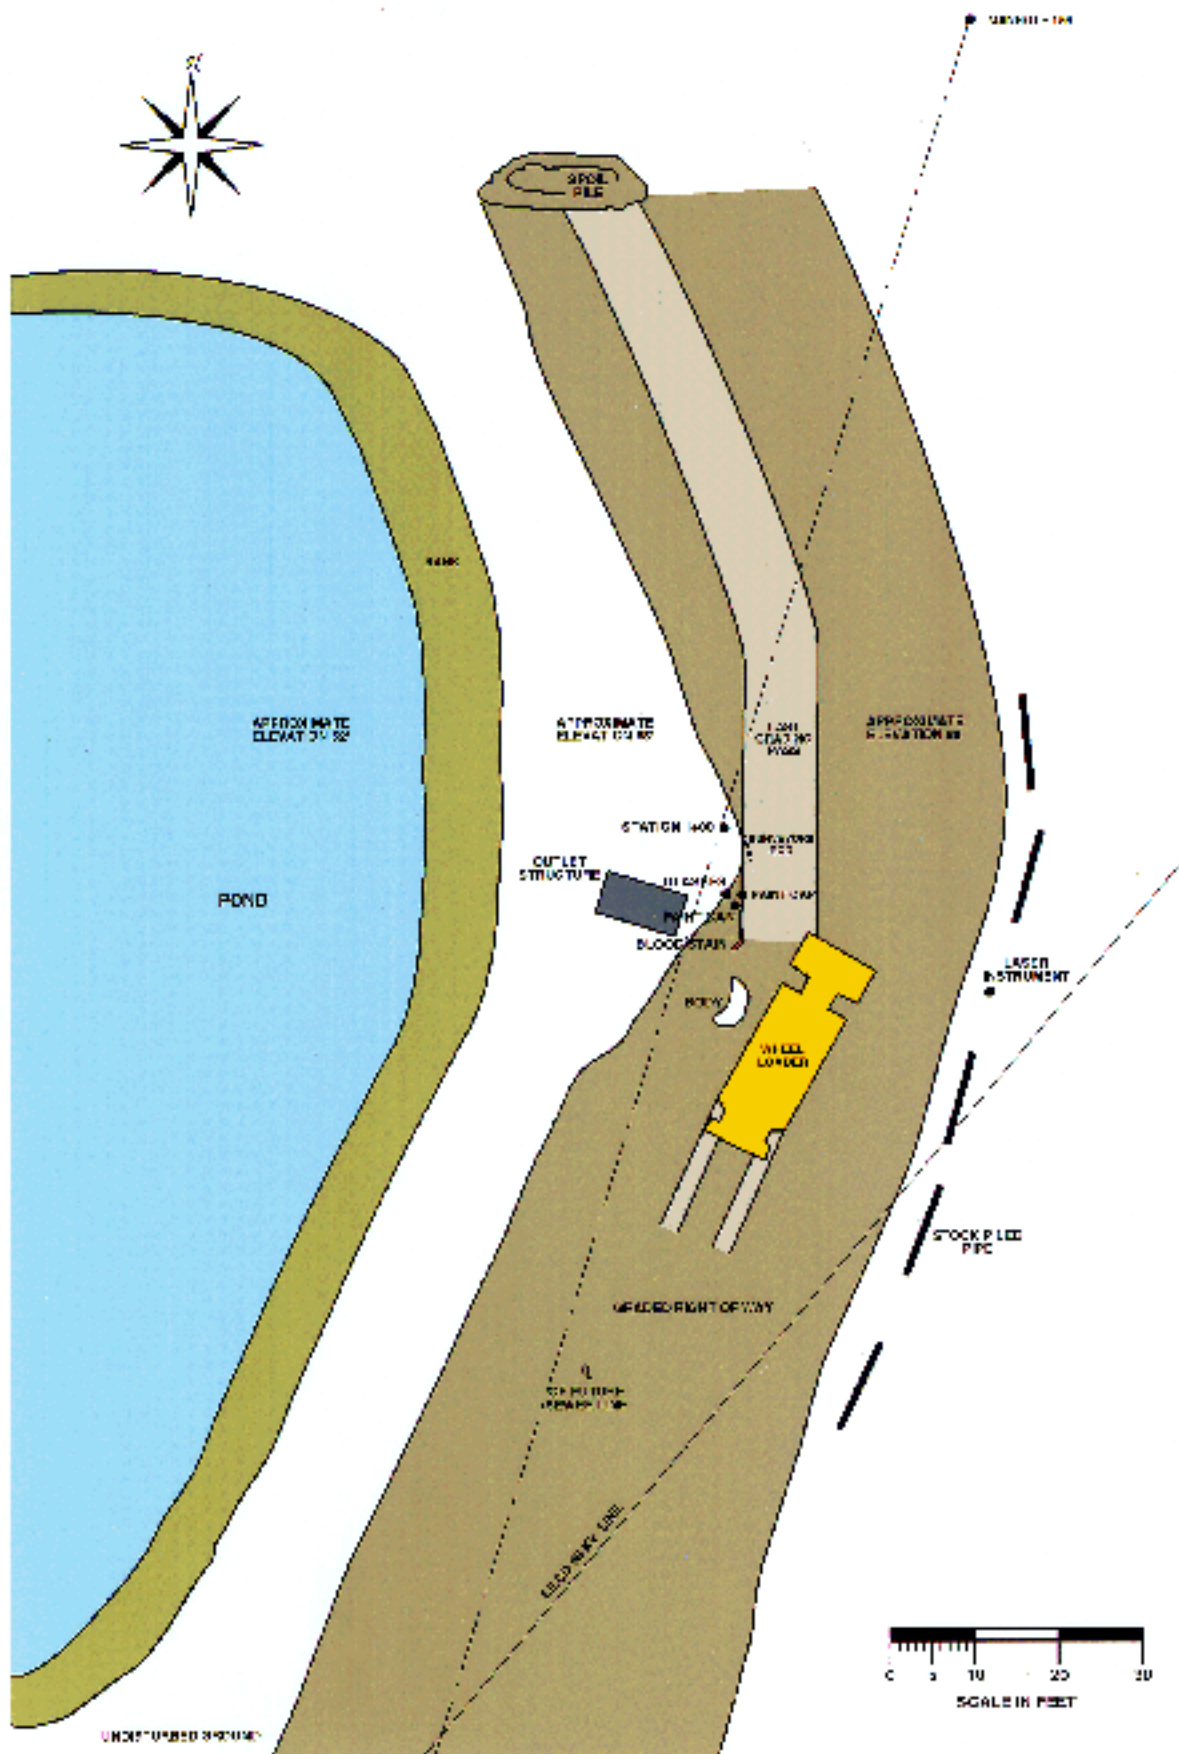
Figure 2-1. Accident Scene Diagram

The Operator had just dumped the wheel loader's bucket of dirt in the spoil pile. Then, with the wheel loader in reverse gear and moving up to 4.5 miles per hour (6.6 feet per second), the Operator dragged the bucket to smooth out the rough grade. About 55 feet from the spoil pile (and 20 feet north of the stake), the Operator turned the wheel loader slightly to the left, putting its left side in line with the Laborer (see Exhibit 2-2). The wheel loader's tracks showed that it again turned slightly near the stake, swinging the wheel loader's rear end to the left. At this location the recharge basin's outflow structure narrowed the grading zone (see Exhibit 2-3). The evidence is not conclusive as to whether the Laborer 1) slipped or tripped into the path of the wheel loader while stepping back out of the way and falling on his back, or 2) was struck in the back as he was walking away and spun around to land on his back in the path of the wheel loader. The Laborer was run over by at least one of the left tires of the wheel loader. Not aware of what had happened, the Operator continued back approximately 45 feet and then began moving forward on a new path just east and to the right of the previous pass. After moving

The Laborer was run over by at least one of the left tires.

forward for about 25 feet, the Operator saw the surveyor's rod on the ground, stopped the wheel loader, opened the cab's door, and saw the Laborer lying on the ground to the left of the wheel loader.
