**Office of Oversight
Environment, Safety and Health**

*Type A Accident Investigation
of the December 8, 1999*

**Multiple Injury Accident
Resulting from the
Sodium-Potassium Explosion
in Building 9201-5
at the Y-12 Plant**

February 2000

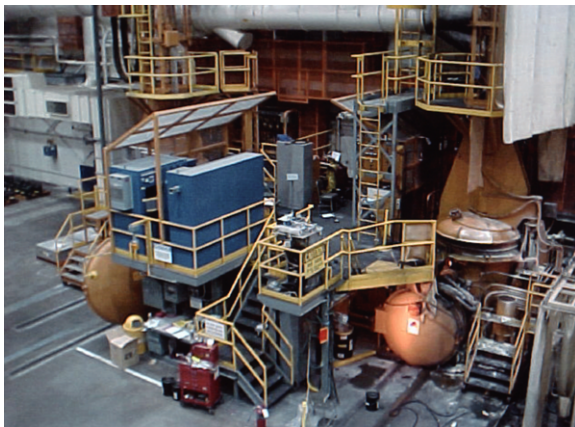
Exhibit #1. Skull Caster Furnace and Accident Scene

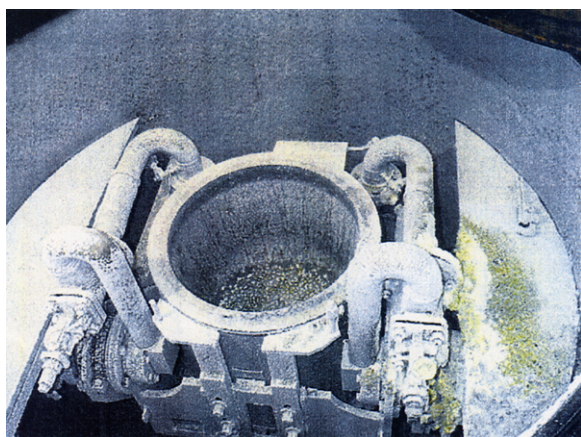
During December 2 through 7, Y-12 Plant personnel entered the area several times to observe conditions and add argon. On December 3, workers took pictures (Exhibit #2) of the furnace and observed a “fine white snow.” On this entry, the process engineer indicated that the NaK “did not look right” and that he saw things that he “hadn’t seen before.” The process engineer suspected potassium superoxide because of the yellow color observed on the surface of the NaK. He directed the furnace surface to be sprayed with mineral oil in an attempt to minimize further oxidation, which again caused reactions, noise, and generation of significant quantities of black and white smoke. On Monday, December 6, the furnace cover was lifted and the task of spraying the entire furnace with mineral oil was completed. During these recovery activities, the workers wore lab coats, booties, and gloves for PPE.

Exhibit #2. Skull Caster Furnace and Crucible on December 3, Showing NaK and Yellow Potassium Superoxide

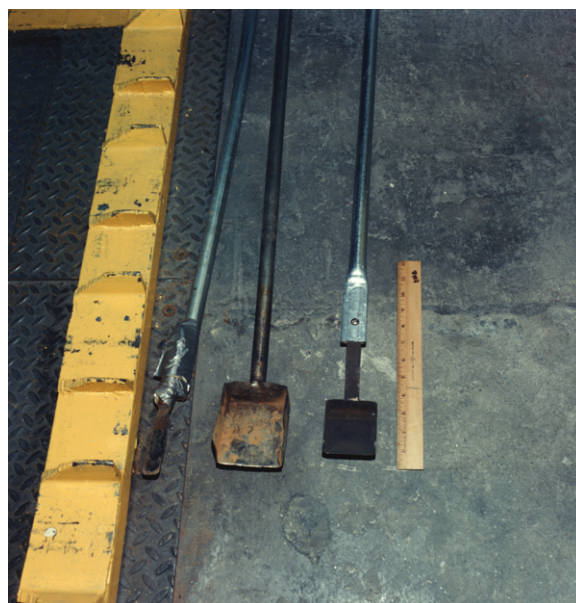
At about 9:30 a.m., the recovery team opened the cover further (about half open) and then began to use a stainless steel rod in an attempt to break up the NaK crust. The operator (CO-1) believed that this tool was too short because he had to bend over the furnace to reach the NaK with the rod. The operator then tried another lift tool (one fitted with a flat scraper on the end), but it was flimsy and could not break through the hard crust that had formed. The operator again began to use the steel rod to lift the crust in an attempt to determine whether unreacted NaK could be seen. Two of the operators then left to find materials to make a longer probe (see Exhibit #3).

Exhibit #3. Metal Tools Used To Probe and Break Up the NaK Spill

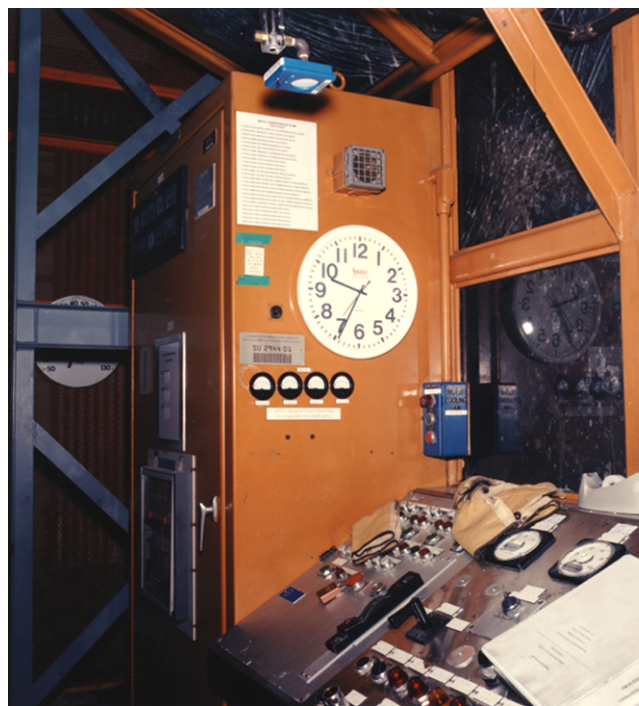
Exhibit #4. Skull Caster Furnace Control Panel Showing Clock Stopped as a Result of the Accident

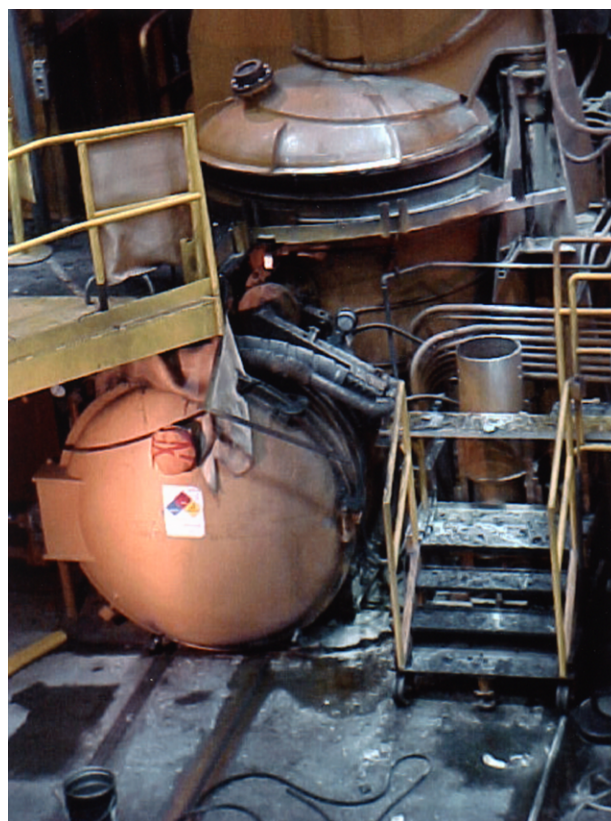
Exhibit #5. Skull Caster Furnace Showing Explosion Damage and NaK Residue

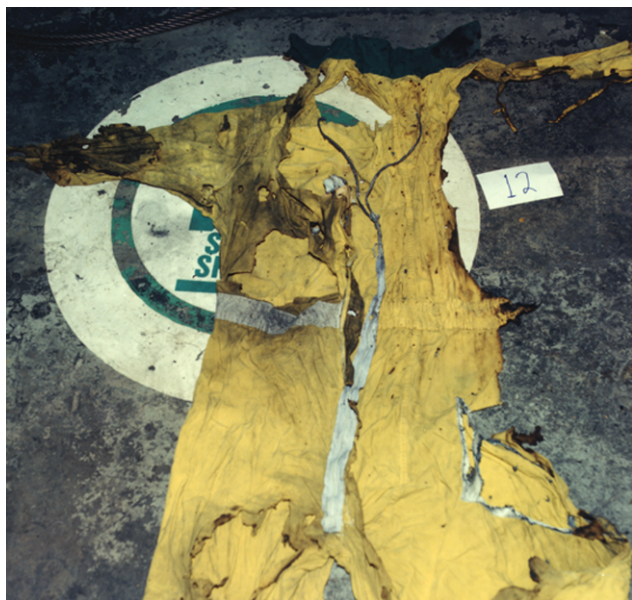
Exhibit #6. Standard Coveralls Burned During Explosion

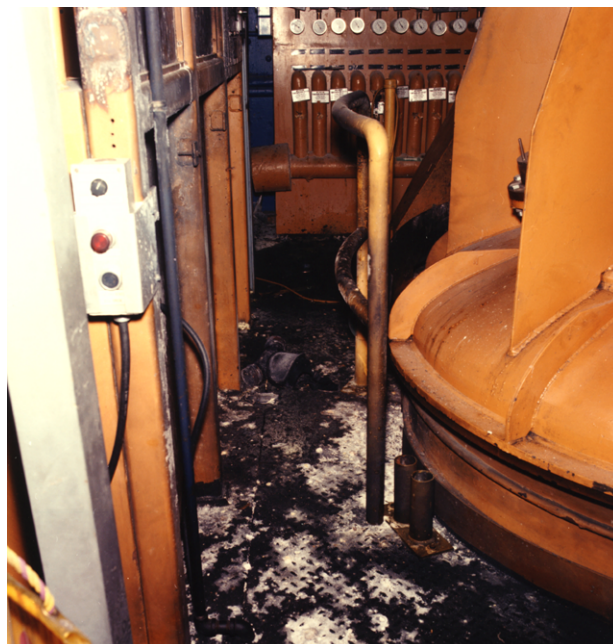
Exhibit #7. Residual NaK from Explosion Near Furnace

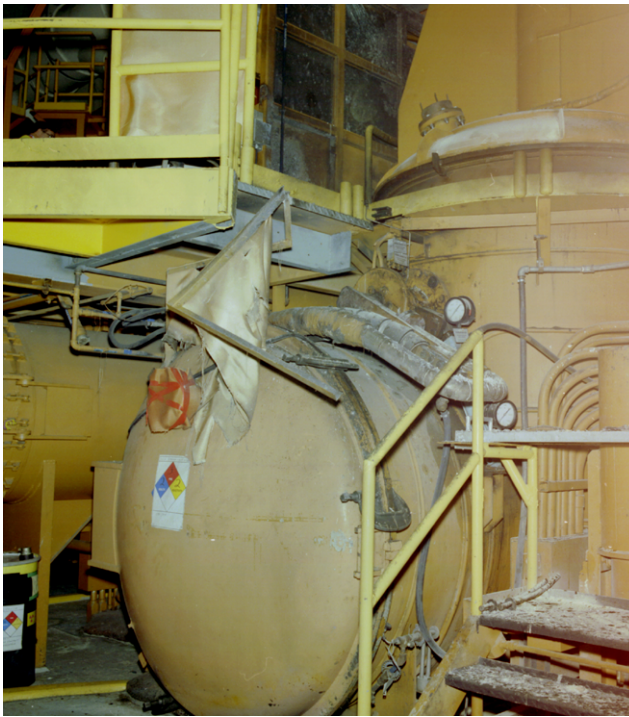
Exhibit #8. Furnace Showing Explosion Damage

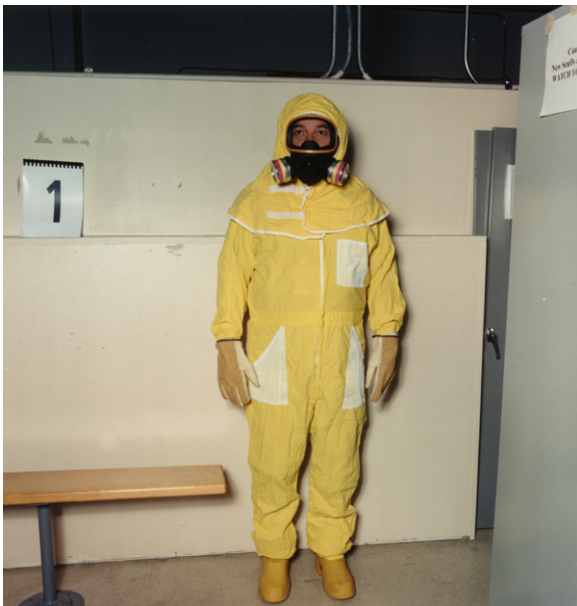
PPE Worn by Three Workers

- Standard coveralls (not flame-resistant)
- Leather gloves (not flame-resistant)
- Cartridge-type respirator (not supplied air)

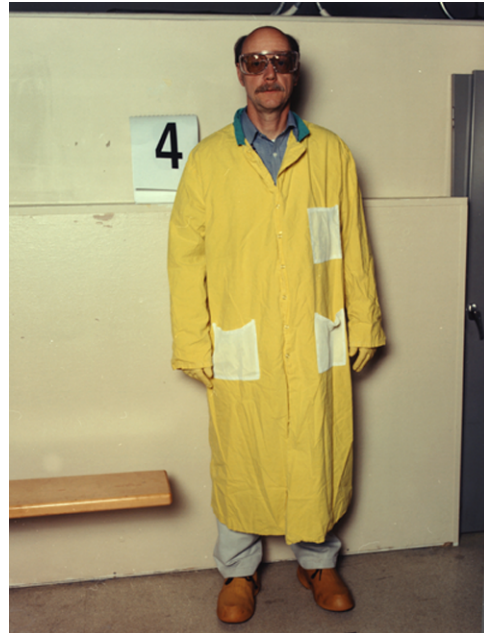
PPE Typical of That Worn by Other Workers

- Standard lab coats (not flame-resistant)
- Standard shoe covers and gloves (not flame-resistant)
- No respirator

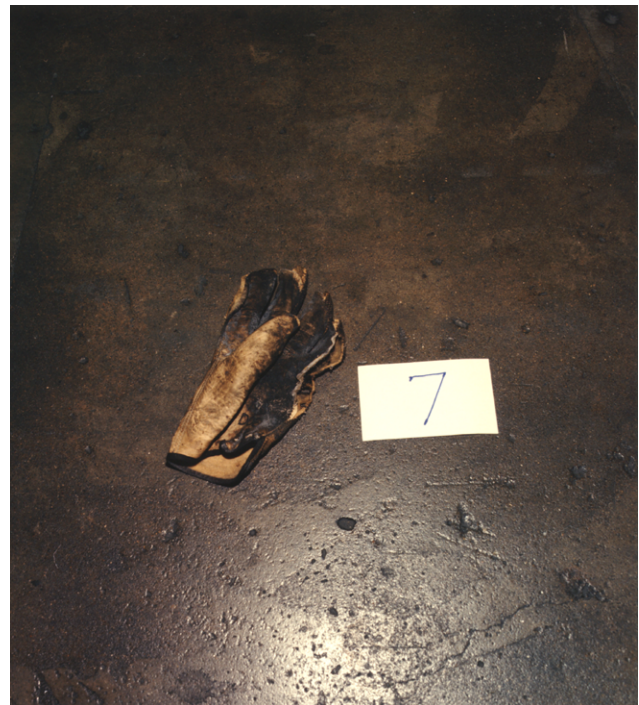
Standard Work Glove Burned from Explosion/Fire

Contrary to the manufacturer’s recommendations, some crucible changeout activities specified leather gloves dipped in mineral oil (not dry), and failed to specify flame retardant clothing, clothing without cuffs or pockets, or an SCBA. The 1988 final safety analysis report required PPE consisting of a “face shield, flame proof coveralls, hard hat and shoes when [operators] are working with NaK.” The current crucible changeout procedure (and recovery plan) also omitted some PPE requirements that were in older versions of the procedure. For example, earlier procedures required Nomex® (flame-retardant) coveralls for crucible removal, repair, cleaning, and installation. The Nomex® requirement was included in procedures until November 1989.

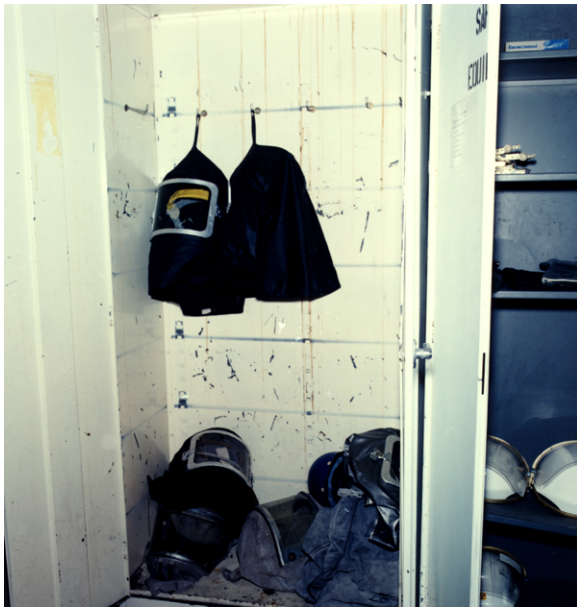
NaK suits were not staged at the furnace for the spill recovery on December 8 for either planned work evolutions or response to abnormal events (see Table 4 and Exhibit #12). Section 9 of the recovery plan requires an NaK suit for cleaning the furnace walls and floor. For abnormal response actions, Section 2 of the recovery plan refers to the abnormal response action of the crucible changeout procedure (Section 4.8), which requires the use of an NaK suit for both NaK spills and external NaK oxidation events, either of which could have occurred in removing the spilled NaK from the furnace.

Exhibit #12. NaK Locker Showing the Lack of NaK Suits

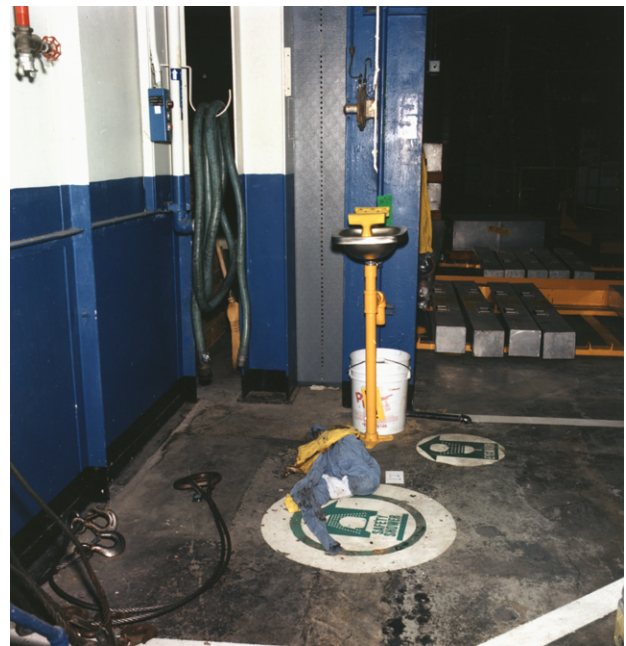
Exhibit #13. Safety Shower Showing Lack of Berms and Burned Clothing

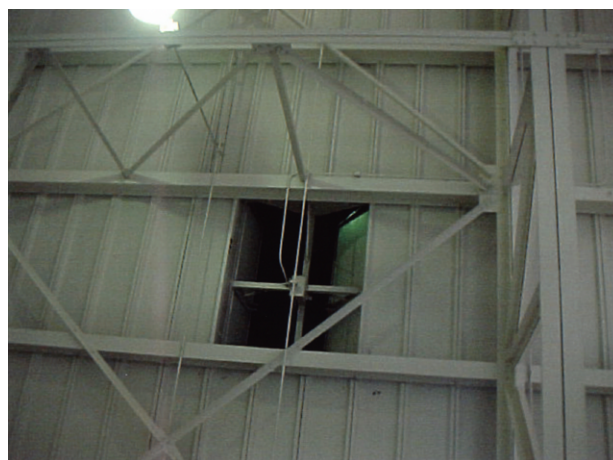
Exhibit #14. Open Roof Vents

design drawings connected the two roof vents over the skull melt furnace to a push button switch located in an office; however, as noted above, building personnel were unaware of the switch, and no switch was located. During a fire protection system upgrade, the other two roof vents were connected to smoke detectors for a large industrial saw and an oven in the general area, but away from the skull caster furnace. During testing of the new system before the spill and accident, the roof vents did not function, so they were presumably electrically inoperable at the time of the spill and accident. A work request was initiated to correct the deficiency, but the work had not been completed before the NaK spill and accident.
