Type A Accident Investigation

**Subcontractor Fatality at the
Pond B Dam Upgrade Project
on July 26, 2004
at the
Savannah River Site
Aiken, South Carolina**

September 2004

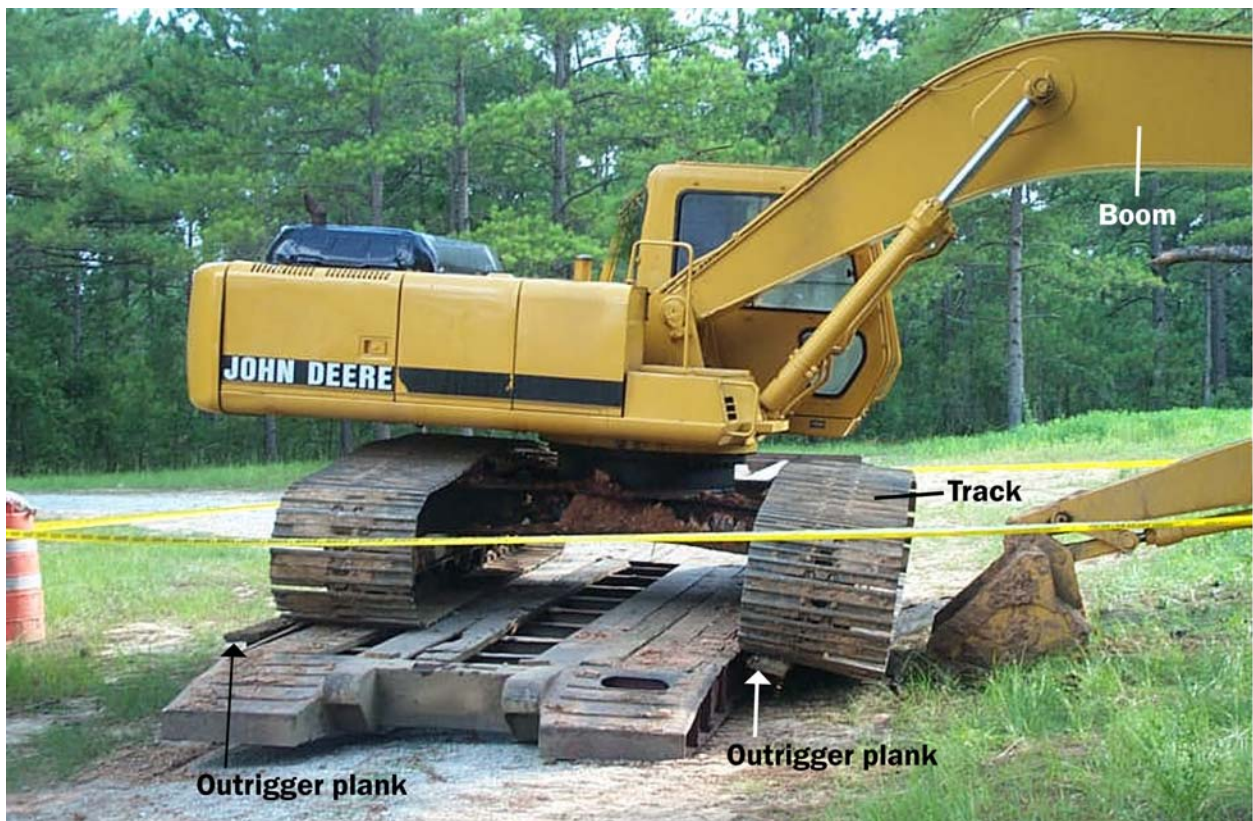
Figure 2-1. The accident scene

The driver positioned the outrigger and plank on the driver's side of the lowboy, and the teamster assisted the driver in positioning the outrigger and plank on the passenger side (post-accident visual examination indicated that outriggers were missing on the lowboy – three on the passenger side and two on the driver's side). The outrigger plank on the driver's side spanned six outrigger positions, including one of the missing positions. The teamster drove the excavator onto the lowboy trailer from the front end of the trailer. He stated that he loaded the excavator as a courtesy to the driver. The GradeSouth employee is a teamster, not an operating engineer.

The teamster raised the excavator boom and swung it about 90 degrees to the right so that it was nearly perpendicular to the excavator tracks. He positioned the boom and the arm to place the bucket on the ground about 10 to 12 feet from the trailer. In this position, the arm is at an approximate 45-degree angle to the ground. John Deere recommends that the arm should be at a 90- to 110-degree angle to the boom, allowing the track to be elevated by applying downward force on the boom only, rather than operating in "two-stick" control

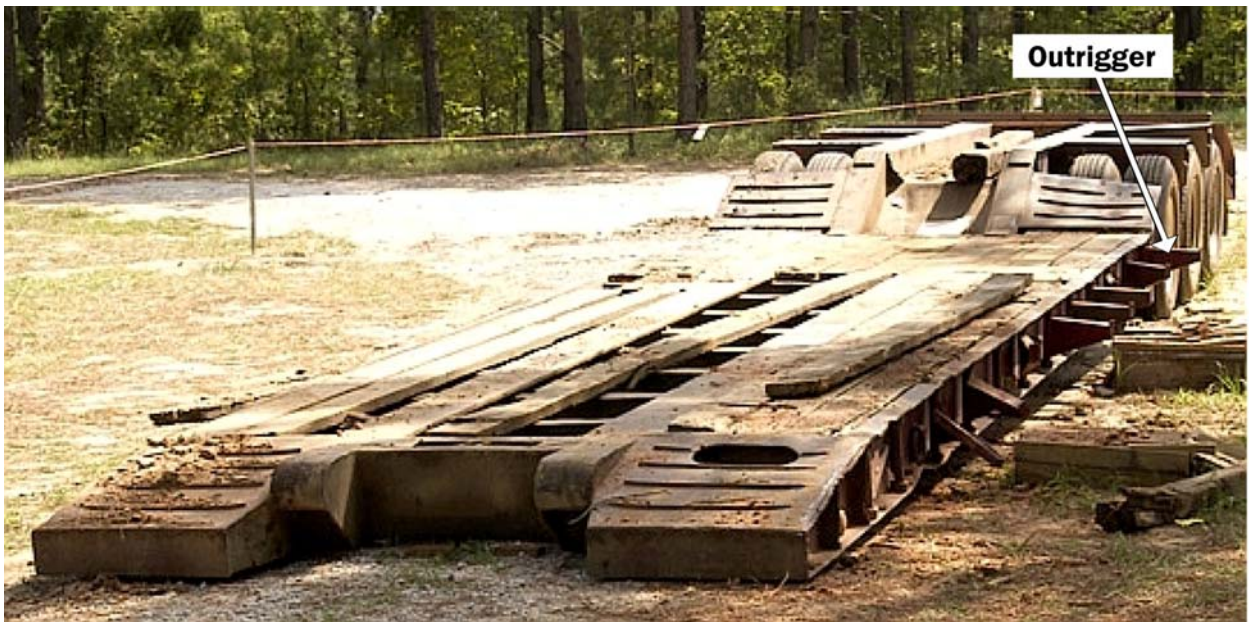
Figure 2-2. Lowboy after removing excavator

the excavator toward the front of the trailer and signaled the teamster by hand when the excavator was positioned where he wanted it. The teamster also stated that the truck driver told him that the plank on the outrigger on the driver's side of the lowboy was cocked and that the driver asked him to use the boom to lift the track on that side of the excavator so that he could reposition the plank correctly on the outrigger. Post-accident statements by the teamster indicate that neither he nor the truck driver considered stopping work or backing the excavator off the trailer and starting over when the plank became cocked.

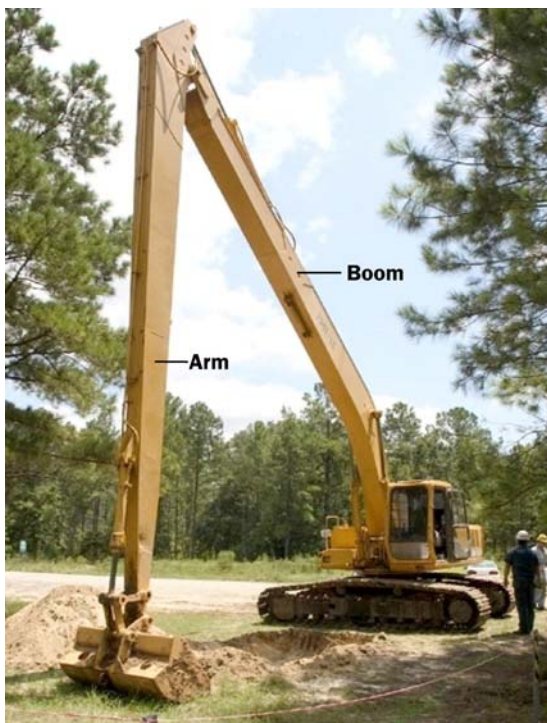
Figure 2-3. (left) The recommended arm configuration for lifting tracks

(illustrated in Figures 2-3 and 2-4). The teamster then used the excavator controls to push down on the boom and out on the arm to raise the track (i.e. “two-stick” control). He stated that the truck driver verbally directed him at least twice to raise the track higher. During this activity, the driver was in the teamster’s line of sight. The driver then squatted down near the excavator and trailer, and he then disappeared from the teamster’s line of sight.

at 90 to 110 degrees (as recommended by John Deere) because of the long boom. He noted that a regular excavator could be raised in that manner but with a long-stick excavator, there is a chance of bending the piece of equipment or not picking it up at all. The Board believes the teamster's assumption was incorrect.

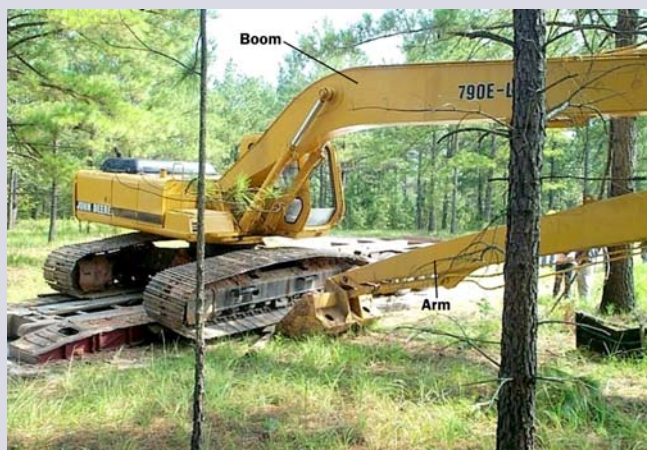
Figure 2-4. (below) Approximate arm configuration the teamster used.

The Board conducted engineering analysis and calculations, and simulated the accident conditions in the field to assist in analyzing the accident. Engineering analysis indicate that initially, the excavator configuration was stable with about 16,000 pounds of force on the bucket and 35,000 pounds of force on the stationary track. The Board determined that, while the track was elevated, a leak on the hydraulic line to the arm cylinder (caused by a loose fitting) relieved hydraulic pressure from the arm cylinder. The gradual loss of pressure in the cylinder resulted in a redistribution of loads within the excavator structure, which caused a buildup of lateral loads at the excavator support points (the stationary track and the bucket). After the lateral loads built up to a level that exceeded the frictional holding capability at the excavator supports (between either the stationary track and trailer or the bucket and ground), slippage occurred, until sufficient pressure was built up in the cylinder to re-support the load. This action occurred repeatedly, causing either the bucket or the track to slip, until the suspended track was again resting on the trailer bed.

The simulation of the accident conditions using the excavator involved in the accident, with the existing hydraulic leak present, confirmed the Board's engineering analysis. Both bucket slippage and track slippage were noted with a similar pre-accident excavator configuration. The simulation was re-performed after repair of the hydraulic leak by tightening the loose fitting. No bucket slippage or track slippage was noted. However, the raised track did lower slowly over the next 20 minutes, probably from slow internal leakage around the cylinder piston

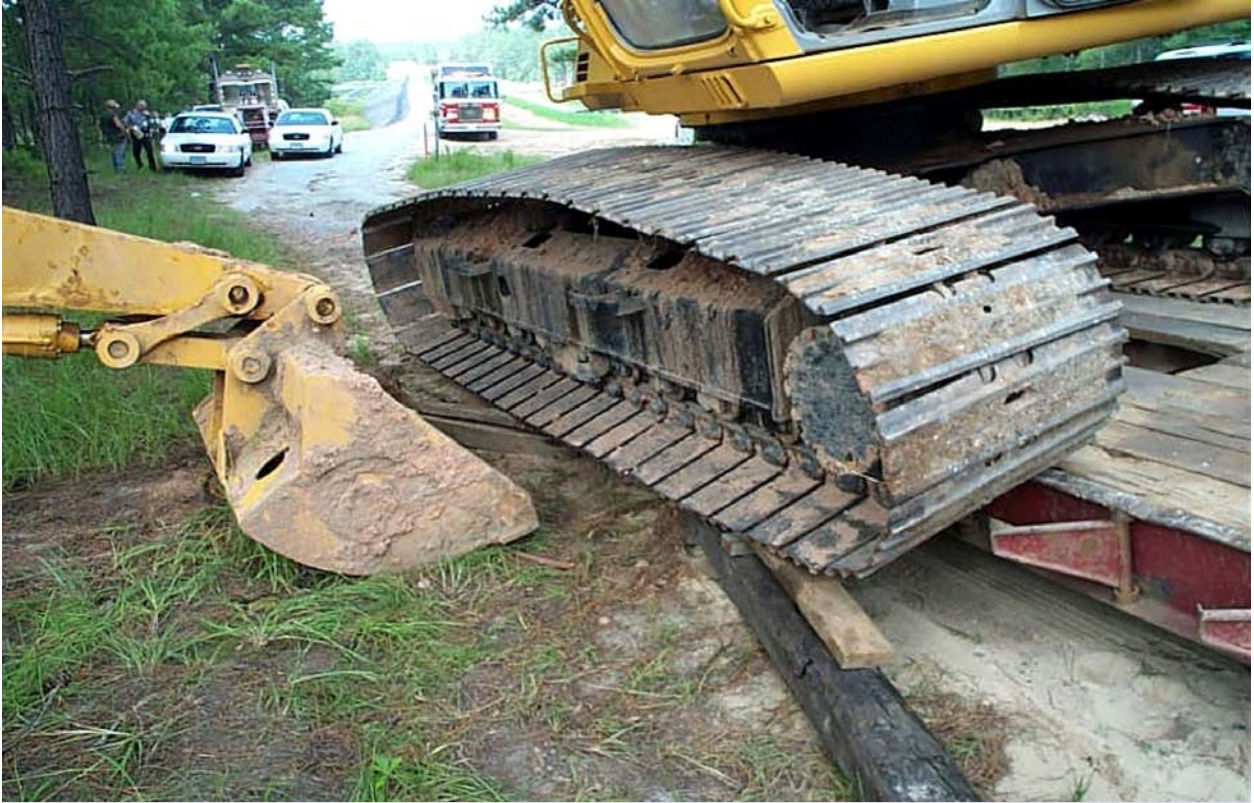
Figure 2-5. The scene immediately following the accident

The first responders noted that the driver's feet were near the track and that his body was positioned at approximately the same angle as the lumber (Figure 2-5) that was placed under the track by GradeSouth personnel to prevent the tracks from falling onto the driver. They also noted that the driver's pants were torn and that his right leg and pelvis were injured. The driver could not provide the first responders with an accurate description of the accident. During the first responders' initial assessment, the driver's blood pressure decreased and heart and respiratory rates increased. The driver was given oxygen by non-rebreather mask and placed on a Reeves Sleeve for transport.
