Type A Accident Investigation Report

**Vehicle Fatality Accident, July 1, 2008
59th Avenue NE and Highway 117
West of Cando, North Dakota**

August 2008

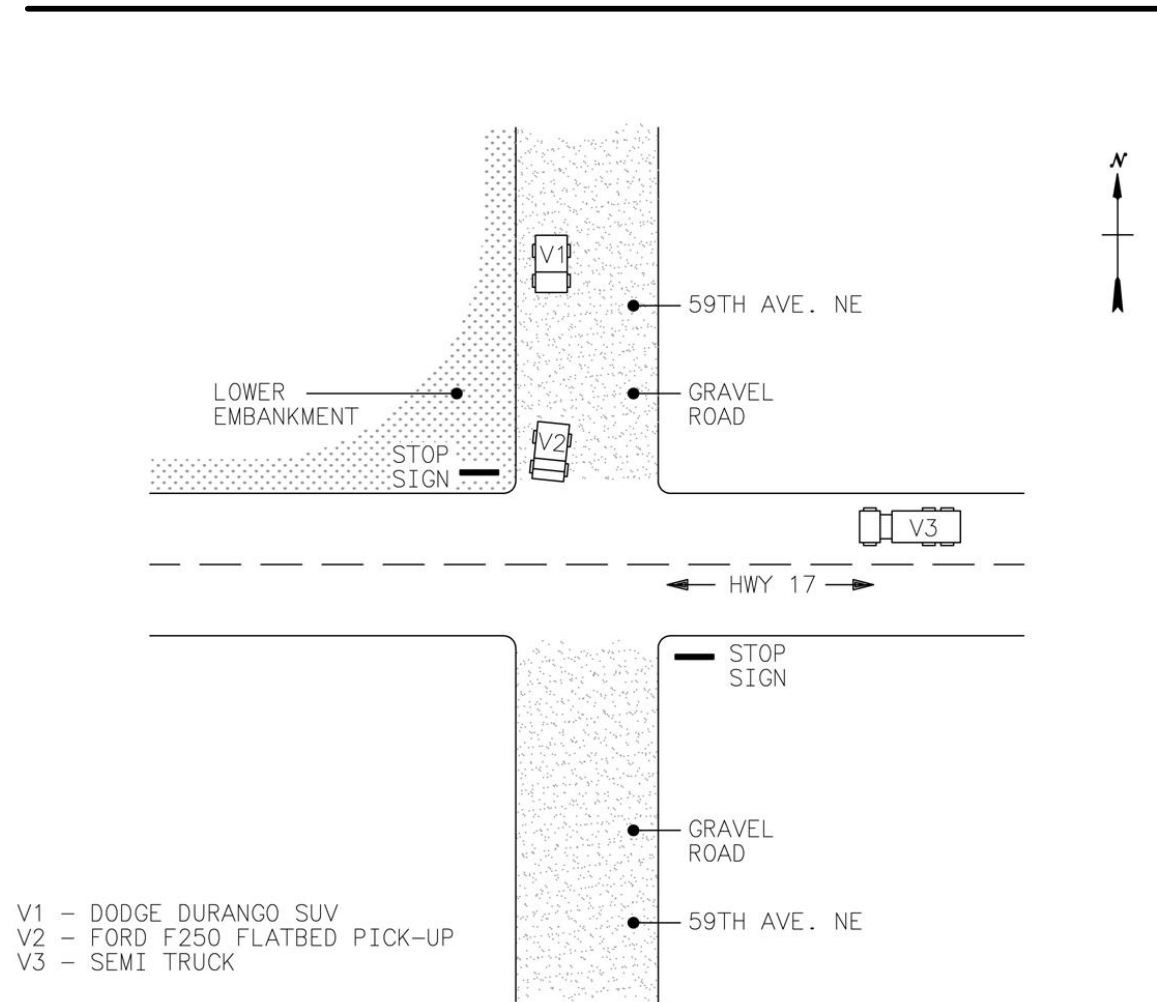
Figure 3 - Pre-crash diagram

Both vehicles had been participating in various field site visits and were enroute to their next destination. The lead vehicle (V2) produced heavy dust due to dry road conditions. V2 stopped at the intersection, angled slightly to the west, waiting for cross traffic before making a right hand turn onto Highway 17. When V1 saw V2 through the dust cloud stopped at the intersection, V1 was too close to stop, swerved to the left to avoid V2 and collided with V2 from behind (rear-ended).

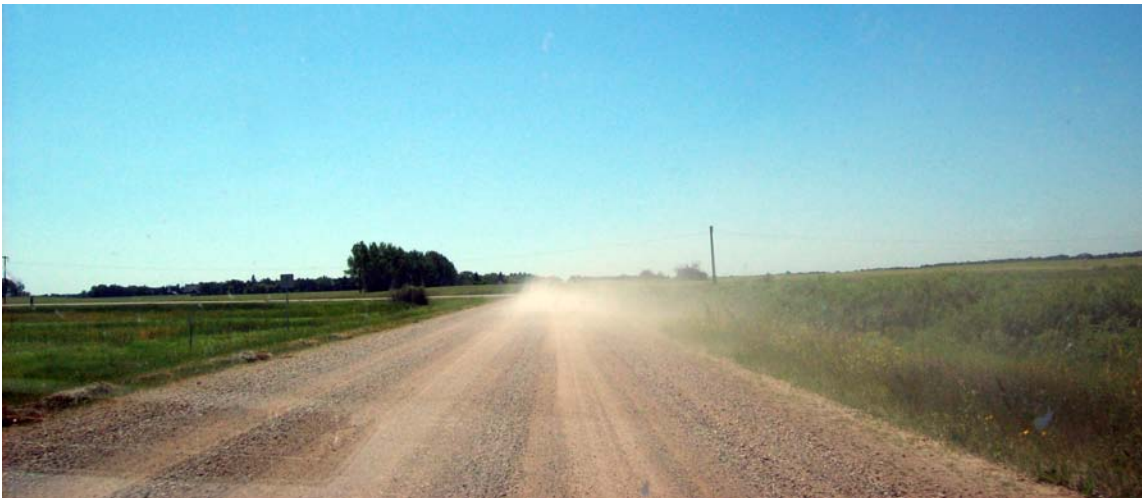
Simulated road conditions heading south on 59th Avenue approaching the intersection at Highway 17.

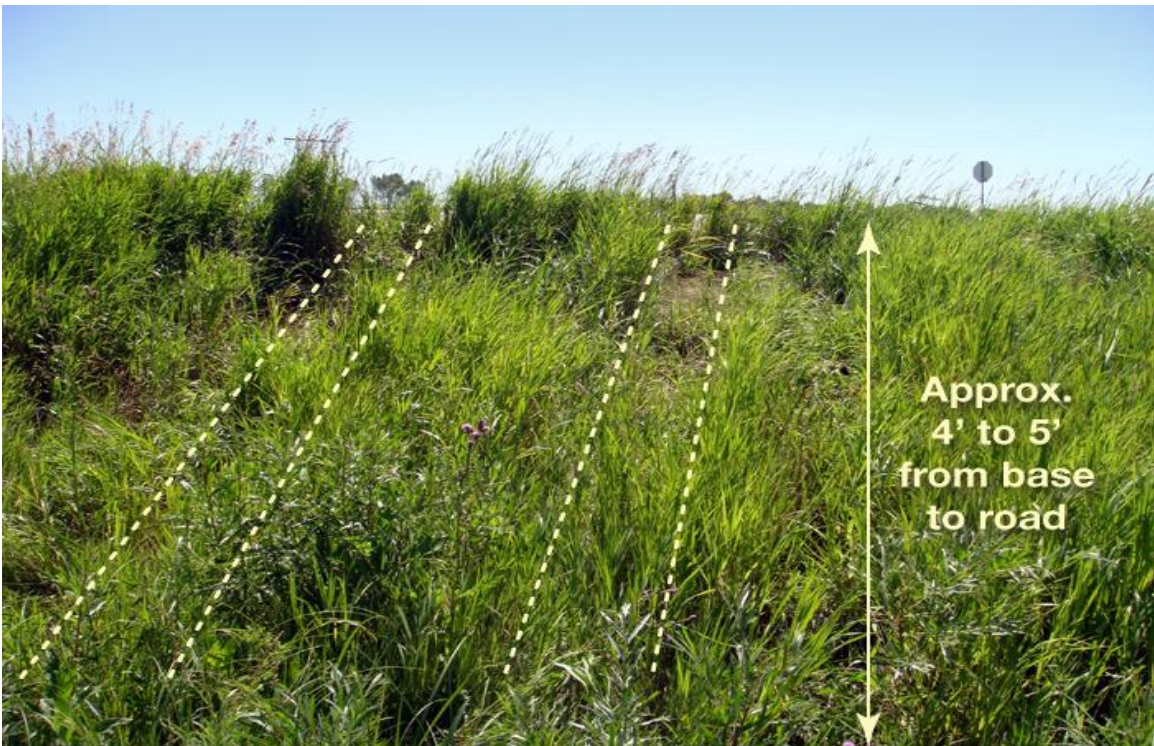
Dotted lines indicate where V2 entered embankment and the arrows show the approximate depth of the embankment.

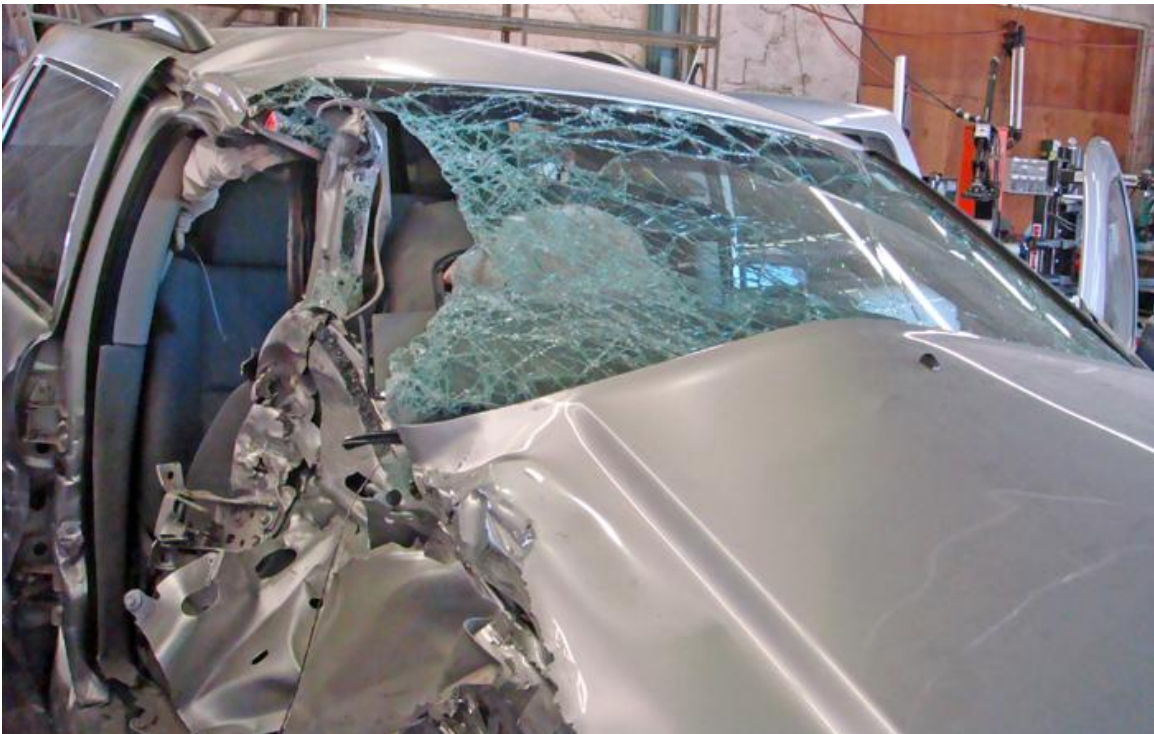
Photo shows the crash energy impact location.

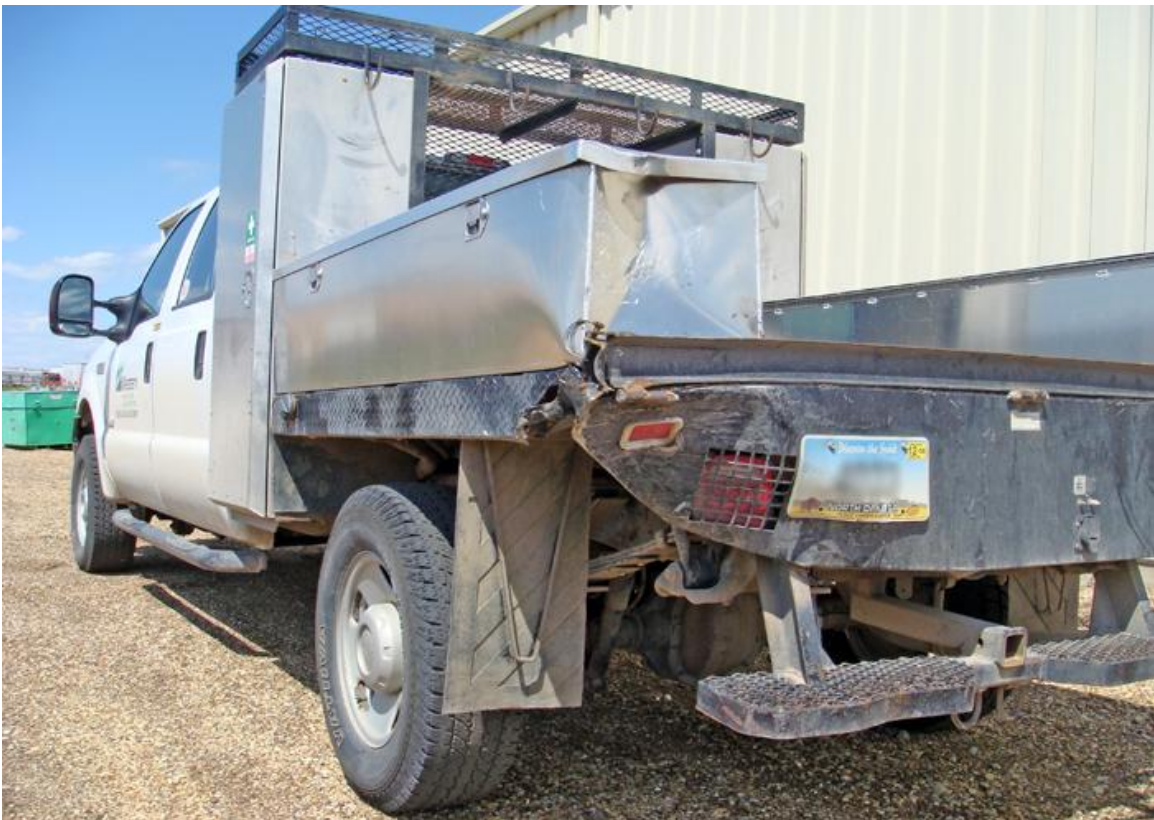
Photographs 11 and 12

Photos show damage from crash to V2.
