**Post Fire Field Reconnaissance July 31, 2006
Brins Fire Area, Oak Creek Canyon
Red Rock Ranger District, Coconino National Forest**

Polly Haessig, Geologist, Mogollon Rim Ranger District
August 1, 2006

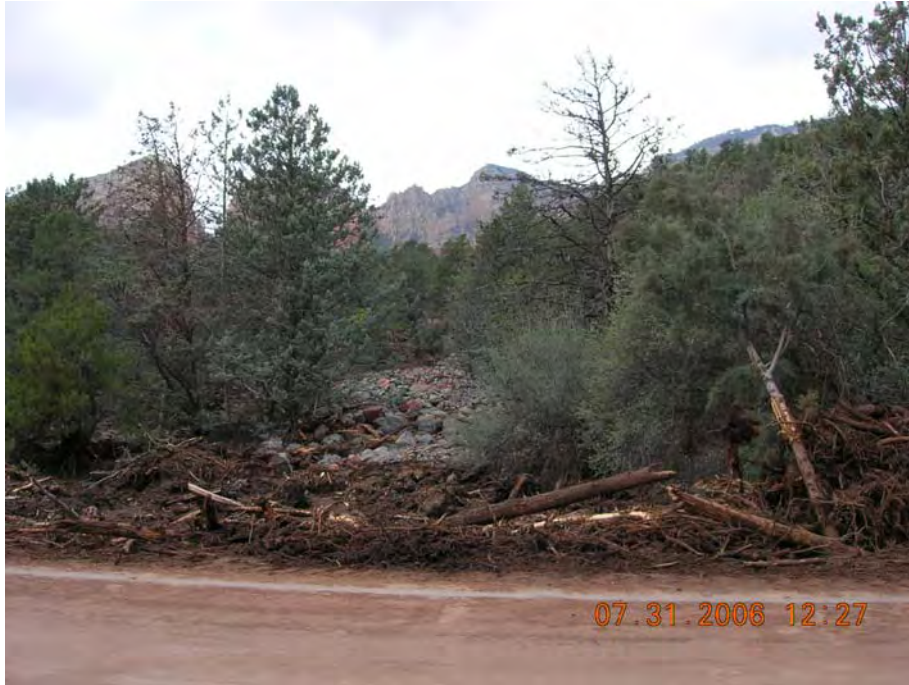
DSCN 1438 Debris flow that plugged pipe at crossing and flowed over the Highway. Stream is at ~ M.P. 377 where powerline crosses highway. Don't know exactly what this channel looked like before the fire – large boulders in background may have been the “debris “ part of the flow and the sediment trees, and wood debris are what backed up at the pipe inlet.

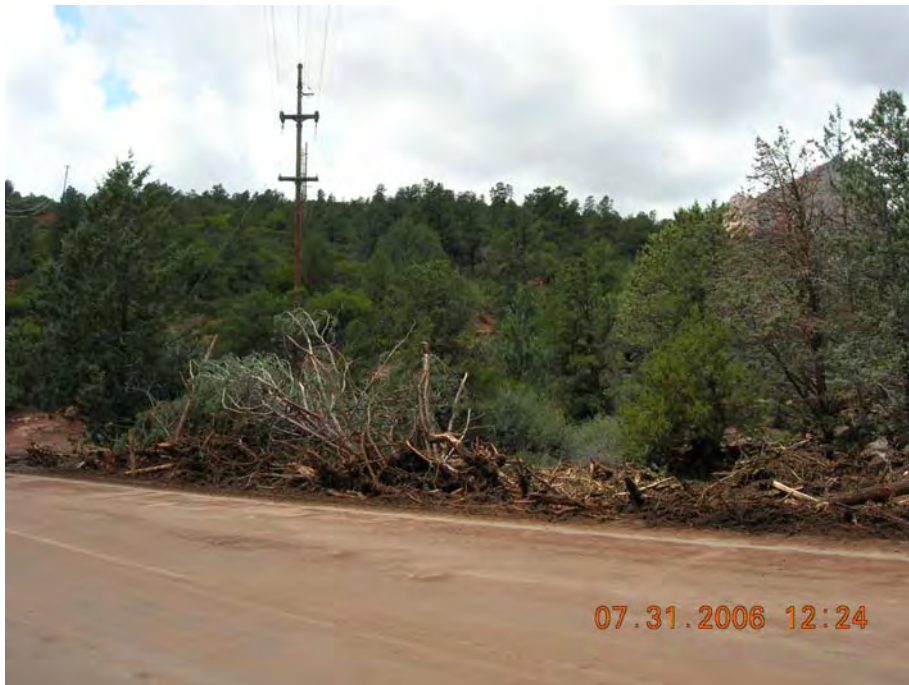
DSCN 1431. Same location as above but looking at Oak Creek side of the highway where mud and debris were cleared by equipment. This location is at an old road that joins up with the Wilson Trail and there are two pullouts on the east side of highway that were closed to public use.

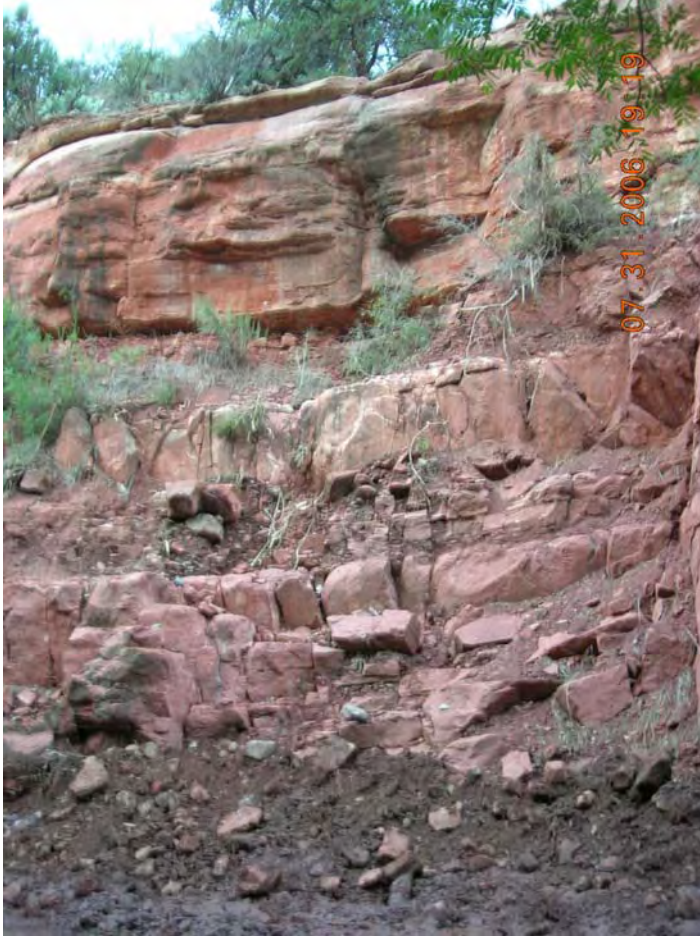
DSCN 1584: Rock slide and sediment debris, location ~ M.P. 77.8, just north of Trout Farm about 300 feet. Didn't hike above the sandstone ledge but the immediate area above the rock outcrop was unburned and out of the fire perimeter. There is a concavity in the outcrop where much of the rock failed. The probable cause of the rock fall was concentration of water running over the top of the ledge loosening up the rock and soil along preexisting fractures. The lower part of the outcrop area is highly fractured. Need to recon the slopes above the ledge to see if channels were formed where the water concentrated up slope and if the burned area above was a factor. The upper part of the rock outcrop shows a water mark staining where water has flown before. The rock and mud piled up over the guard railing and flowed over into Oak Creek – see picture below.

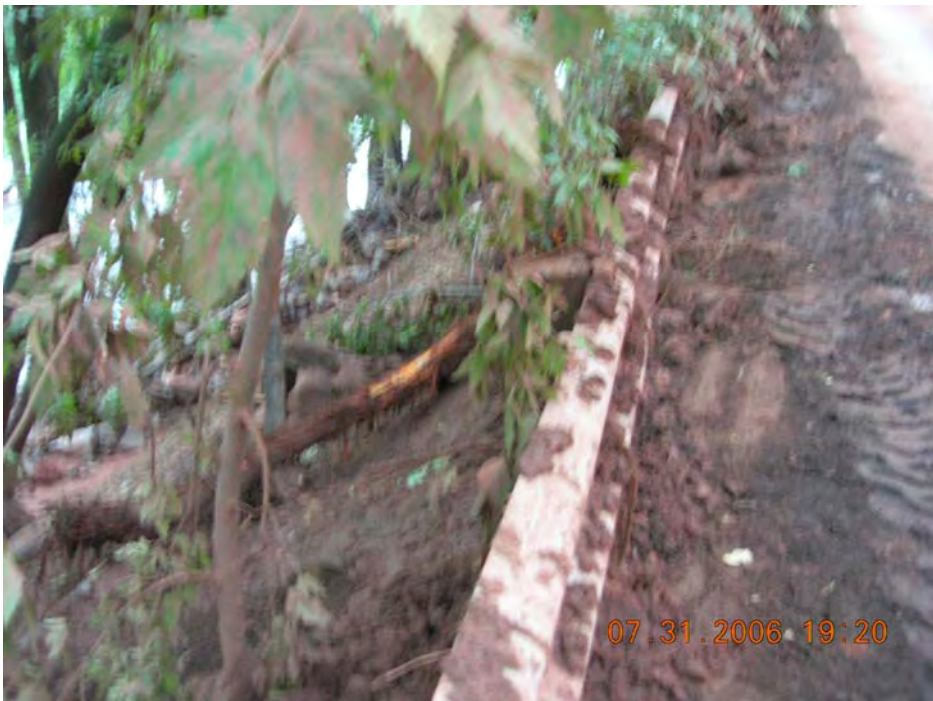
DSCN 1586. Blurry picture of the remnant rock, wood debris and sediment piled up along the guard rail at same location as above.

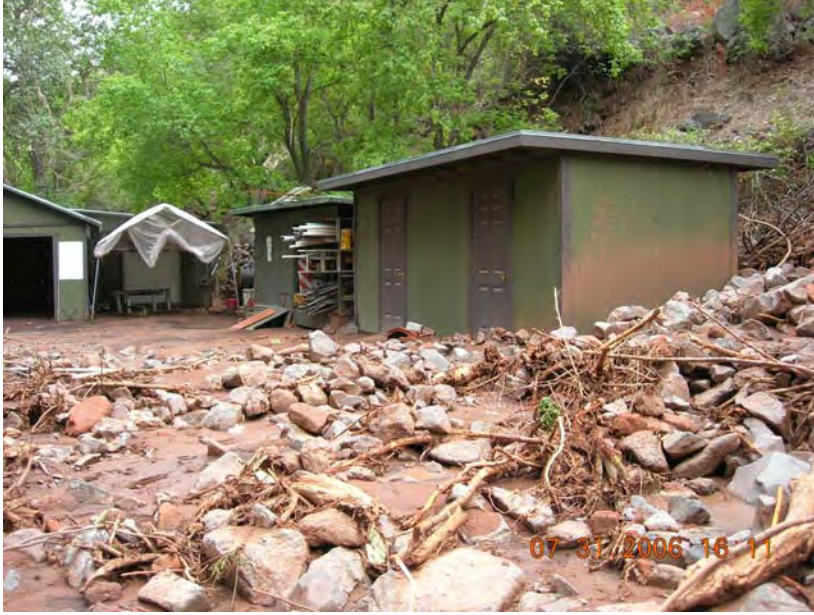
DSCN 1510: Debris flow deposit at bone yard behind Oak Creek Visitor Center at Indian Gardens.

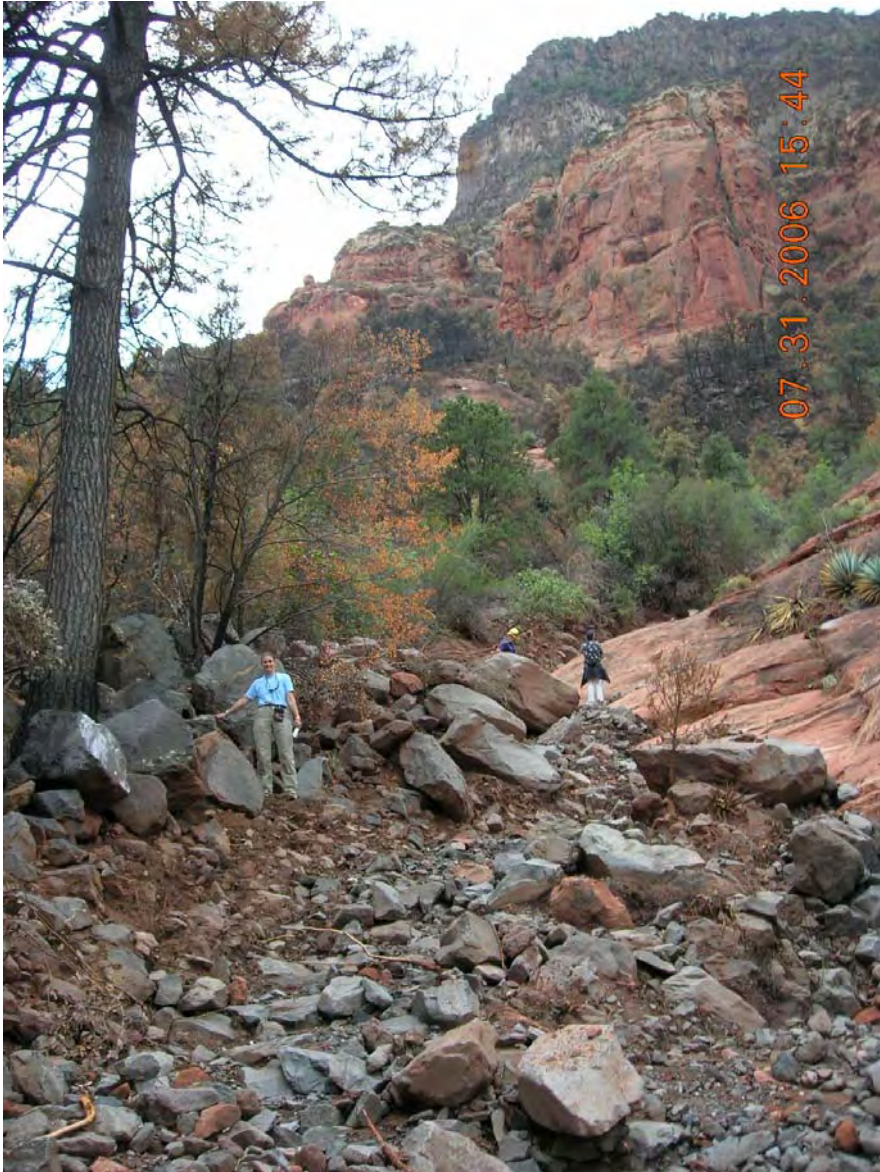
DSCN 1493: Debris flow in channel above the Visitor Center bone yard. Ann's hand is pointing to the height the water and debris flow in the channel. We could see an area at the head of the small watershed where there was erosion or possibly a shallow debris side hollow that initiated the sediment and rock flow.

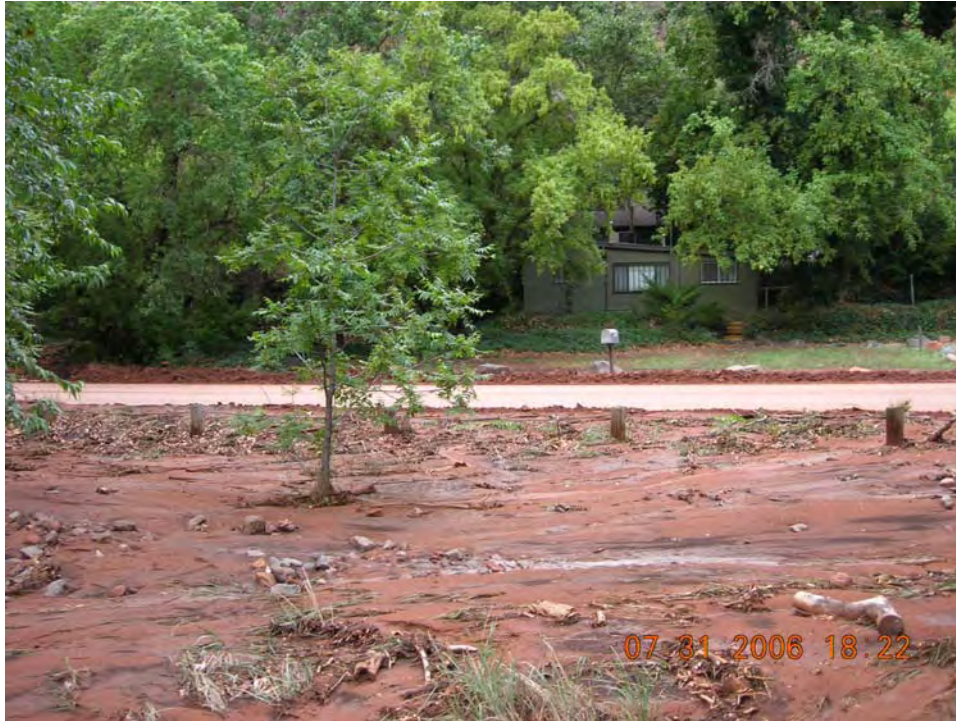
DSCN 1550:
Sediment deposited
on terrace on the
east side of the
Highway (view
west towards the
Visitor Center).

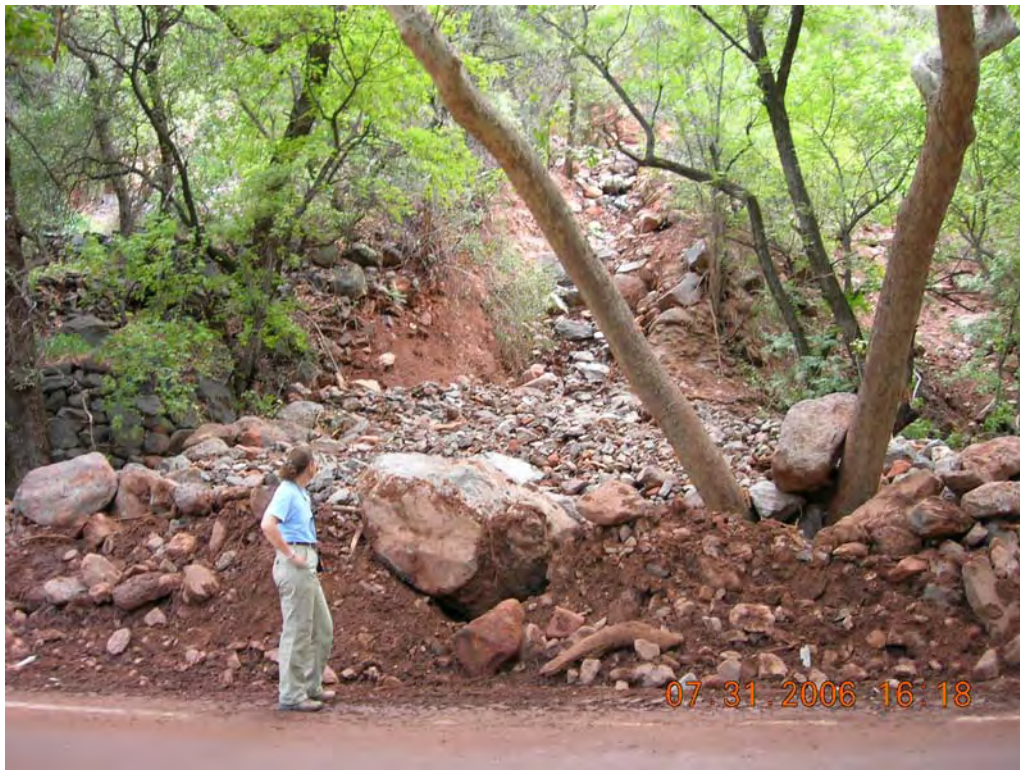
DSCN 1517:
Debris flow
deposit a 100
feet south of
the Visitor
Center. Note
large sized
boulders 3
cubic feet and
less. Height of
deposits is
about 4 feet or
so.

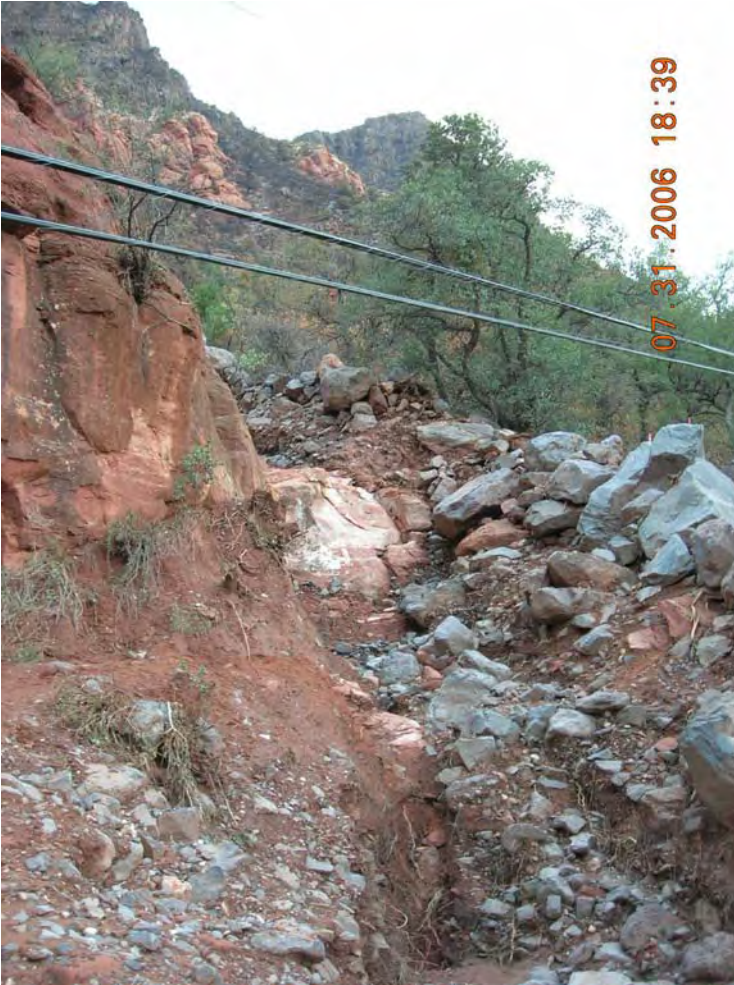
DSCN 1564: Channel that was the source of the debris flow deposit on the highway in the previous picture. South of Visitor Center.

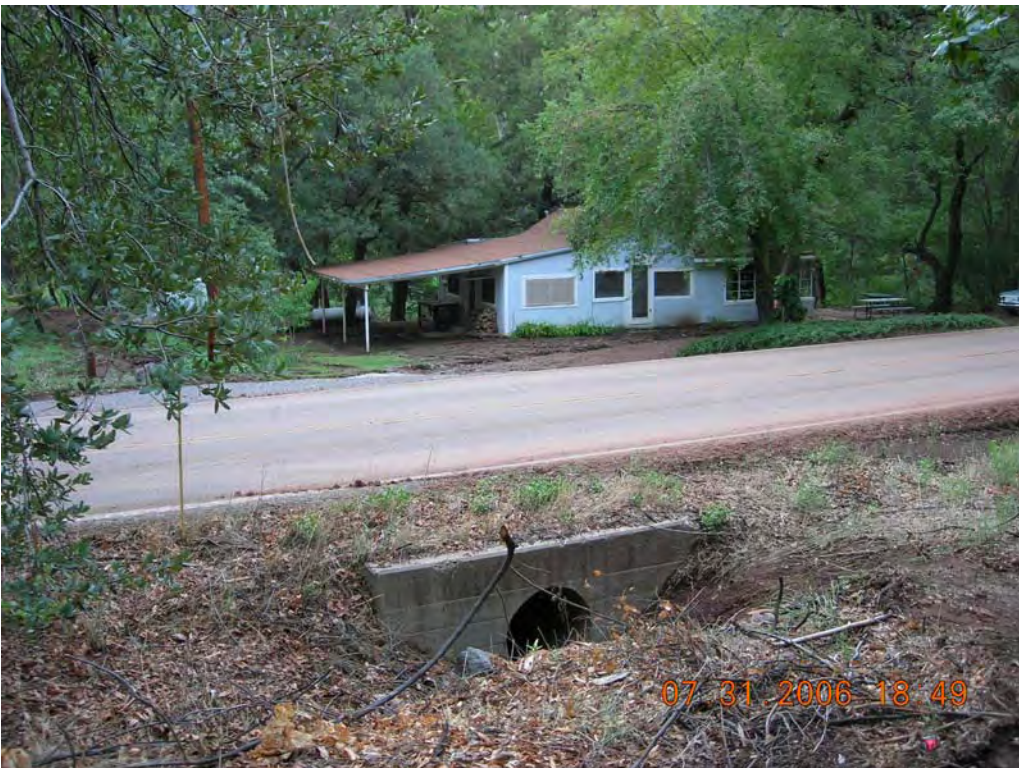
DSCN 1572: Sediment from the debris flow in the above picture was deposited in the front yard of the blue house just south of the Visitor Center area.

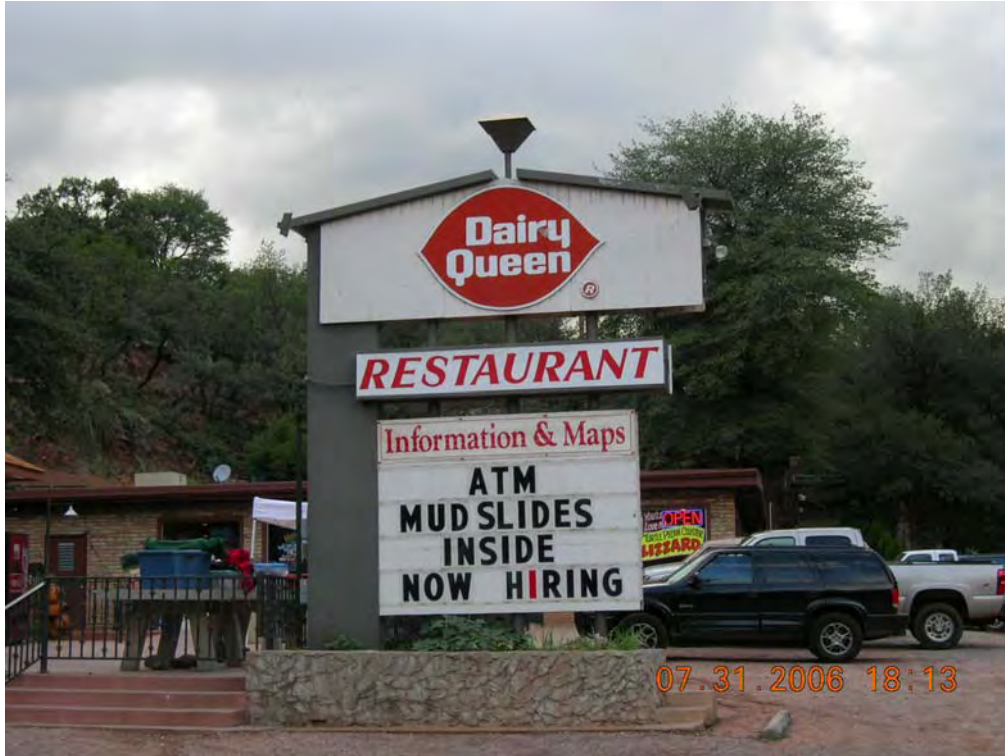
DSCN 1547:
Dairy Queen in
the early
evening of July
31, 2006 after
the mud
deposited in
front of it was
hosed off.

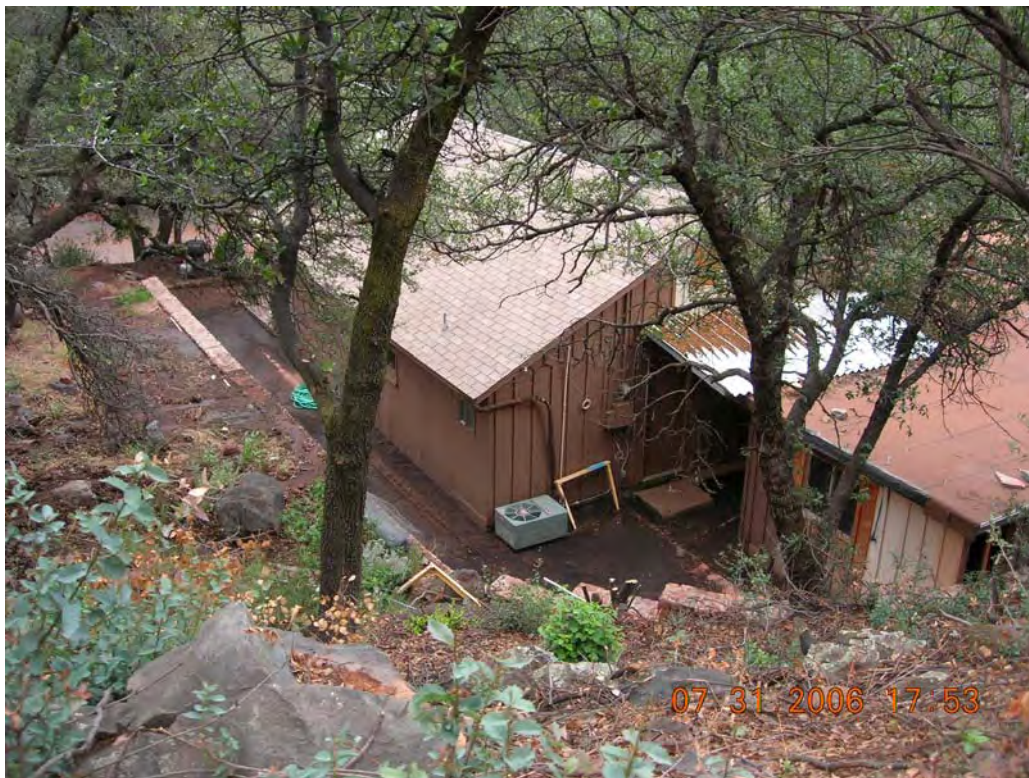
DSCN 1543:
Ash and mud
deposited in
the back of the
Dairy Queen.
Water and
sediment
flowed down
the slope on
the left side of
the photo.

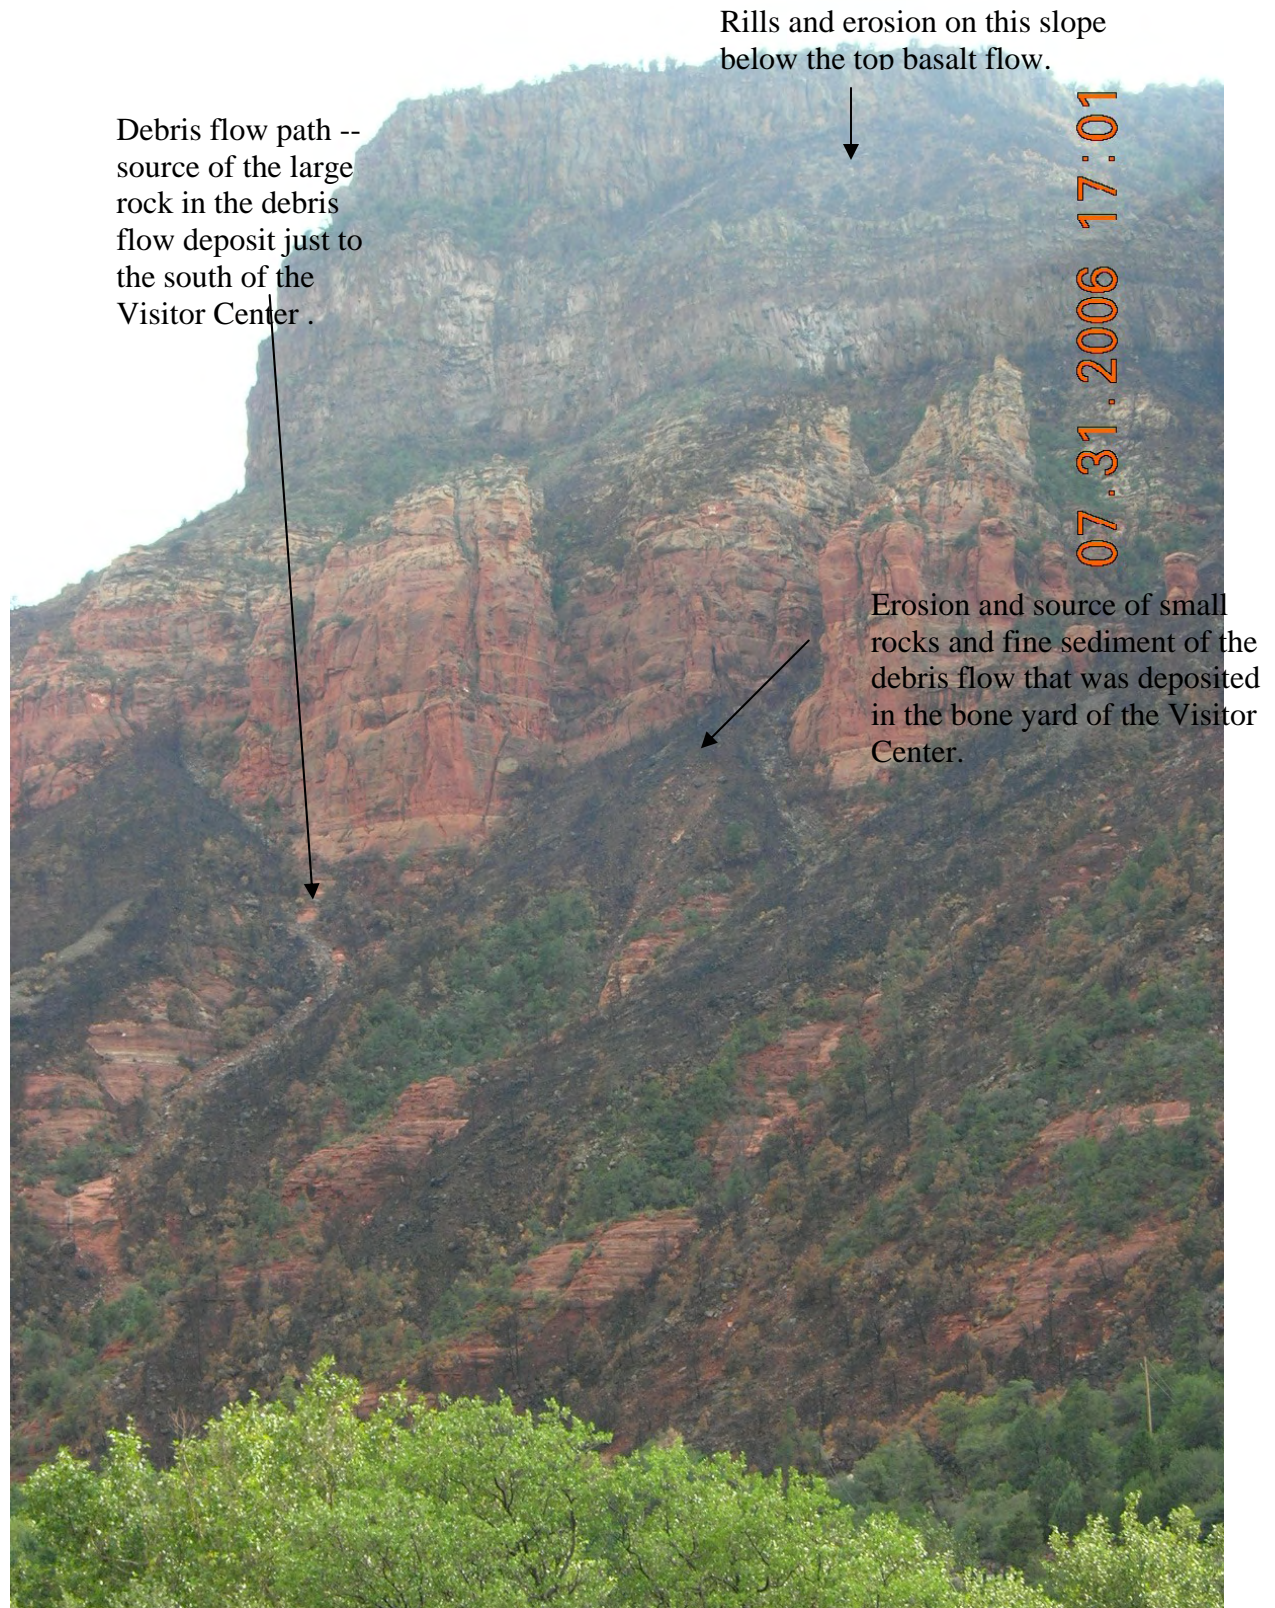
DSCN 1521: View of the First Bench Wilson Mountain slopes above Indian Gardens.
