9201-5 Legacy Problems

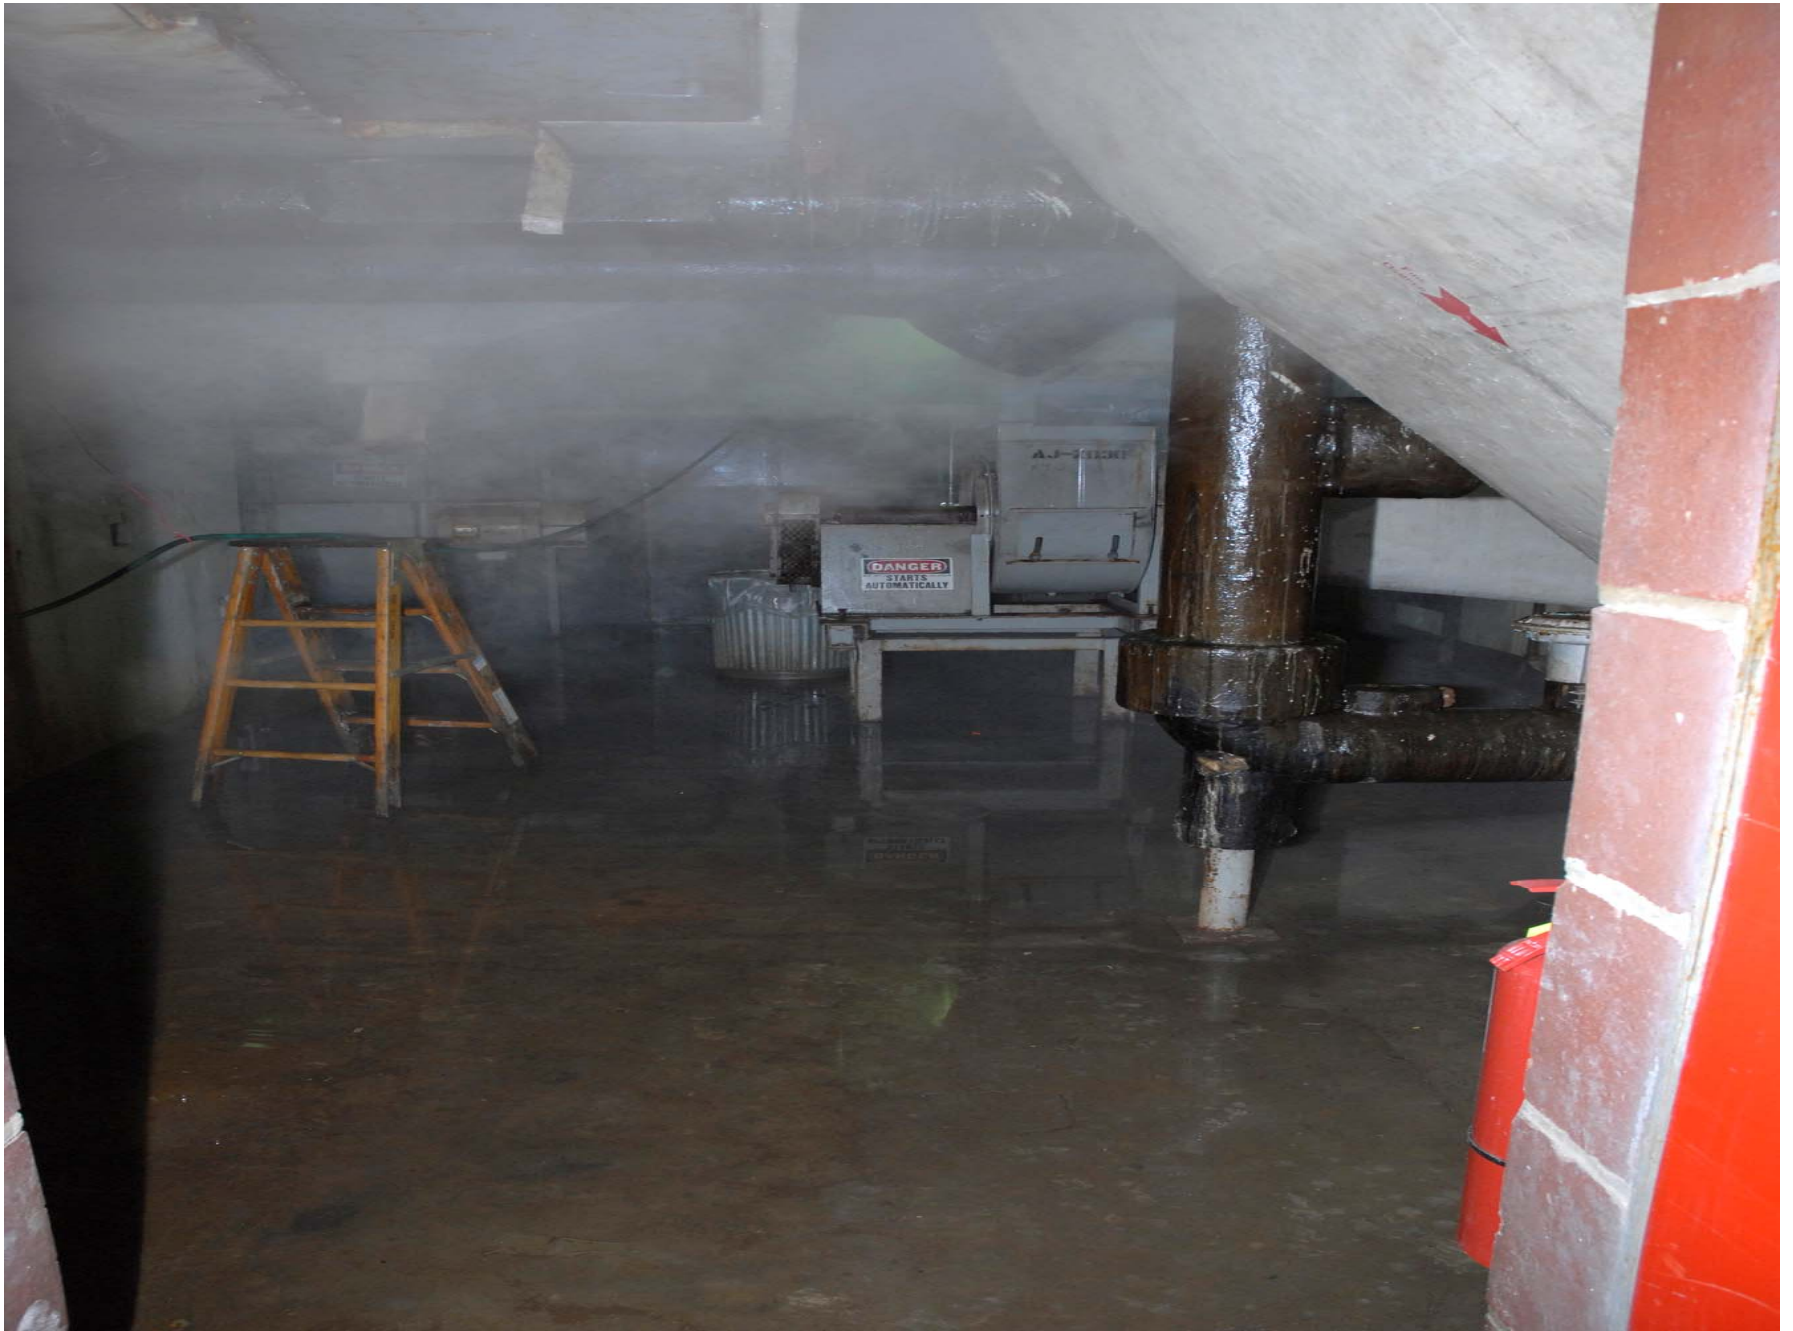
Existing Condition

- HVAC - Cooling Coils, Steam, Fans Out of Service
 - Water Removal – Flooded Wind Tunnels, Sump Pumps Broken
- Roof Repair – Water Infiltration and spalling of reinforced concrete roof panels

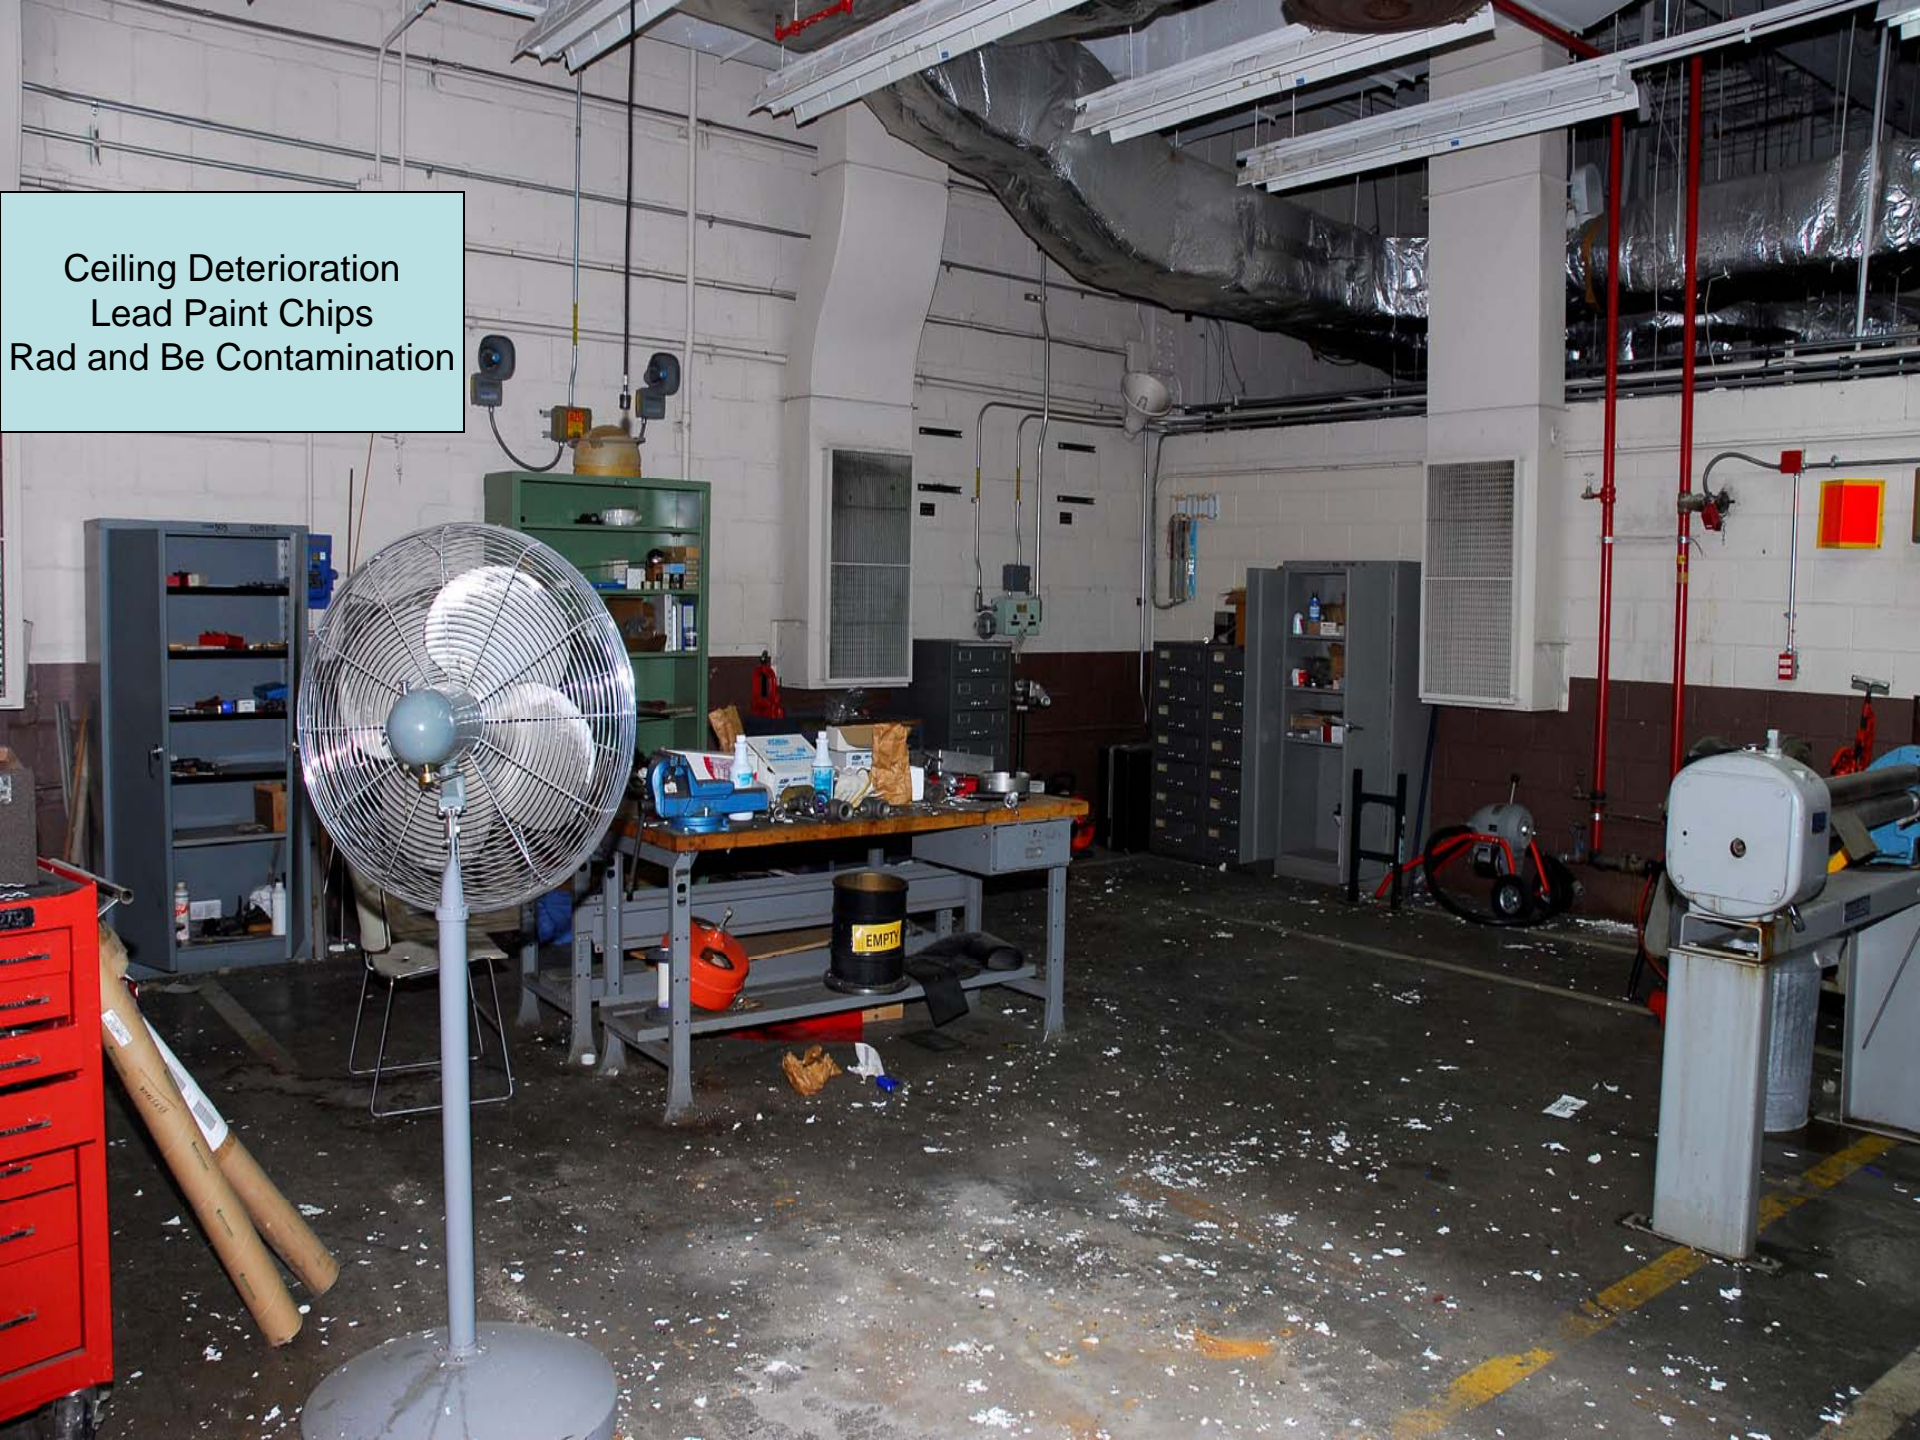
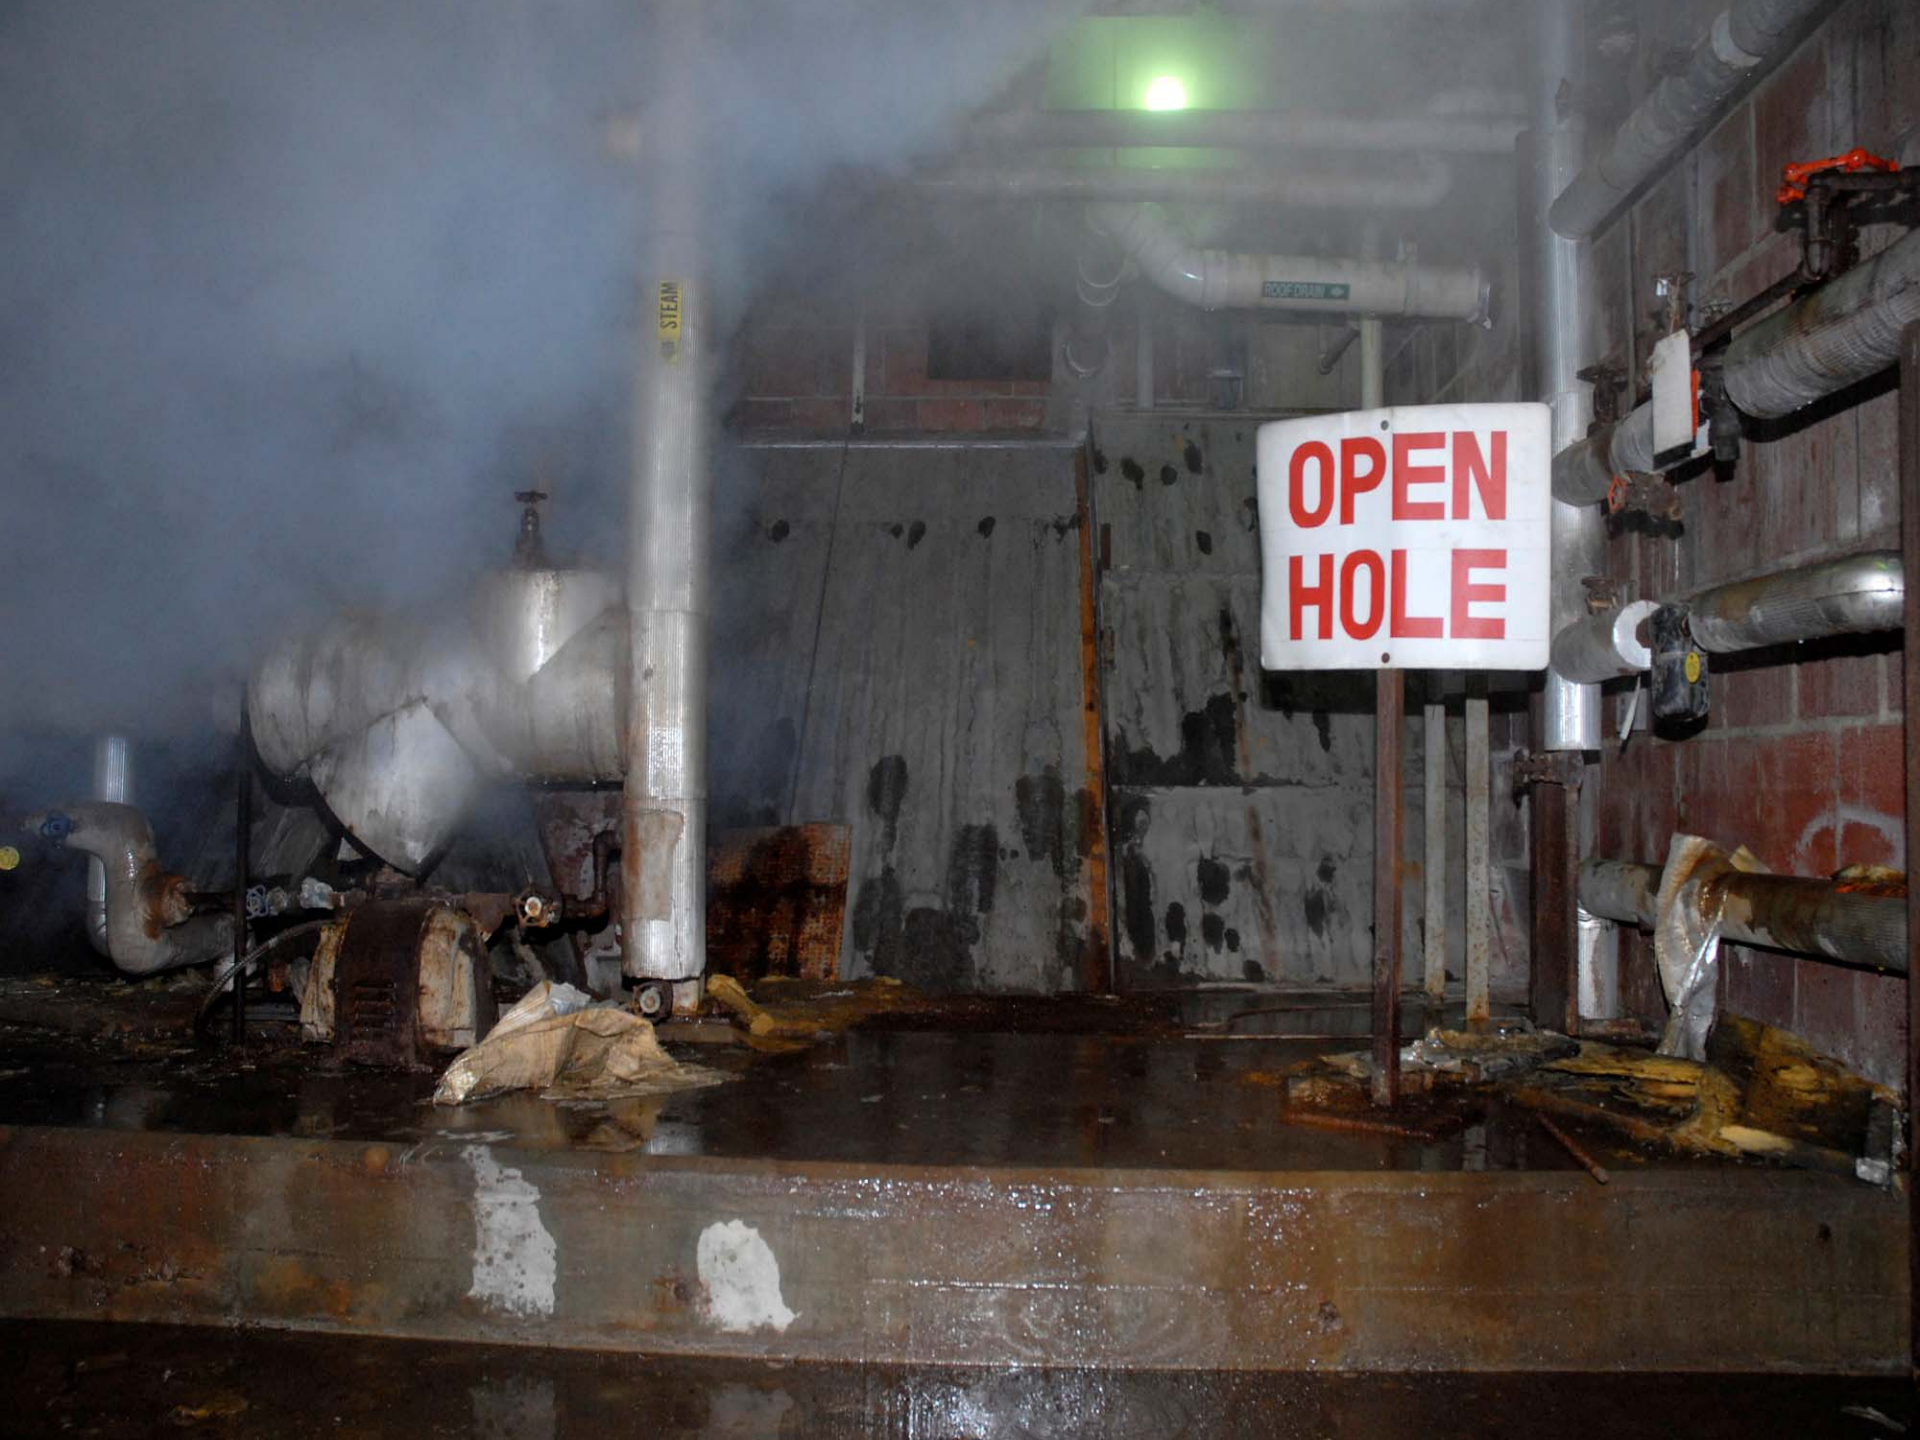
Ceiling Deterioration
Lead Paint Chips
Rad and Be Contamination

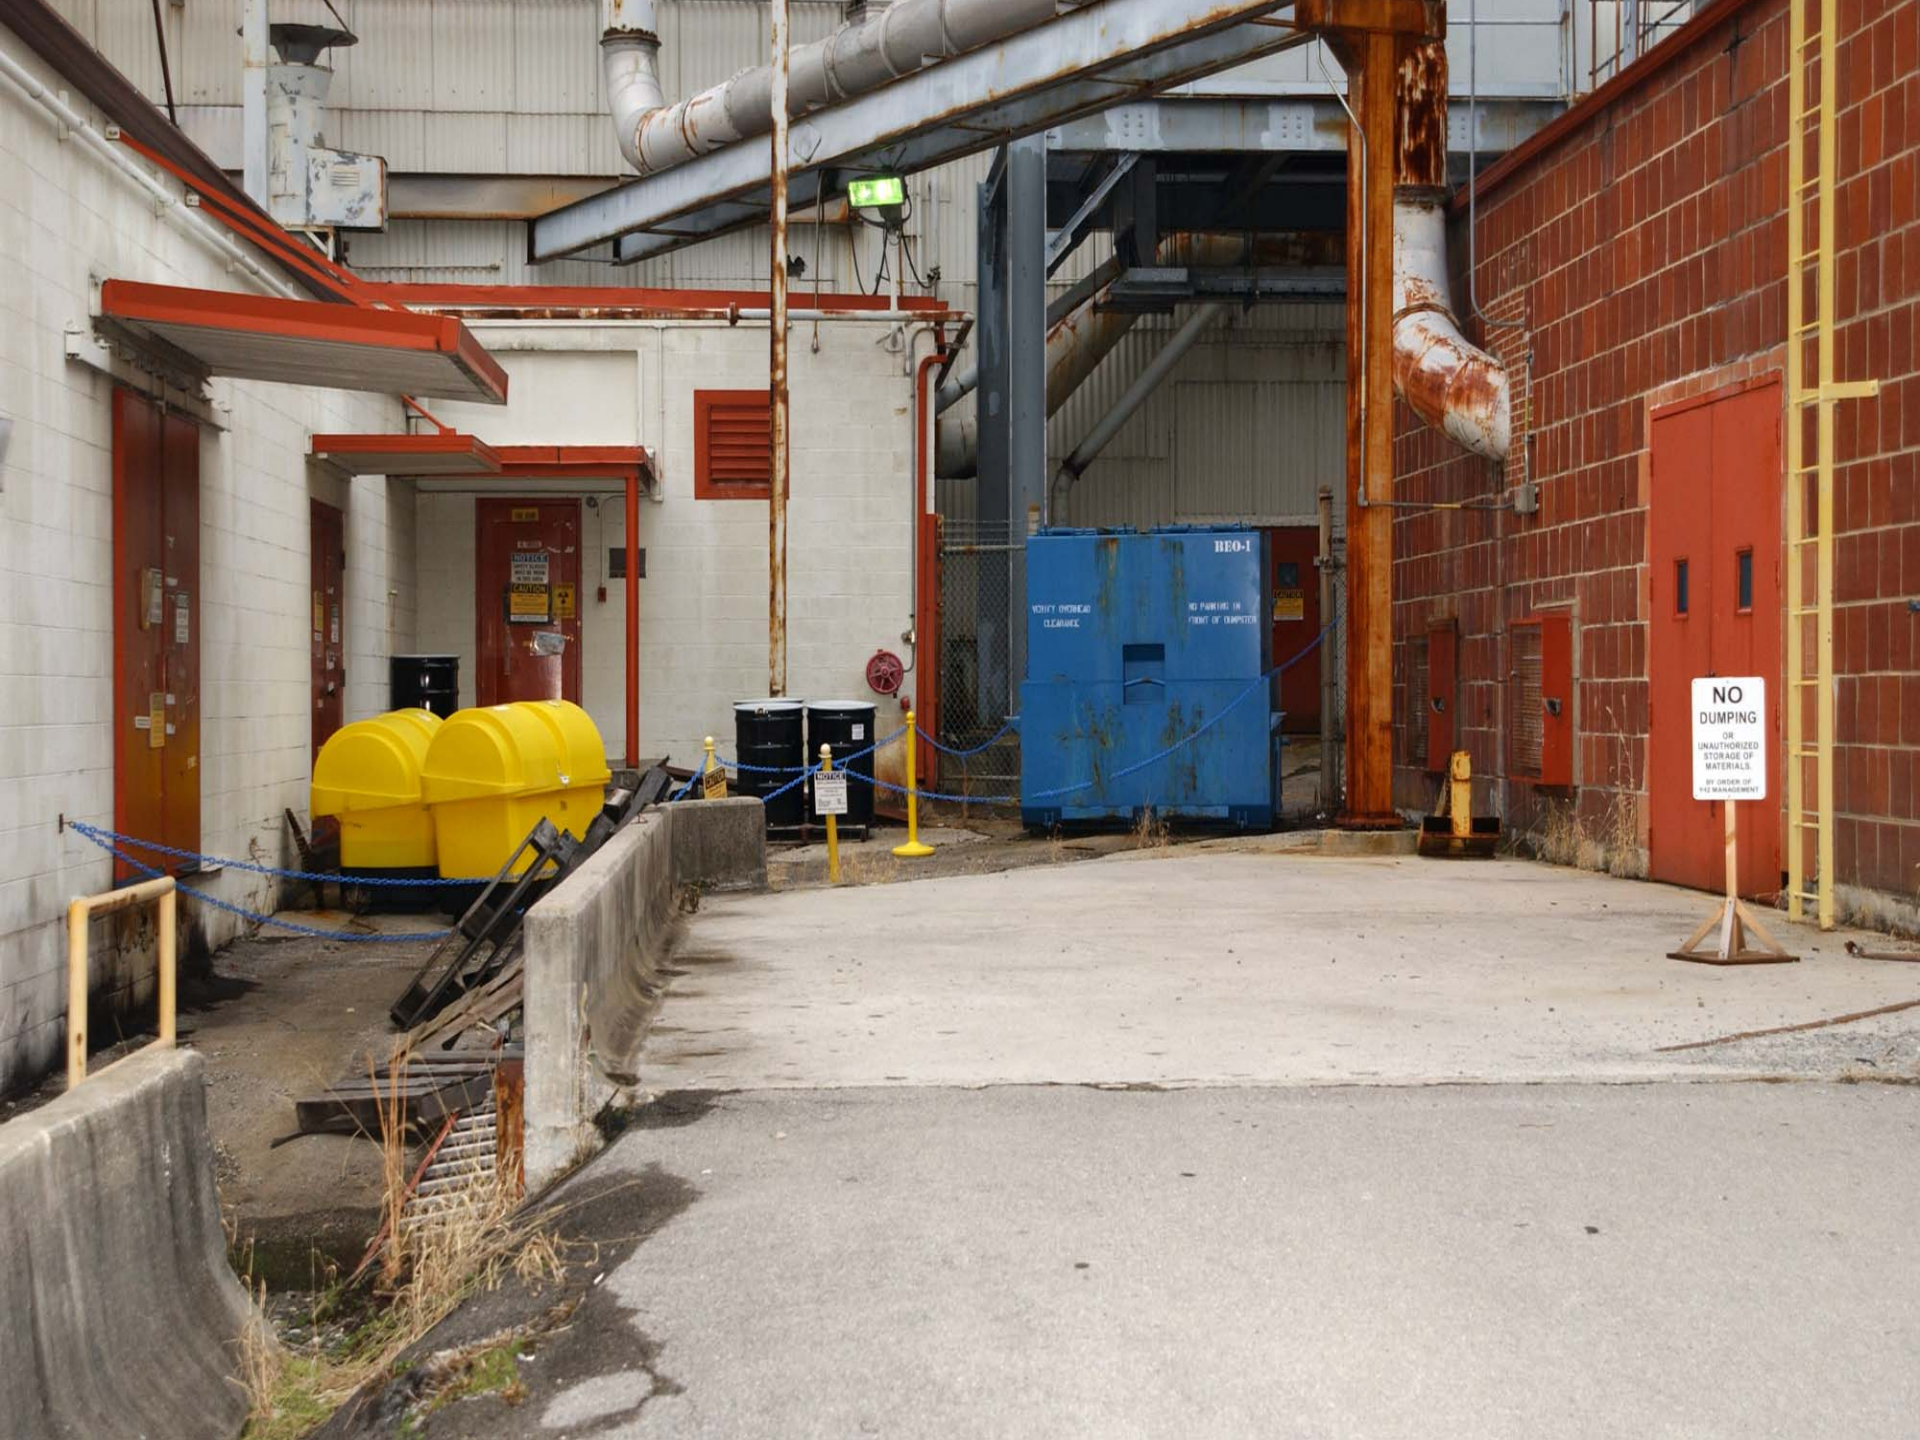
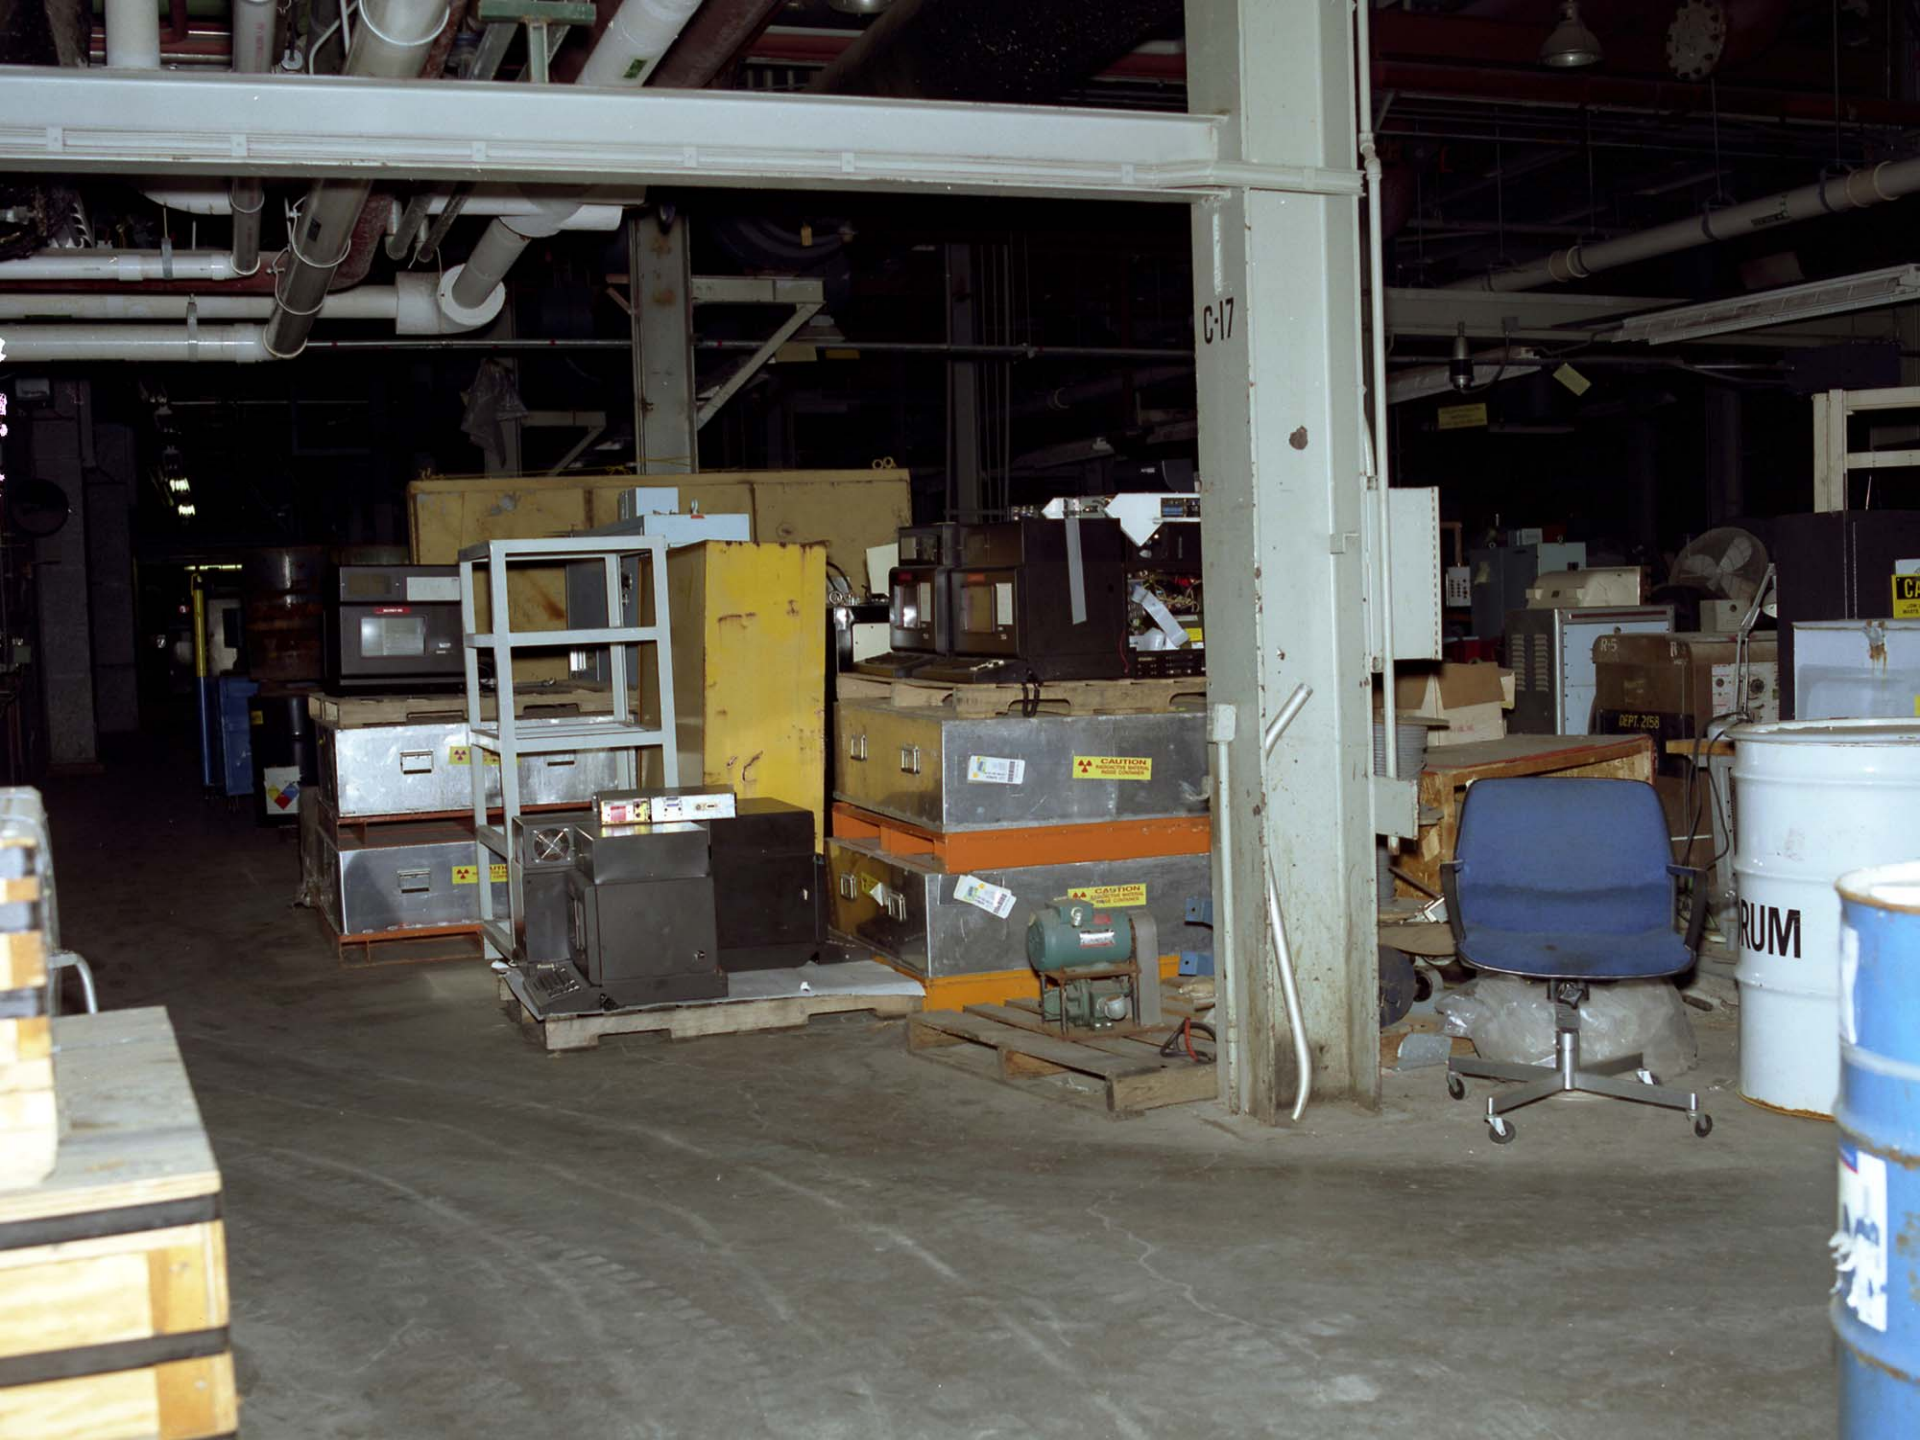
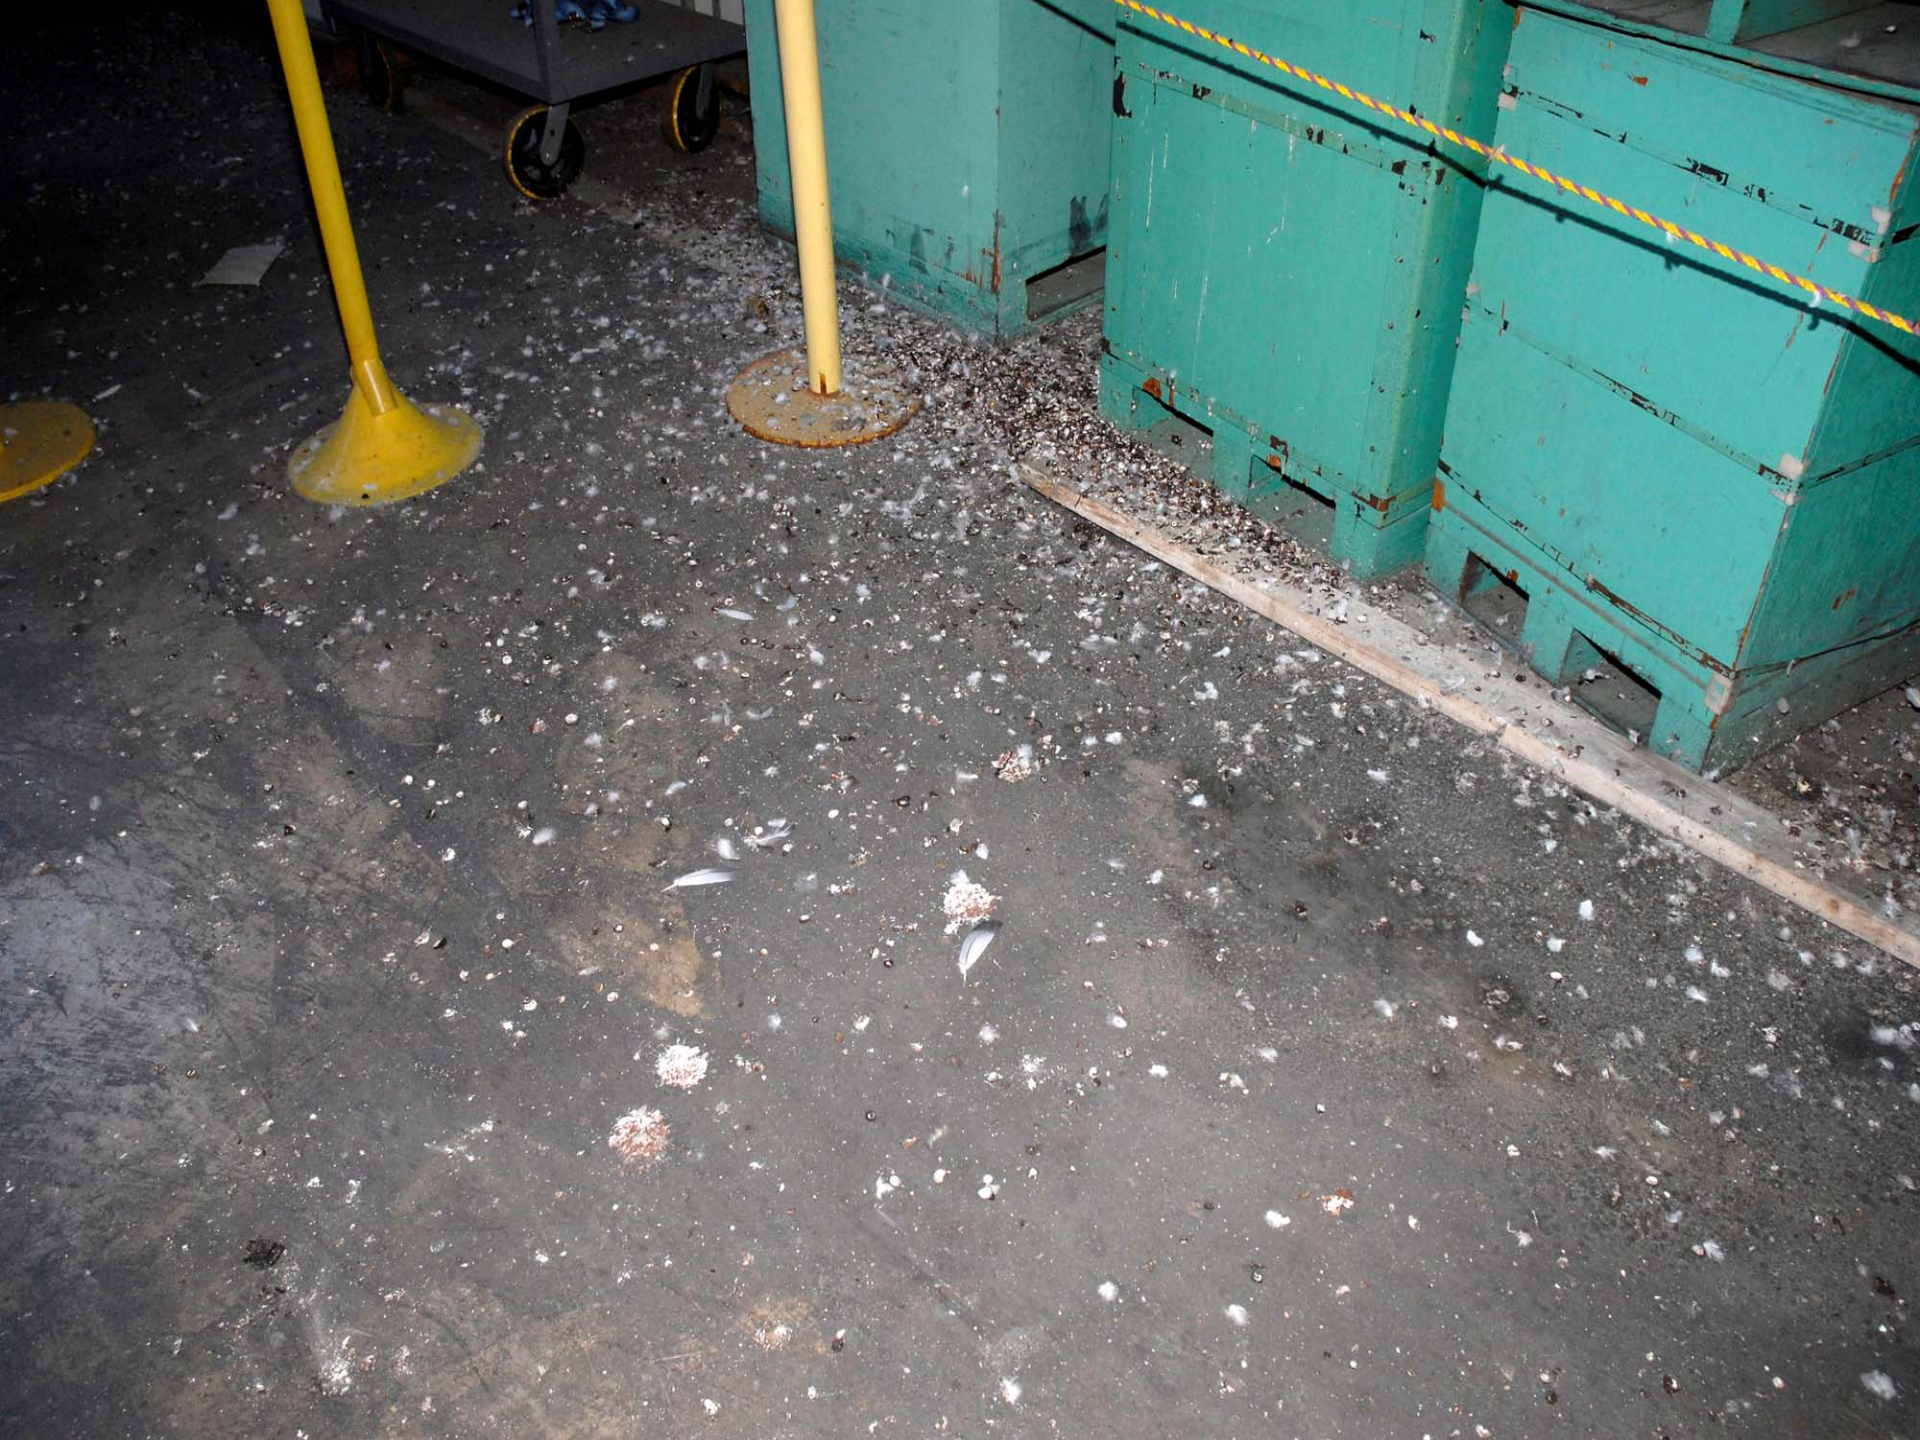
Spread of Beryllium

- Extensive Beryllium Surface Contamination
- Limited Posting-Extensive Surveys
- Surface Contamination Spread into Occupied and Unposted Areas
