## Nondestructive Evaluation (NDE) of Composite-to-Metal Bond Interface of a Wind Turbine Blade Using An Acousto-Ultrasonic Technique.

John H. Gieske and Mark A Rumsey  
Sandia National Laboratories  
Albuquerque, New Mexico 87185

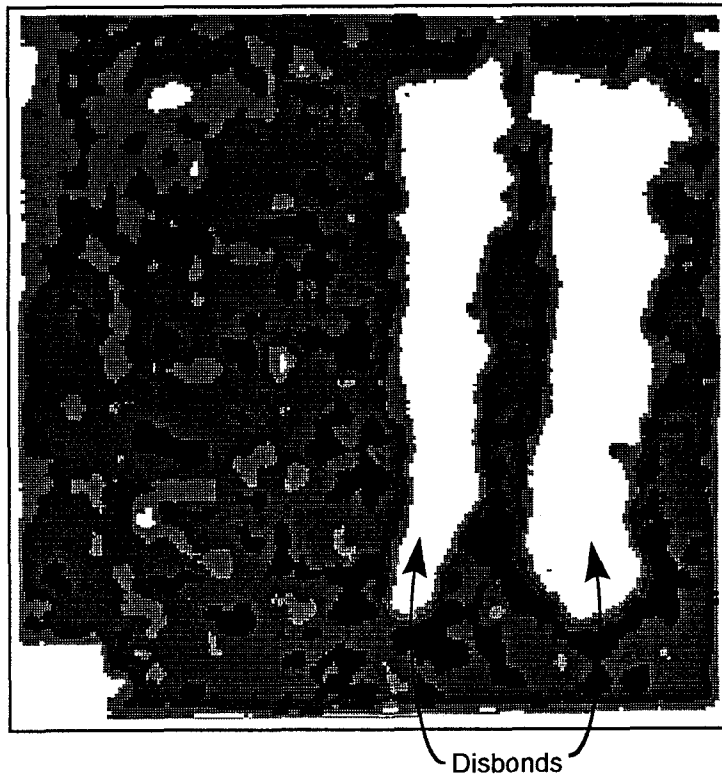
As an example, Figure 3 shows the ultrasonic C-scan results obtained with a TT technique for a 305 mm square test sample that had two strips of disbonds purposely manufactured into the test piece that consisted of the structural components of the fiberglass composite bonded to a steel plate. Adequate C-scan images of the same disbond areas could not be obtained with the pulse-echo or pitch-catch techniques. The results of Figure 3 were obtained with an automated ultrasonic data acquisition and display system using a water bath to couple the ultrasonic energy between the transducers and the test piece. However, water immersion techniques will not be appropriate for wind turbine blade examinations. In addition, the blade will be installed in a fixture or wind turbine where the inside surface of the turbine blade will not be accessible for application of an ultrasonic transducer for the TT technique. For these reasons, an acousto-ultrasonic (AU) inspection technique was developed. The AU technique would approximate the detection capability of the TT technique as near as possible.

Figure 3. C-scan image of the through transmission amplitude for a 305 mm square test sample of the composite bond and steel insert where 2 disbonds were constructed into the adhesive interface.

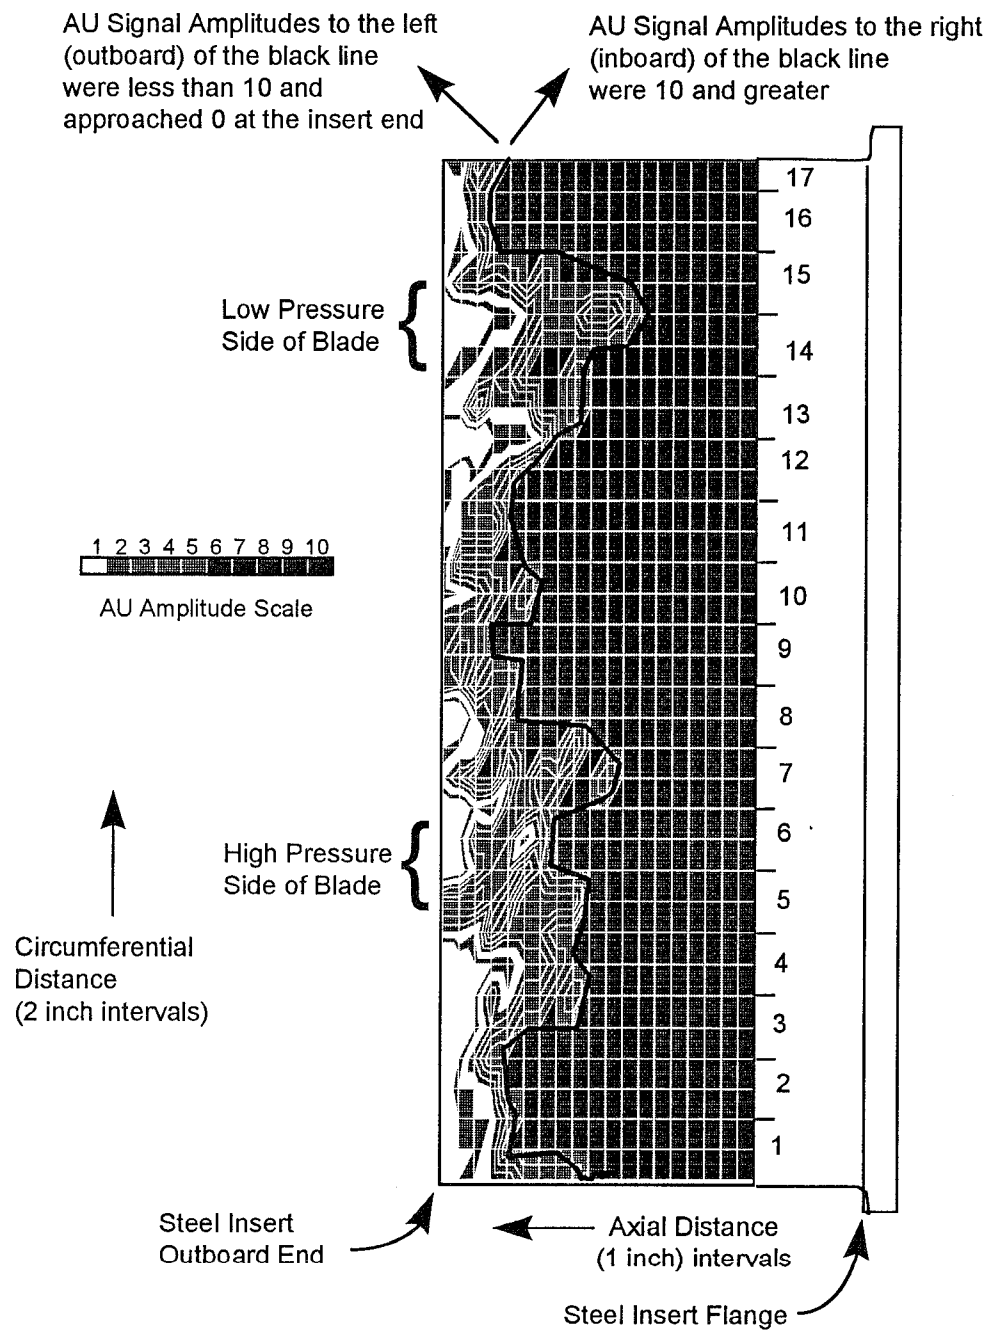
A color contour plot of the tabular data was made by entering the AU data into a Microsoft Excel spreadsheet. Figure 6 displays an equivalent gray scale mapping of the AU data over the steel insert area of the blade. The AU data in Figure 6 indicated that some damage was present at this stage in the fatigue cycle schedule near the high and low pressure sides of the blade as referenced in the sketch of Figure 5. Maximum loading occurs at the outboard end of the steel insert during the fatigue test and during the normal operation of the blade in these two areas. After the AU examination was performed, the blade was fatigue tested to failure. It is noted that the failure of the blade was expected and it did occur in these two areas of the blade.

Figure 6. Contour plot of the amplitude levels of acousto-ultrasonic signals taken around the root bond area at a steel insert of a wind turbine blade.

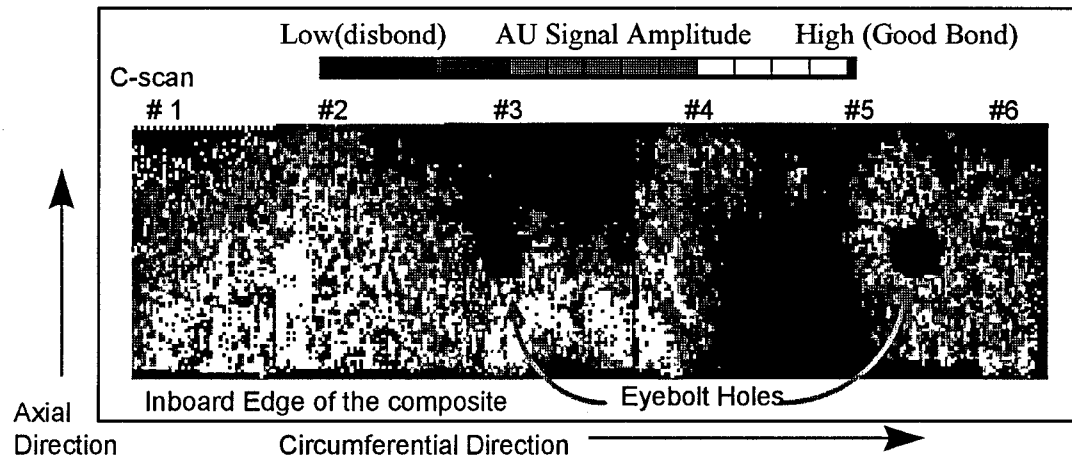
(a) Acousto-ultrasonic Amplitude C-scan Image of Entire Root Bond Area of the Steel Insert

Figure 7(a) displays a montage of the 6 C-scan images collected around the entire circumference of the blade. The C-scan images of Figure 7(a) were rendered in a simple gray scale since the normal 16 color scale could not be reproduced in this publication. Some detail of the AU signal variations is therefore lost but an assessment of the disbonded area is clearly indicated in the gray scale images. The area of Figure 7(a) shown in black where a low AU signal amplitude was recorded indicated the area of disbond.

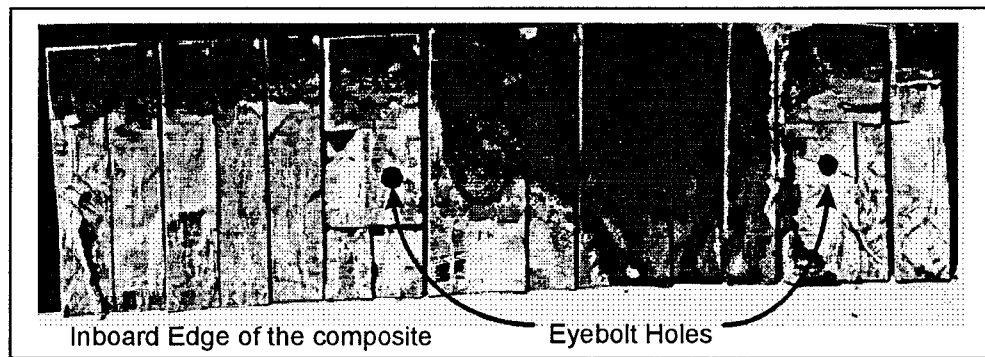
(b) Photograph of Pieces of the Composite Removed from the Steel Insert Root Bond Area in Sections Placed Together in the Same Orientation as the above C-scan Image

Figure 7(b) shows the corresponding visual examination of the bond interface of this blade by cutting the segments of the composite and removing them from the steel insert. The removed pieces of the composite were reassembled with the metal-to-composite bond interface facing outward. A photograph of the reassembled pieces is shown in Figure 7(b) where the bond failure is shown in black due to a dark metal oxide present on the adhesive surface of the failed area. A comparison of Figures 7(a) and 7(b) shows that the AU data correlated well with the disbond visually observed after removing the composite with the exception of two small areas. The area to the right of center in Figure 7(a) indicated an area of low AU signal but not completely disbanded. It is possible that the composite was held in compression against the metal surface so that a so-called kissing bond existed in this small area. Also, the area just above the left eyebolt hole in Figure 7(a) is shown in black because the metal path to the receiver was obstructed by the eyebolt hole. This area does not show a disbond in Figure 7(b).

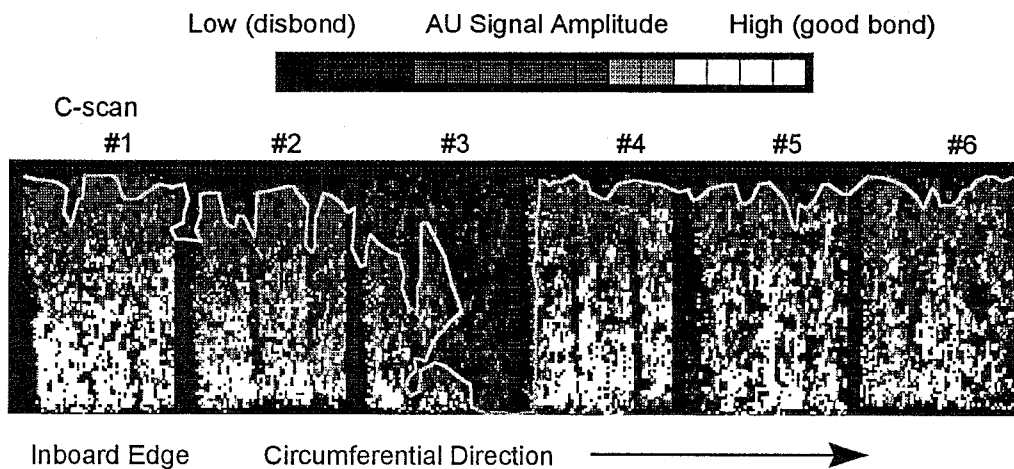
(a) Acousto-ultrasonic Amplitude C-scan Image for the Entire Root Bond Area of the Steel Insert for Turbine Blade #3

The steel insert area of a third blade was also examined with the PC data acquisition and display system. A manufacturing defect was suspected in this blade but the location and extent of the defect was not known. Figure 8(a) shows the montage of the 6 C-scans of the AU signal amplitude. The AU signal amplitude data was processed so that a black color was assigned to signal amplitudes below a given threshold value. The result is shown in Figure 8(b). The area of the defect is then clearly indicated in Figure 8(b) by the area in black. After the AU examination was made, a partial removal of the composite skin at the area of C-scan number 3 showed that a large void existed in one of the layers in the composite and the void area correlated well with the C-scan image number 3.
