U.S. CHEMICAL SAFETY AND HAZARD INVESTIGATION BOARD

INVESTIGATION REPORT

REFINERY EXPLOSION AND FIRE

TEXAS CITY, TEXAS

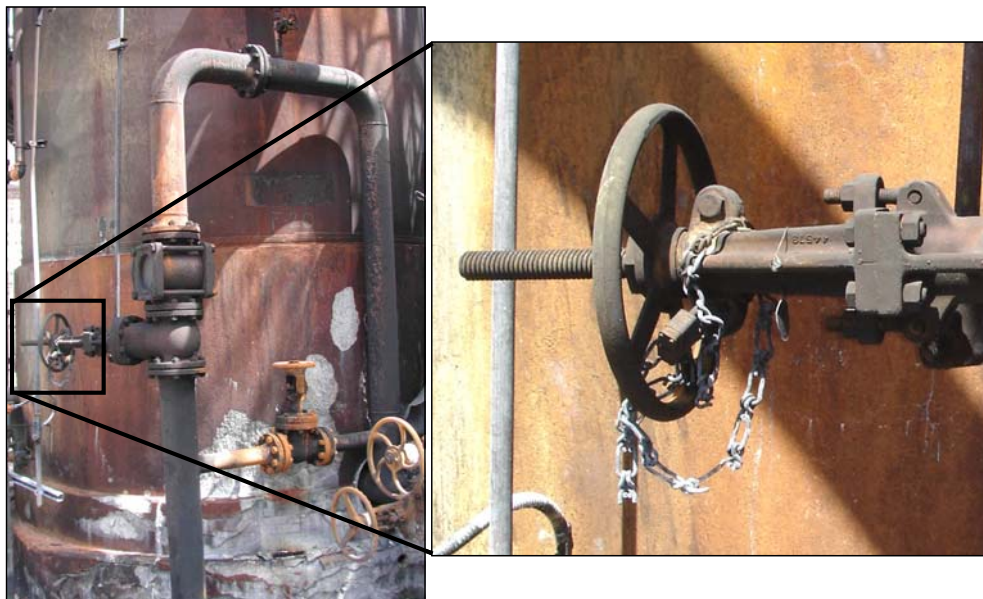
Figure 4. Left: Gooseneck piping and manual block valve (chained-locked open) Right: Close-up of manual block valve

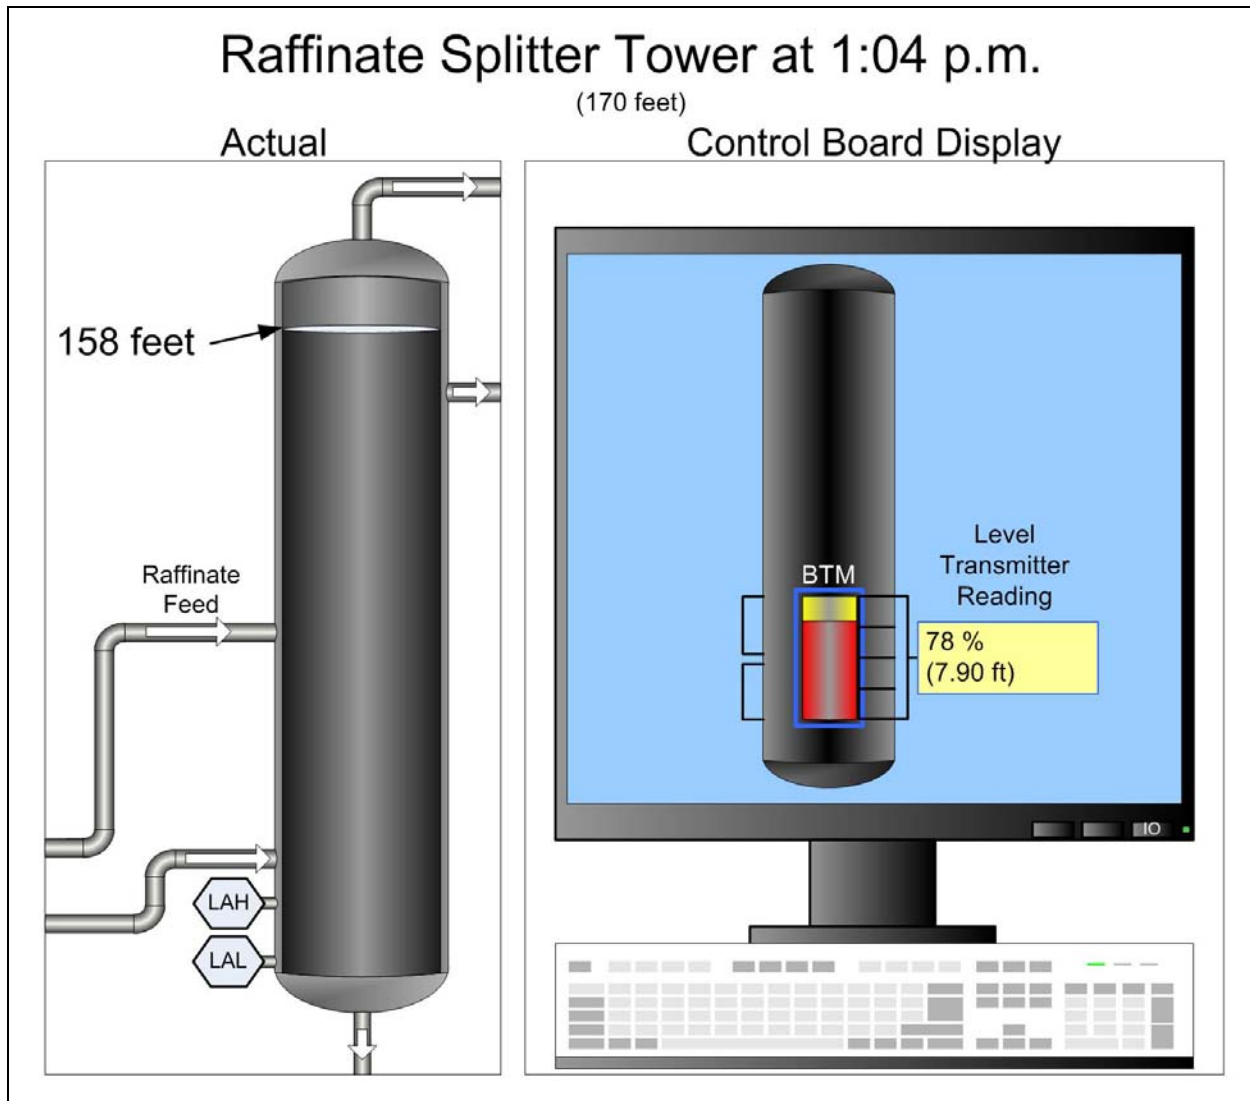
Figure 6. At 1:04 p.m. the liquid level in the tower was 158 feet (48 m), but the computerized control system indicated to operators that the level was at 78 percent of the level transmitter (7.9 feet, or 2.4 m, of liquid in the tower).

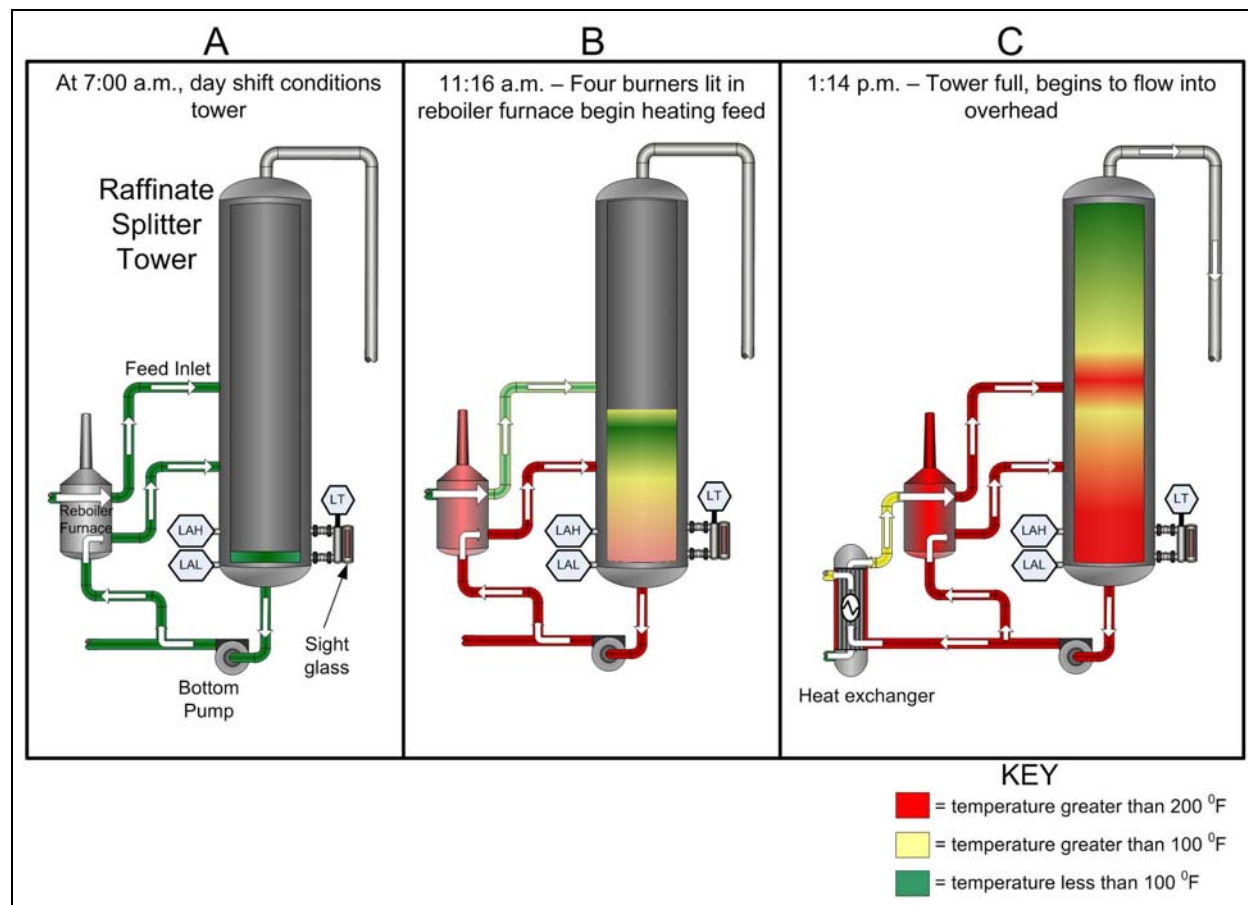
At 1:14 p.m., sub-cooled⁴³ hydrocarbon liquid flowed out of the top of the raffinate splitter tower and into the vertical overhead vapor line, due to overflowing and rapid heating of the column (Figure 7).

Figure 7. Heating of feed in the splitter tower

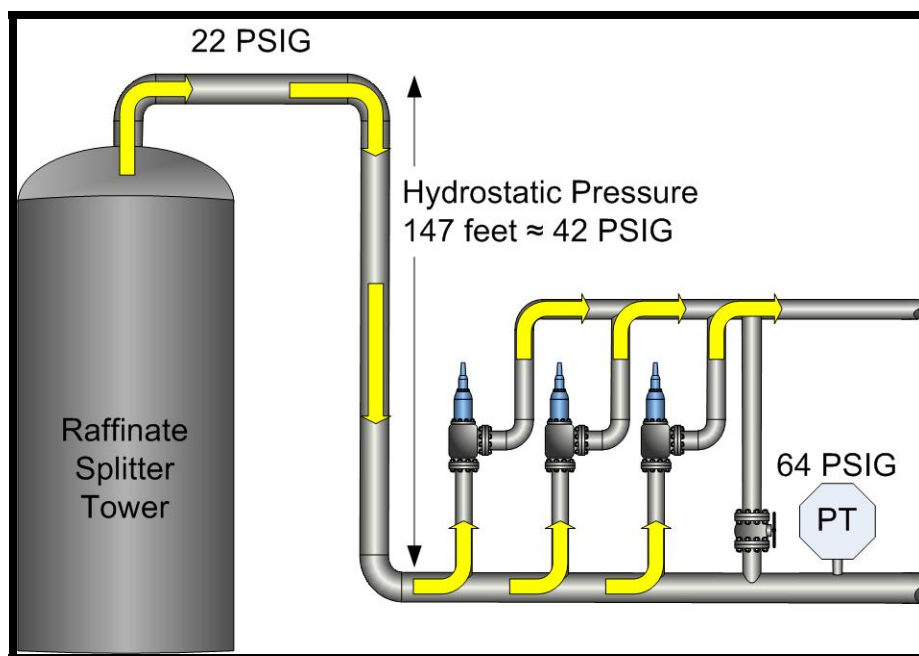
Figure 8. Hydrostatic head of liquid in overhead piping leads to the three relief valves opening

The minimum closing (blowdown) pressure for the three safety relief valves to stop flowing was 37.2 psig (256.5 kPa). Computerized control system data indicate that all three safety relief valves were fully open and flowing at capacity for slightly longer than six minutes. An average pressure of 61 psig (421 kPa) at

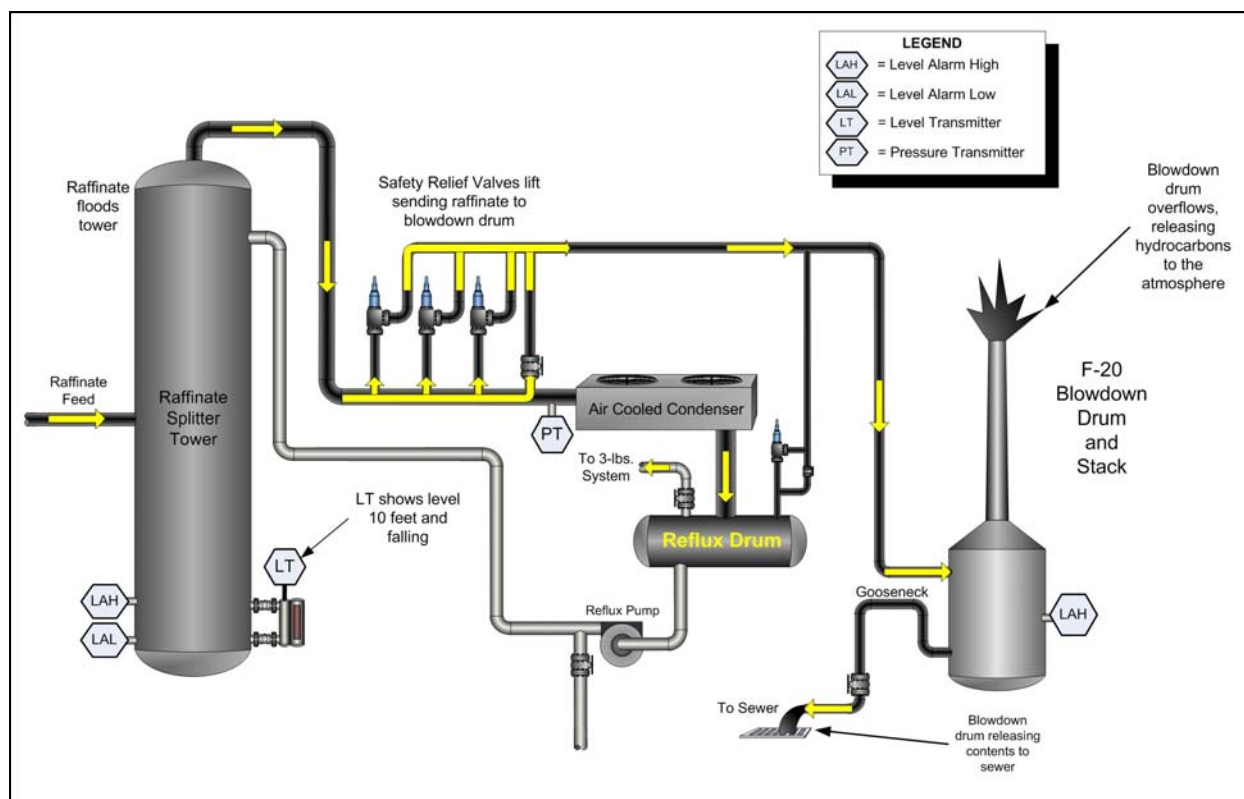
Once the blowdown system filled, flammable liquid discharged to the atmosphere from its stack as a geyser and fell to the ground (Figure 9). Shortly after the ISOM operators began troubleshooting the pressure spike, they received, via radio, the first notification that the blowdown drum was overflowing. In response to the radio message, the Board Operator and Lead Operator used the computerized control system to shut the flow of fuel to the heater, while the other operators left the satellite control room and ran toward an adjacent road, Avenue F, to re-direct traffic away from the blowdown drum, as required by BP's "Emergency Response Procedure A-7."

Figure 9. Tower overfills and blowdown drum releases hydrocarbons

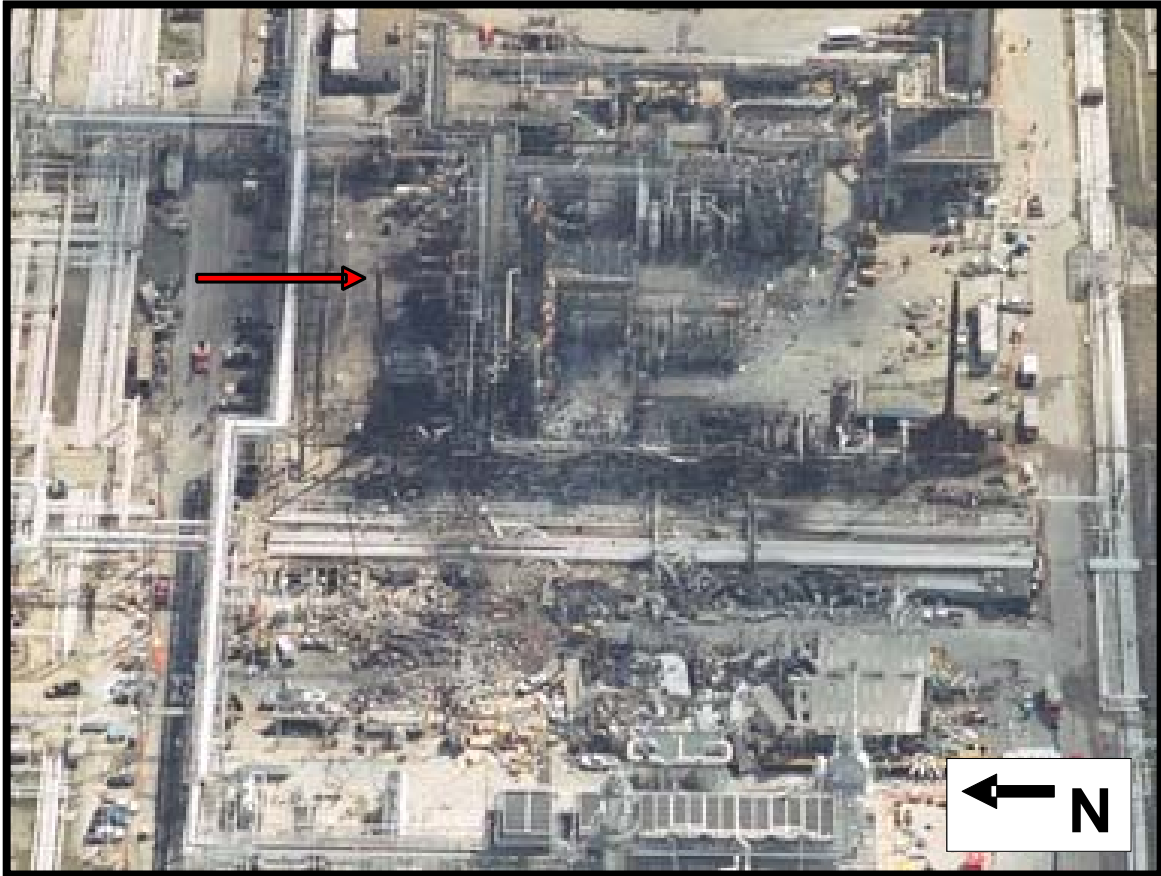
Figure 10. The darkened areas in and around the ISOM unit had the heaviest fire damage; the red arrow points to the top of the blowdown stack

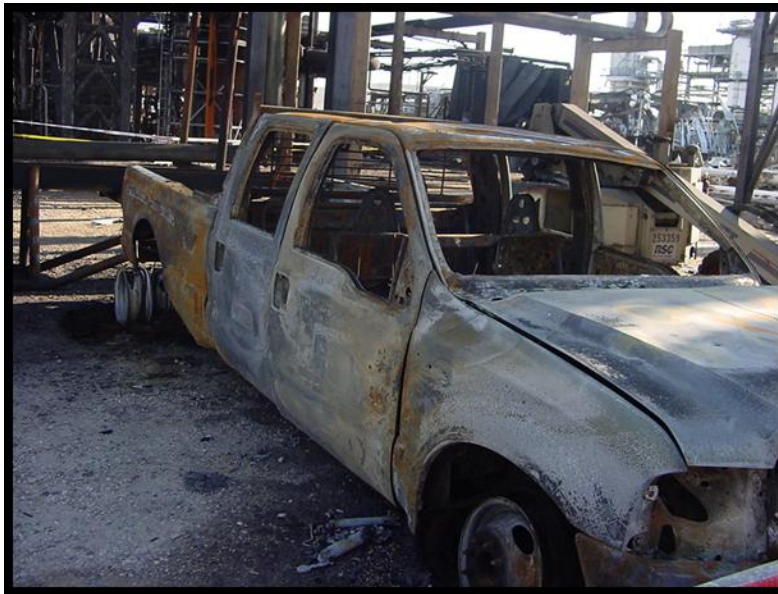
Although several potential ignition sources (Appendix H.16) were identified, the most likely ignition point was an idling diesel pickup truck (Figure 11). This truck was parked about 25 feet (7.6 m) from the blowdown drum, and several eyewitnesses reported seeing or hearing the truck's engine over-revving when the vapor cloud reached it.

Figure 11. Idling diesel pickup truck at north end of ISOM unit

Two eyewitnesses saw the truck catch fire, followed shortly by the vapor cloud explosion. One eyewitness saw sparks leaving the truck after a backfire and igniting the vapor cloud. While the diesel pickup has been positively identified by witnesses as an ignition point, this does not preclude the potential that the cloud was additionally ignited by other sources.

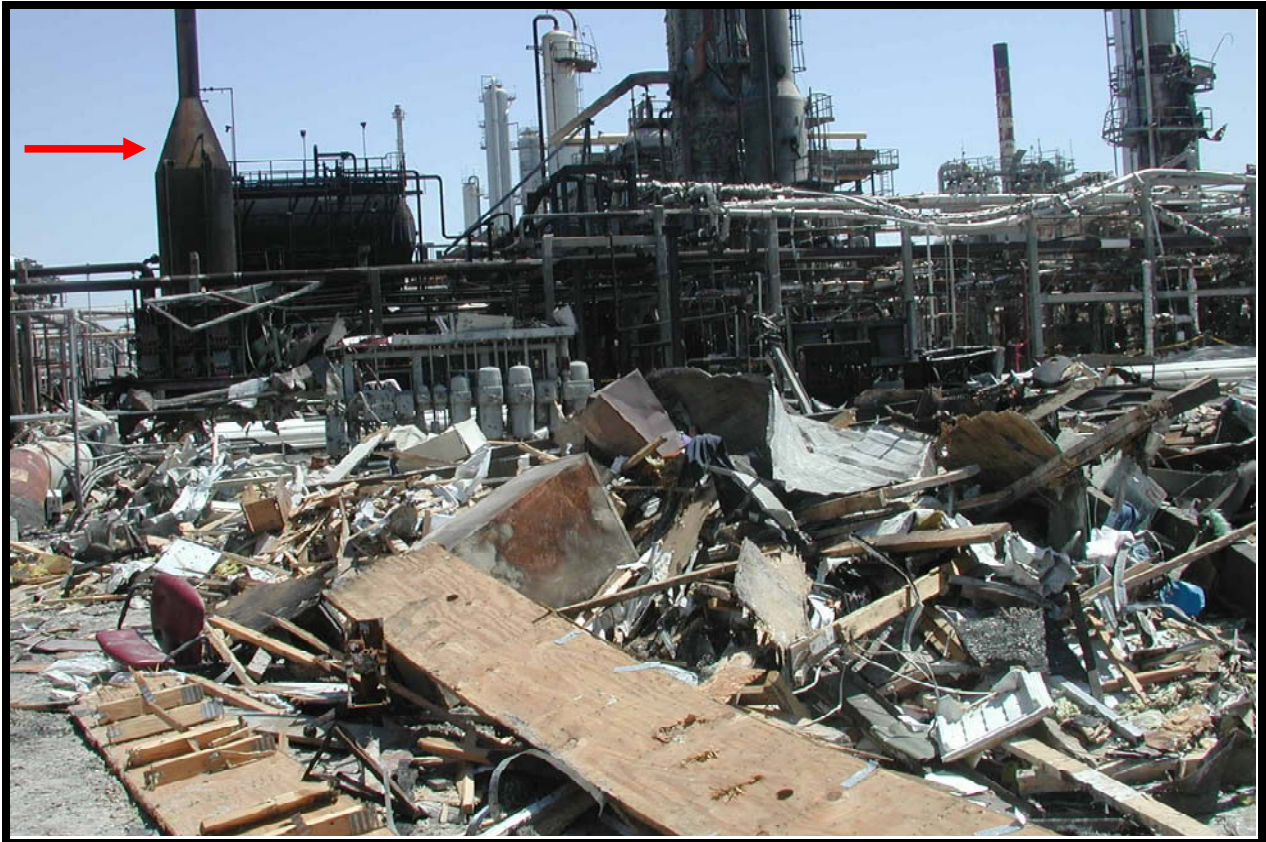
Many of the approximately 70 vehicles in the vicinity of the ISOM unit were damaged and a number were destroyed. More than 40 trailers were damaged; 13 were destroyed. On June 30, 2006, the CSB released a detailed analysis of the trailer damage, which can be viewed or downloaded from the CSB website, www.csb.gov.

Figure 13. Destroyed trailers west of the blowdown drum (red arrow in upper left of the figure)

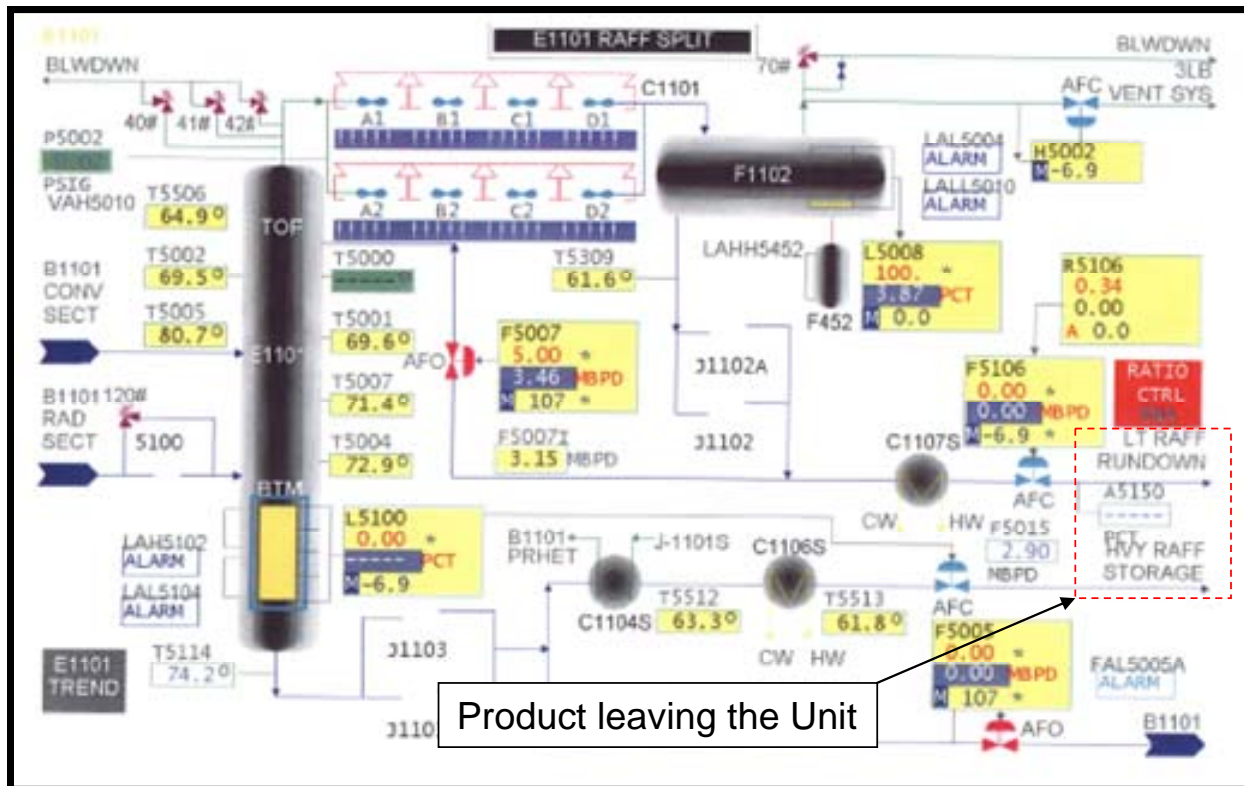
Figure 14. The Board Operator viewed this screen, which provides information on raffinate product leaving the unit but not the liquid being added to the unit.

A poorly designed computerized control system display was found to be a cause in another major incident, the 1994 [explosions and fire at a Texaco plant in Milford Haven](#), in the United Kingdom. The control system did not calculate the material balance of the system and the operators did not know how to make such calculations. The computerized control system was also configured to display only portions of the unit in discrete detailed sections, and did not allow for a complete overview of the process, just like the control system screens for the Texas City ISOM unit. The U.K. Health and Safety Executive⁸³ recommended that computerized control systems include a process overview and, as appropriate, material balance summaries to ensure full process oversight by operators (HSE, 1997).

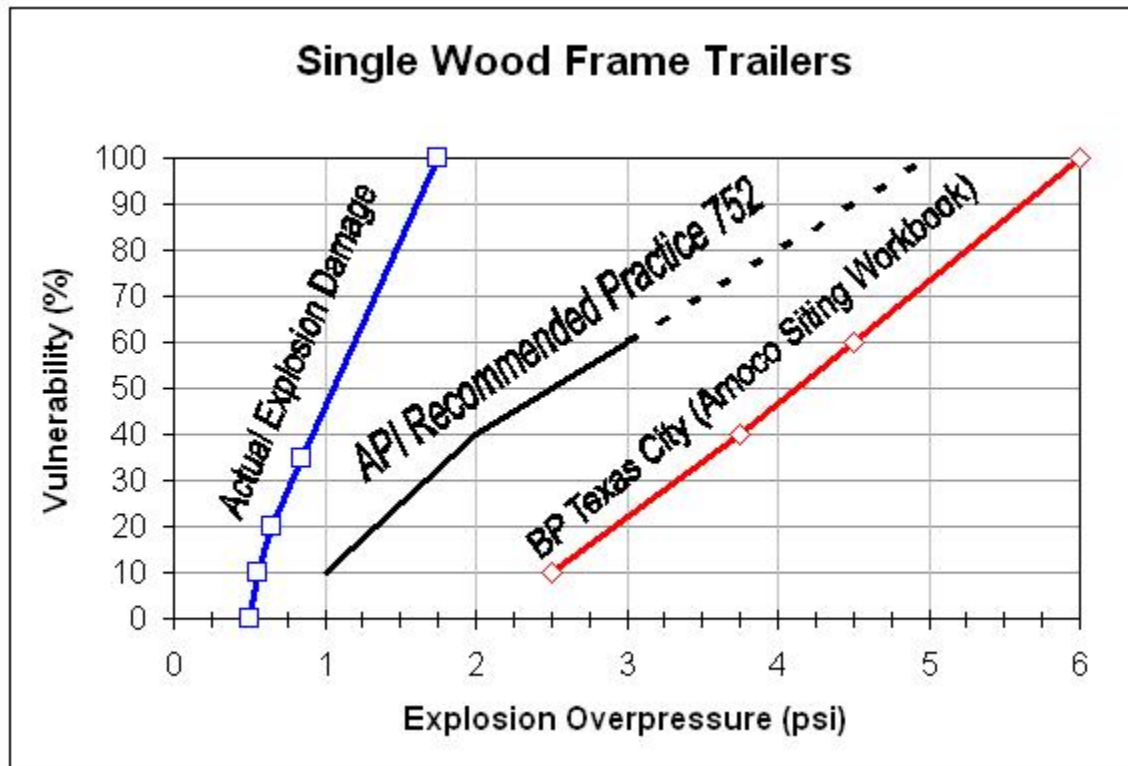
Figure 16. Comparison of explosion damage based on API and BP Texas City criteria

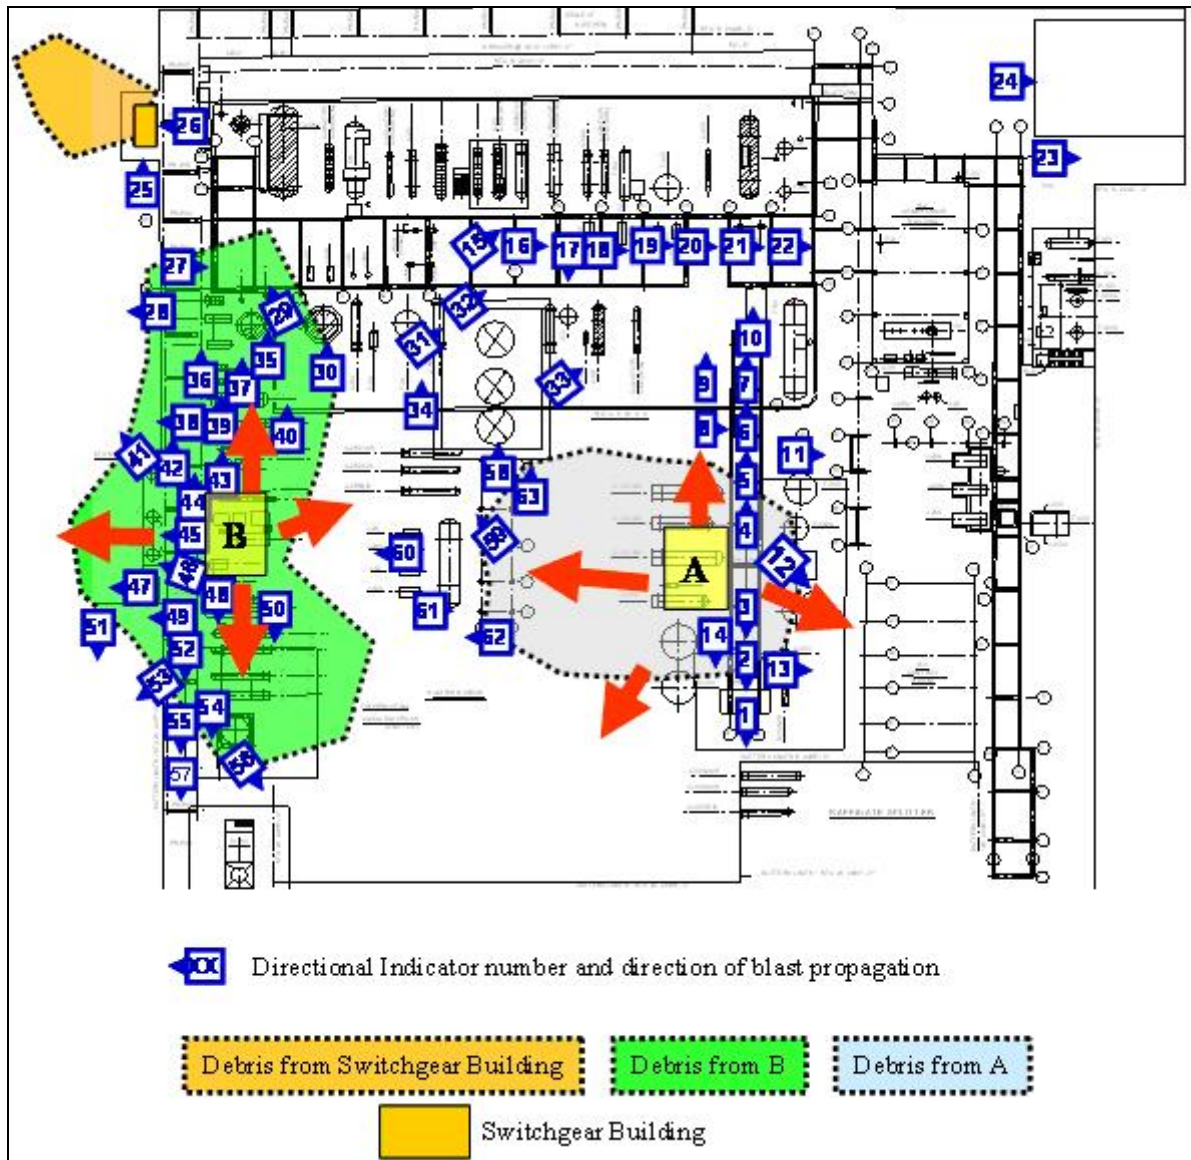
- Areas surrounding the intense pressure regions in the ISOM unit, including the satellite control building, experienced 5 psi and greater overpressures.
- The catalyst warehouse and the six temporary trailers sited directly north of it experienced approximately 2 to 2.5 psi overpressure.
- The east edge of the NDU, first layer of storage tanks south of Ave. G, and the south edge of the ULC unit experienced about 1 psi overpressure.
- The west edge of the NDU, second layer of tanks south of Ave. G, the south portions of ULC and ARU units, and the western edge of the ARU unit experienced 0.5 psi and greater overpressures.
- Five ULC turnaround trailers sited west of Sixth Street; the remainder of ULC and ARU units, and storage tanks farther south experienced 0.25 psi and greater overpressures.

Figure H- 1. Intense blast regions in the ISOM unit

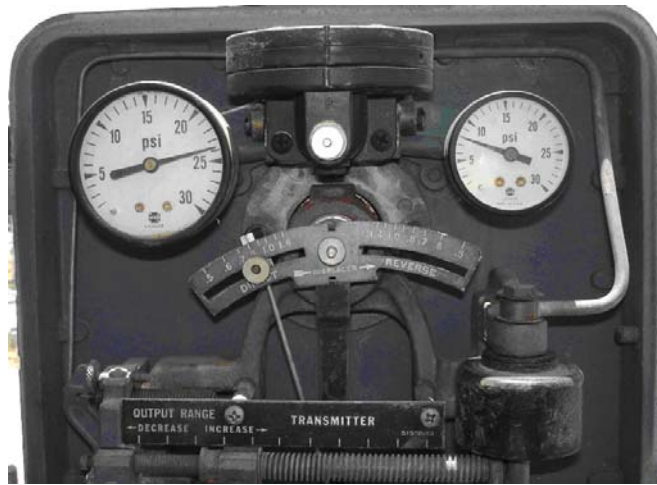
The CSB investigators learned that the instrument data sheet, which should have been used for calibrating the transmitter, had not been updated since 1975 when the tower was part of a different process with a different feed fluid. The data sheet had never been changed to reflect the operating specific gravity in the ISOM process; furthermore, instrument technicians responsible for maintaining and calibrating the transmitter stated that the data sheets—even if they had been updated—were unavailable to them. The CSB learned that these data sheets were filed in an engineer’s office and were not typically given to technicians with work orders for instrument calibration.

Figure S- 3. LT-5100 cabinet showing calibration set for 0.8 specific gravity

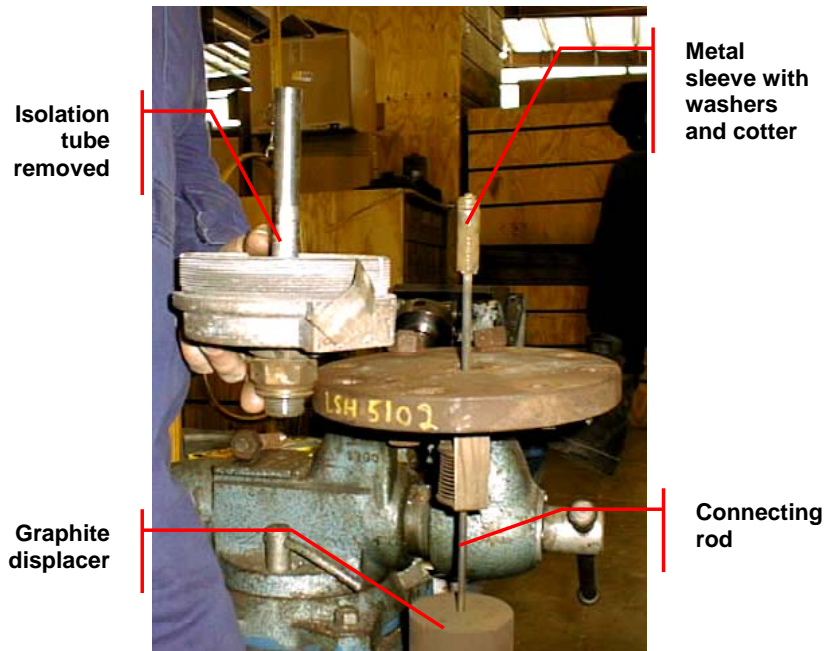
Figure S- 4. LSH-5102 internal components

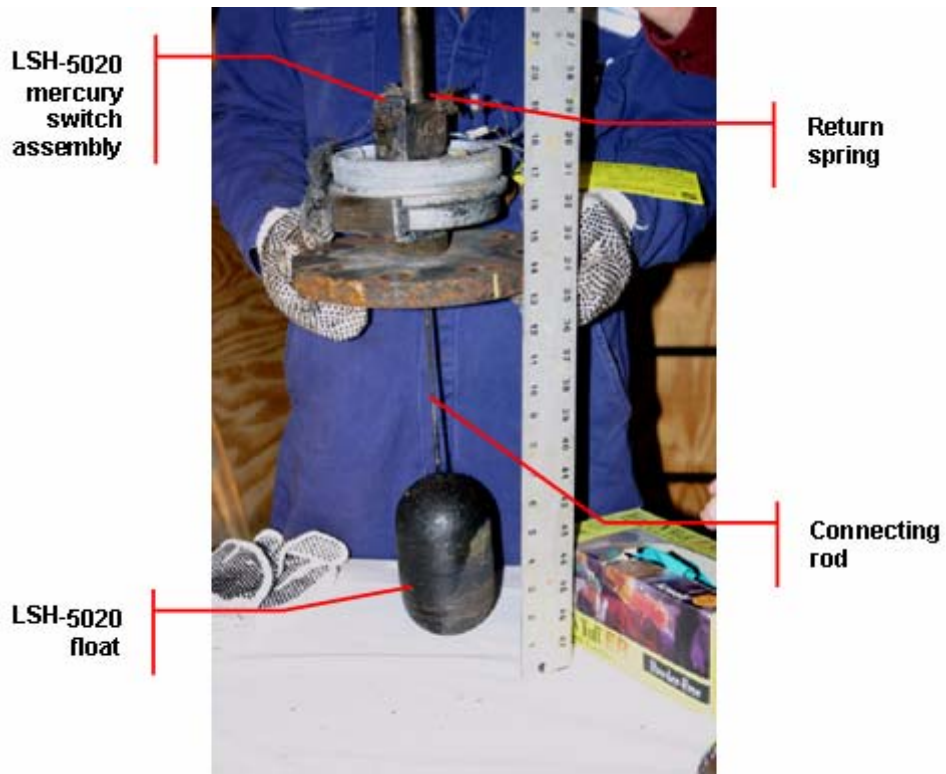
Figure S- 5. Internal components of LSH-5020 blowdown drum high level alarm

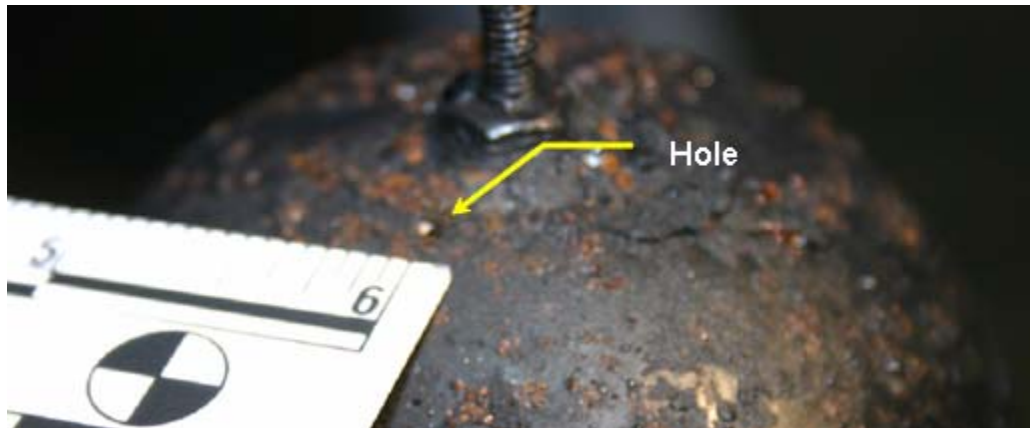
Figure S- 6. Close-up of LSH-5020 float, showing corrosion and hole

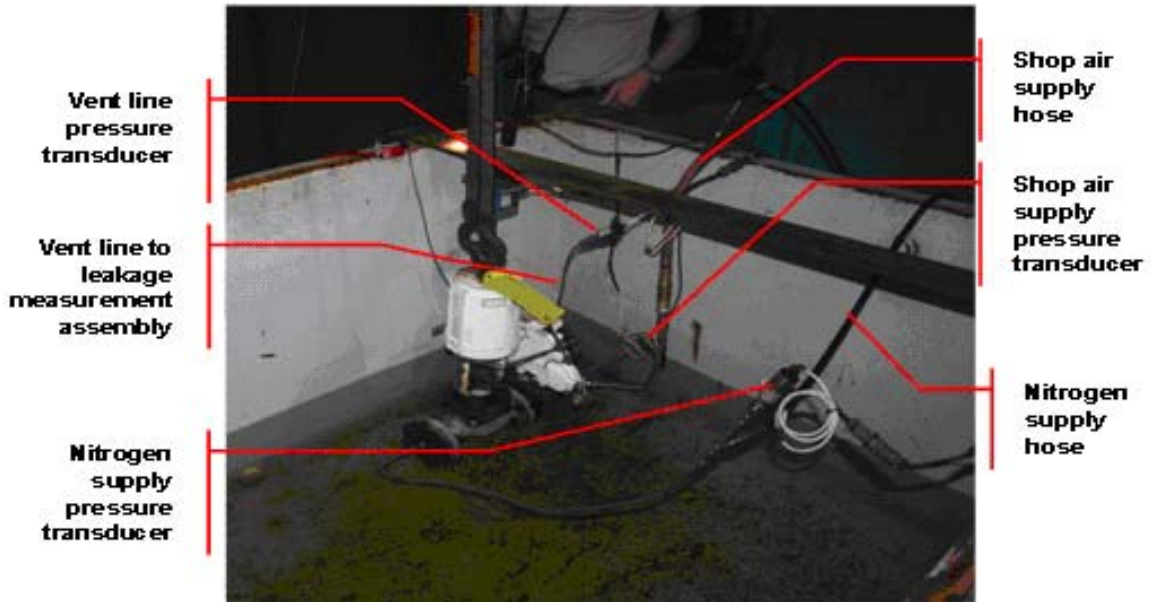
Figure S- 7. PCV-5002 shop testing
