PART B5

INCIDENT EVENTS

This part of the report covers the significant events which took place at the time of the accident. The period covered is 55:52:00 g.e.t. to 56:00:05 g.e.t. Prior to this period, spacecraft operation had been essentially according to plan and neither the ground controllers nor the crew had any warning of the events about to occur. The first indication of a problem was a loud bang heard by all three crew members which was followed by a master caution and warning. The immediate indications in the spacecraft were that this warning had been triggered by an electrical transient. Several minutes later two fuel cells failed in the power system, and the crew became fully occupied trying to reconfigure the spacecraft electrical system. Fourteen minutes later they noticed venting and began to understand what had actually happened in the cryogenic oxygen system.

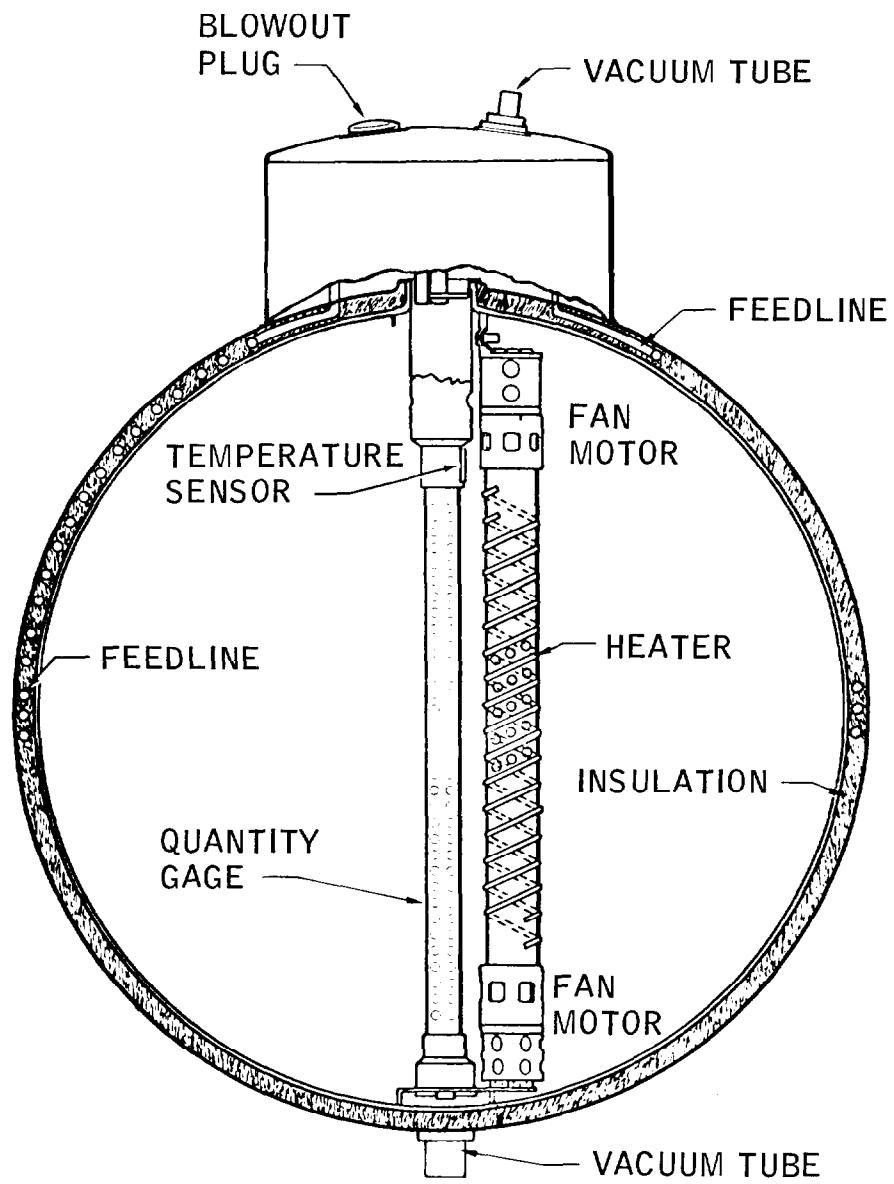
Figure B4-11.- Arrangement of components within oxygen tank.

the two fans and quantity gaging probe is shown in figure B4-11. The flight plan called for the fans to be operated in both the hydrogen and oxygen tanks at the following times: 3:40, 12:09, 23:12, 29:40, 37:30, and 46:39 g.e.t. The ground controllers requested the oxygen tank no. 2 fans to be operated at 47:54 and both the oxygen and hydrogen fans be operated at 51:07.

At 47:40:08 the oxygen quantity changed from approximately 82 percent to 100 percent, or full-scale high. This change in reading or quantity system malfunction occurred just after or at the time the oxygen tank no. 2 fans were turned on. Because of the way the system recovered at the time of the accident, the data indicate that the probe or its associated wiring shorted. Since the instrumentation system was in low bit rate, it is possible to determine exactly when the oxygen

tank no. 1 and no. 2 fans were turned on. The electrical data indicate that the oxygen tank no. 1 and no. 2 fans were turned on between the times of 47:40:05 and 47:40:08. A plot of cryogenic pressures, quantities, total CSM current, and ac main bus 2 is shown in figure B4-12. Therefore, the oxygen tank no. 1 and no. 2 fans were turned on in a period of time between 3 seconds prior to the probe malfunction and the time that the probe malfunctioned.

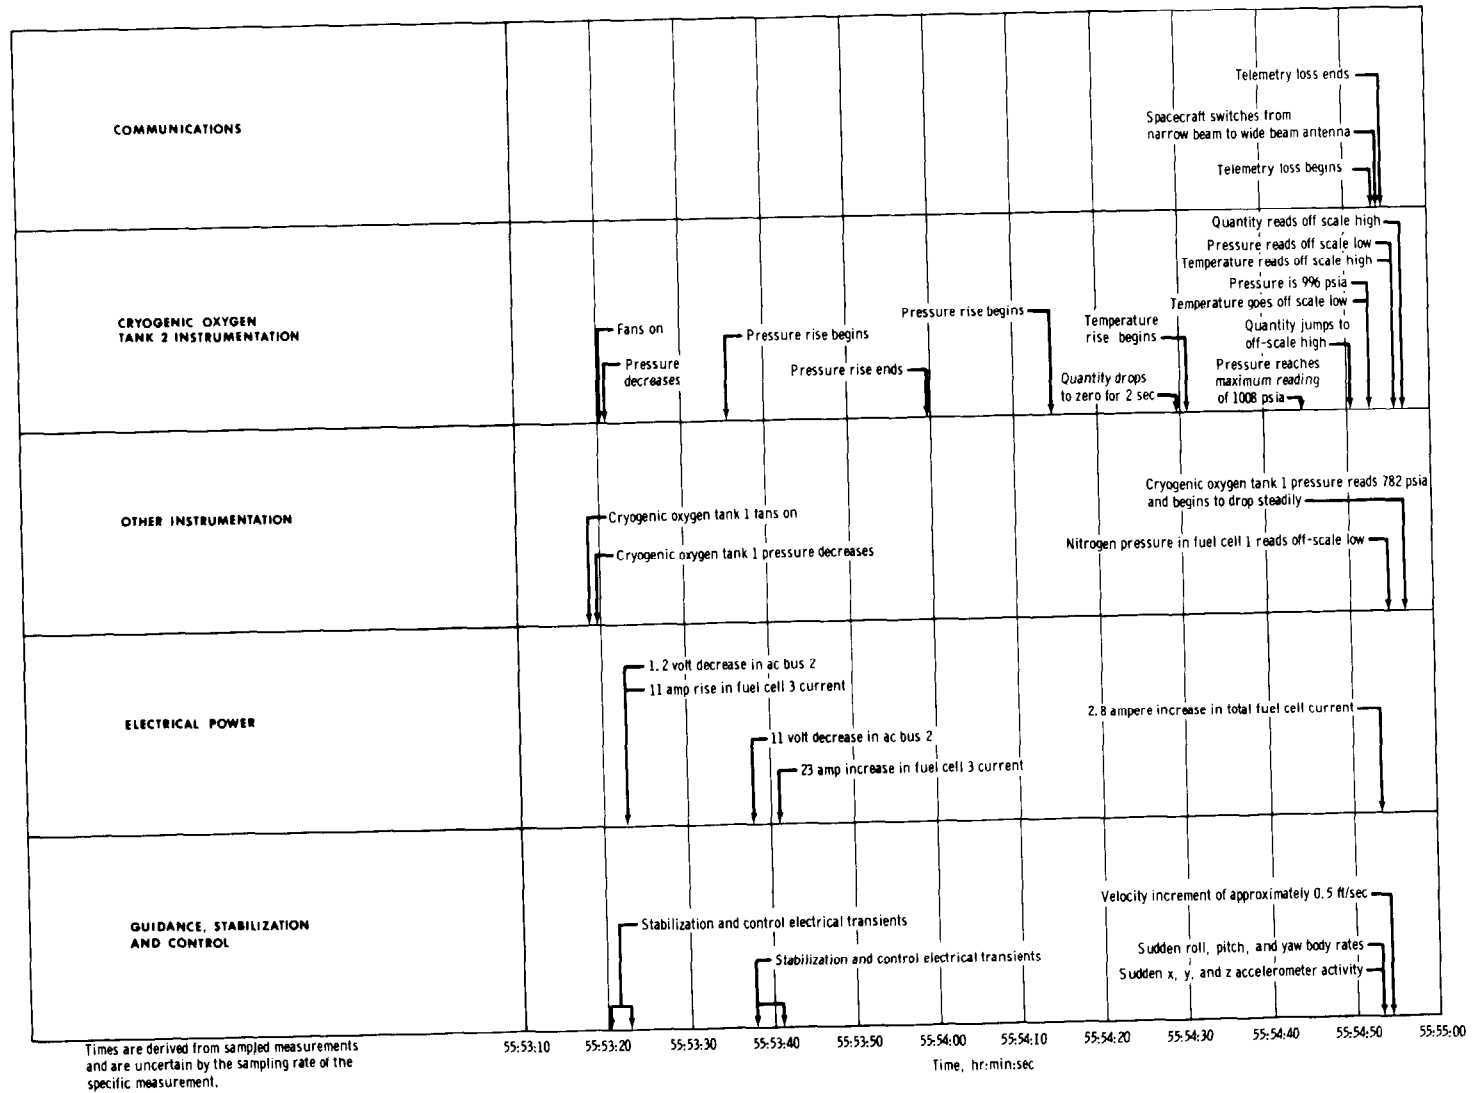
Figure B5-1.- Sequence of events immediately preceding the accident.

Table B5-I is a detailed chronology of the events during this time period, and figure B5-1 shows the sequence of events grouped according to spacecraft systems. For events obtained from telemetry data, where time is shown to a fraction of a second, this refers to the time at which the parameter in question was actually sampled by the telemetry system. As discussed in Part B7 of this Appendix, the characteristics of the

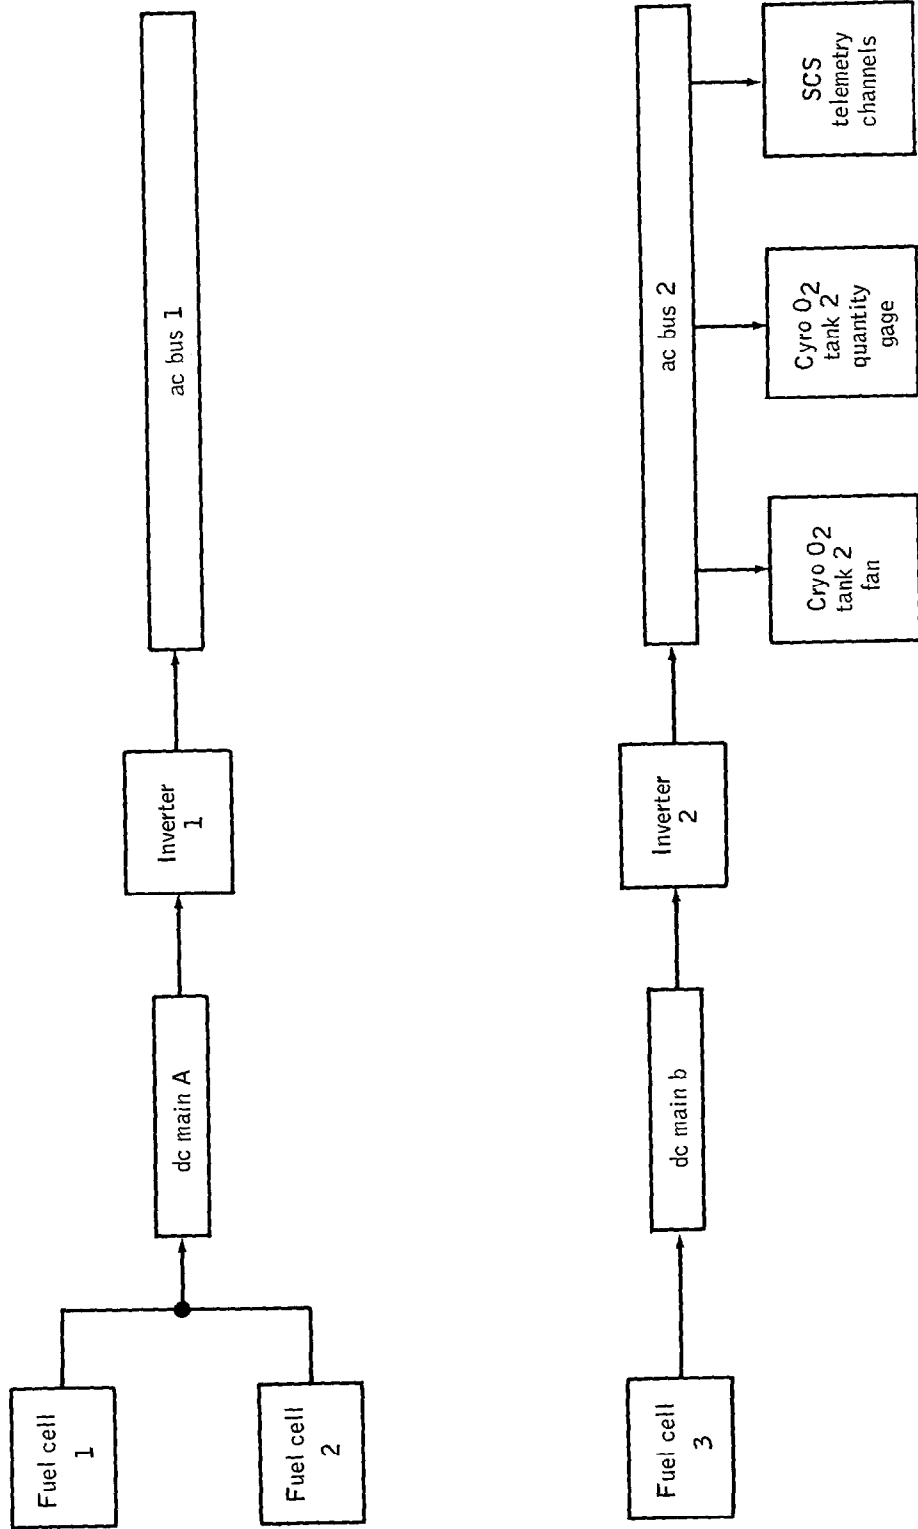
Figure B5-2.- Configuration of electrical power system at 55:53:20.

At 55:52:00, just prior to the accident, the electrical system was configured as shown in figure B5-2. Fuel cells 1 and 2 were supplying main bus A; fuel cell 3 was supplying main bus B. The power for the fans in cryogenic oxygen tank no. 2 was being supplied by ac bus 2, as was power for the quantity sensor in that tank. The stabilization control system thruster vector control system was receiving its power from ac bus 2. Two quantities in this system, the pitch and yaw thrust vector control gimbal commands, though not intended for measurement of electrical system currents and voltages, are sensitive indicators of electrical transients on ac bus 2. These quantities are telemetered to the ground with a sampling rate of 100 samples per second. At 55:52:00 the telemetry system was operating in the high-bit-rate mode and the narrow beam antenna was in use.

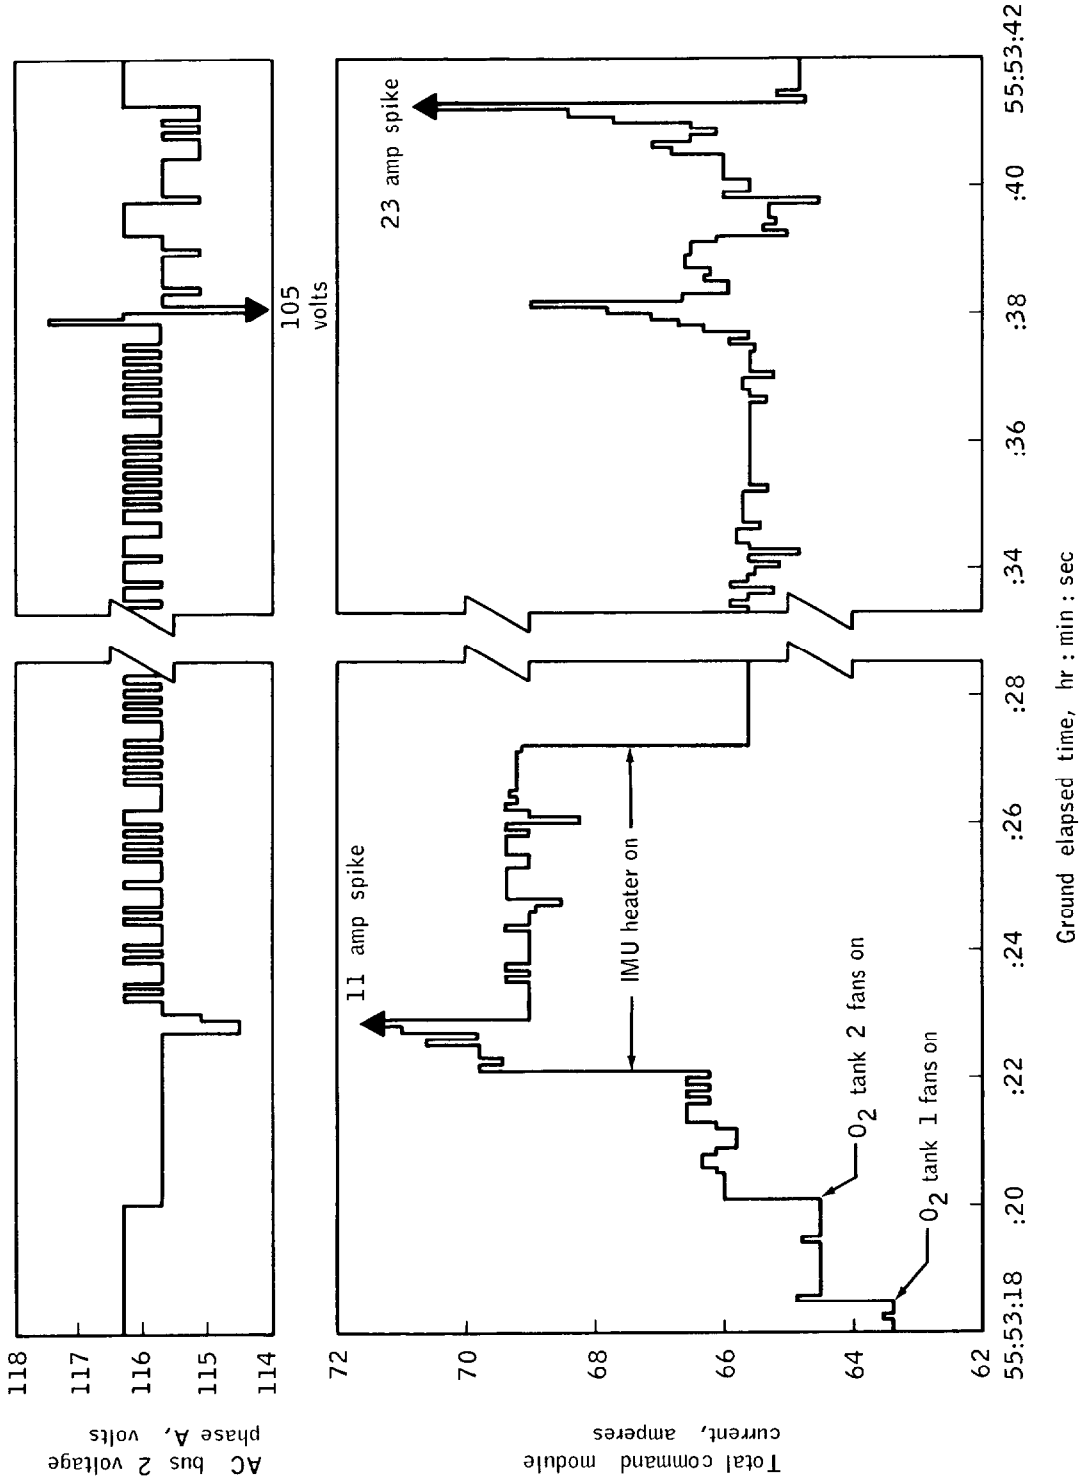
Figure B5-4.- Electrical anomalies.

These events indicate that at the time of the 11-amp spike, a load may have been disconnected from ac bus 2. This could have been one of the fan motors in cryogenic oxygen tank no. 2.

At 55:53:38 another abnormal electrical disturbance occurred, a 3-amp spike of current and variations in ac bus 2 voltage. The ac bus 2 voltage first increased 2 volts and then dropped suddenly from 116 to 105 volts. The ac bus 2 is a three-phase electrical system, although the only voltage telemetered is phase A. The operation of the inverter which generates ac bus 2 is such that it attempts to maintain a constant average voltage among the three phases; if one phase becomes heavily loaded, the inverter will increase the voltages of the other two phases. Consequently, it is possible that the voltage rise in ac bus 2 at 55:53:37.8 was caused by a heavy load applied to phase B or phase C. The decrease in voltage immediately afterward was probably caused by loading of phase A.

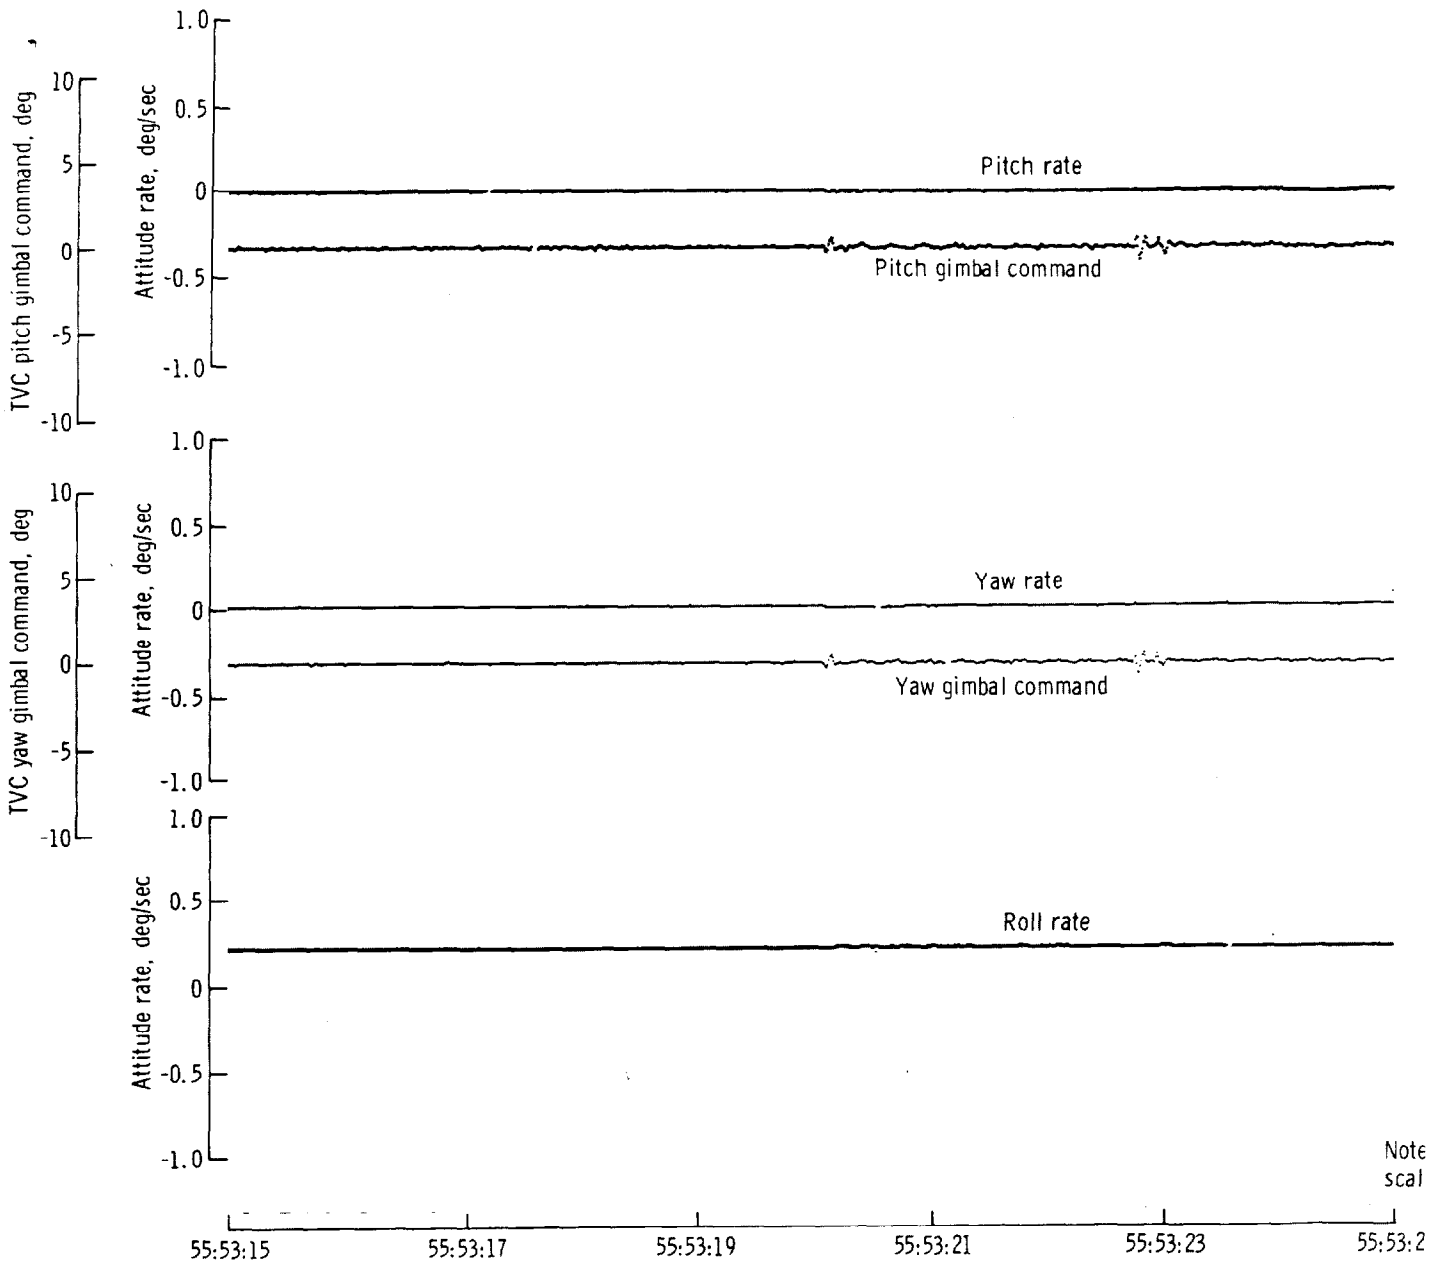
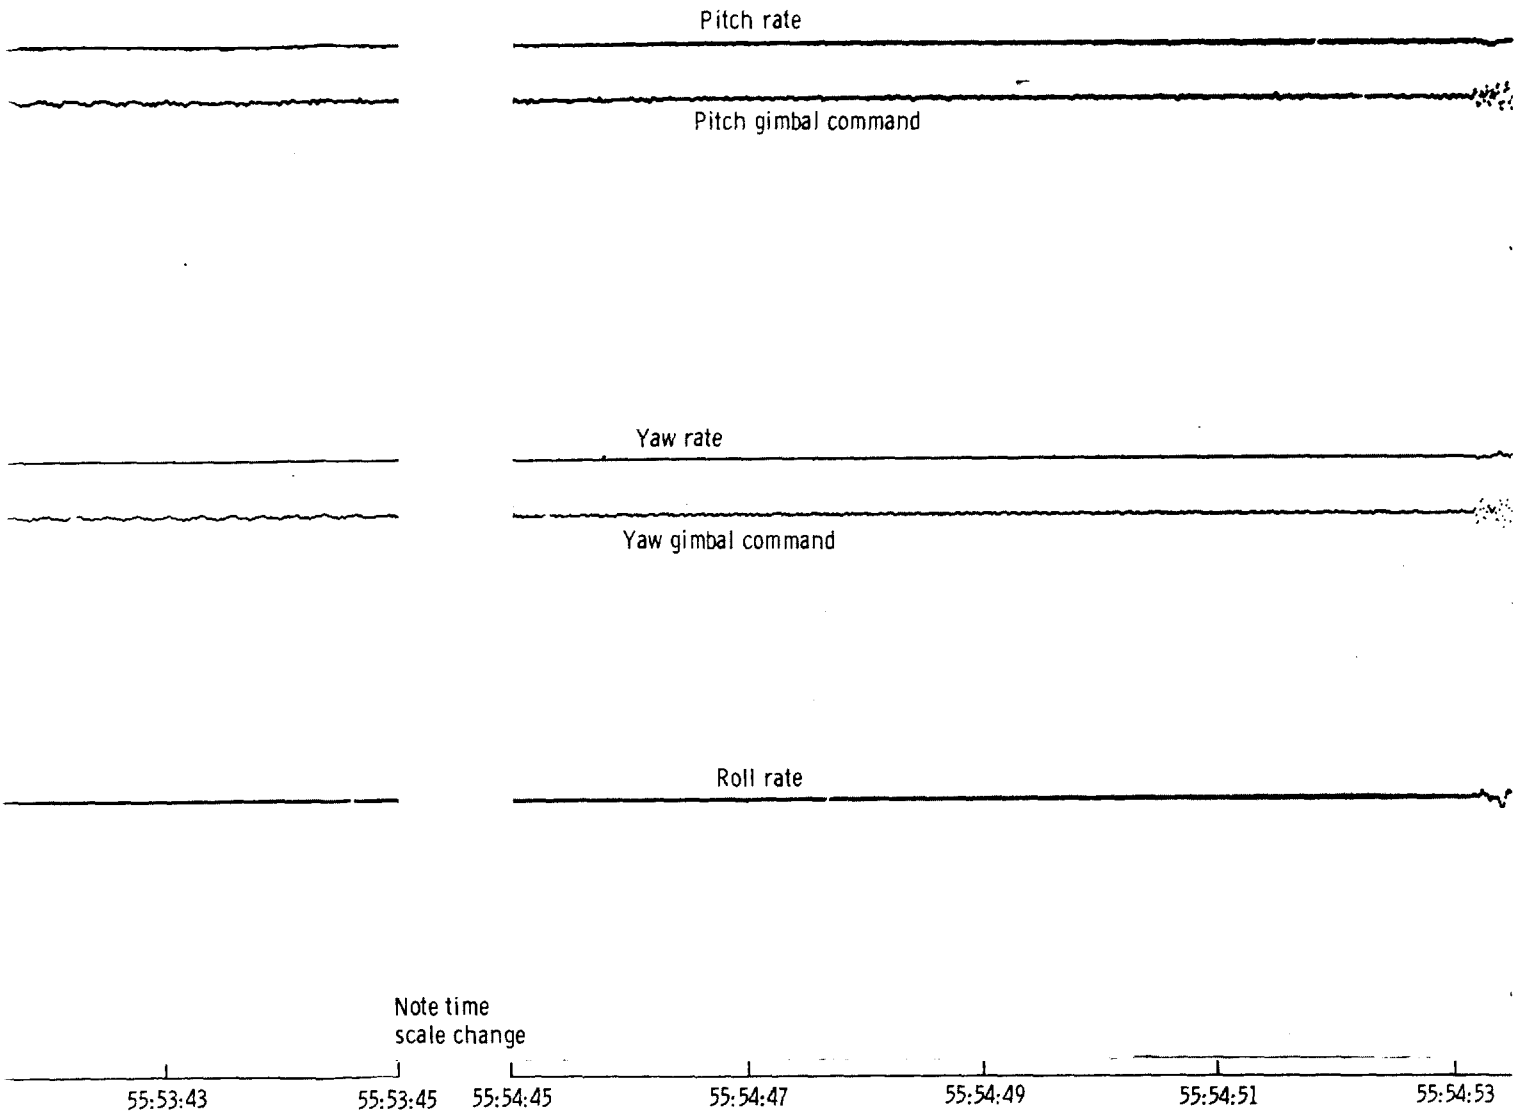
Figure B5-5.- Disturbances observed on thrust vector control gimbal command signals.

At 55:53:41 a 23-amp spike occurred on fuel cell 3 output current, after which the total command module current returned to a steady value within 0.3 ampere of the value prior to turnon of cryogenic oxygen tank no. 2 fans. Also, the voltage of ac bus 2 returned to the value it had shown prior to fan turnon. At the same time transients appeared in the stabilization control system, as shown in figure B5-5.

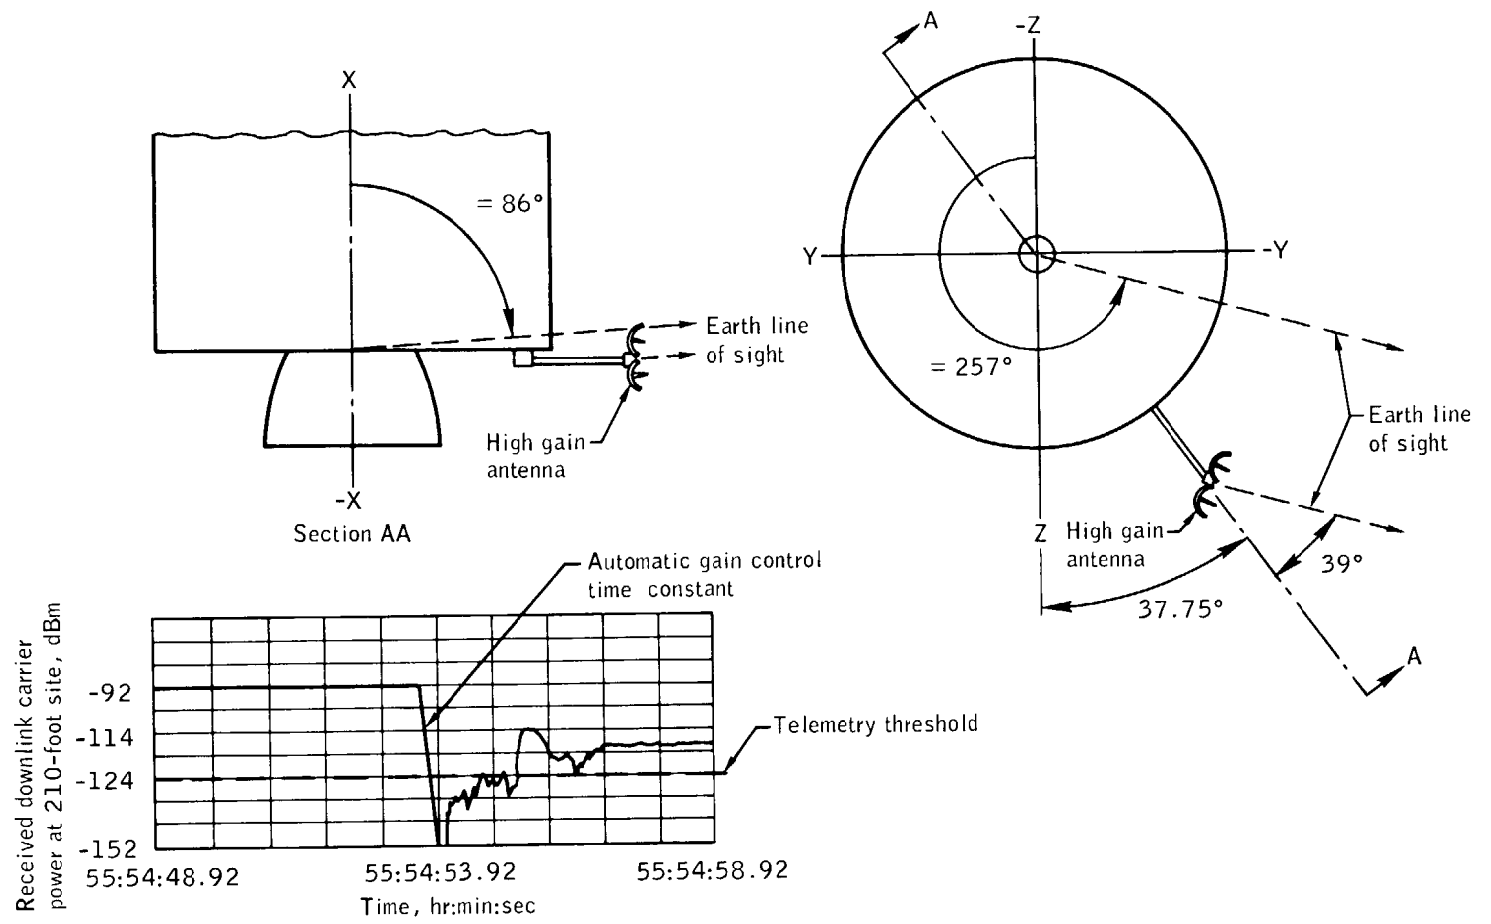
Figure B5-6.- Received S-band downlink power.

Although figure B5-6 indicates that the signal required 0.3 second to decrease 60 dB, the actual time was probably much shorter. The decrease of 60 dB in 0.3 second is the same as that obtained when the input signal is abruptly removed from the receiver. This slow response is caused by long time constant circuitry in the automatic gain control.
