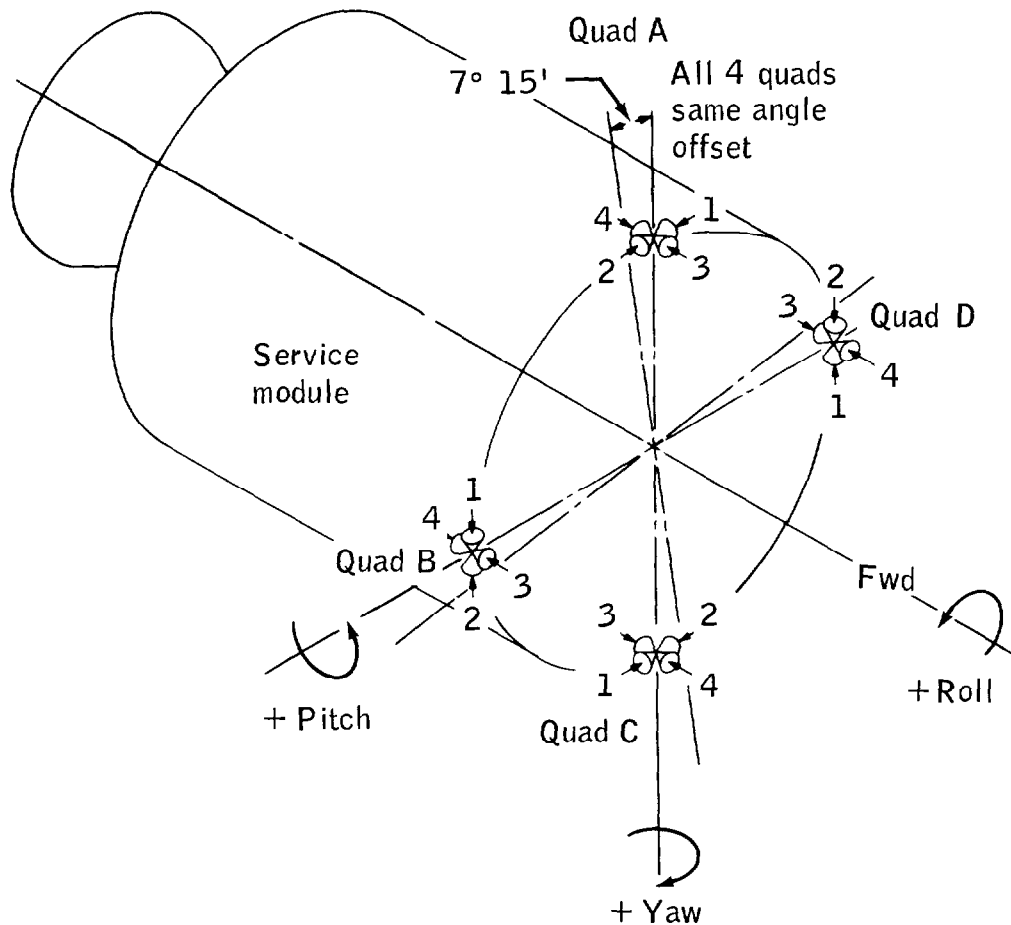
Figure B6-2.- SM RCS quad location and thruster numbering system.

spurious rates. It was observed that thruster 3 in quad C was receiving firing signals almost continuously, but was having no success in stopping the negative pitch rate. In an effort to gain control over the negative pitch rate, at 56:32 Mission Control requested the crew to put the Auto RCS Select switch of thruster 3 of quad A on main bus A. It was suspected that C-3 thruster was not really firing because there was no perceptable reduction in quad C propellant.

Based on a close observation of firing signals to quad C and the resulting spacecraft response, the flight controllers thought that the quad C propellant isolation valves had been jolted closed by the incident that caused the loud bang. The computer was still sending firing signals to the auto coils, but they were apparently having no effect and propellant was not being used by this quad. Therefore, to save the small amount of electrical power that was being spent by sending firing signals to the coils, at 57:29 Mission Control directed the crew to turn off the auto coils to this quad.

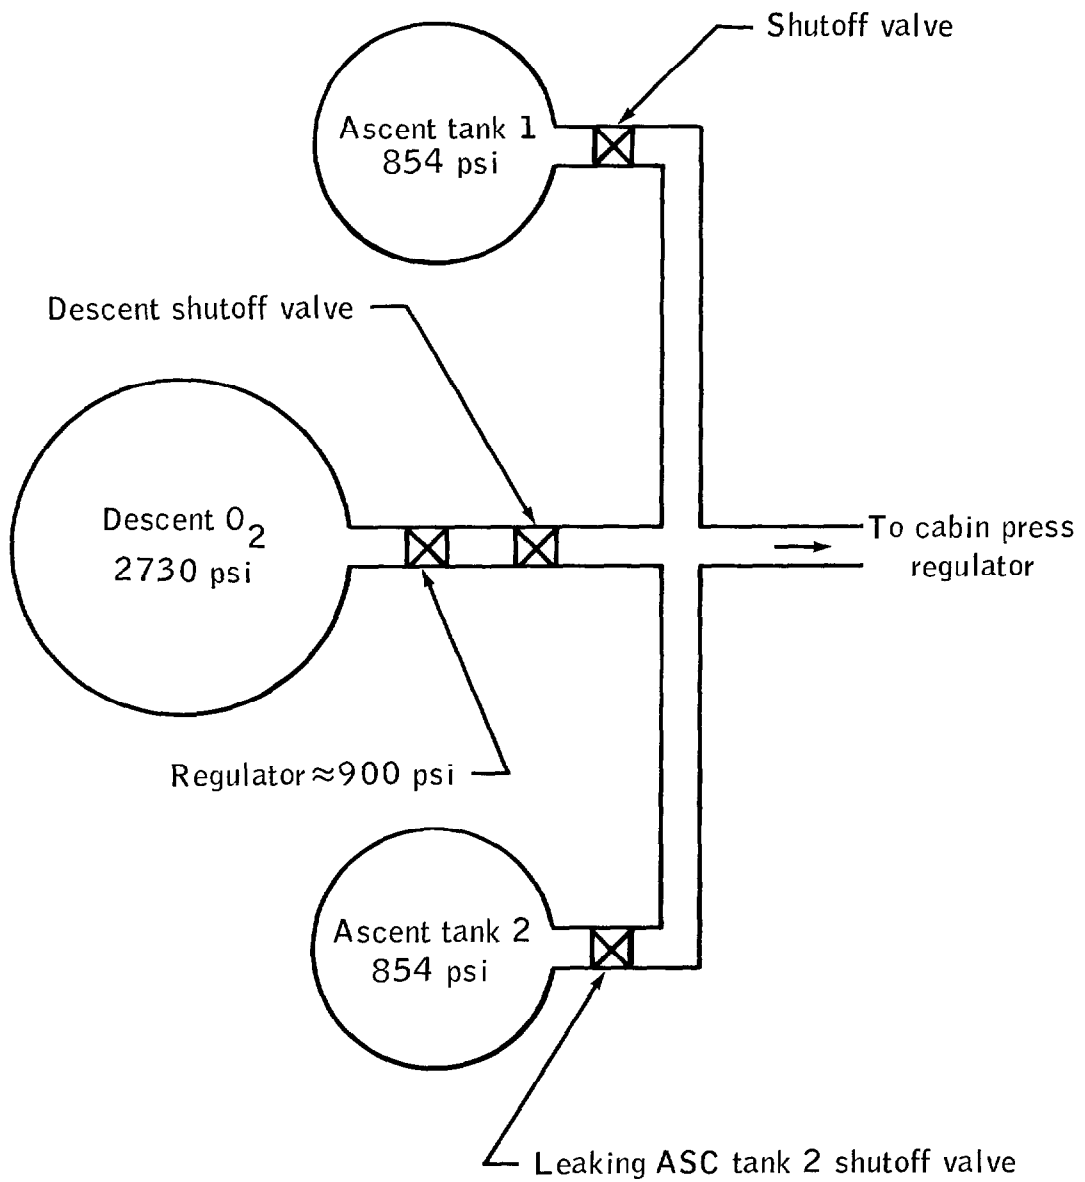
Figure B6-3.- Schematic of LM oxygen storage system.

An abnormally high pressure reading was noted in one of the LM ascent stage oxygen tanks shortly after telemetry data were received in Mission Control, and the crew was directed to use oxygen from this tank instead of the descent tank. Later it was diagnosed that the shutoff valve leaked, allowing the higher pressure oxygen from the manifold to leak into this ascent tank. The condition in itself was not a problem; the net effect was that this ascent tank was raised to a slightly higher than normal pressure which was well within the tank limits. This degraded the system redundancy, however, and had a subsequent leak developed in this tank, the LM oxygen supply would have been depleted (fig. B6-3).

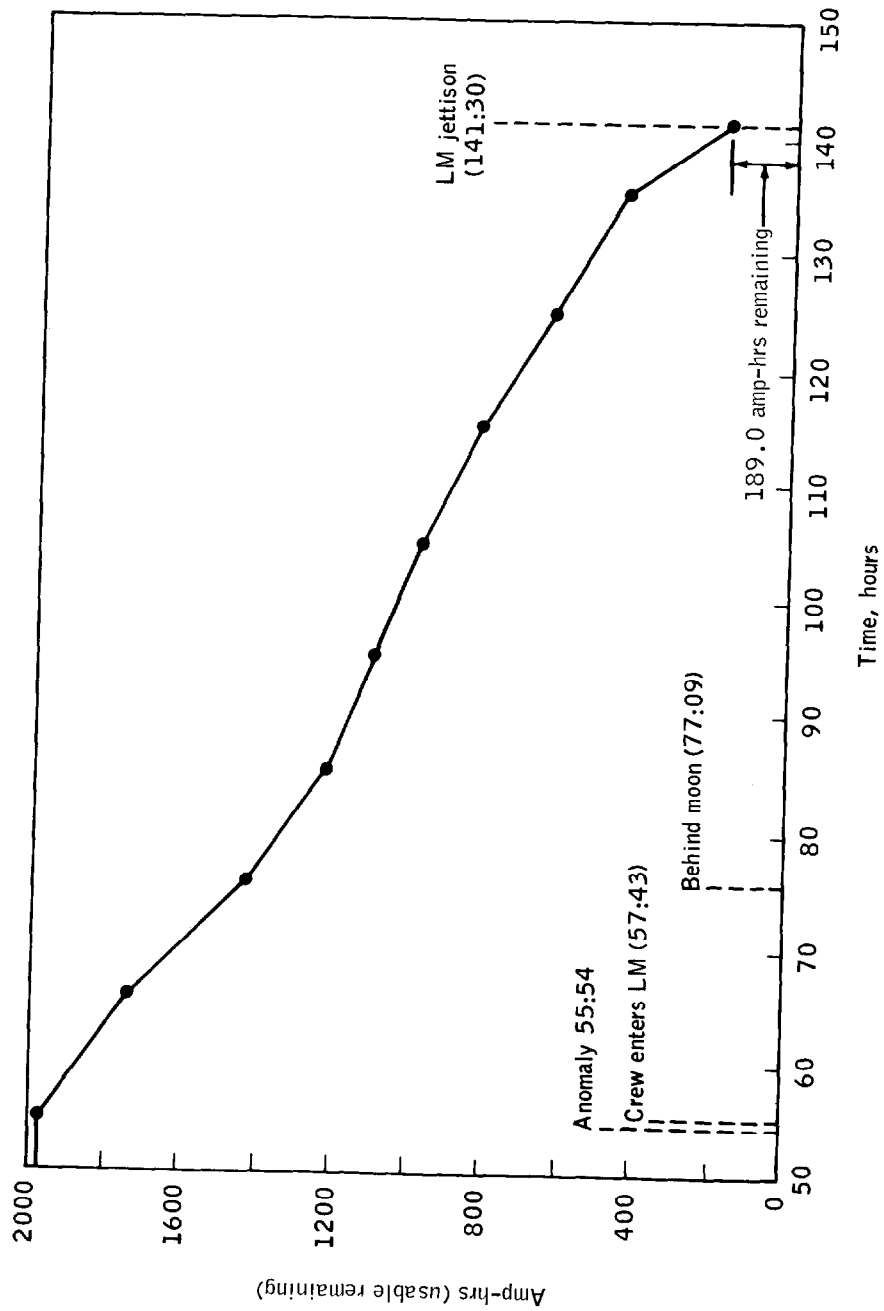
Figure B6-4.- Electrical power system consumables status.

in Mission Control where telemetry was available. There were three possible valid causes of the warning light: an overcurrent, a reverse current, or a battery overtemperature condition. The troubleshooting systematically eliminated all three, and Mission Control concluded the problem was a faulty temperature sensor. The crew was advised to reconnect the battery about an hour later. No problems with the battery ever developed, but the sensor indication later became erratic, causing several MC&W alarms. A plot of total usable amp-hours remaining in the LM batteries is contained in figure B6-4.

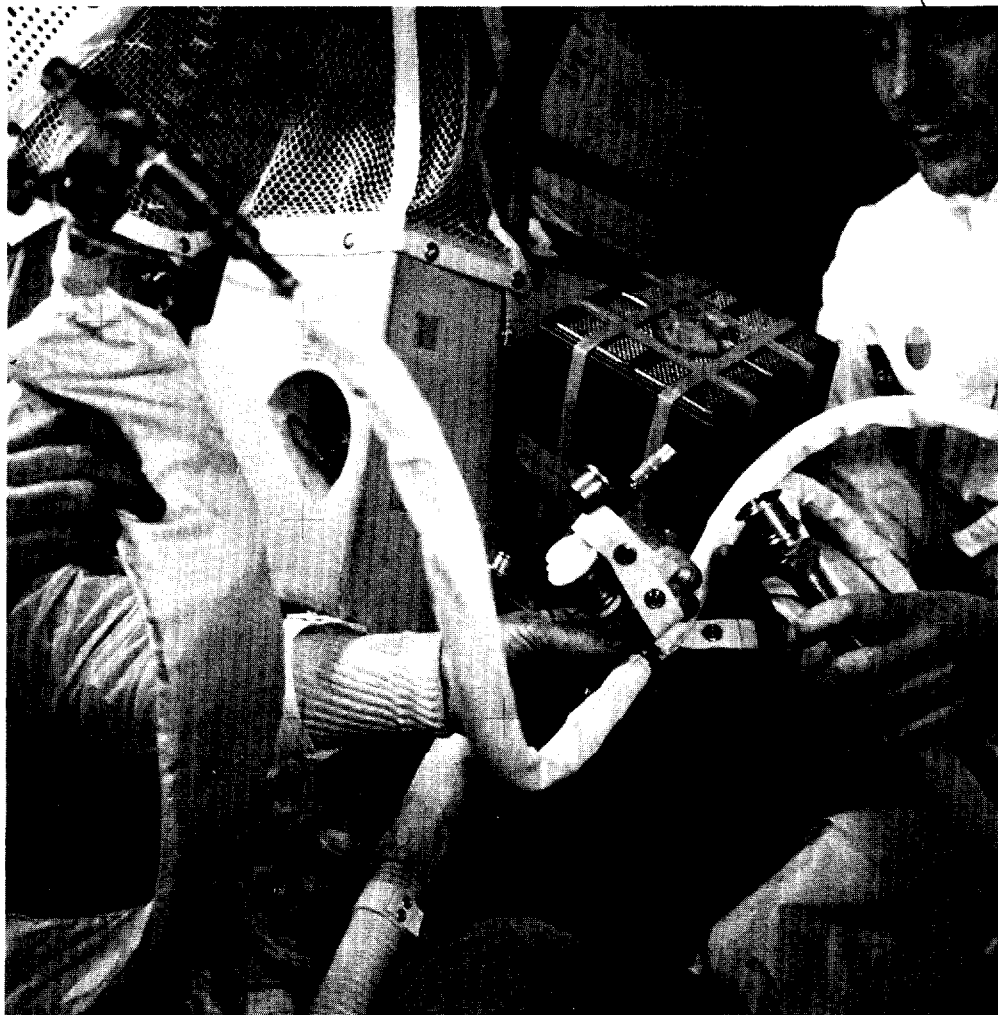
Figure B6-7.- View of CM LiOH cannister modification as installed in the LM.

The problem of removing carbon dioxide from the cabin oxygen was a serious one. The LM, like the CSM, uses lithium hydroxide (LiOH) cartridges to scrub the recirculated oxygen to remove odors and carbon dioxide. The LiOH cartridges are rated for a specified total man-hours capacity, and eventually must be replaced when they become saturated. The LM cartridges were not adequate for carbon dioxide removal for three men for the duration of the Earth-return trip. There were more than adequate cartridges in the CM, but they would not fit in the LM canisters. There were several methods suggested for solving the problem, including powering up the CM system to circulate cabin oxygen through its LiOH canisters. The method that was actually used was developed by Crew Systems Division personnel at MSC. It consisted of using tape, flight data file cards, and plastic bag material to connect the CM LiOH canisters to the LM oxygen circulation system. The crew implemented the modification and it worked very well. The partial pressure of carbon dioxide reading indicated by the onboard gage dropped rapidly from 8mm Hg to 0.1mm Hg soon after the rig was completed at 94 hours g.e.t. The modification was not tried until this time in order to get maximum use from the LM cartridges. About 20 hours later, the carbon dioxide partial pressure reading had increased to 1.8mm Hg, and a procedure for putting two additional cartridges in series to those in the CM canisters was given to the crew. This procedure was also developed by engineers at MSC (fig. B6-7). After this second modification was completed, the carbon dioxide partial pressure remained below 2mm Hg for the rest of the mission, without any further modifications necessary.

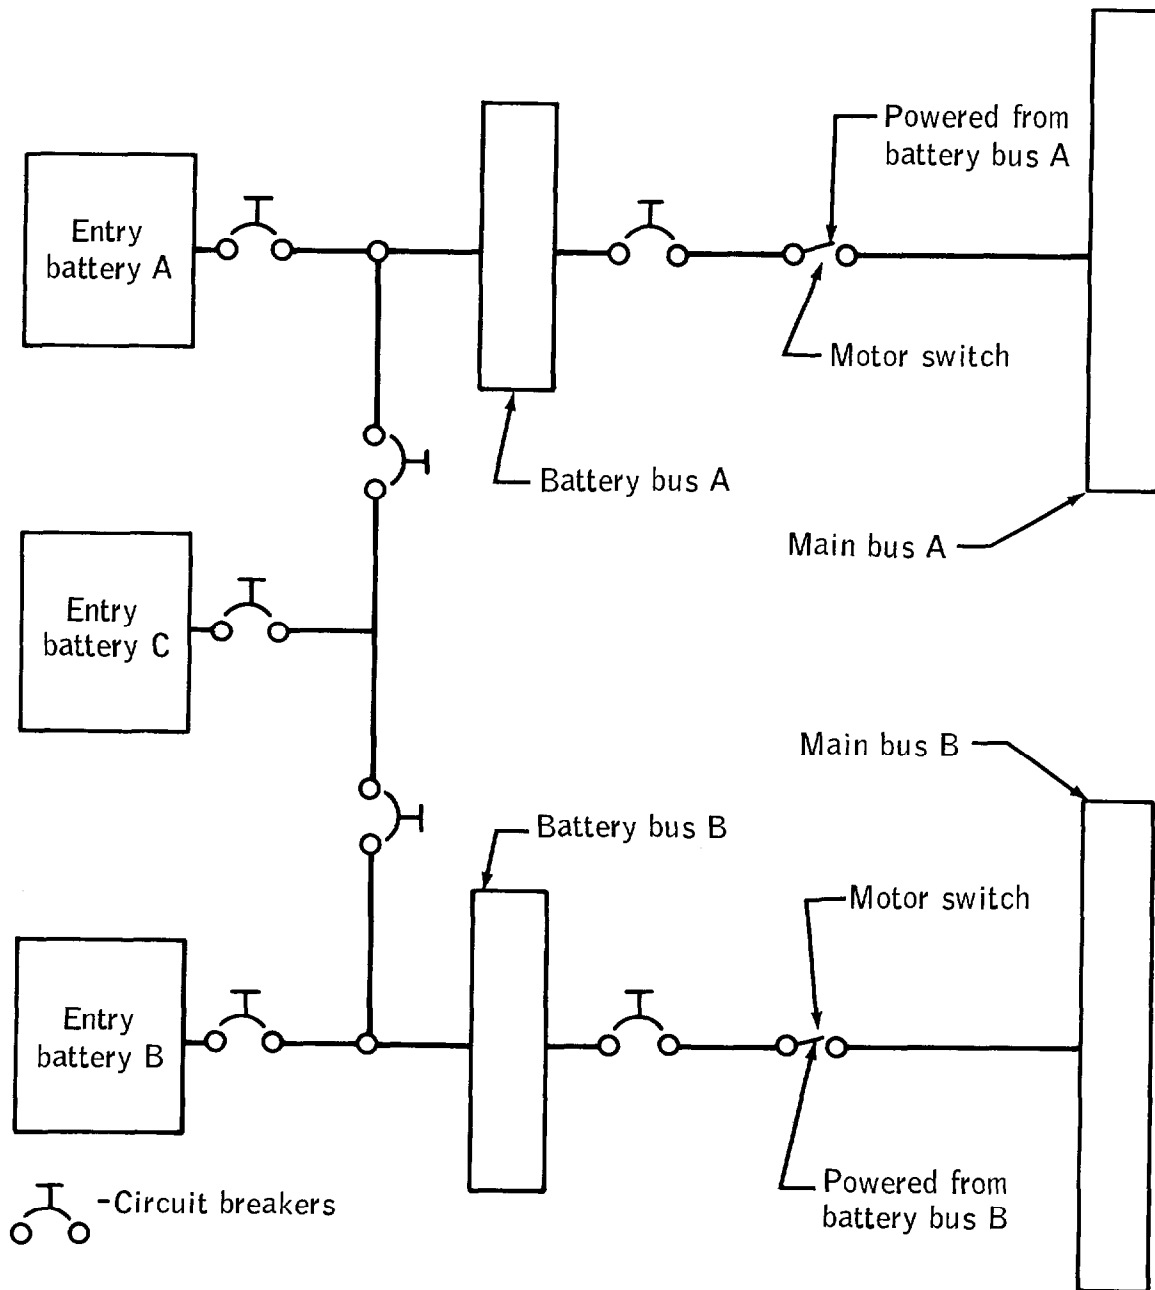
Figure B6-8.- Simplified wiring diagram showing battery power to main busses.

The next task was to determine the status of main dc bus B. Because power had not been applied to the bus since the failure of fuel cell 3 at 55:58, it was not certain that a major short did not exist on it. Mission Control defined a procedure which used entry battery B to apply power to the bus. The procedure contained 12 steps, and the displays the crew should monitor were defined, along with the expected indications. The baseline configuration described in the preceding paragraph insured that all loads were isolated from the bus. The procedure was implemented at 94:21 hours and verified that there were no shorts on the bus.

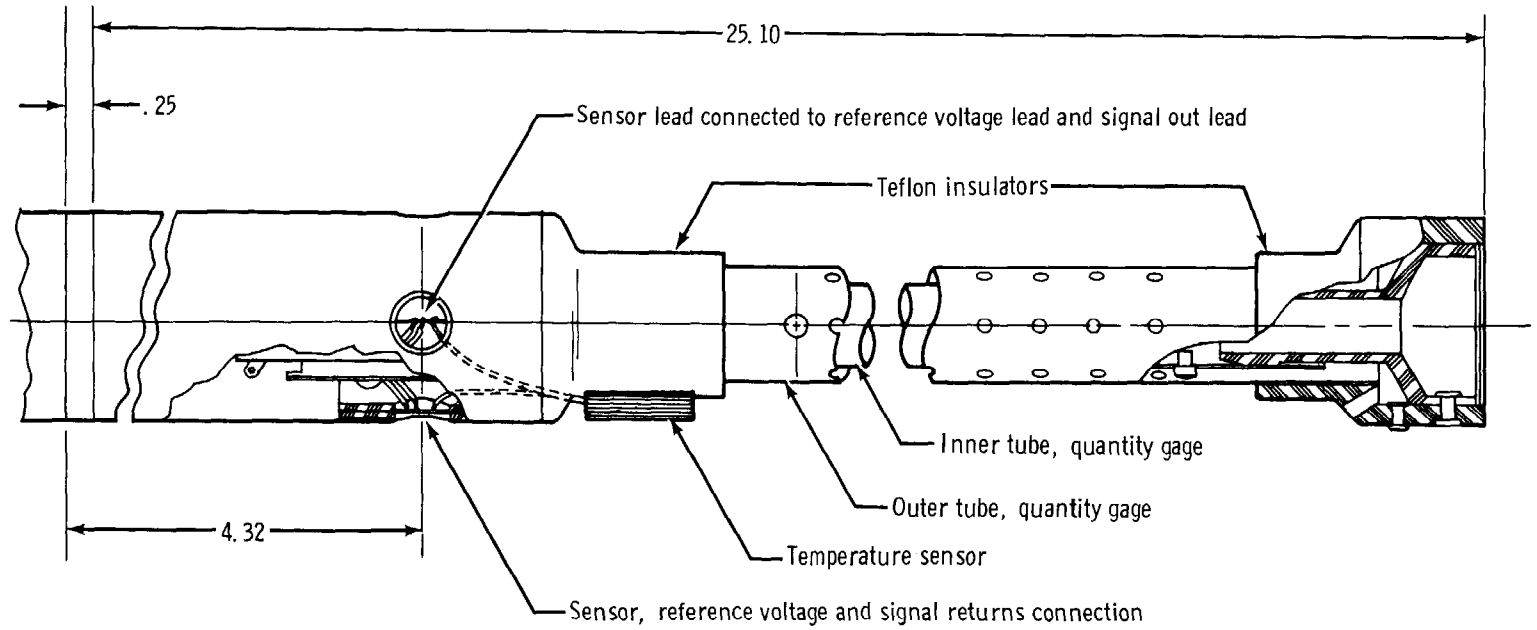
Figure B7-1. - Oxygen quantity gage and temperature sensor location.

The temperature measurement is made with a platinum resistance thermometer (R/T) encased in an Inconel sheath attached to the Teflon insulator part of the quantity probe (fig. B7-1). The resistance of the R/T and the transducer output voltage increase with temperature. The signal conditioner which serves as a reference voltage generator and amplifier is located on the oxygen tank shelf. An electrical schematic of the transducer is shown in figure B7-2.
