INTEGRATION, SYSTEM TESTING, AND PRELAUNCH CHECKOUT OF THE CRYOGENIC OXYGEN STORAGE TANKS

Summary of Significant Aspects of Serial No. 0008 Tank
Prelaunch Integration Test and Checkout History

Investigation and Supporting Work

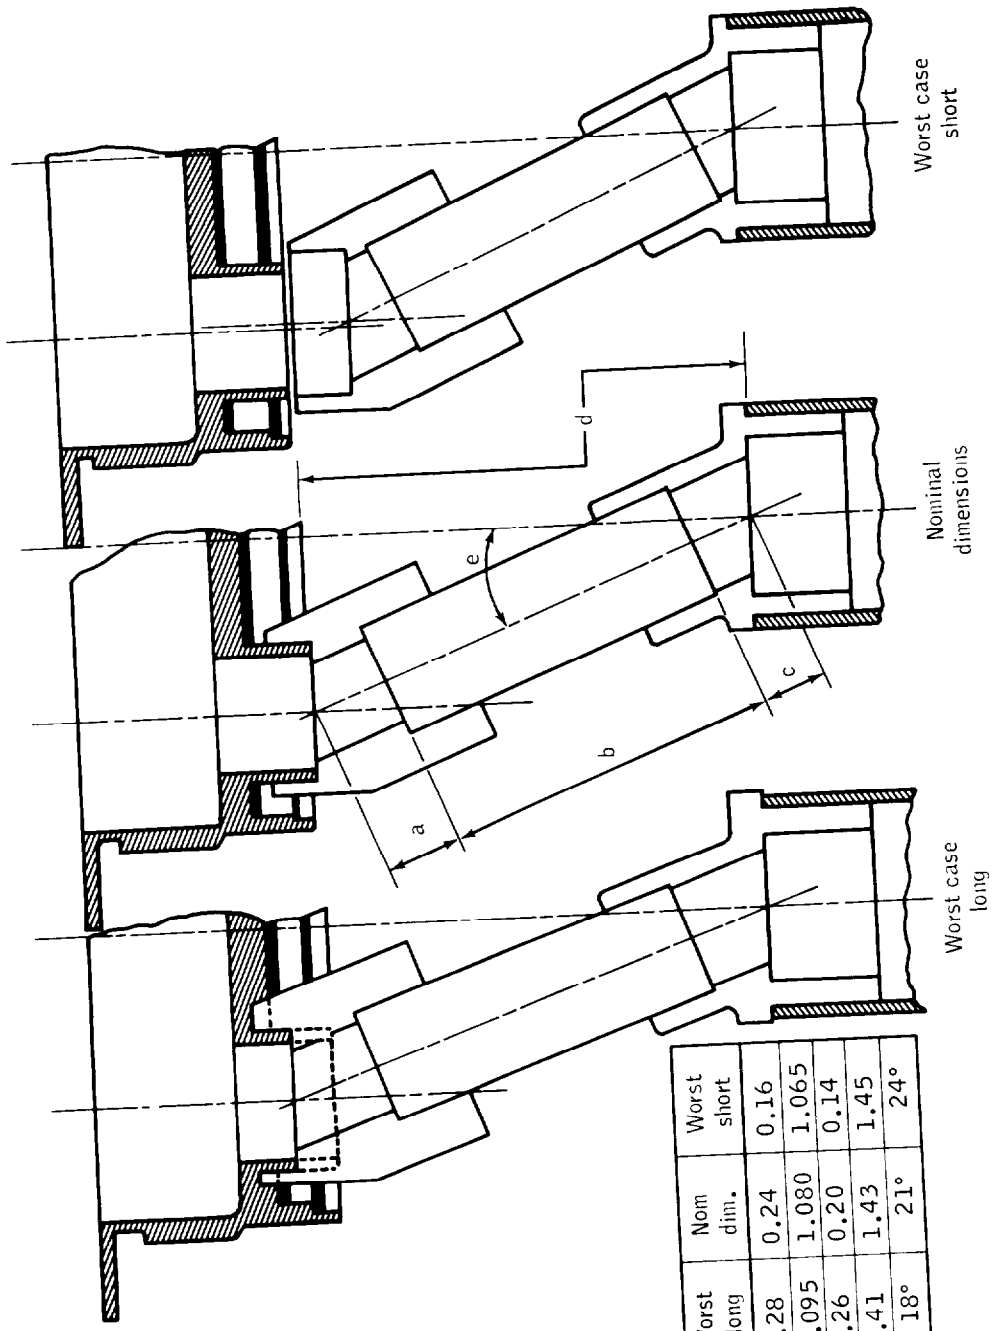
Figure C4-49.- Extreme and nominal tolerance cases for fill tube connection parts.

A 10-times-size layout was made of the fill tube connection situation with the parts at the various limits of size permitted by the engineering drawings. In addition to the length tolerances permitted by the drawing dimensions, the diametral clearance also permits the parts to assume angles beyond the ranges stated on the drawings. As an aid to check all the various positions to which these parts could move, individual cutout paper parts were made for the two Teflon bushings and the interconnecting Inconel tube. Figure C4-49 shows that the worst-case short tolerance parts can fall out of position as the tank is moved about. At the other extreme, parts that are at the high end of the permitted tolerances will not assemble. This is shown on the left-hand view. The nominal case provided little or no axial clearance but still does not provide gas-tight seals at the various diameters.

In addition to the tolerance condition that can exist for the fill tube connecting parts, the center tube of the quantity probe could move downward due to Teflon cold flow. The center tube is supported in the axial position by two Teflon bushings installed in the center tube and a semi-tubular rivet. Prolonged heating, such as the vacuum pumpdown cycles (three cycles for this tank assembly resulting in a total of 1532 hours at 190 to 220° F), could result in the thin walls of the center tube slowly cutting into the Teflon bushings.

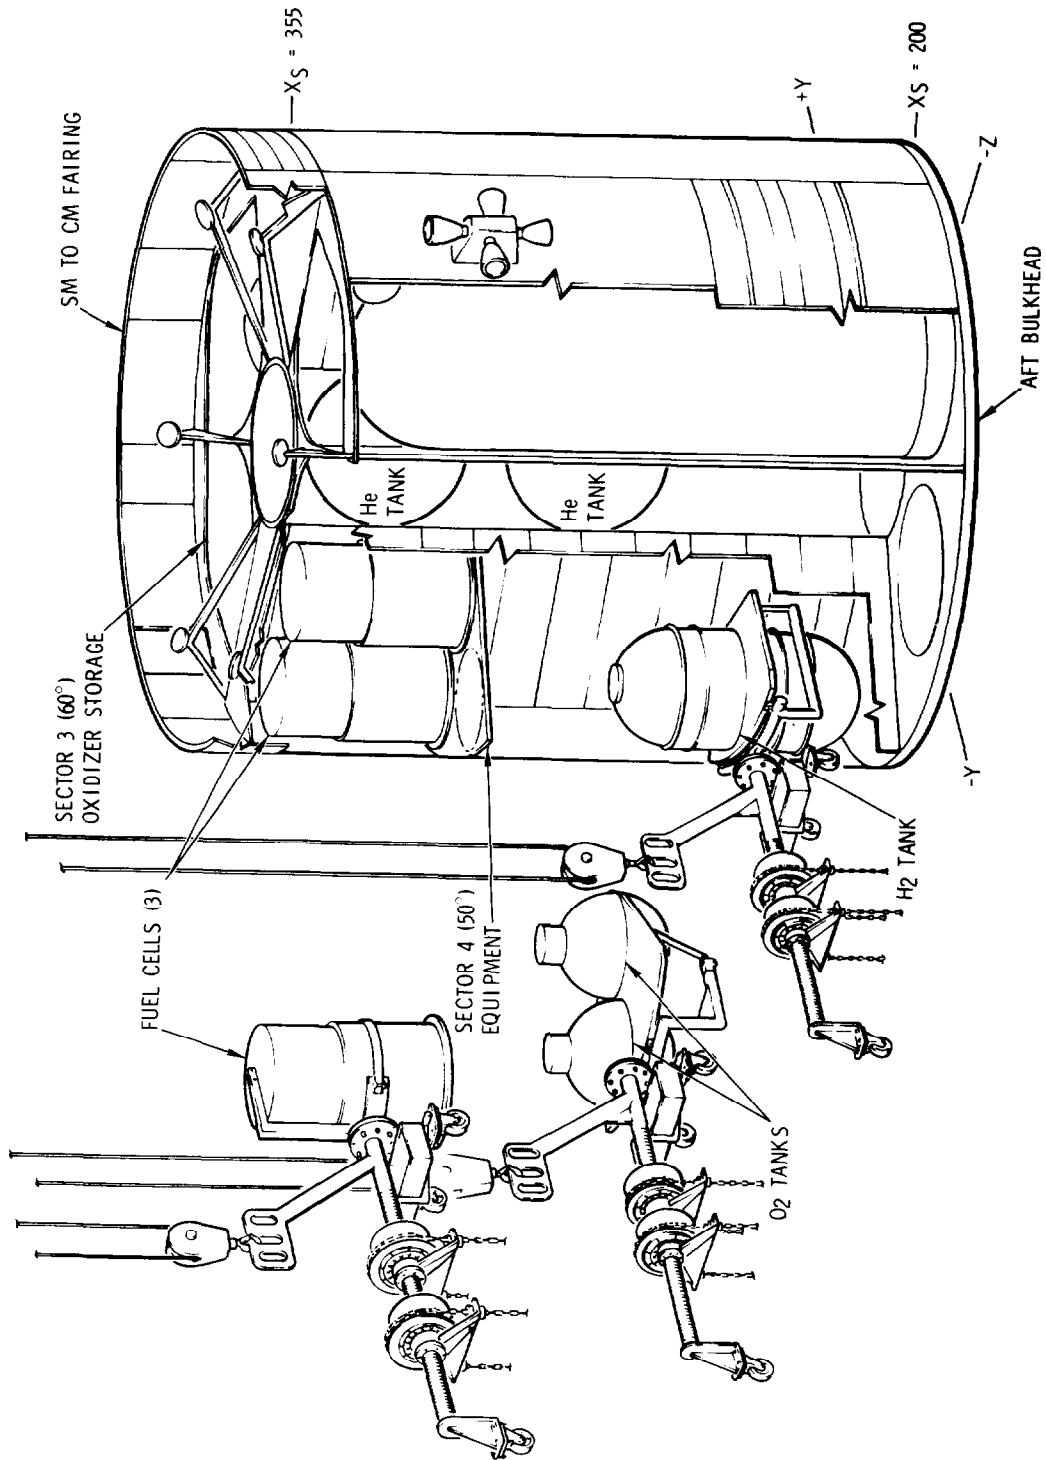
Figure C4-53.- SM bay 4 tank installation.

In preparation for this attempt, the 10 bolts attaching the shelf to the adjacent beams were removed. The existence of a small, 11th bolt introduced from underneath and behind tank no. 1 was overlooked by all persons involved. The factory crew brought into position a lifting fixture particularly devised for inserting tanks and shelves into sectors of the service module (fig. C4-53).

Under the particular circumstances of October 21, 1968, the unnoticed 11th bolt into the shelf served as a tie-down beyond the tips of the lifting fork such that raising the fixture produced rotation of the entire assembly, most noticeably the counterbalance. The 11th bolt still was unobserved. Attempts were made to balance the fixture by moving a weight and to lift the assembly by operating the overhead bridge crane. In these steps sufficient load was placed on the fixture to break it above the cross-arm of the fork.

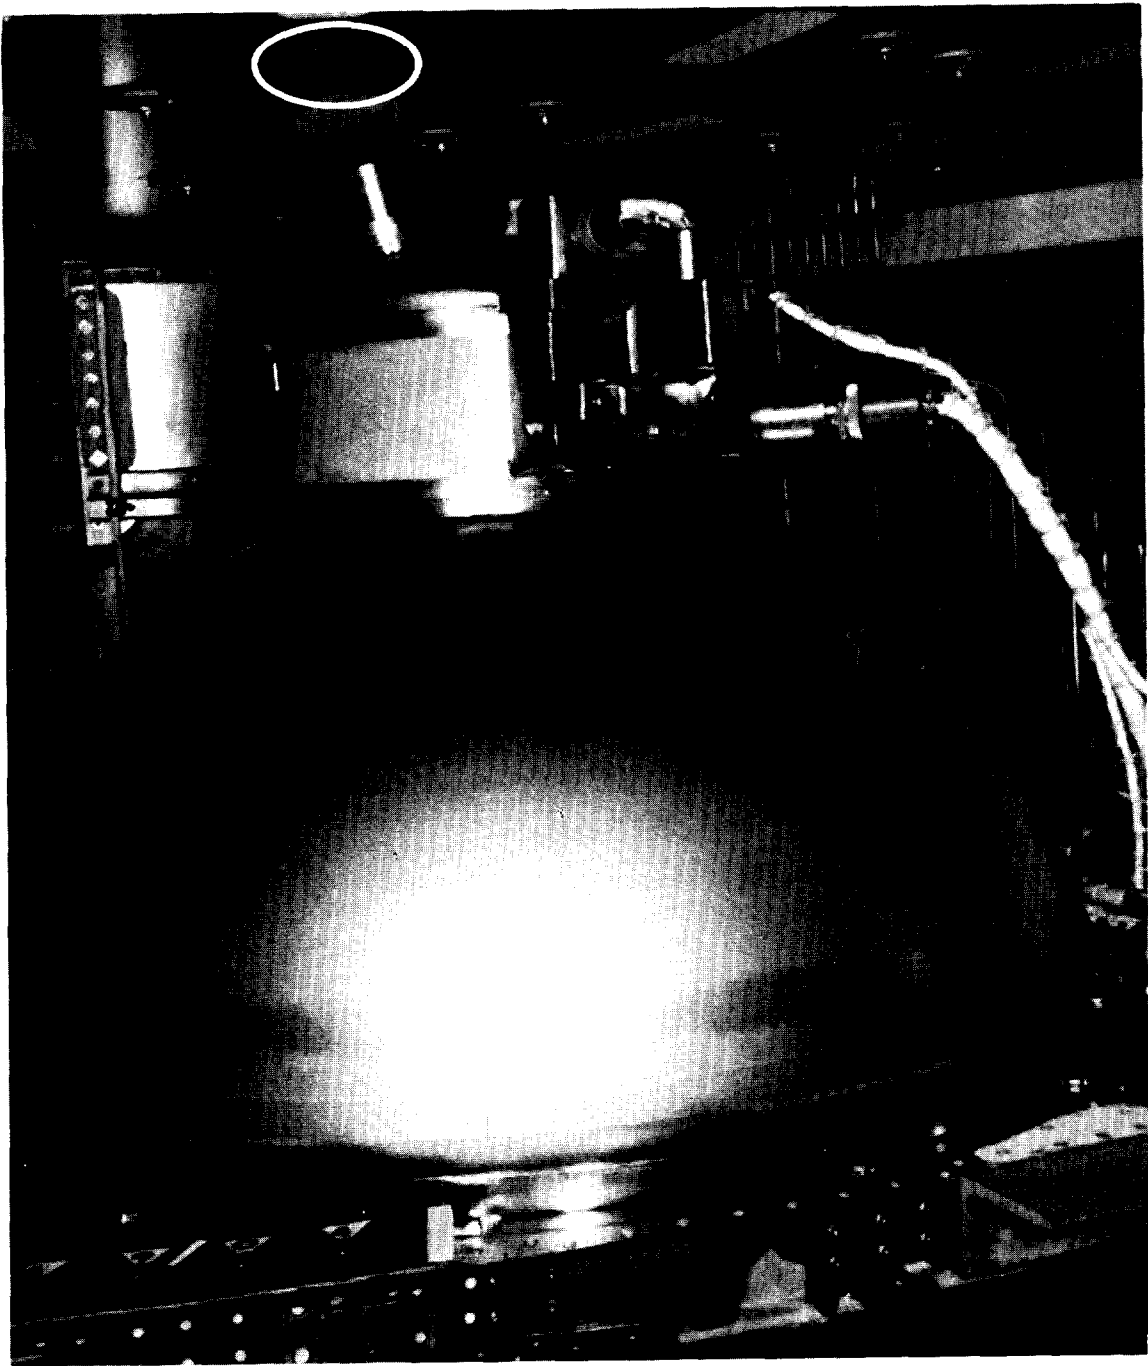
Figure C4-54.- Replacement oxygen shelf installed in Service Module 106. Note repairs to fuel cell shelf over oxygen tank no. 2.

The oxygen shelf moved and came to rest on the supporting beams through what was at the time described as a "2-inch drop". Observation of adjacent portions of SM 106 identified minor damage, including a dent in the underside of the fuel cell shelf above.

Figure C4-54 shows the repair patch over this dent immediately above the vacuum pinch-off cover can of tank no. 2 in the oxygen shelf that replaced the one undergoing the "shelf drop" incident in SM 106.

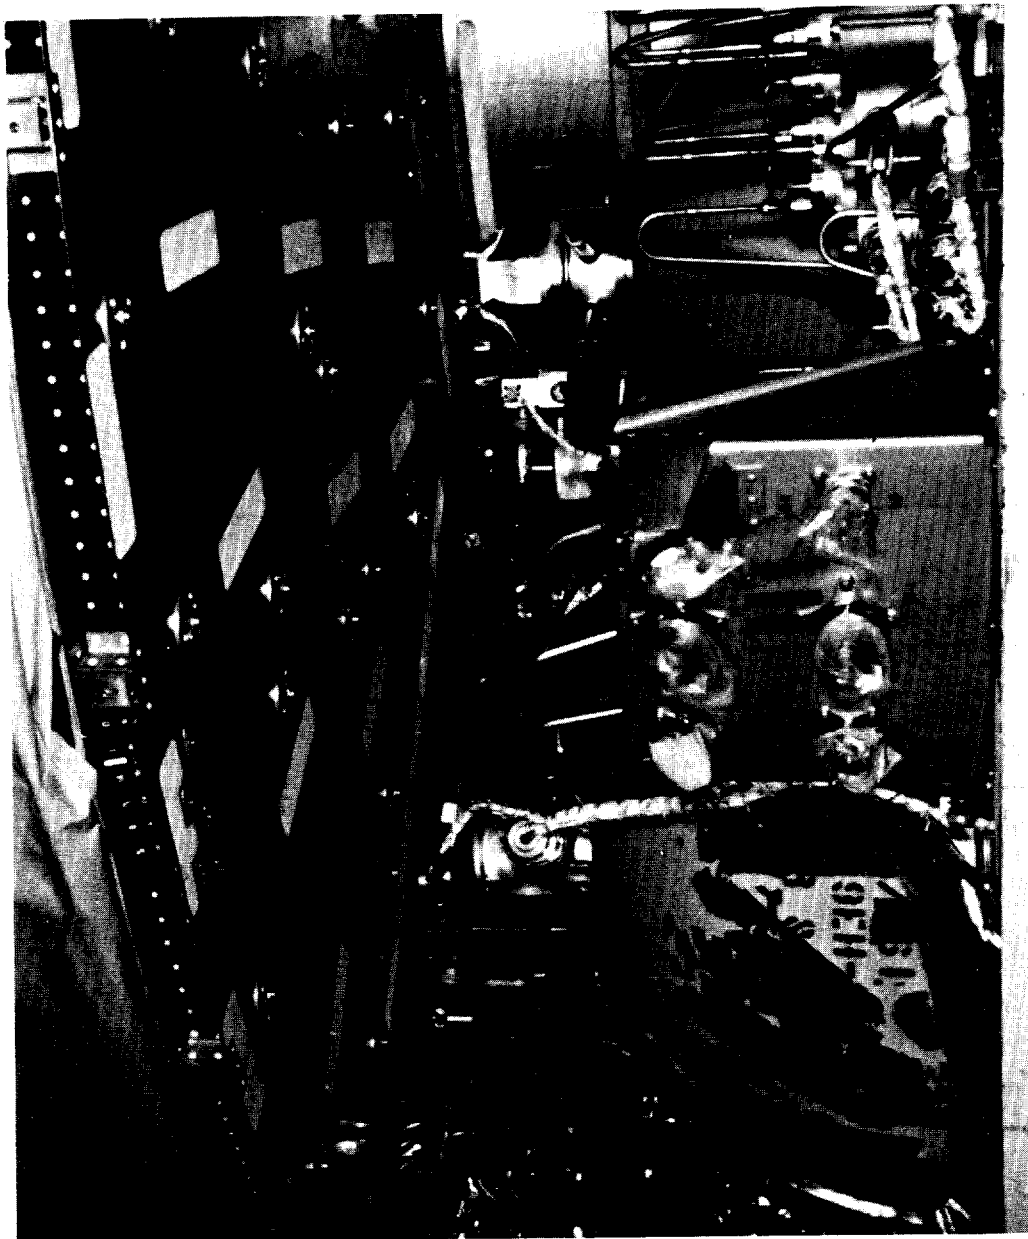
Figure C4-55.- Oxygen shelf installed in service module.

In figure C4-55, showing the installation of the oxygen shelf in SM 109, the condition of the farthest right tubing in the lower part of the picture reflects the comments of two DR's that one tube had a "slight bend" at the valve module and another (lower) was "badly bent." As the highest tubes, farthest from the 11th bolt and the high point of tank no. 2, these two may have participated in the "shelf drop" incident. Neither was found to be in need of repair after leak check.

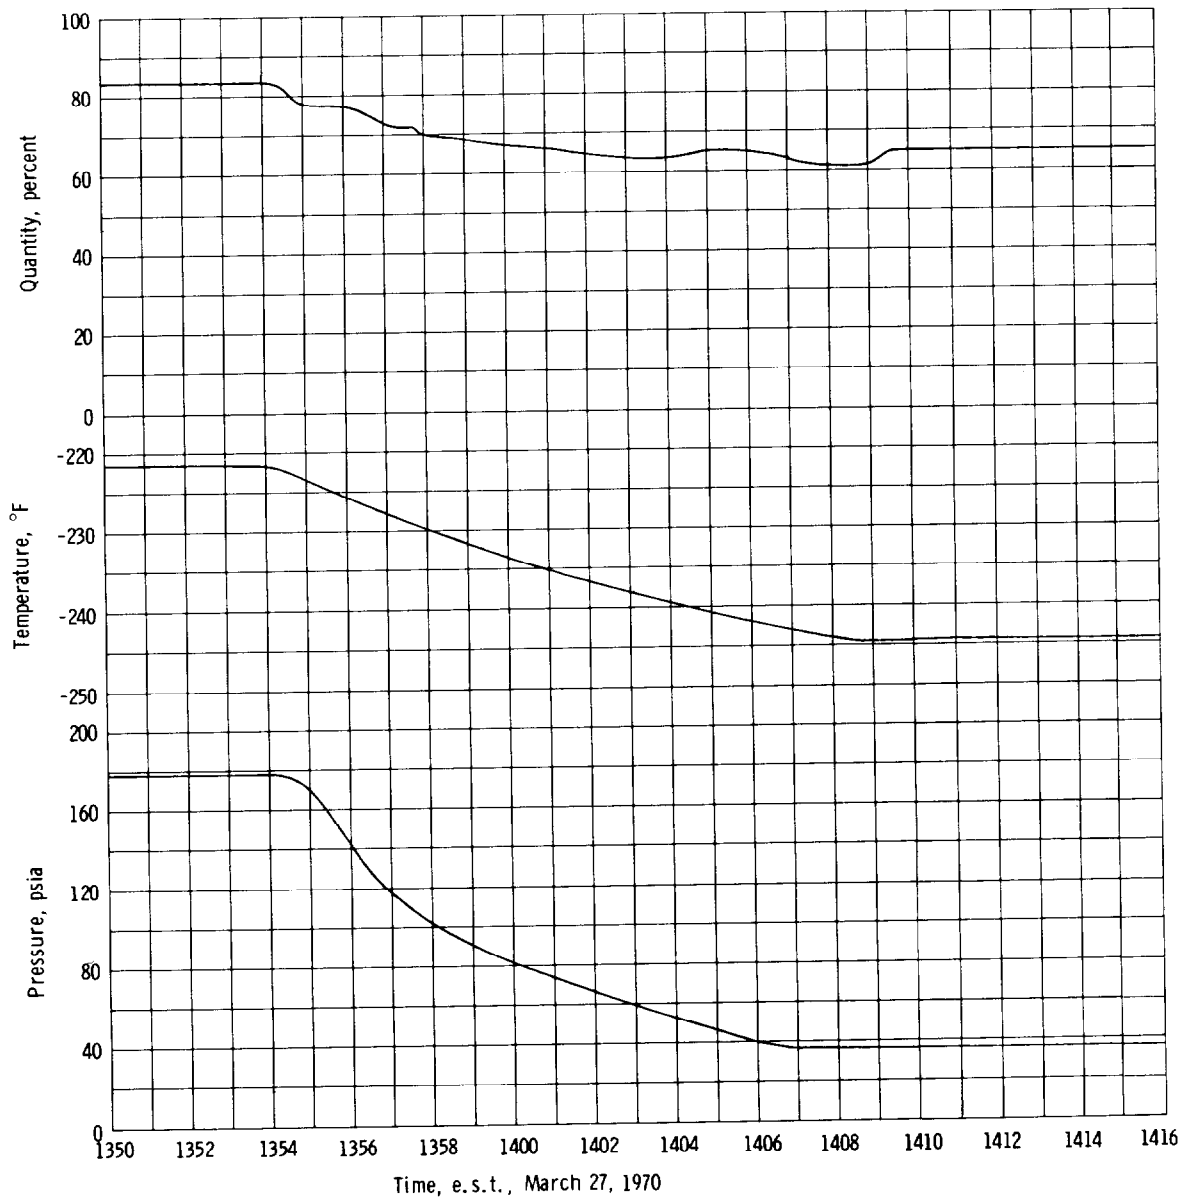
Figure C4-58.- Oxygen tank 2 detanking characteristics (pressure decay through the fill line - CDDT).

On March 27, detanking of tank no. 2 was again attempted. The tank had self-pressurized to 178 psia with a quantity of 83 percent indicated. By opening the fill line valve the pressure was depleted to approximately 36 psia in about 13 minutes. The quantity indication went down to about 65 percent (see fig. C4-58).

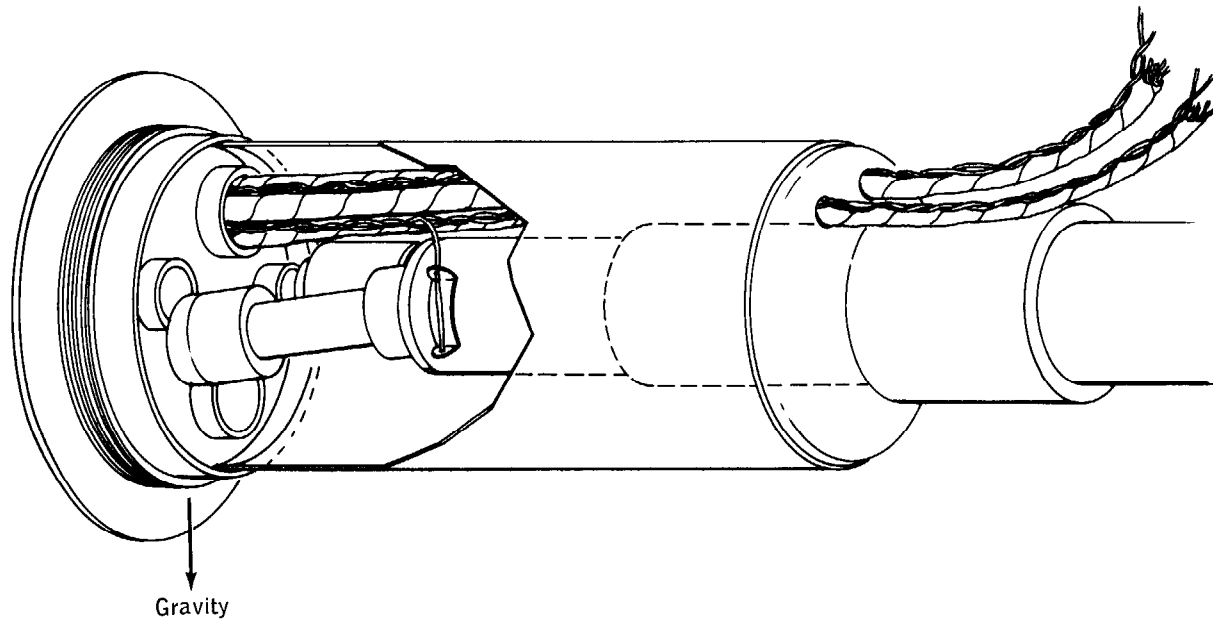
Figure C4-64.- Isometric sketch of quantity probe head as oriented during SM transportation.

It appears pertinent to this review to note that during SM transportation the fill tube segments within the upper portion of the oxygen tank no. 2 quantity probe assembly lay with the tank-exit end of the fill tube segments about 20 degrees above the horizontal, if they were still in place after previous handling and the "shelf drop." Neither the wires nor the feed line filter were below it to restrict rotation of the fill tube about the central tube of the quantity probe (fig. C4-64).

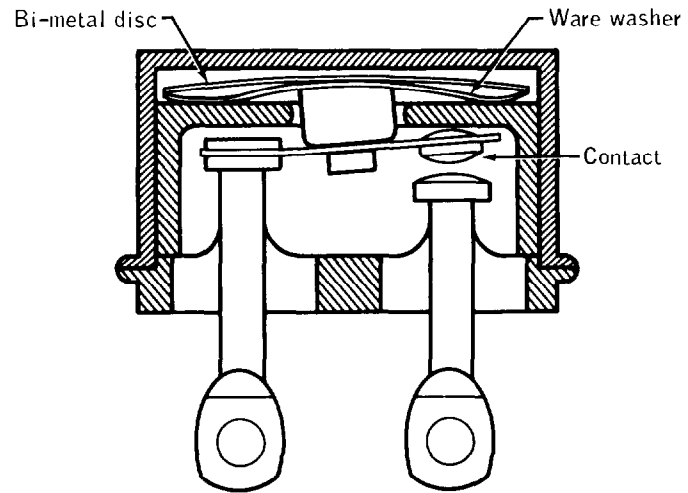
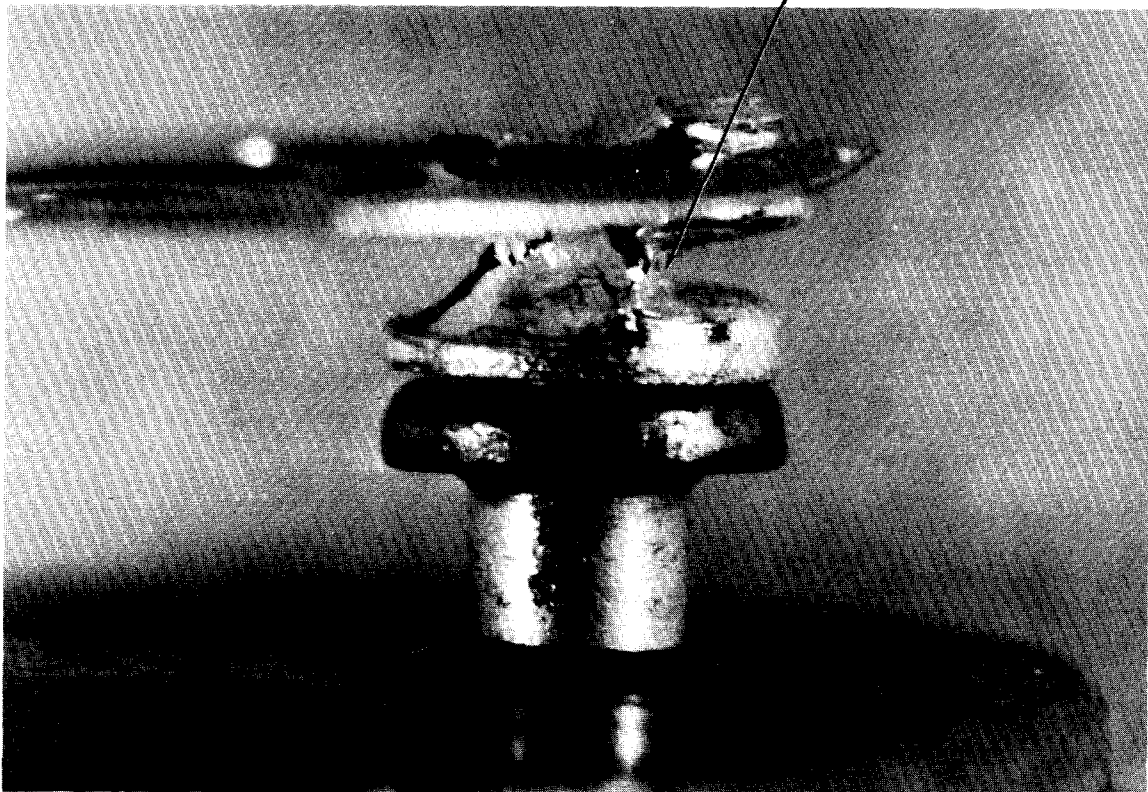
Figure C4-67.- Thermostat configuration and welded contacts.

The test was started and after a few cycles in this mode the previously nonfunctioning (open) thermostat started indicating normal function. At this time it was decided to revert to the originally intended test configuration, i.e., the thermostats directly controlling the heaters. Data from that point on indicated that the thermostats were not cycling the heaters. The heater tube temperature data looked just like the nonthermostat test run. The test terminated at this point and the thermostats were removed and X-rayed. The X-rays indicated that the contact gap was bridged. One thermostat had its case carefully removed to examine the conditions of the contacts (fig. C4-67).

A review of the thermostat design and the manufacturer's ratings indicate that the thermostats are severely overloaded in current-interrupting capability at the ground power condition. Open contact spacing at 65 V dc is such that a sustained arc can be established and the contacts melted at this first attempt to interrupt power of this magnitude.

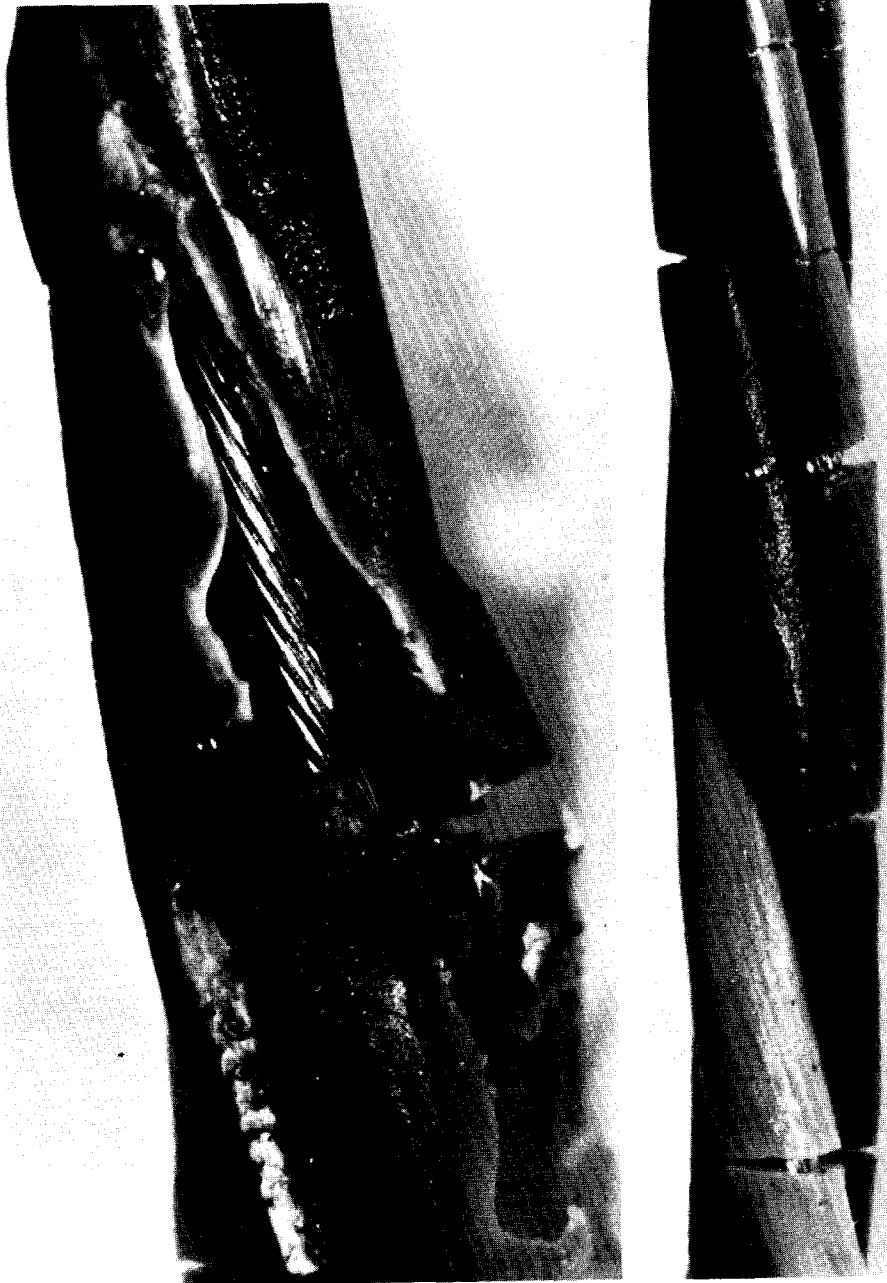
Figure C4-68.- Wire damage from heater tube assembly temperature test.

Inasmuch as thermostat failure would be expected at the first attempt to interrupt the ground power level, the conditions of heater tube temperature measured during the first test of this series would be indicative of those experienced during the KSC special detankings of March 27, 28, and 30. Since a review of the heater ground power supply voltage recordings made during the special detanking operations showed no indication of heater cycling, a special postflight test was conducted at KSC which showed that the cycled load equivalent to the heaters would cause a cycling in the voltage recording. Figure C4-68 shows sections of motor lead wire removed from the heater tube conduit.
