ABNORMAL EVENTS IN THE HISTORY OF THE OXYGEN TANK

The Design Panel conducted a review and evaluation of the design of those elements of the Apollo spacecraft systems that were implicated as contributing to the Apollo 13 accident. These comprise primarily the oxygen tanks of the service module, the associated valves, plumbing, and electrical systems. In addition, the Panel surveyed other systems within the spacecraft to determine whether their designs contained potential for failures similar to those of the oxygen tank.

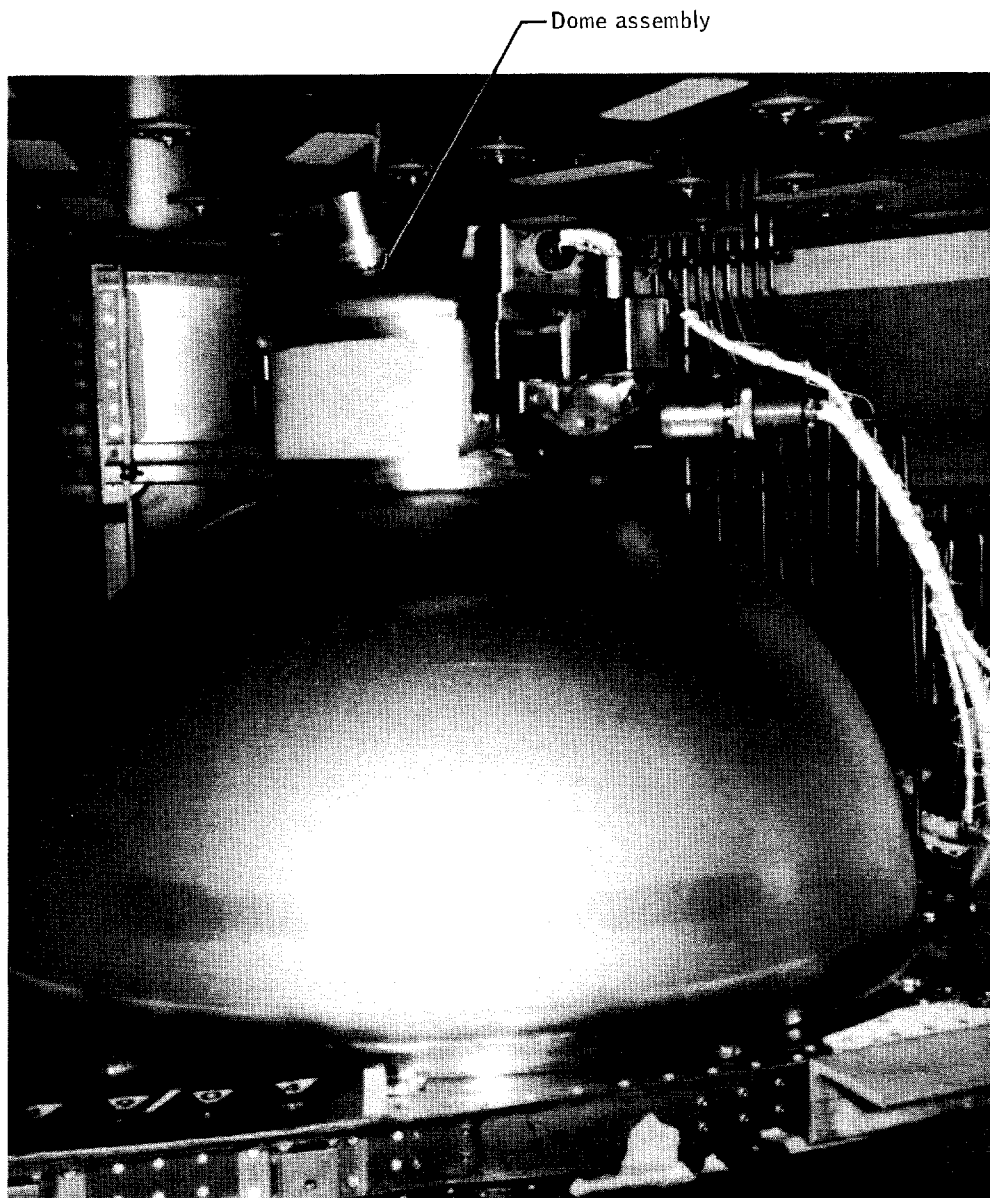
Figure D3-20.- Oxygen shelf showing location of tank dome assemblies.

the dome contains the upper pinch-off tube, through which the annulus is evacuated, and a burst disc (rated at 75 psi \pm 7.5 psi) that provides burst protection for the outer shell in the event of leakage from the inner shell into the annulus. The arrangement of the fluid lines and electrical conduit within the dome is shown in figures D3-21 and D3-22. The coiling of these lines provides the high impedance path for heat leaks between the inner and outer shells of the tank. In the case of the large diameter vent line, this path is made longer by use of a double-walled tube outside the dome, with connection between inner and outer walls at the extremity of the projection of the tube from the tank.

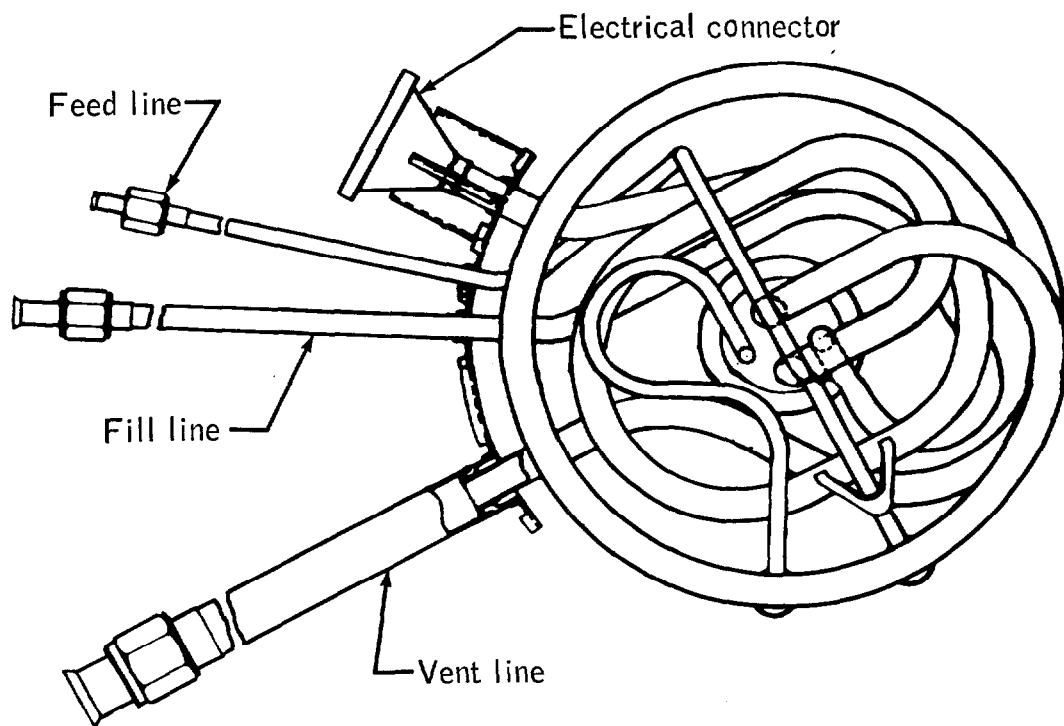
Figure D3-21.- Arrangement of tubing within tank dome assembly.

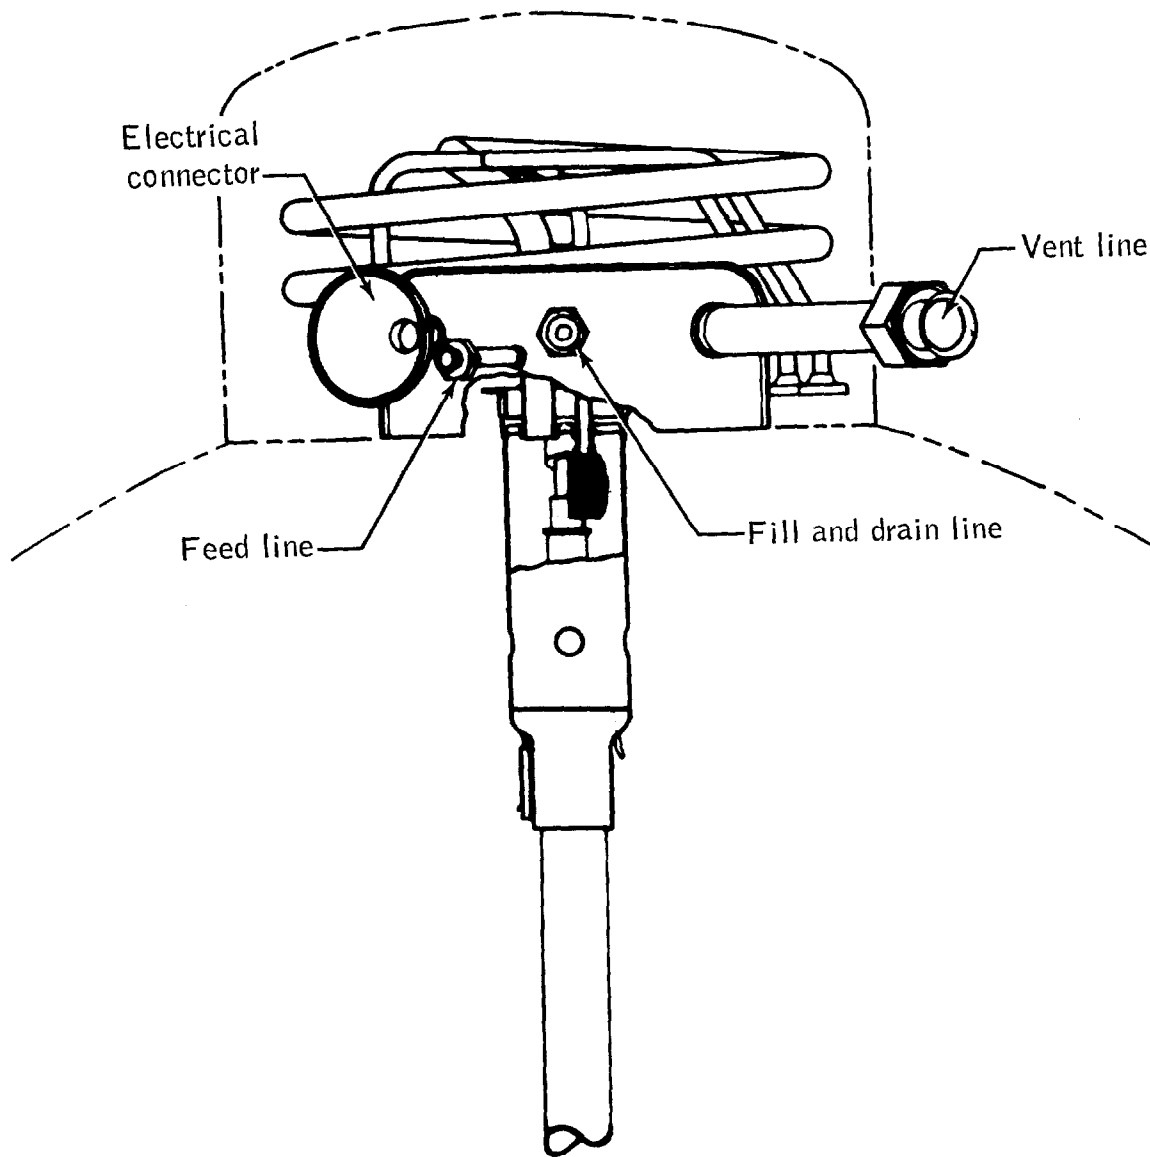
Figure D3-22.- Arrangement of tubing within tank dome assembly.

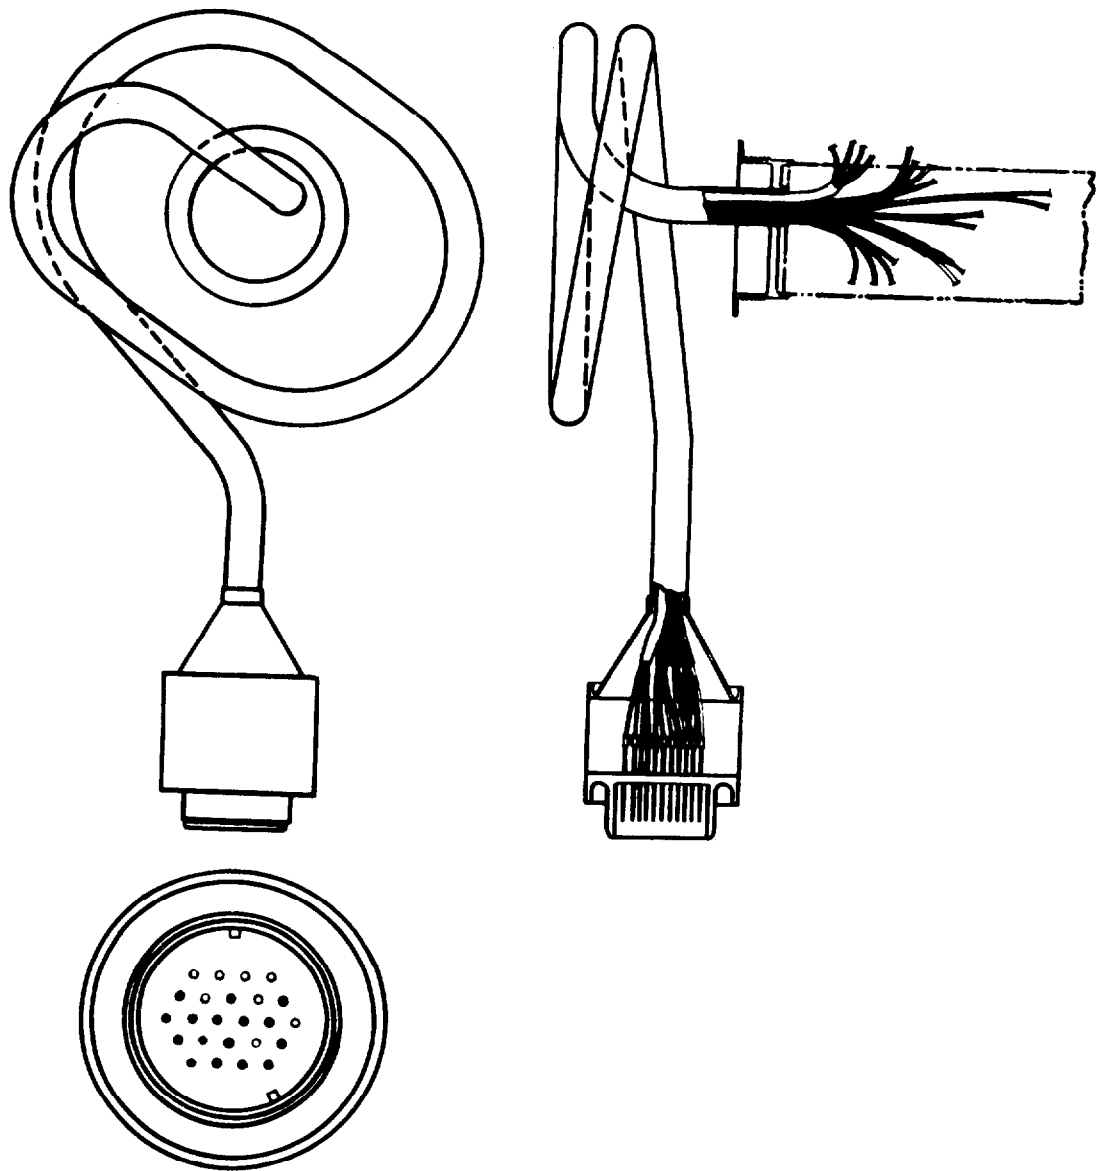
A total of 18 wires pass through the electrical conduit, eight AWG no. 26's, four AWG no. 22's, and six AWG no. 20's. The conduit is shown in figure D3-23. At the start of the investigation some members of the Panel felt that the unorthodox detanking procedure used at KSC could have resulted in unacceptably high temperatures in this electrical conduit due to resistive heating of the heater wires. This possibility is discussed in a later section.

Figure D3-23.- Arrangement of electrical conduit.

The design of this portion of the tank results in a configuration in which it is not possible to perform visual inspection of wiring after assembly. In consequence, the possibility of damage, in many cases undetectable by normal quality assurance procedures, is significant.

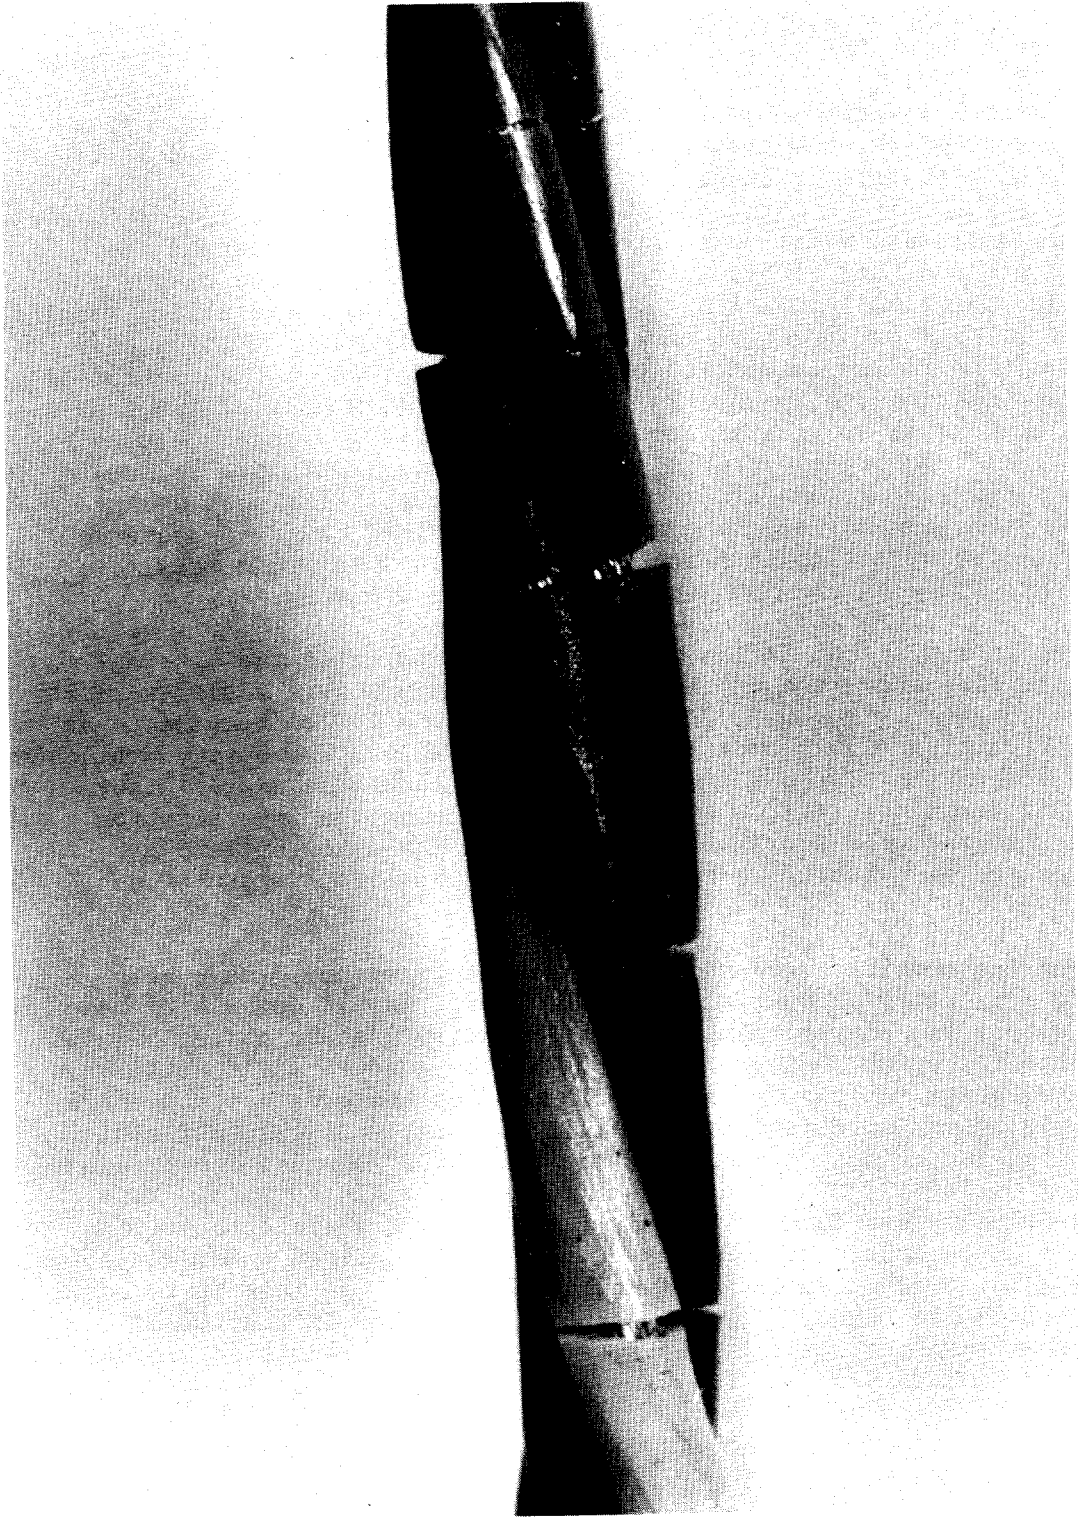
A test simulating prolonged application of power to heaters and fans with a heater probe half immersed in liquid nitrogen at one atmosphere pressure was conducted at MSC. After 8 hours, a thermocouple mounted directly on the outer casing of a heater element at a location where it was in contact only with the gaseous nitrogen in the ullage indicated a surface temperature of about 1000° F. At the same time, the temperature of the conduit wall reached 735° F.

Posttest inspection of the wiring indicated that the insulation had been seriously degraded (fig. D3-24). The insulation had become relatively brittle and had cracked in numerous places. Upon any subsequent flexing of the wire, the insulation would either break off or shift to widen the cracks, in either case exposing the conductor. Such an exposure would set the stage for a future short circuit. The state and nature of the degradation of the insulation depends on the temperature it reaches. It should be noted that this test was conducted in a nitrogen atmosphere, whereas the actual prolonged heater operation occurred in an oxygen environment. An oxygen environment is less benign chemically than one of nitrogen, and greater degradation than that observed might occur. The all-up test at Beech should provide more definitive information on this matter.

In summary, the nonstandard detanking procedure probably provided the mechanism for initiating the flight failure by causing sufficient damage to wire insulation to expose the conductor(s) of the fan motor leads. This would permit a short circuit to occur and initiate combustion within the tank. It is also possible that some solder was melted during the prolonged heating. Under the normal gravity conditions on the launch stand, it would be possible for a drop(s) of solder to fall free and solidify and remain in the tank. This could possibly lead to the subsequent shorting of the capacitor gage.

Figure D3-24.- Photograph of wire damage.
