CHAPTER 4
REVIEW AND ANALYSIS OF APOLLO 13 ACCIDENT

PART 1. INTRODUCTION

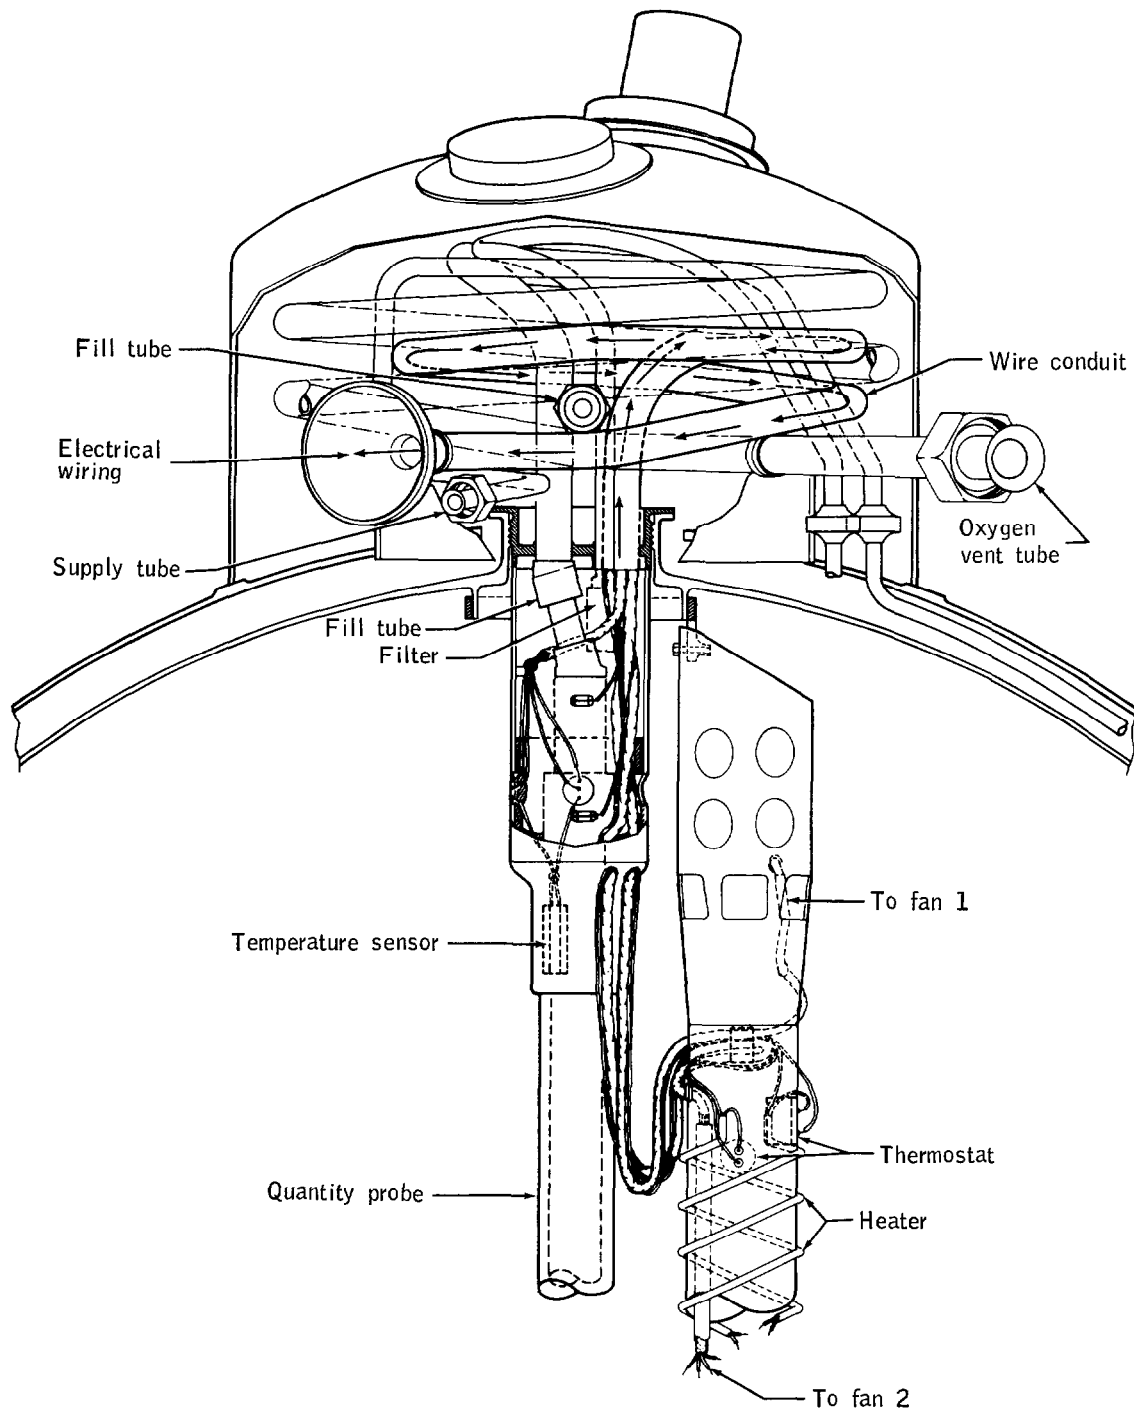
Figure 4-2.- Oxygen tank wiring and lines.

As shown in figure 4-2, the fill line from the exterior of the SM enters the oxygen tank and connects to the inner cylinder of the capacitance gage through a coupling of two Teflon adapters or sleeves and a short length of Inconel tubing. The dimensions and tolerances selected are such that if "worst case" variations in an actual system were to occur, the coupling might not reach from the fill line to the gage cylinder (fig. 4-3). Thus, the variations might be such that a very loose fit would result.

As noted earlier in this chapter, and shown in figure 4-2, each heater is protected with a thermostatic switch, mounted on the heater tube, which is intended to open the heater circuit when it senses a temperature of 80° F. In tests conducted at MSC since the accident, however, it was found that the switches failed to open when the heaters were powered from a 65 V dc supply similar to the power used at KSC during the detanking sequence. Subsequent investigations have shown that the thermostatic switches used, while rated as satisfactory for the 28 V dc spacecraft power supply, could not open properly at 65 V dc. Qualification and test procedures for the heater assemblies and switches do not at any time test the capability of the switches to open while under full current conditions. A review of the voltage recordings made during the detanking at KSC indicates that, in fact, the switches did not open when the temperature indication from within the tank rose past 80° F. Further tests have shown that the temperatures on the heater tube may have reached as much as 1000° F during the detanking. This temperature will cause serious damage to adjacent Teflon insulation, and such damage almost certainly occurred.

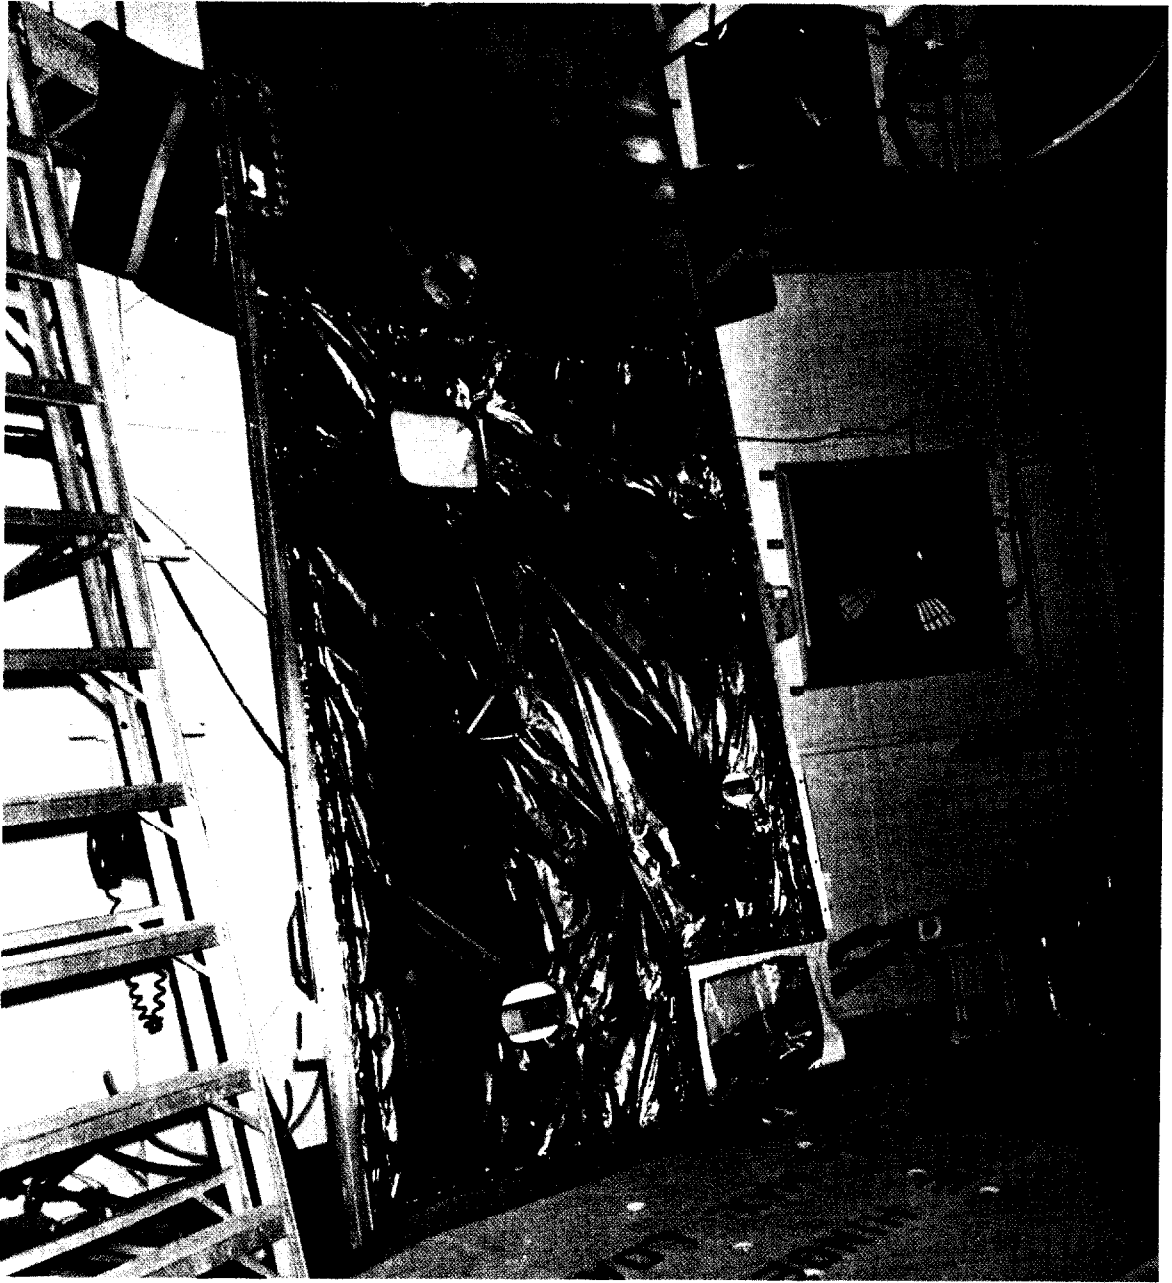
4-8.-
Figure ~~4-8~~ Inside view of panel covering bay 4.

of the Apollo 13 service module (SM 109) at the North American Rockwell plant prior to shipment to KSC. Figure 4-5 shows the fuel cell shelf, with fuel cell 1 on the right, fuel cell 3 on the left, and fuel cell 2 behind cells 1 and 3. The top of oxygen tank no. 2 can be seen at the lower left. Figure 4-6 shows the oxygen tank shelf, with oxygen tank no. 2 at left center. Figure 4-7 shows the hydrogen tank shelf with hydrogen tank no. 1 on top and hydrogen tank no. 2 below. The bottom of the oxygen shelf shows some of the oxygen system instrumentation and wiring, largely covered by insulation. Figure 4-8 is a photograph of the bay 4 panel, which was missing from the service module after the accident.

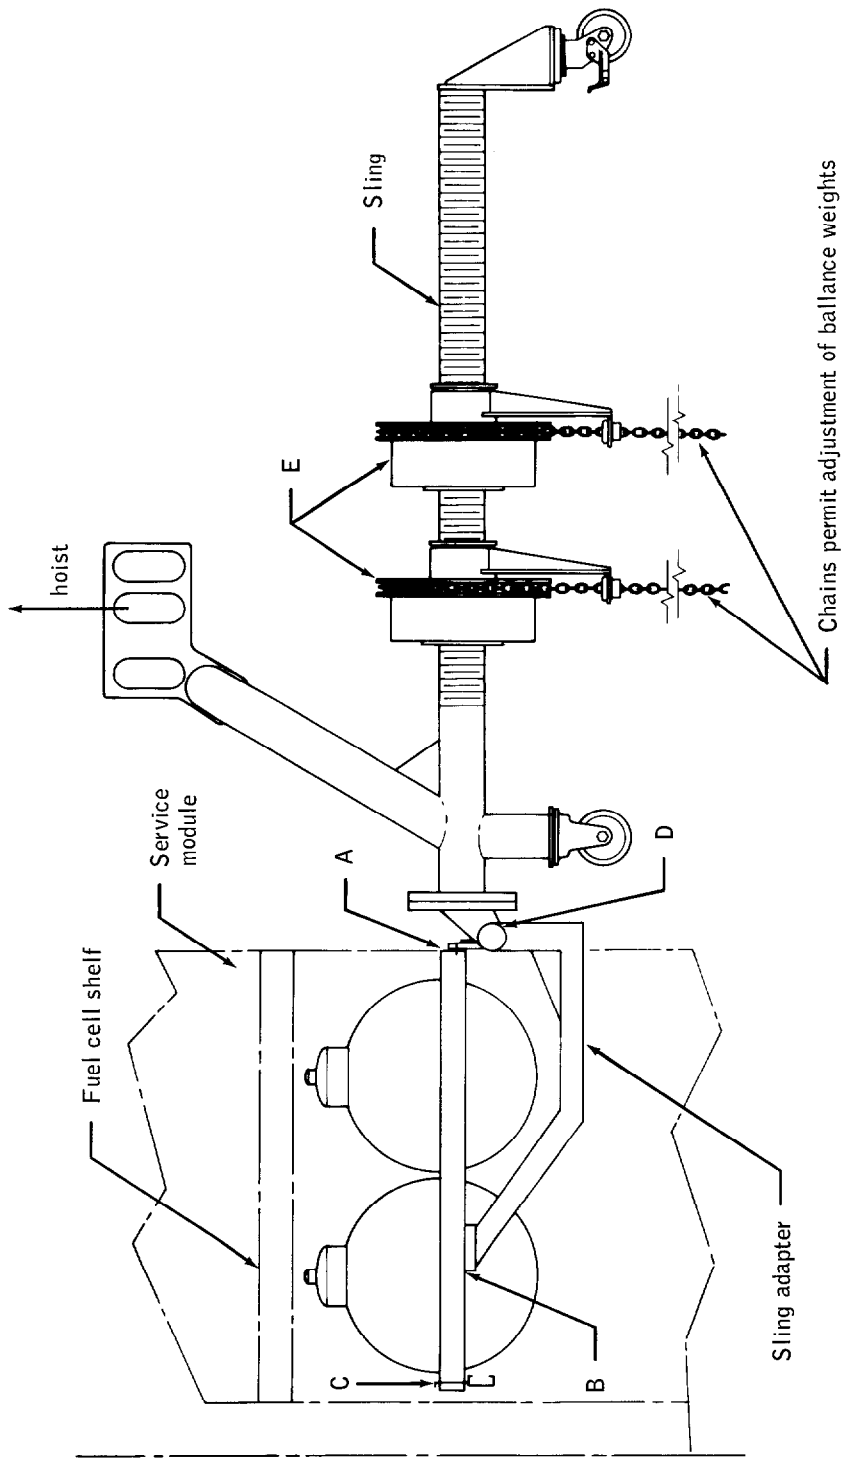
Figure 4-9.- Hoist and sling arrangement - oxygen shelf.

The oxygen shelf was removed in the manner shown in figure 4-9. After various lines and wires were disconnected and bolts which hold the shelf in the SM were removed, a fixture suspended from a crane was placed under the shelf and used to lift the shelf and extract it from bay 4. One shelf bolt was mistakenly left in place during the initial attempt to remove the shelf; and as a consequence, after the front of the shelf was raised about 2 inches, the fixture broke, allowing the shelf to drop back into place. Photographs of the underside of the fuel cell shelf in SM 106 indicate that the closeout cap on the dome of oxygen tank no. 2 may have struck the underside of that shelf during this incident. At the time, however, it was believed that the oxygen shelf had simply dropped back into place and an analysis was performed to calculate the forces resulting from a drop of 2 inches. It now seems likely that the shelf was first accelerated upward and then dropped.

The remaining bolt was then removed, the incident recorded, and the oxygen shelf was removed without further difficulty. Following removal, the oxygen shelf was retested to check shelf integrity, including proof-pressure tests, leak tests, and functional tests of pressure transducers and switches, thermal switches, and vac-ion pumps. No cryogenic testing was conducted. Visual inspection revealed no problem. These tests would have disclosed external leakage or serious internal malfunctions of most types, but would not disclose fill line leakage within oxygen tank no. 2. Further calculations and tests conducted during this investigation, however, have indicated that the forces experienced by the shelf were probably close to those originally

calculated assuming a 2-inch drop only. The probability of tank damage from this incident, therefore, is now considered to be rather low, although it is possible that a loosely fitting fill tube could have been displaced by the event.

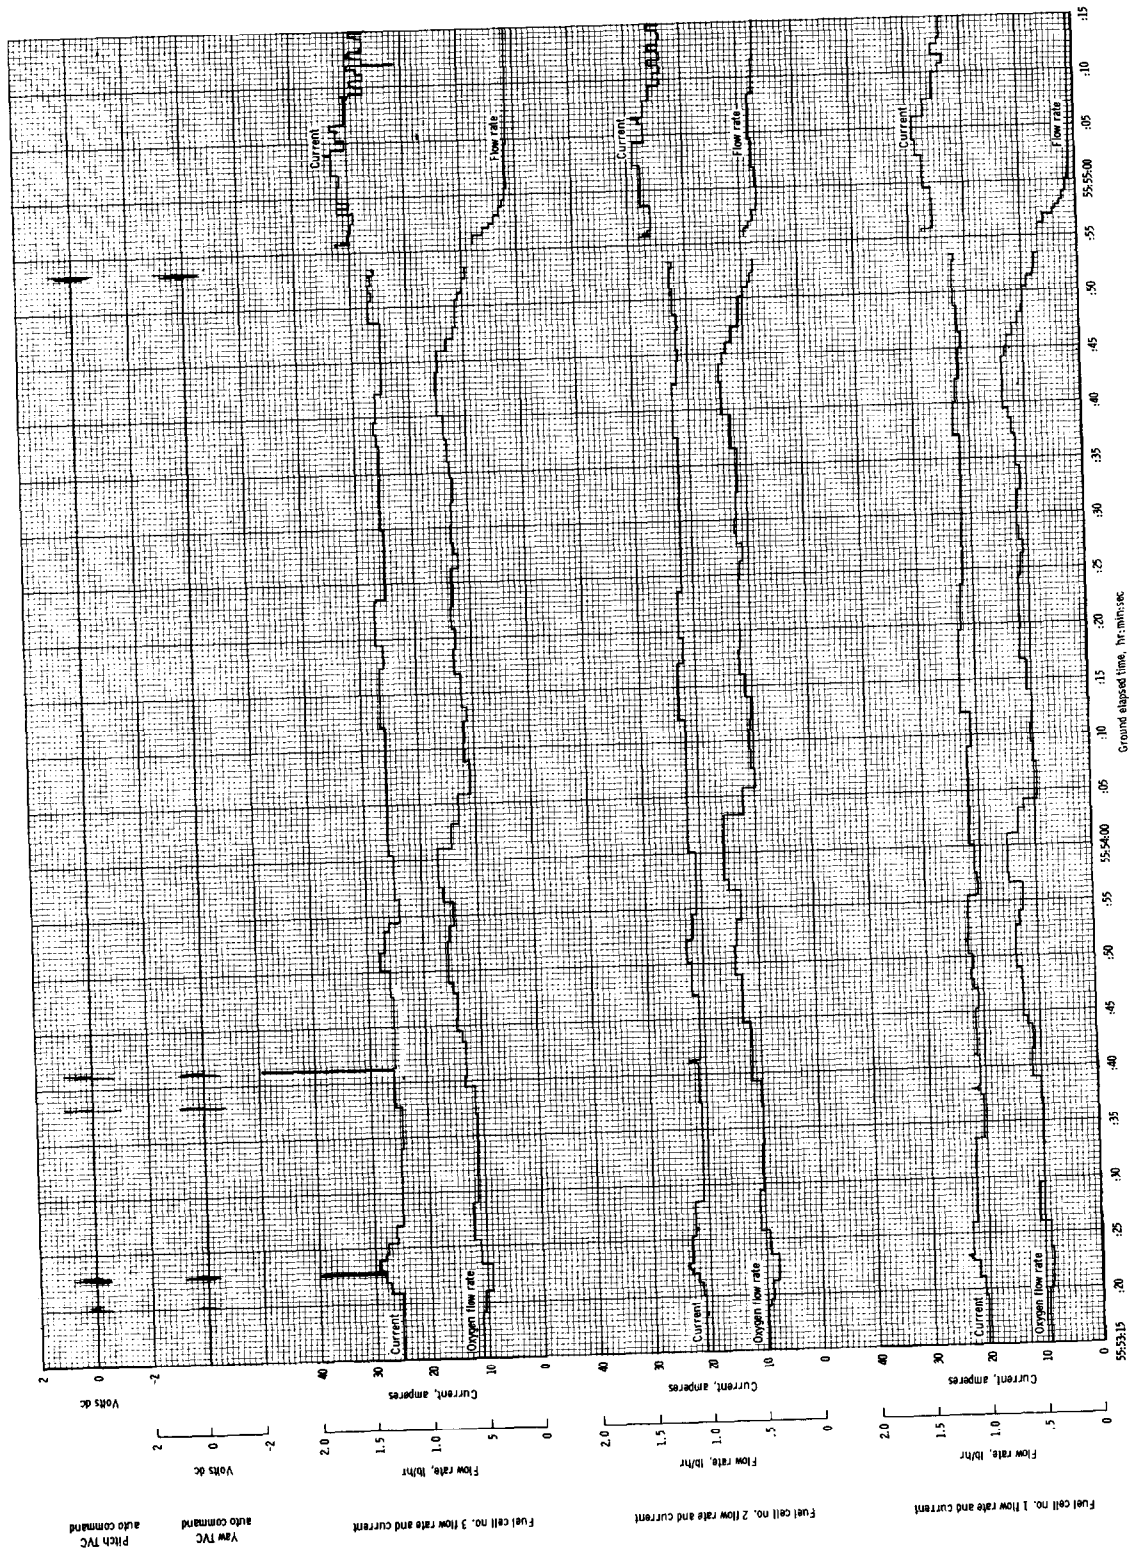
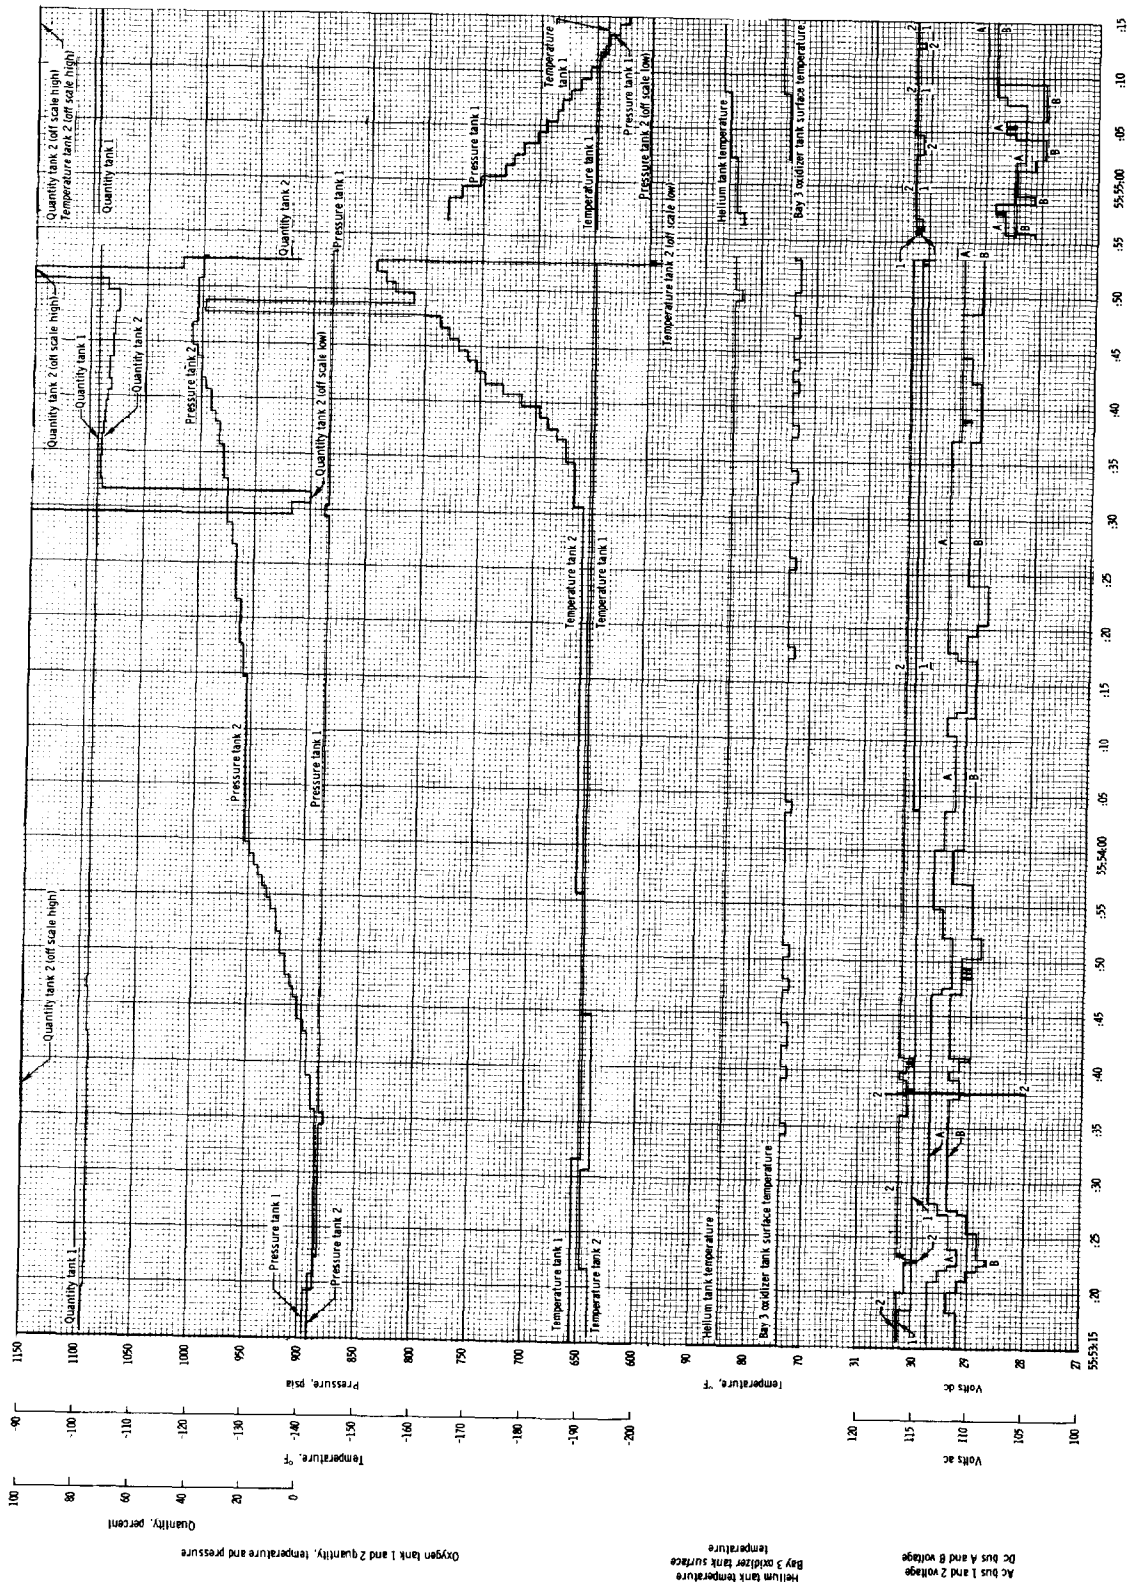
Figure 4-10.- Telemetry record.

The various telemetered parameters of primary interest are shown in figure 4-10 and listed in table 4-11.
