**UNITED STATES
NUCLEAR REGULATORY COMMISSION
REGION IV
611 RYAN PLAZA DRIVE, SUITE 400
ARLINGTON, TEXAS 76011-4005**

July 27, 2004

**SUBJECT: ARKANSAS NUCLEAR ONE - NRC INTEGRATED INSPECTION REPORT
05000313/2004003 and 05000368/2004003**

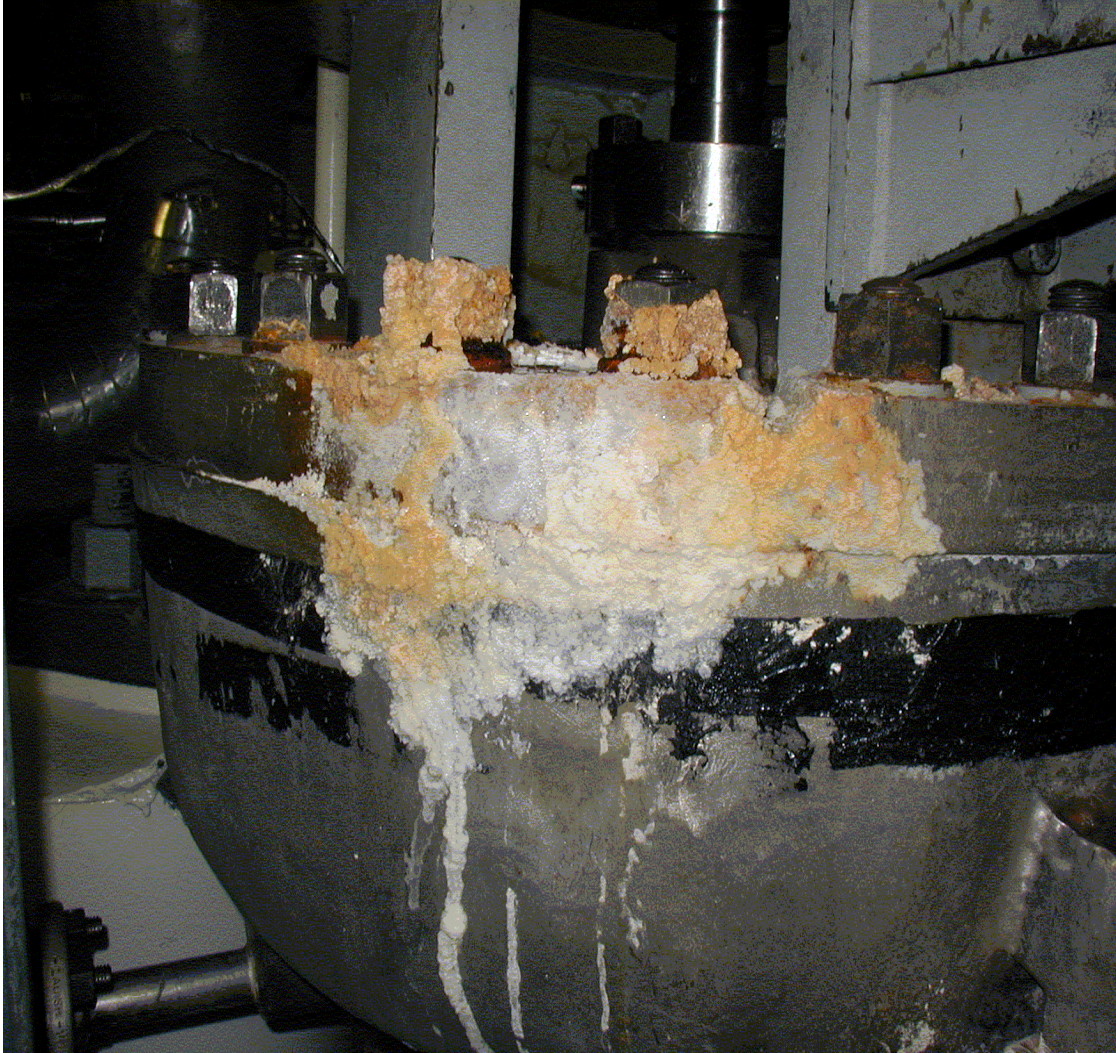
Unit 2 Containment Spray Pump B
Boric Acid Deposits

Description. On February 15, 2004, operations personnel noted discolored boric acid deposits on three of the Unit 2 Containment Spray Pump B studs and initiated CR ANO-2-2004-0292. This CR documented the fact that boric acid deposits had been a recurring issue on this pump as documented in CR ANO-2-2003-0674 initiated May 9, 2003. The inspectors independently discovered the same condition on February 24, 2004. The inspectors questioned licensee personnel to determine why the boric acid deposits had not been cleaned and evaluated. Licensee personnel informed the inspectors that they could not find any records associated with the removal of boric acid from the pump and that they would address removal of the deposits on the pump.

In a follow-up tour of the pump area on March 24, 2004, the inspectors noted that the boric acid deposits were still present on the pump. The inspectors noted that the deposits had existed for approximately nine months with indications of material wastage (discolored boric acid) and no apparent action by the licensee to remove the boric acid. Licensee personnel informed the inspectors that removal of the deposits would occur during an inspection of the pump in July 2004. The inspectors considered this action to be untimely due to the indications of active material wastage. Additionally, the

inspectors determined that Procedure 1032.037A, "Identification and Evaluation of Boric Acid Leakage," did not provide guidance for correcting conditions where boric acid was corroding material. The licensee, subsequently, cleaned the deposits on March 26, 2004. A picture of the pump before cleaning is included in the attachment.
