SUBJECT: DIABLO CANYON INSPECTION REPORT NO. 50-275/01-03; 50-323/01-03

Facility: Diablo Canyon Nuclear Power Plant, Unit 1 and 2

Dates: April 1 through May 19, 2001

Attachment 2 Auxiliary 1-2 Overheated Joint 309

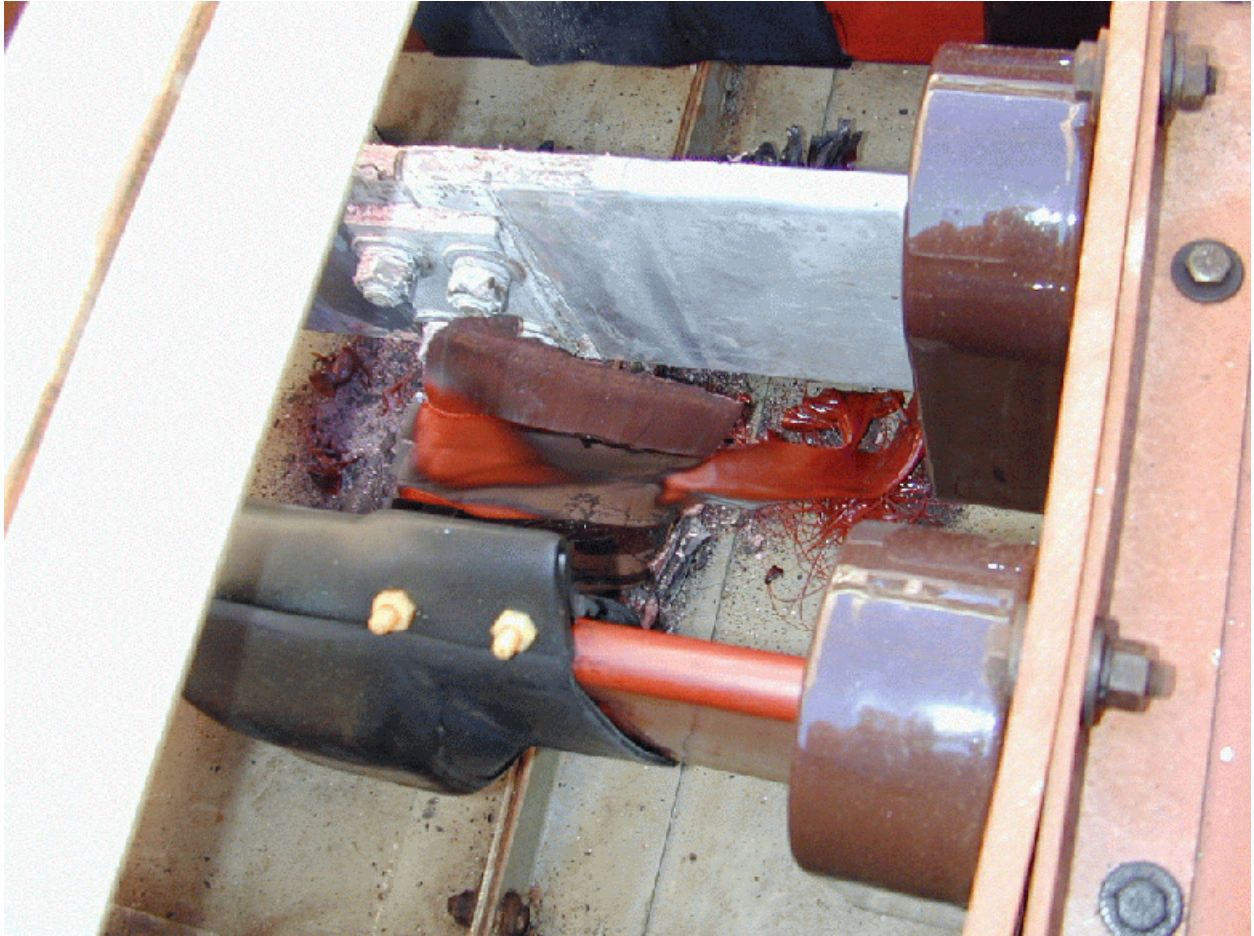
The licensee determined that an overheated splice joint was located on the center phase of the 12 kV bus bar from Auxiliary Transformer 2-1 to Buses D and E. The splice joint was located outside of the turbine building approximately 10 feet from the transformer. The inspectors verified that there were no other bus ducts in close proximity to the bus duct at the degraded splice joint. The inspectors noted that the adjacent joints on either side of the degraded joint had evidence of overheating, as well as the Raychem insulation on the center phase. As seen in Attachment 2, a second Splice Joint (307A) had also degraded because of overheating.

The inspectors noted that the licensee expressed surprise at the amount of overheating and degradation identified at Joint 309. The licensee concluded that the joint would not have lasted another operating cycle without failing. The licensee estimated that the joint could have failed within 4-6 months since the failure mechanism (increased resistance resulted in increased heating that increased the degradation/resistance, et cetera) was increasing exponentially. The inspectors concluded that the licensee had missed a failure by a small margin. The inspectors noted that had a failure occurred that the power supply to the reactor coolant pumps and circulating water pumps would have tripped. An anticipatory reactor trip would have occurred. The event would have resulted in a loss of load reactor trip with loss of normal heat removal. This type of failure is tracked by the performance indicators.

View 1 of BUS 309 Showing degraded Insulation on Bus Bar.

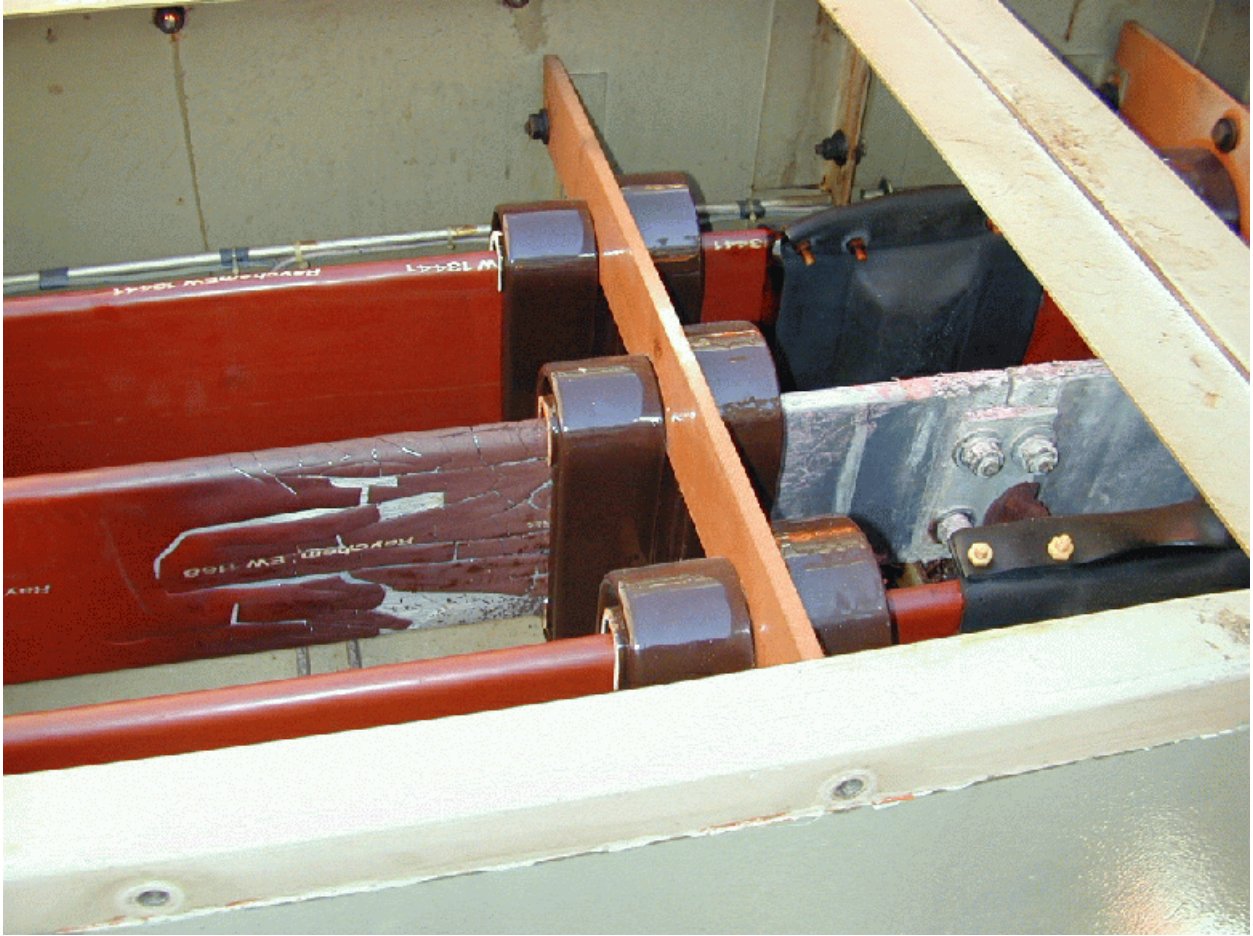
View 2 of BUS 309 Showing degraded Insulation on Bus Bar

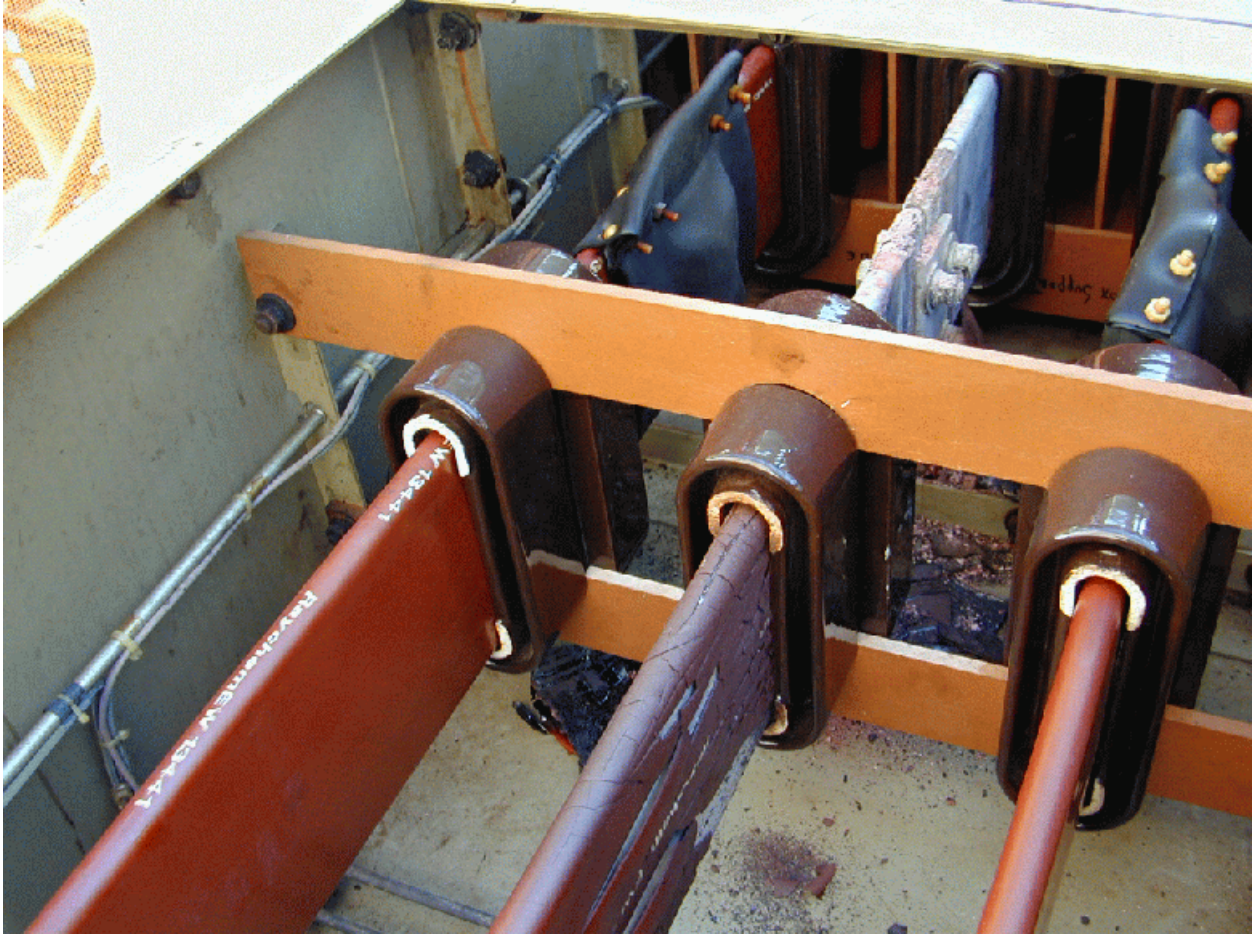
View 1 of BUS 309 Showing degraded Insulation on Bus Bar
