CNWRA 2003-04
Revision 1

ANALYSIS OF RAIL CAR COMPONENTS EXPOSED TO A TUNNEL FIRE ENVIRONMENT

**U.S. Nuclear Regulatory Commission
Contract NRC-02-02-012**

**Center for Nuclear Waste Regulatory Analyses
San Antonio, Texas**

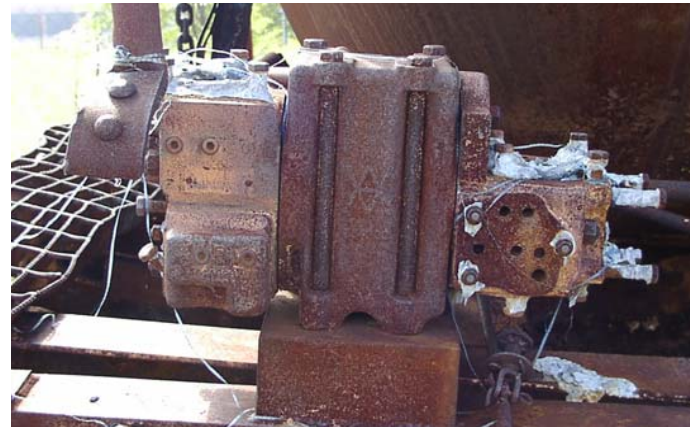
Remainder of ABDX-L Air Brake Valve from Car 52—This air brake valve exhibited evidence of prolonged fire exposure. The valve includes several die-cast aluminum covers, which had completely melted as a result of the fire. The valve was found approximately 10 m [33 ft] uphill from the spill site, and approximately 1 m [3.3 ft] from the tunnel floor. A similar valve assembly was found at the midpoint of Car 51, approximately 20 m [66 ft] uphill from the fire source. Although the exact model type was not determined, the valve cover was clearly from the same family of products and was composed of the same aluminum alloy. A third air brake valve was found approximately 30 m [100 ft] from the spill site, and analyzed.

Figure 3-1. The ABDX-L Control Valve (Clockwise from Top: Valve Body Schematic, Photograph of Damaged Valve on Car 52, Corresponding Outline of the Valve Body)
