*Aerospace  
Safety  
Advisory  
Panel*

*Annual Report*  
—FOR—

*1 9 8 6*

COVERING CALENDAR YEAR 1986

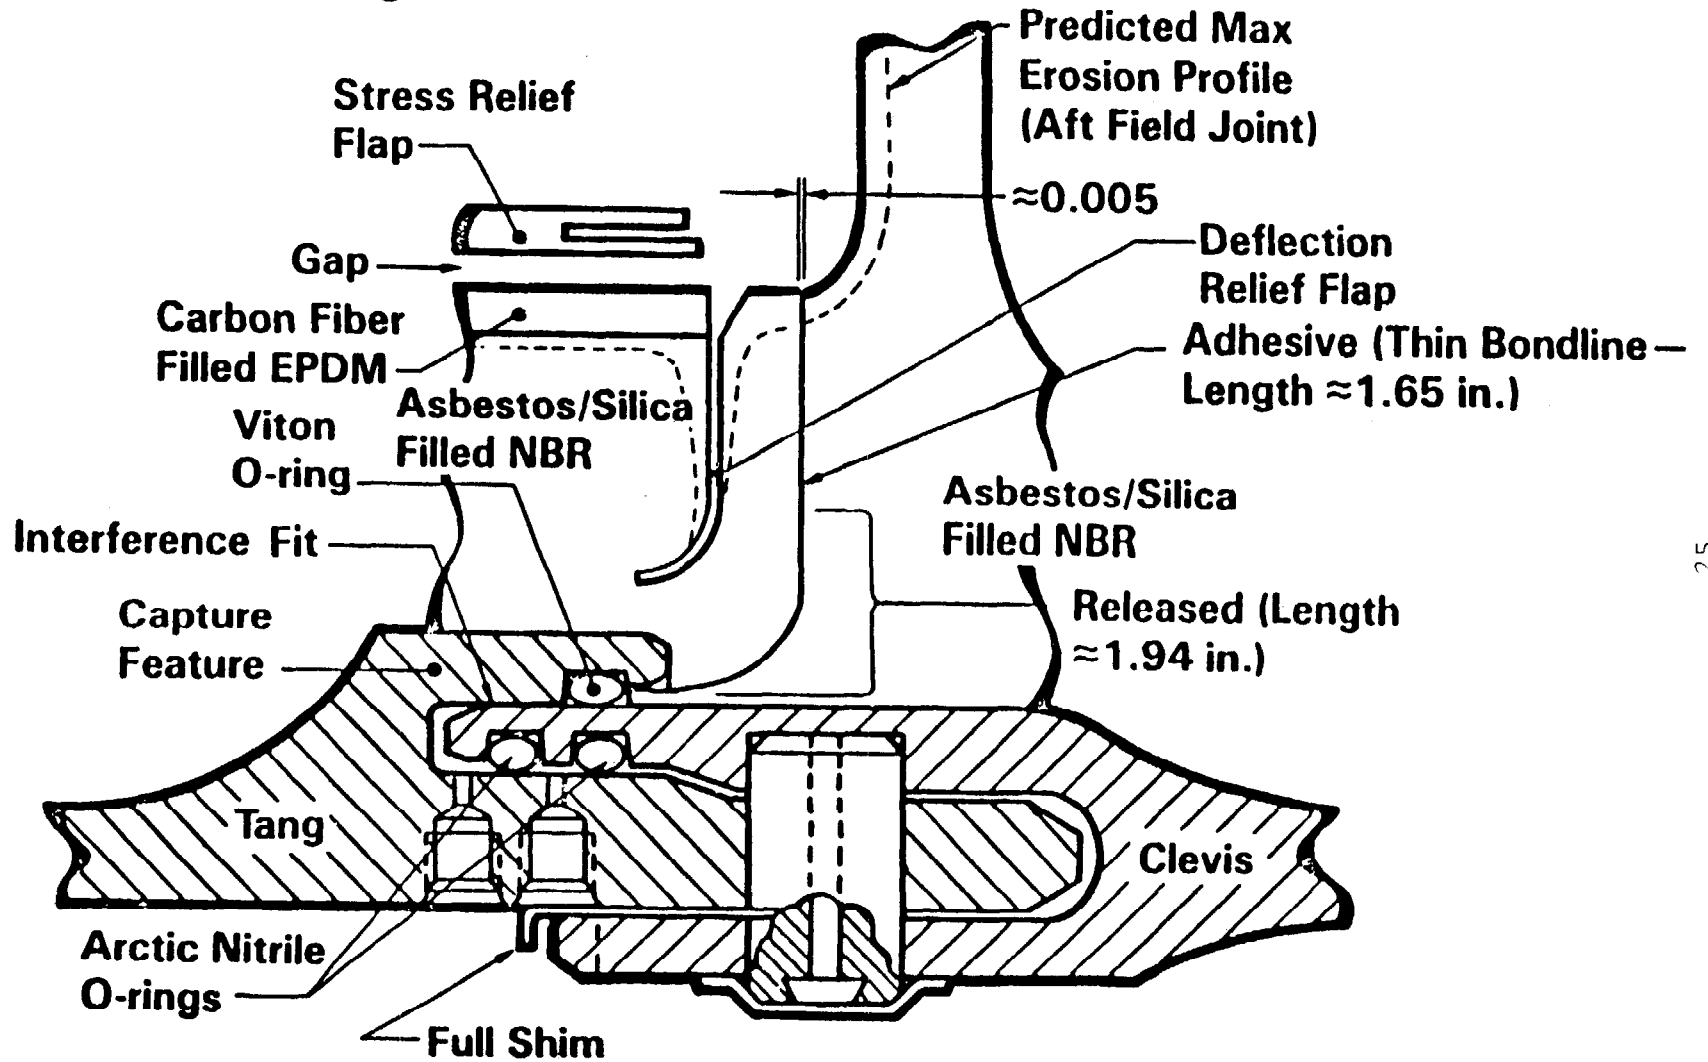
## Field Joint Baseline Design

Case to Case Joint: The baseline field joint redesign chosen includes an interference-fit capture feature to minimize gap opening that results from joint rotation; three "O"-ring seals with two intervening test ports; improved unvented (bonded) insulation joint configuration to prevent hot gases from reaching the seals; larger seal gland widths to allow axial movement; and a joint heater to control temperature at the seals. Seal materials with improved resiliency and grease compatibility may eliminate the need for joint heaters.

In the baseline design, the unvented insulation at the segment juncture is bonded together. This sealed insulation may be subject to local vent holes which can make it difficult to test under the "worst-case-leak" condition. In addition, it would be difficult to disassemble the segments without damage to the insulation at the joints. The alternate "vented" labyrinth design for this interface between segment insulation has been eliminated due to problems surfaced during thermal calculations. Additional unvented designs with various bonded insulation joints are being pursued.

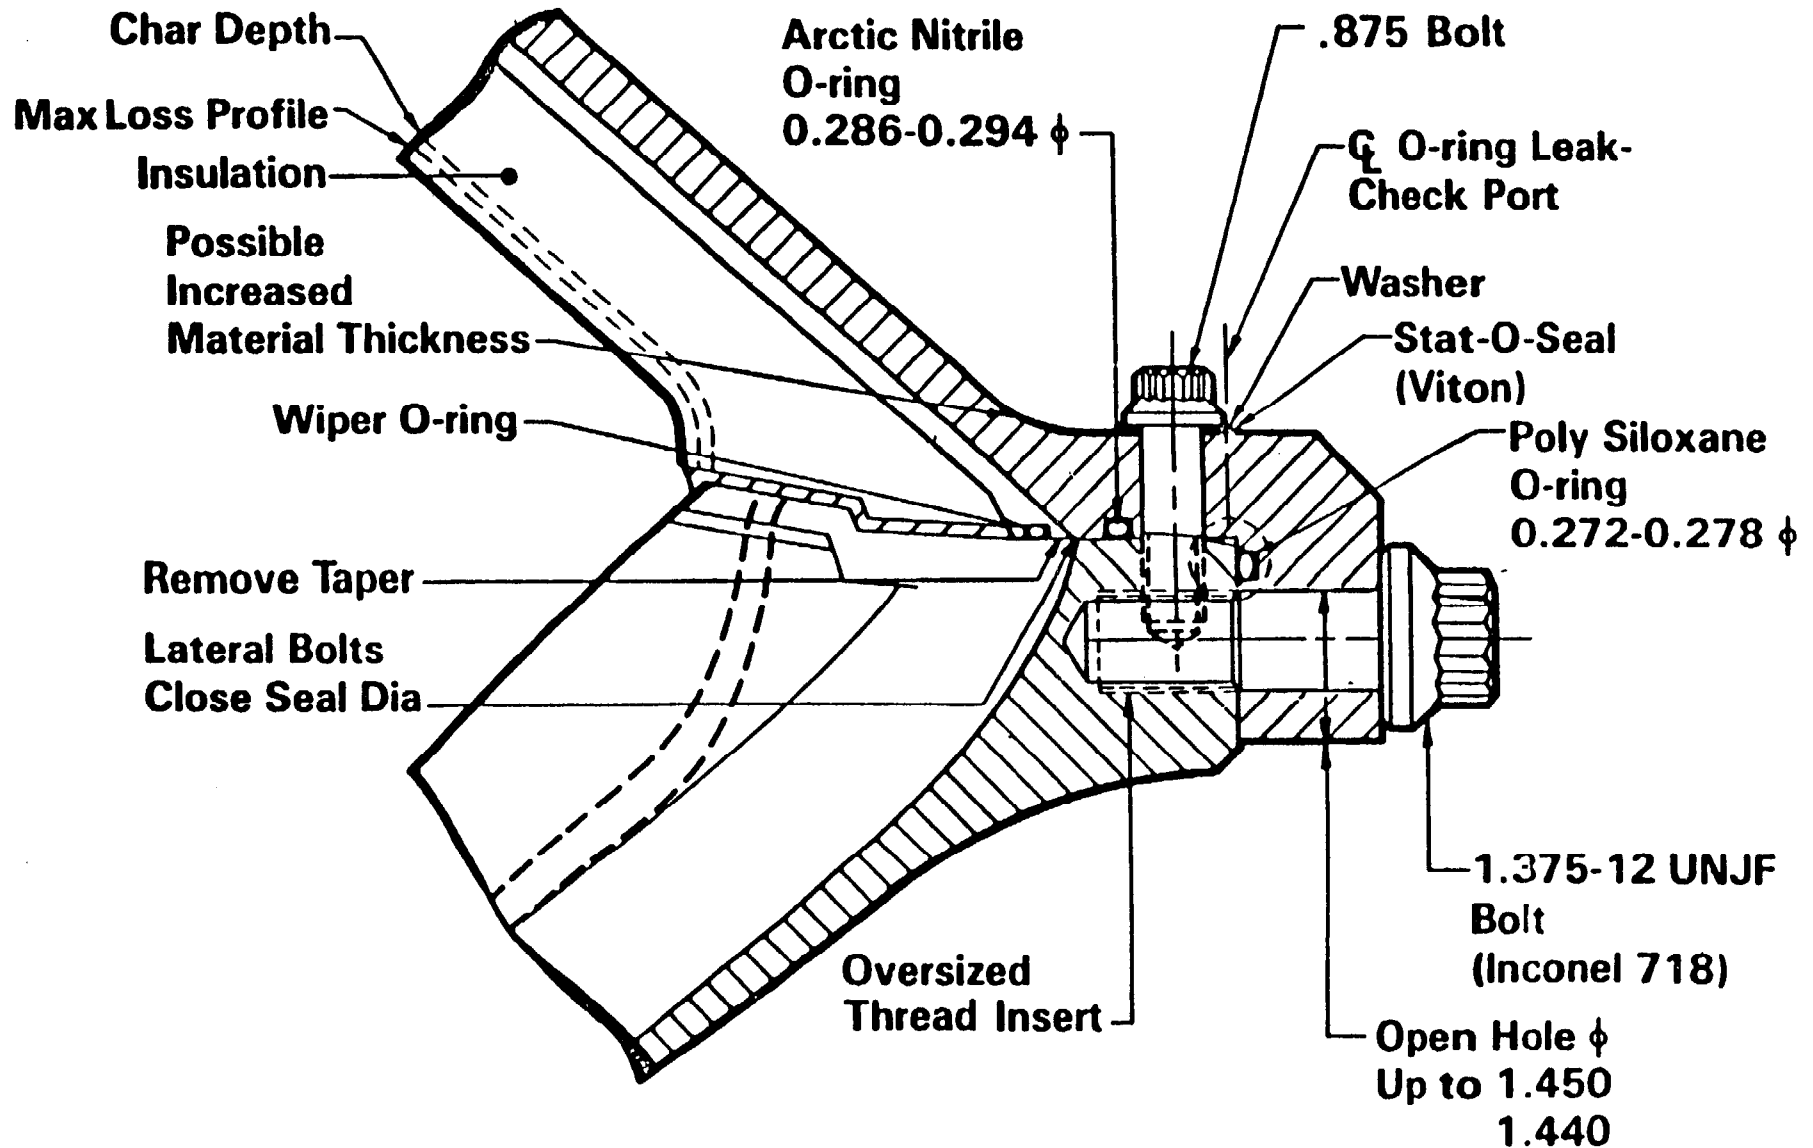
## Case-to-Nozzle Baseline Joint Configuration

The addition of the bolts adds multiple potential leak paths and residual stresses in the fixed housing that can reduce the reliability of the joint. The wiper seal bears on insulation rather than on metal. This could limit the pressure that can be employed during leak testing of the assembly.

There are a number of unresolved design questions at this time. Among them are the possibility of hot gas jet impingement or circumferential flow of such gas that could result from an insulation debond, and the ability to disassemble the nozzle from the case without damage to the insulation. Two alternate designs are being considered. One incorporates a metal thermaloc U-seal which maintains contact with the nozzle fixed housing and case aft dome during pressurization. The other concept is to insulate over the case-to-nozzle joint making it a factory joint. This design requires a new "field type" joint in the aft segment case and a redesign of the aft propellant grain. Other contractors have proposed a design wherein joint rotation acts to close the joint against the seal but, unfortunately, this approach probably requires a new forging with attendant schedule impact.

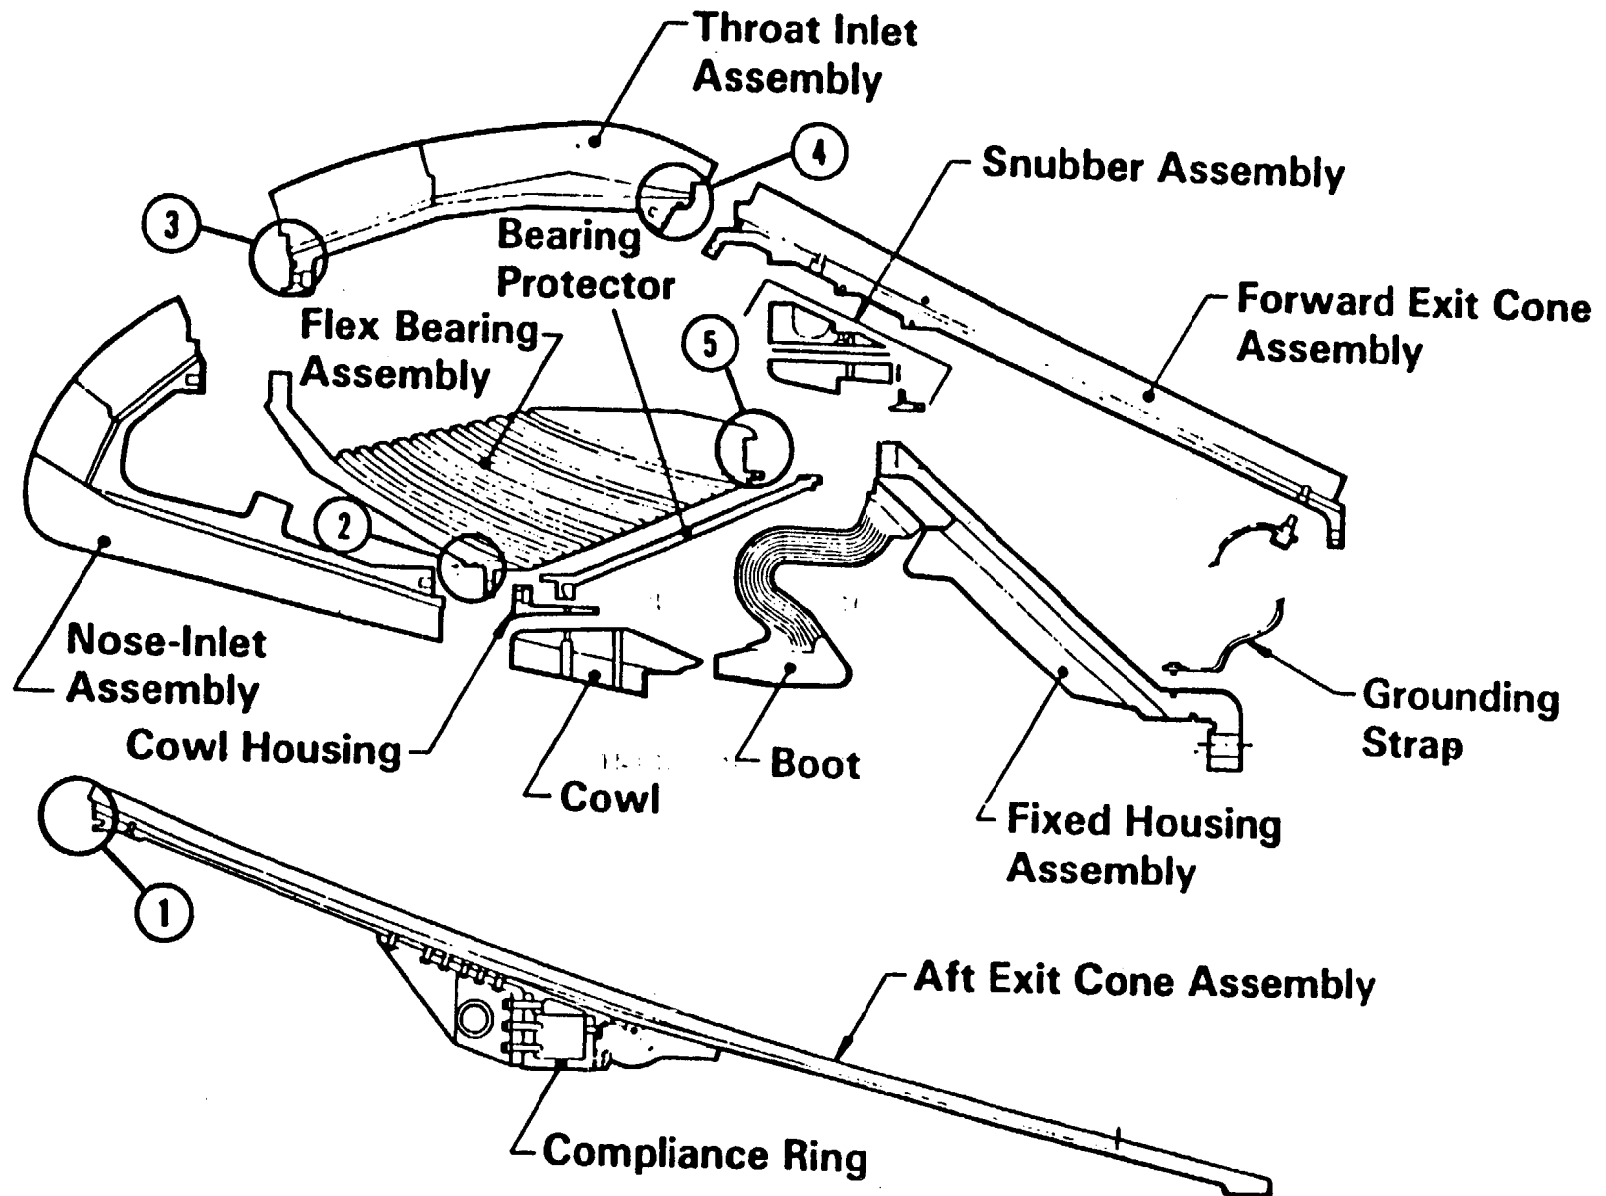
# SRM NOZZLE RECOVERY REDESIGN

seal test port. All of these joints act to close the joint under operating load conditions except for the "number 5" joint which acts to close the inboard seal and open the outboard seal in operation.
