# **Investigation of Beryllium Exposure Cases Discovered at the North Las Vegas Facility of the National Nuclear Security Administration**

**August 2003**

**National Nuclear Security Administration  
United States Department of Energy  
Washington, DC 20585**

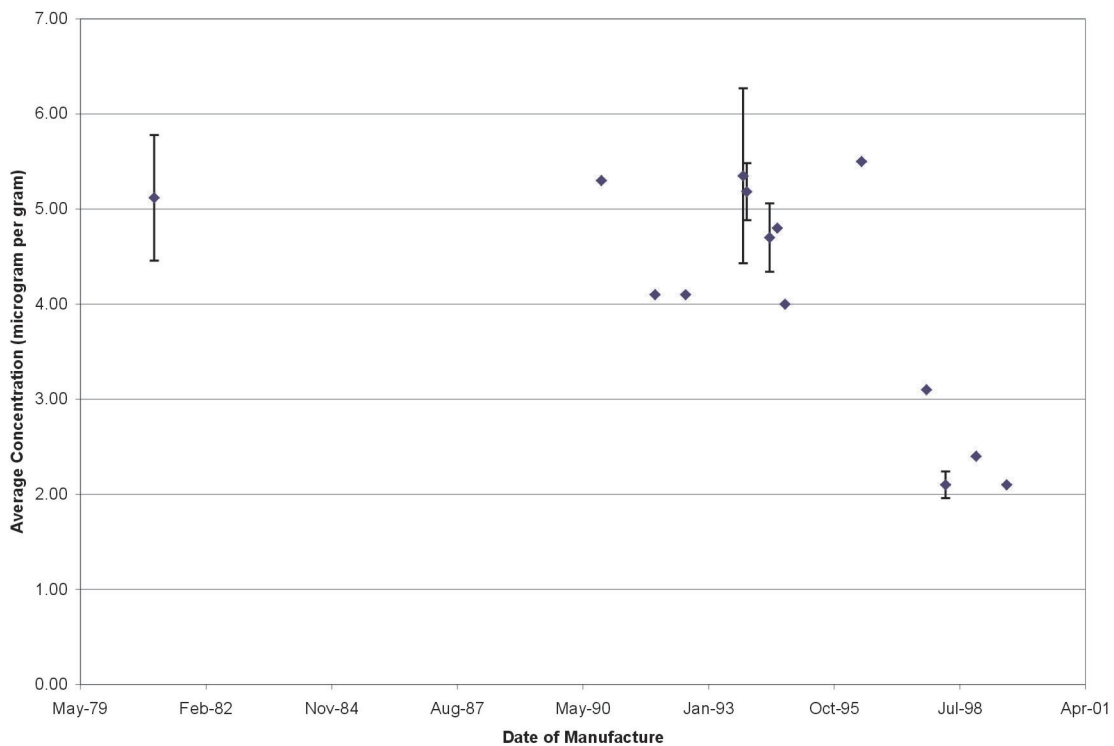
The acoustic ceiling tiles in all of the buildings were sampled by collecting the dust that had accumulated on the upper surfaces. Initial results from the B1 building indicated that the concentration of beryllium in the bulk samples ranged from 1 to over 6  $\mu\text{g/g}$ , about five to ten times higher than the background in the local soil, which was considered to be the main contributor to the dust loading. However, the observed contamination patterns did not correlate with the location of the former machine shop, nor did they correlate with any other suspected release point for the contamination. The only correlation that was observed was an apparent relationship to the age of the tile itself. As the results from the other buildings accumulated, similar results were found in all locations.

Figure 2.2.1-1: Concentration of beryllium in ceiling tiles according to tile age.

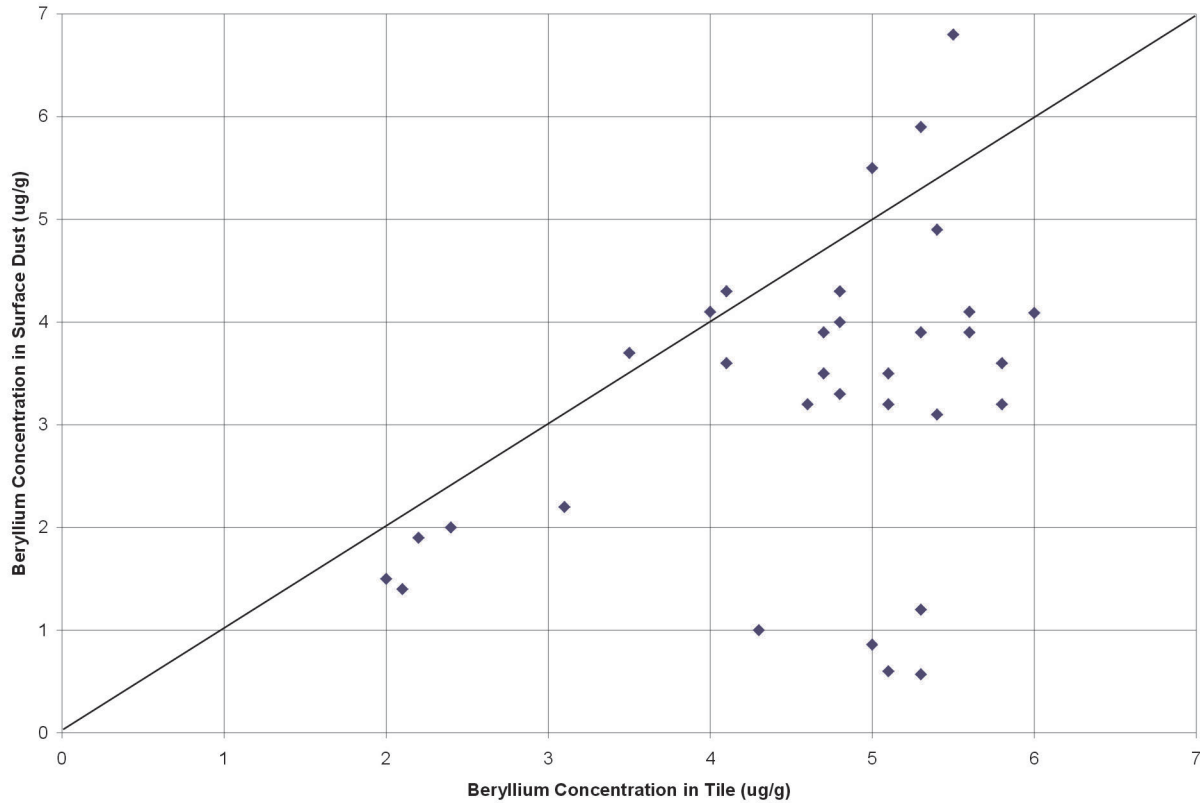
Figure 2.2.1-2: Beryllium on top of ceiling tile versus beryllium inside tile.

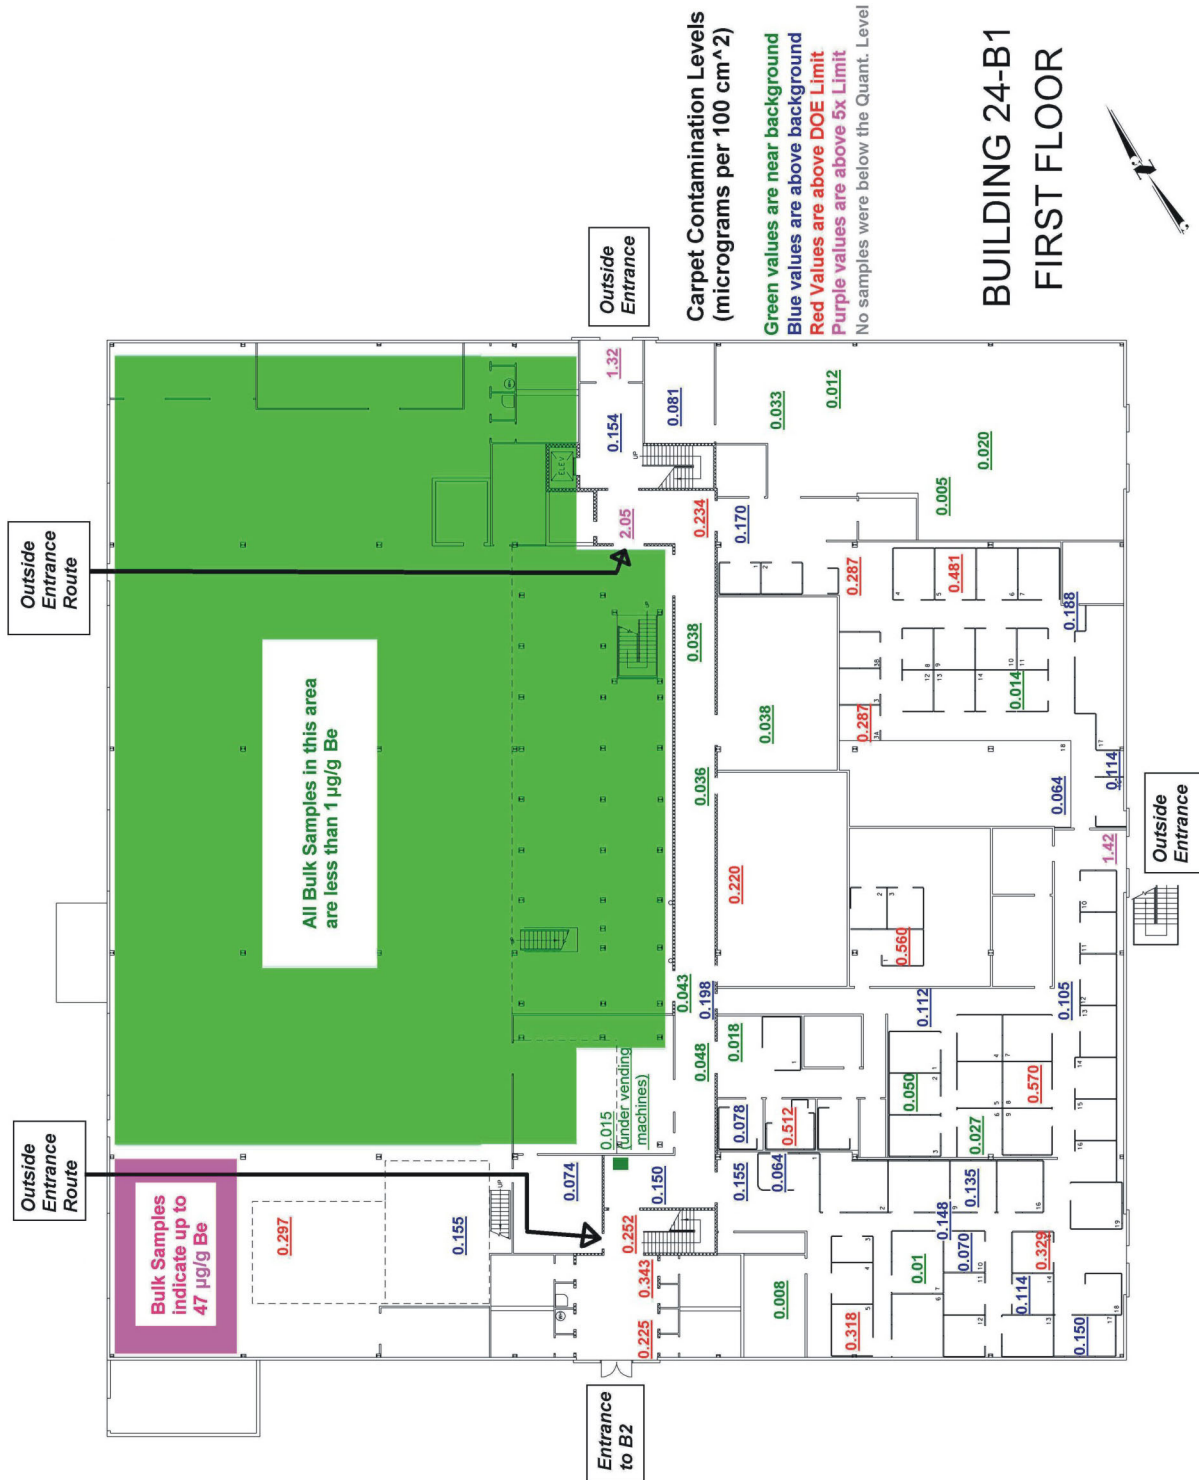
In the concrete areas of the high bay, beryllium contamination was found in the southern end as shown on Figure 2.2.2-2. Several samples were found to have beryllium concentrations ranging from 0.77 to 47.0 µg/g, with the highest levels in the immediate vicinity of a loading or staging area. This area was a small shipping/receiving area for IT/SHAW (see Figure 2.2.2-3). As can be seen from Figure 2.2.2-1, the carpeted section underneath the mezzanine area at the south end of the high bay also contained elevated levels of beryllium, with one sample slightly below and the other above the 0.2 µg/100 cm<sup>2</sup> comparison value.

Figure 2.2.2-1: Beryllium contamination in the first floor of B1.

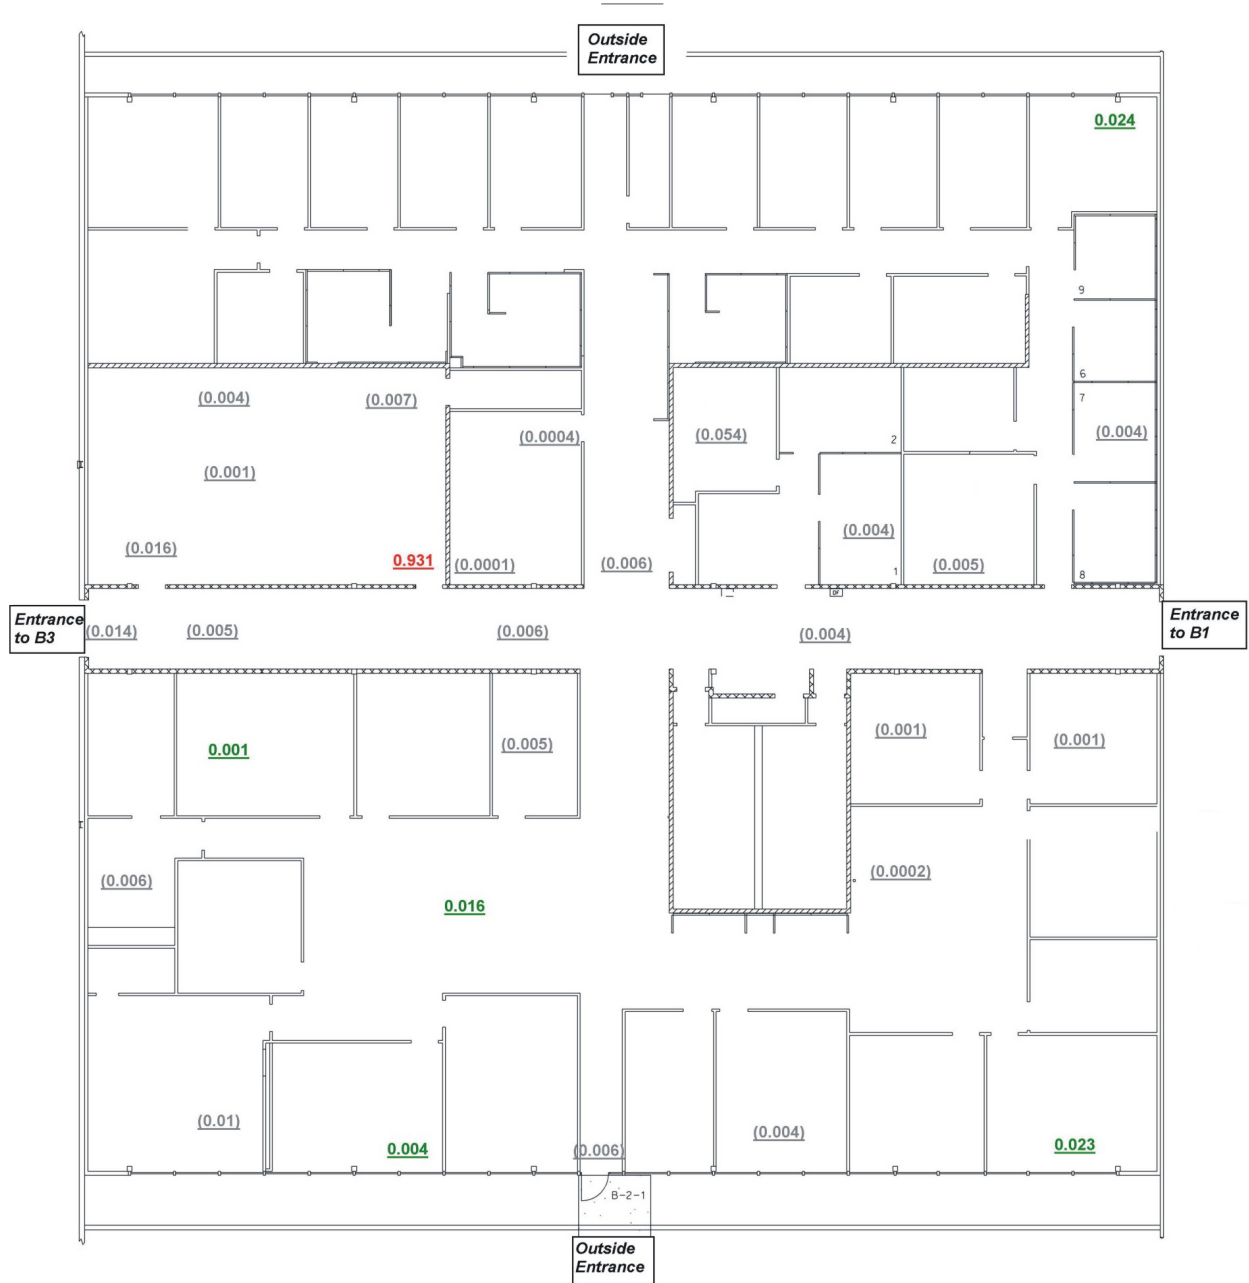
Figure 2.2.3-1: Beryllium contamination in building B2.

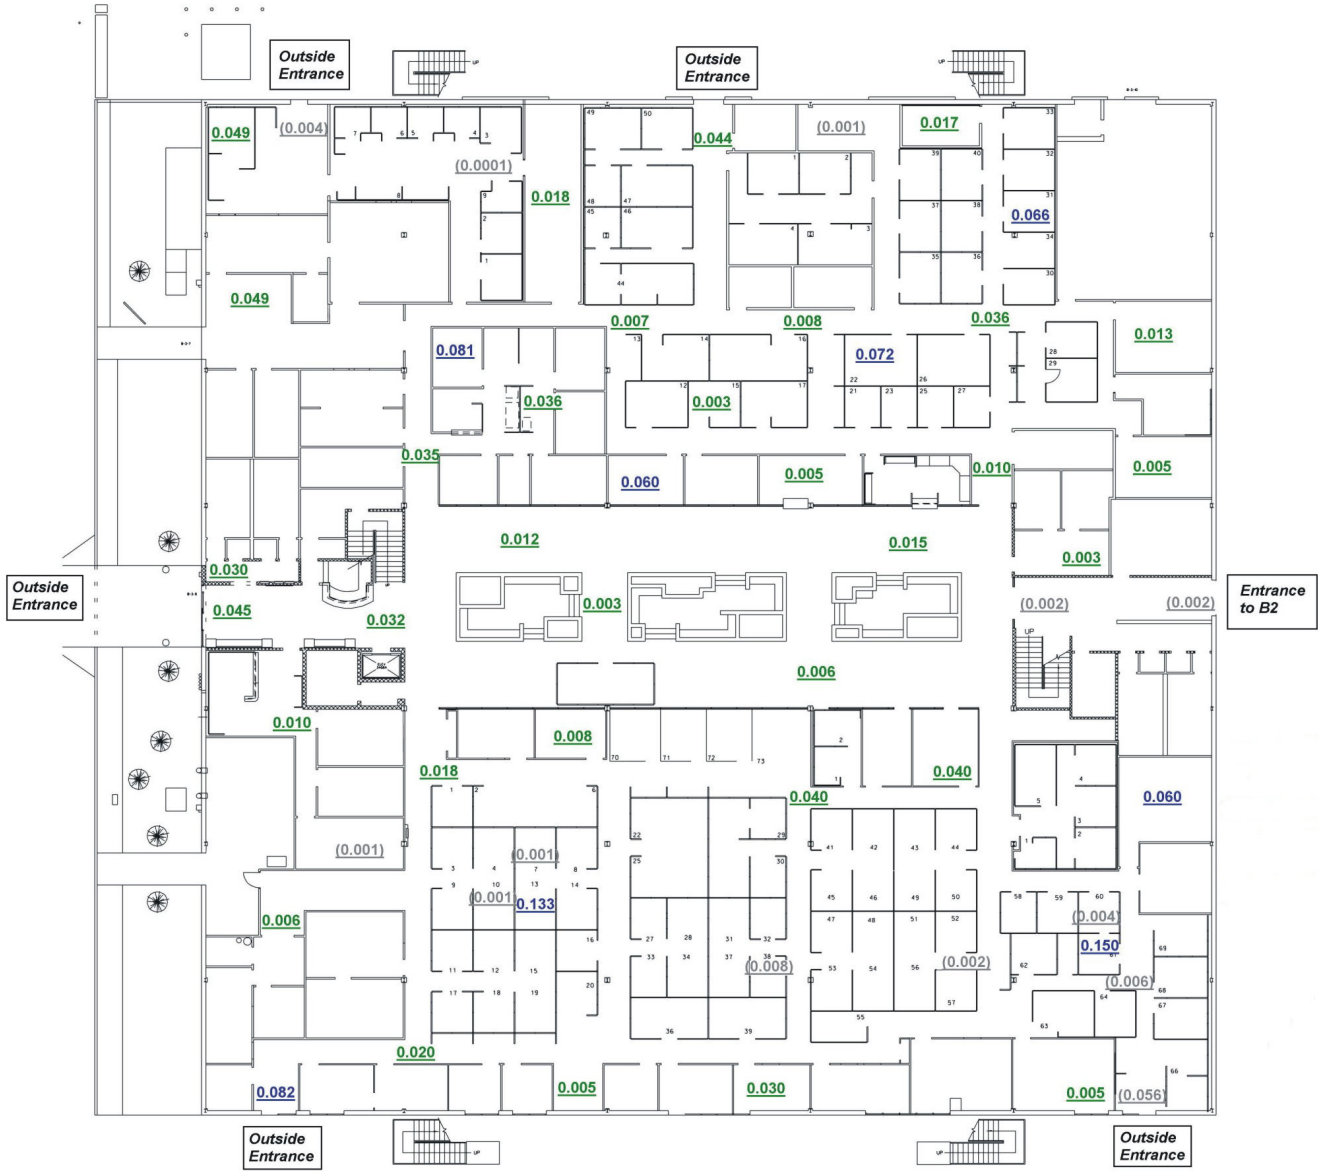
Figure 2.2.4-1: Beryllium contamination in the first floor of building B3.

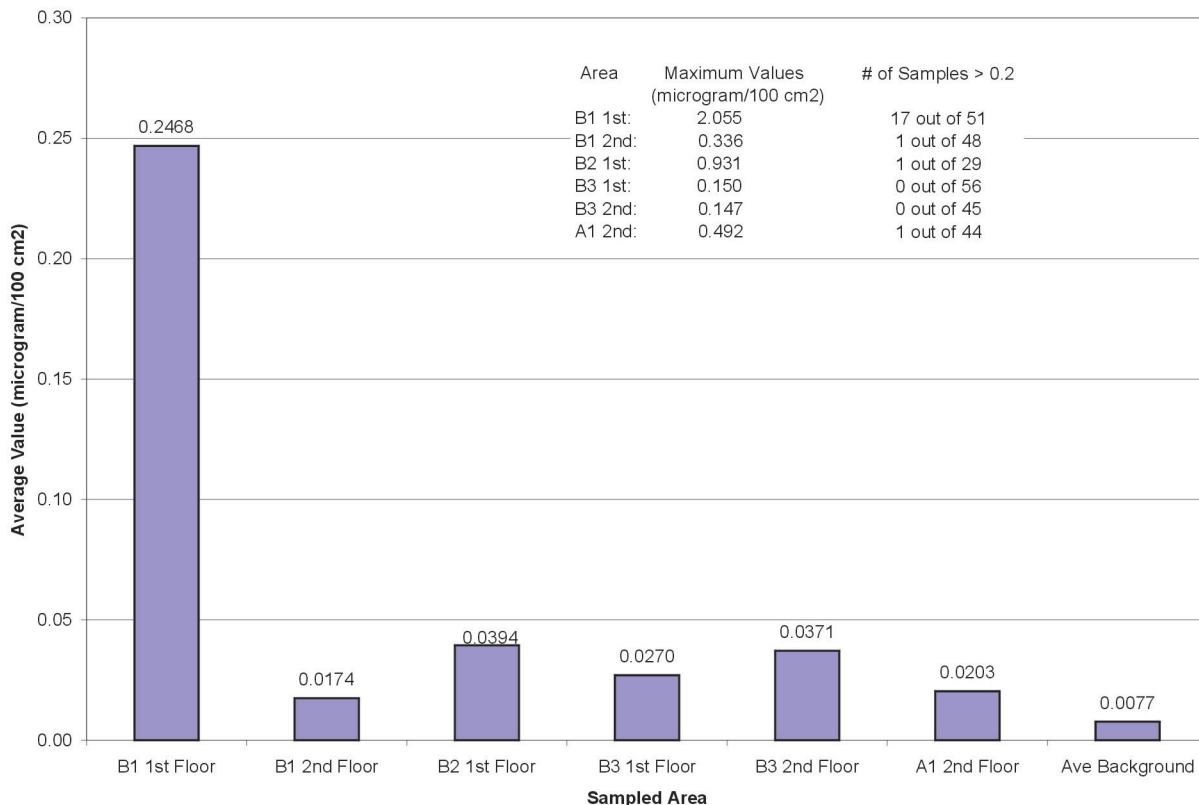
Figure 2.3-1: Comparison of the average beryllium contamination levels in the buildings.

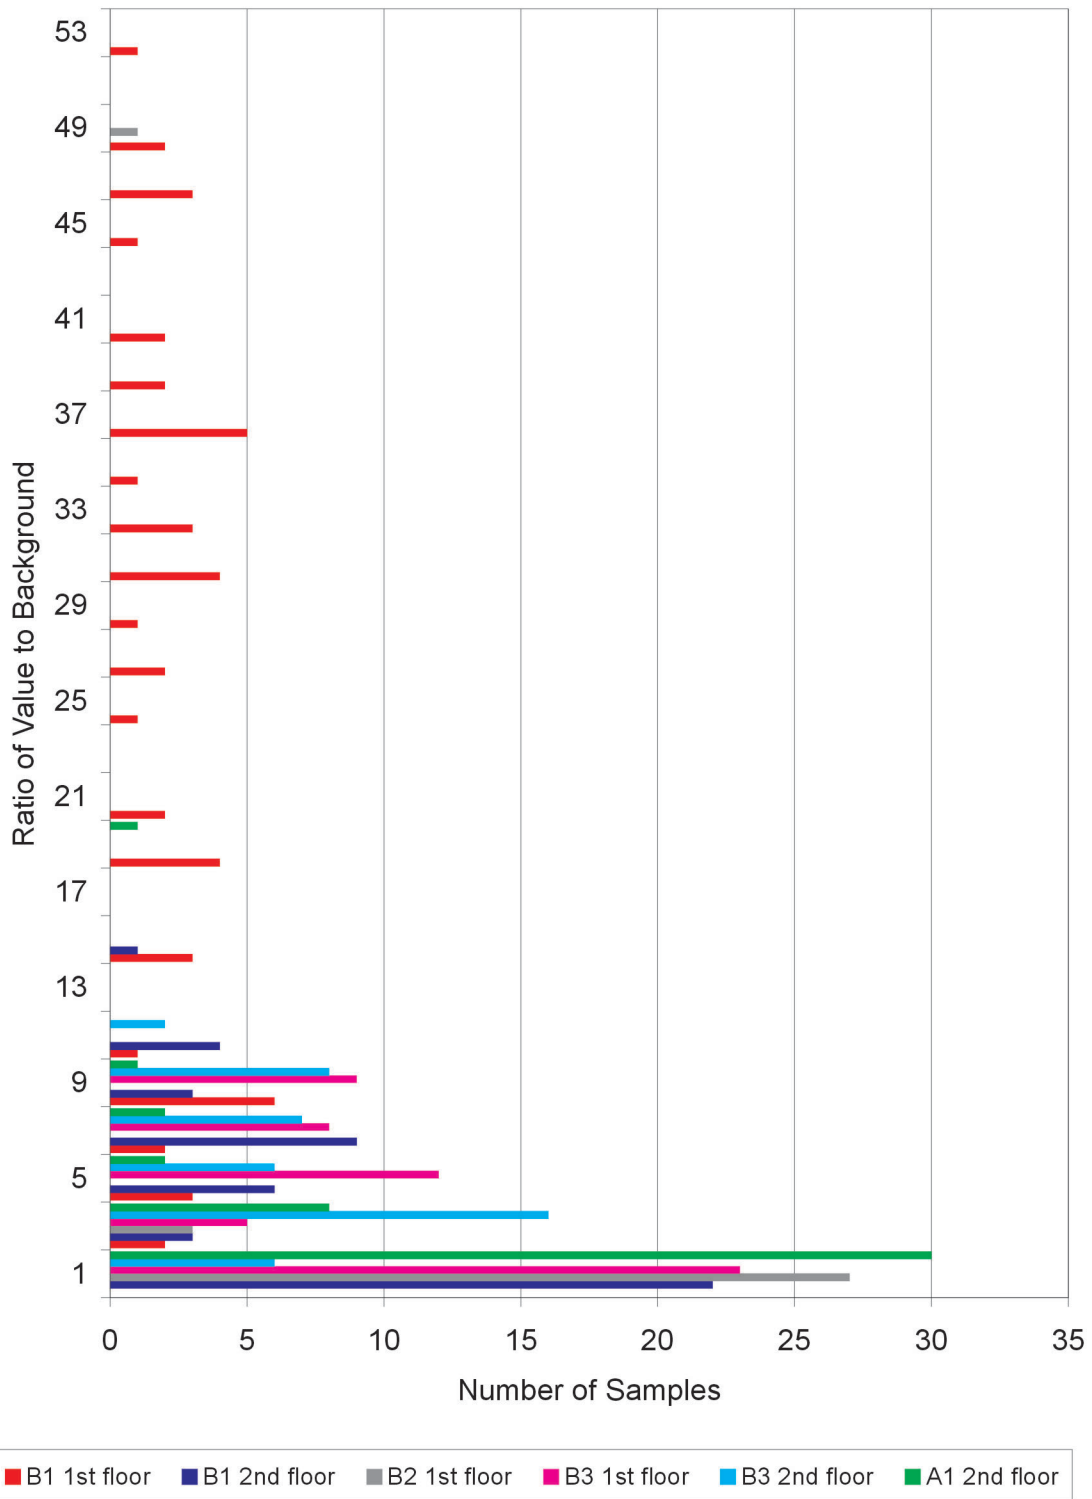
comparison between all of the samples and their individual anticipated background values. While the standards for beryllium contamination are absolute values, i.e., they are not to be corrected for background, it is clear from this figure that the observed values represent levels that are elevated above what would normally be expected in the carpets. Although the concrete high bay area of B1 is not included in these figures, it is also clear from Figure 2.2.2-2 that beryllium levels in the southern end of the high bay are elevated by factors of up to 134 times greater than the background levels in area soils.

Figure 2.3-2: Comparison between individual sample results and anticipated background values.
