Office of Environment, Safety, and Health Oversight
Environment, Safety and Health

Focused Review of the

River Protection Project

July 2001

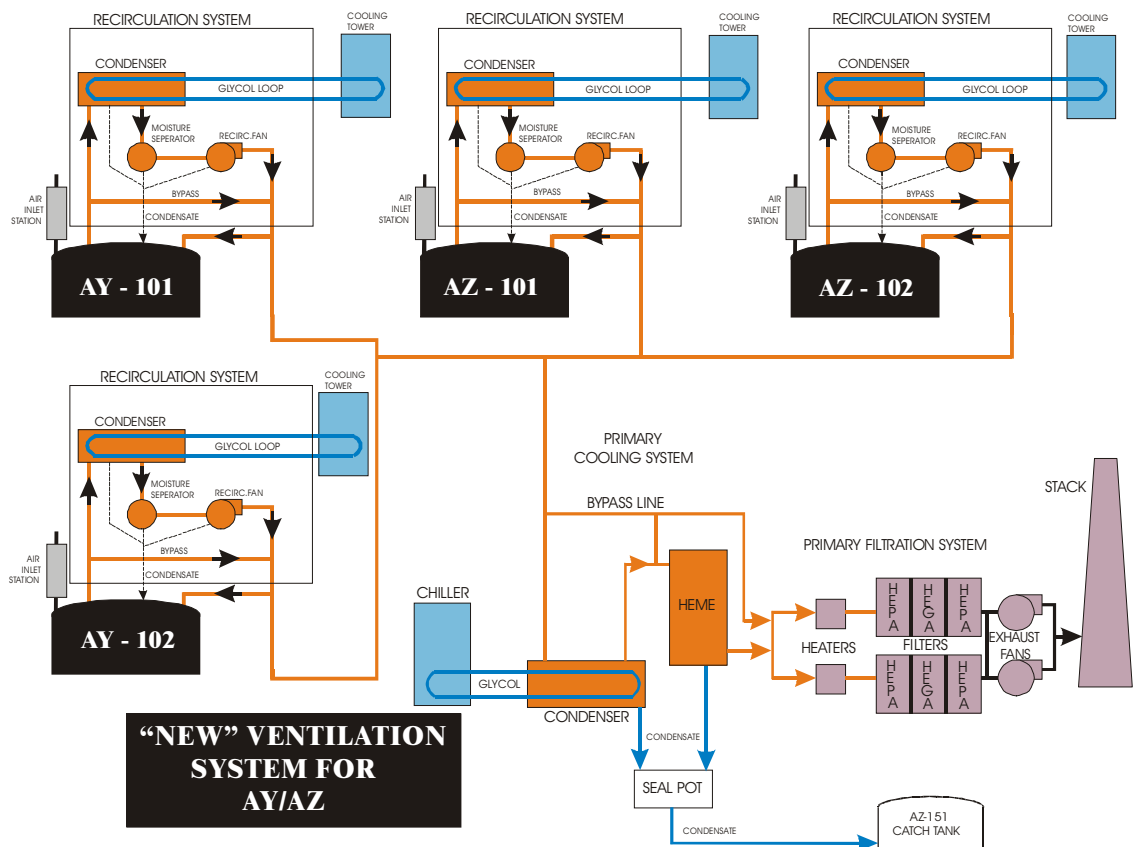
Figure 4. Simplified Diagram of Aging Waste Facility Primary Ventilation System

Facility, a Hazard Category 2 nuclear facility that provides underground tank storage of high-level radioactive waste, consists of four tanks requiring ventilation and HEPA filtration for confinement, cooling, and flammable gas mitigation. In addition to the four underground tanks, the Aging Waste Facility encompasses three other buildings that include the Monitoring & Control Station, the diesel generator/service building, and the ventilation building.

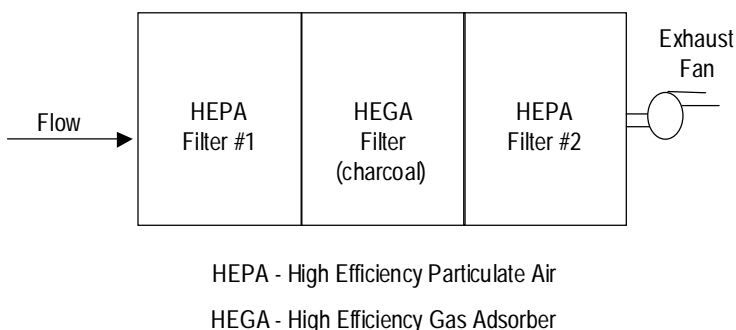
Figure 5. Aging Waste Facility HEPA Filter Train

The review of calculations for the HEPA filter train identified two non-conservative errors that could allow exposures slightly above those analyzed. First, the analyses incorrectly assumed that the filter cartridge frames were made of aluminum; they are made of stainless steel. Second, the analyses did not account for the attenuation that would be caused by the stainless steel filter outer housing. Both factors could cause the actual radioactive burden of the filter to be greater, at the limiting dose rate, than what was calculated. After

discussions with the review team, the CHG engineering organization initiated revisions to the affected calculations. The normal loading of the HEPA filter under current operating practice is low (less than 10 mrem/hour) because filters are changed often, so the calculation deficiency did not result in an immediate safety concern. Re-analysis is necessary to adequately support the safety analysis technical basis. The technical basis for filter changeout needs to be established and documented.

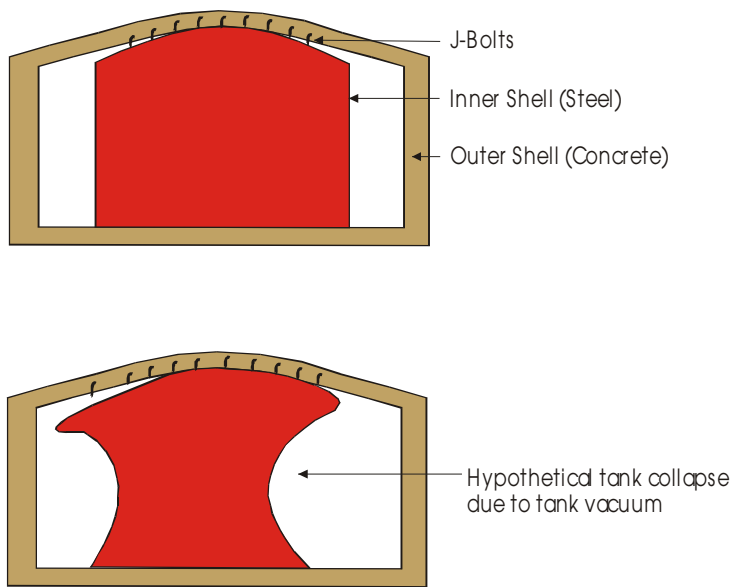
Figure 6. Schematic of Hypothetical Failure of J-Bolts

Tank Structural Analysis. The AY/AZ tank structural analysis for vacuum conditions may be non-conservative. A structural analysis of the AY/AZ primary tanks (the inner shells of the double-shell tanks) determined the ability of the tanks to withstand all negative pressures associated with operation of the ventilation system. A single vacuum relief valve on each tank protects against excessive vacuum and would limit vacuum to minus 6.6 inches water gage. Normal operating vacuum is minus 1.0 to minus 3.0 inches water gage.

The structural analysis was based on American Society of Mechanical Engineers Code Case N-284-1, which addressed tank buckling due to vacuum. This code case required that the 2.0 factor of safety used for the local buckling failure mode be increased by 20 percent to 2.4 when analyzing a hypothetical, total collapse failure mode. The higher safety factor was not used in the analysis, based on the assumptions

that only localized buckling would occur, since the primary tank walls were supported by the primary tank steel shell dome, which is supported by the secondary tank reinforced concrete dome through the connecting embedded J-bolts and risers. These assumptions were based on an undocumented additional assumption that the J-bolts would uniformly assume the load generated by the buckling tank sides. The review team identified that this last assumption was invalid. The load path would initially be only through the outer ring of J-bolts, because the primary tank dome would peel away from the underside of the concrete dome as a result of the downward pull of the buckling sides. Each succeeding inboard bolt circle could assume load only after the outboard bolts had failed, and thus the J-bolt failures would be progressive until there was complete detachment of the steel dome from the concrete dome. This could lead to the total collapse of the primary tank (see Figure 6). The J-bolts or their attachments were the unanalyzed potential weak link in the load path. Therefore, the 2.0 factor of safety used was non-conservative with respect to the Code requirements.

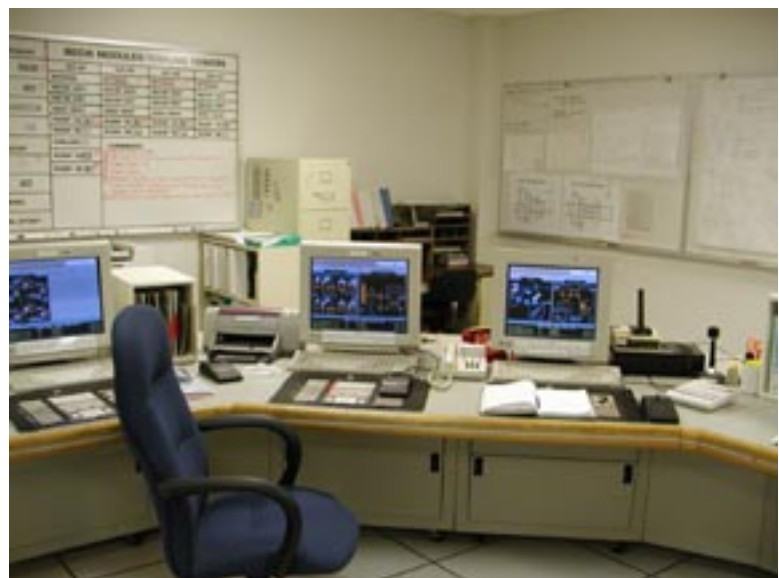
- Several operators raised concerns about their limited training. Although on-the-job training lasted several months, formal training on graphic panels, systems, and equipment is lacking.

- The large number of operators qualified on the Monitoring & Control Station limits individual watch-standing time and affects their ability to maintain proficiency.
