Office of Independent Environment, Safety, and Health Oversight
Environment, Safety and Health

Special Review of the

Rocky Flats Closure Project Site

April 2001

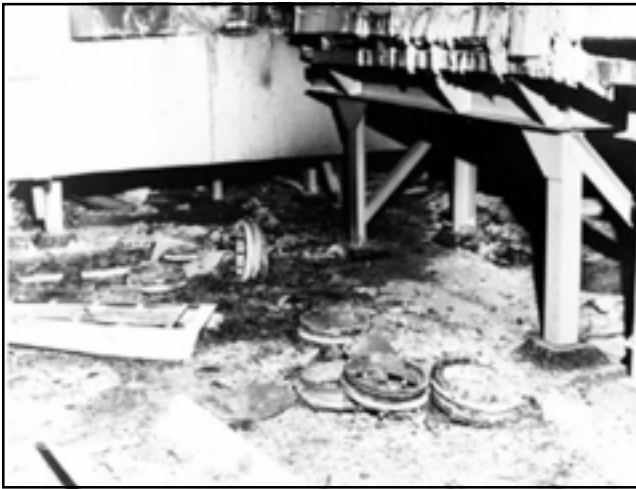
Contamination and Damage Following a 1969 Fire in Building 776/777
