7 Peripheral Buildings

7.1 Introduction

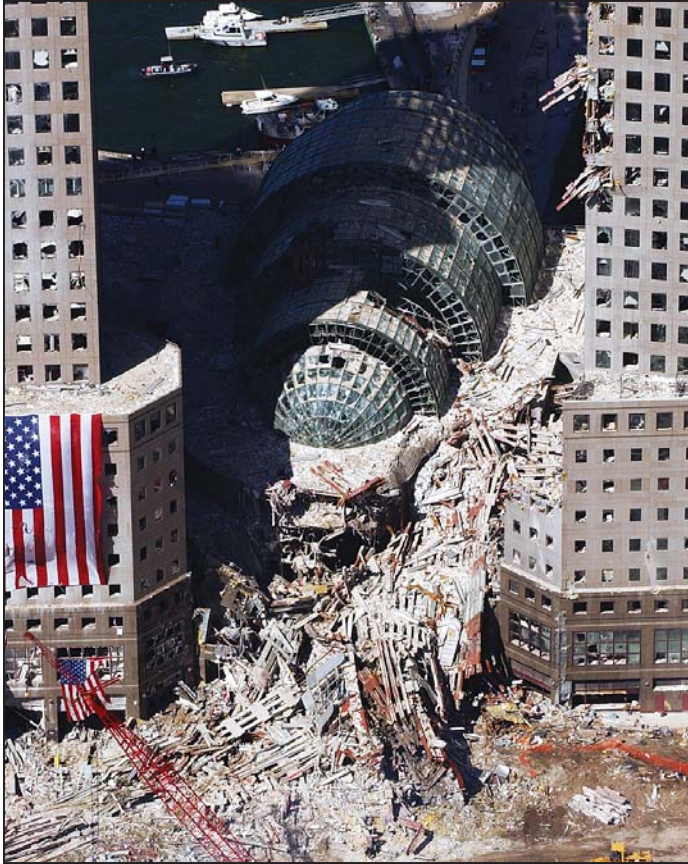
Columns from WTC 1 hit the east end of the structure, particularly the area directly adjacent to the North Bridge. The Winter Garden experienced severe collapse of the eastern end framing. Several other semicircular trusses and parts of the dome were also badly damaged. The western two bays of the roof structure remained intact, but were covered with debris. Inspectors estimated that 60 percent of the roofing glass panels of the structure had collapsed.

Figure 7-3
View of Winter Garden damage from West Street, with WTC 1 debris in front of WFC 2.

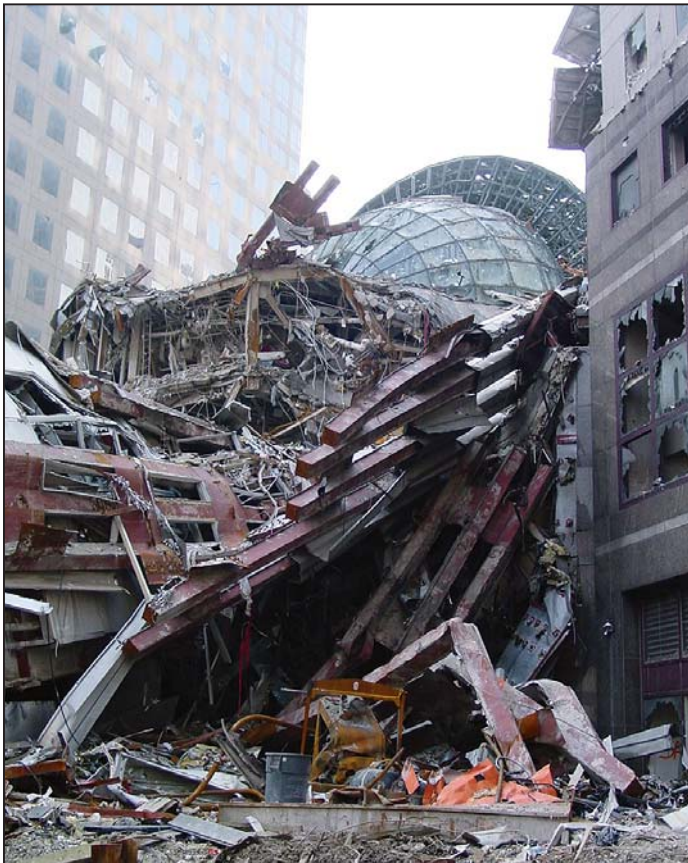
Figure 7-4
View of Winter Garden damage from West Street, with WTC 1 debris leaning against WFC 3.

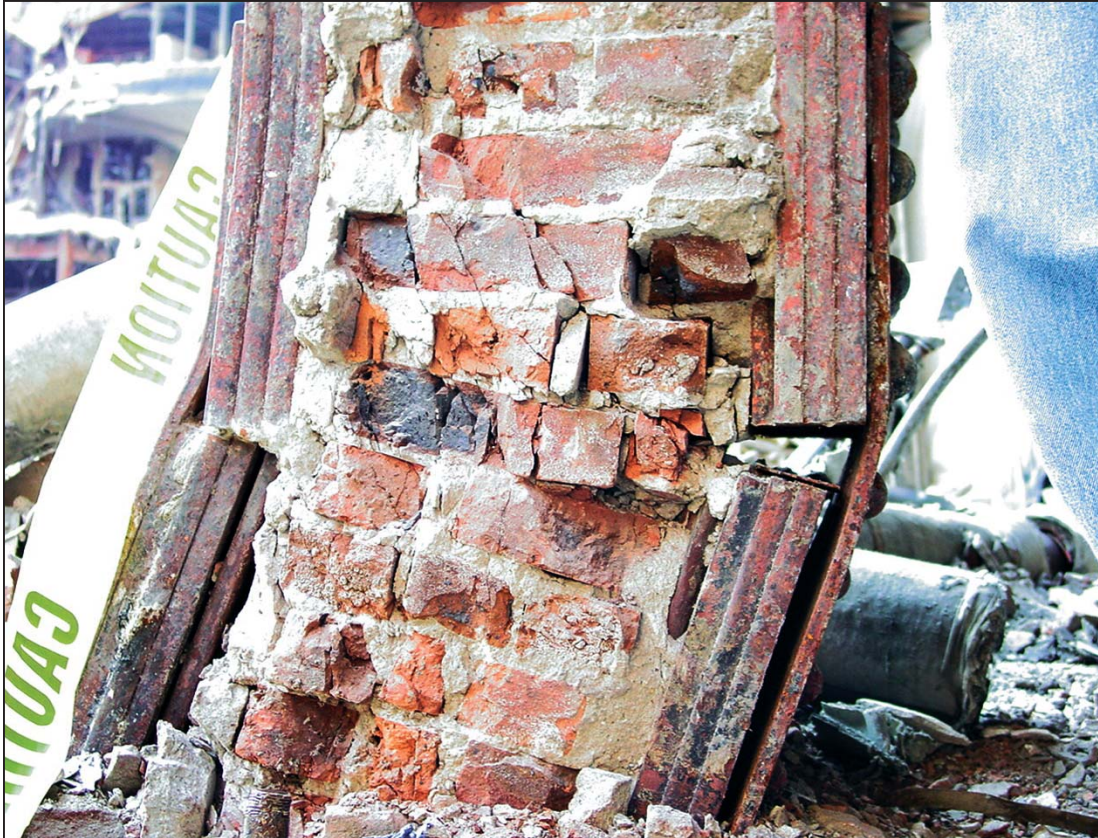
Figure 7-9 Verizon building – column damage on east elevation (Washington Street).

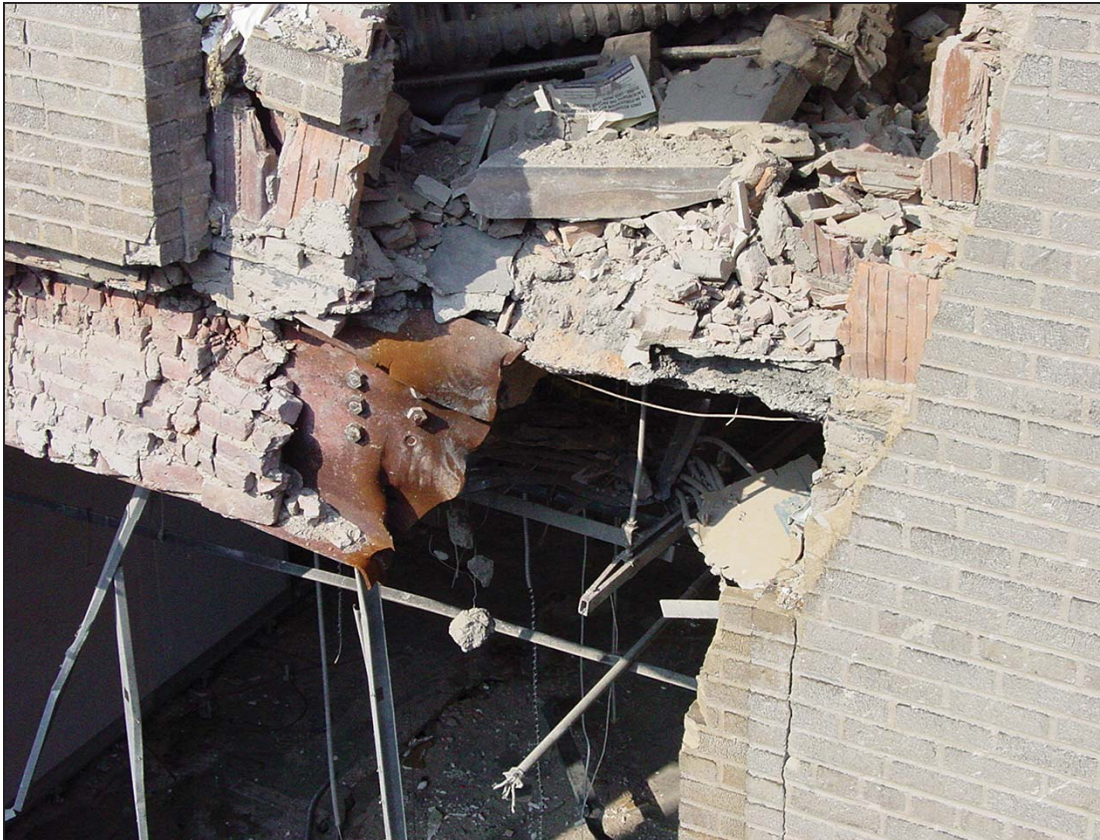
In general, the Verizon building performed well, especially given its close proximity to WTC 7. On the south (Vesey Street) side of the building, damage was extremely localized near the point of impact of projectile debris. In some cases, only a short section of spandrel beam and small area of floor slab were damaged, leaving the remainder of the structural bay intact (Figure 7-12).

Figure 7-12 Verizon building – detail of damage to south elevation (Vesey Street).

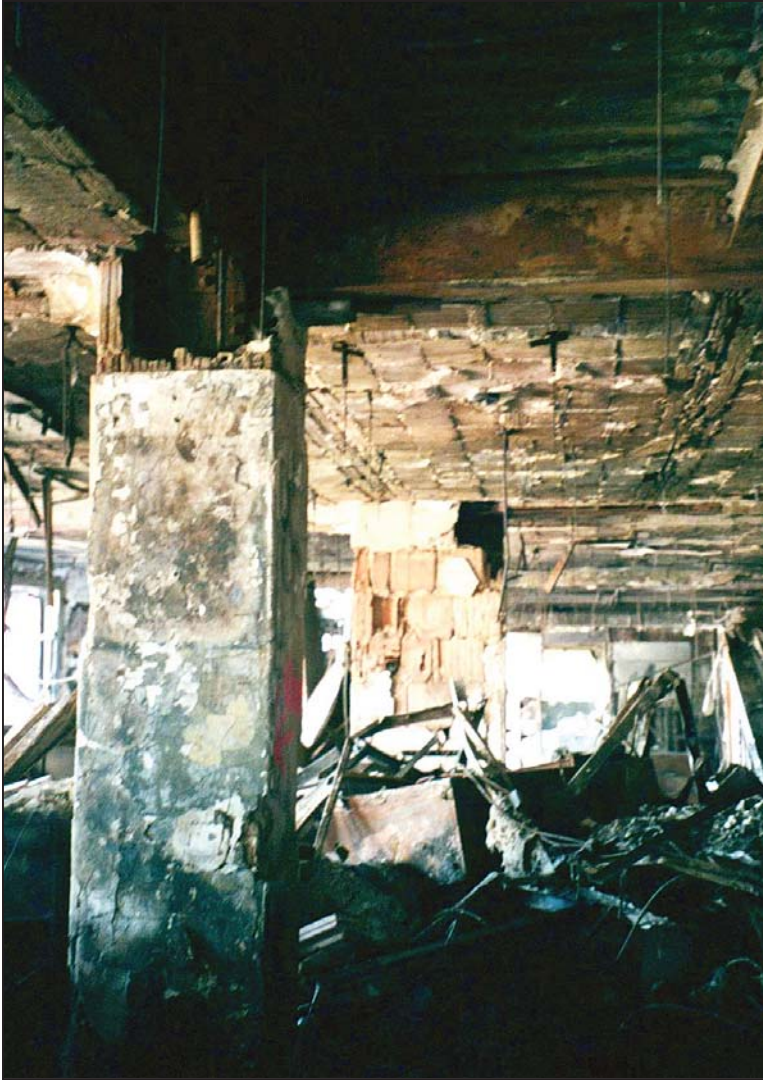
The roof was damaged by debris falling from WTC 2, and approximately half of the north face of the building experienced projectile impact and fire damage. WTC 2 projectiles severed spandrel beams at floors 8 to 11 in the 2nd bay from the west end, and in a middle bay at the 6th floor. Terra cotta slabs were damaged mostly in the exterior bay at these locations. In general, the projectiles damaged only the masonry and broke many terra cotta features. The damage to the interior structural terra cotta floor slabs was primarily due to the brittle fracture of the terra cotta slabs upon impact by large debris. Most of the damage was restricted to the two northernmost bays, with the exception of fire damage on the 1st through 5th, 7th through 10th, 14th, 21st, and 23rd floors. The fire did not spread to the south side of the building, except for the first 4 floors. Columns were buckled 1-2 inches on the 8th and 23rd floors, approximately a foot below the ceiling, as shown in Figures 7-16 and 7-17. A tube column supporting a north exit stair from the roof and a built-up column supporting the roof were the only other heat-induced buckling damage observed during initial inspections.

*Figure 7-16
Buckling damage at top of column
on floor 8 of 90 West Street. Note the loss of fire
protection at the top of the column.*
