April 23, 2002 02-03NRC.DOC MFN 02-025

General Electric Company 175 Curtner Avenue, San Jose, CA 95125

Subject: Failure of CR105X Auxiliary Contacts

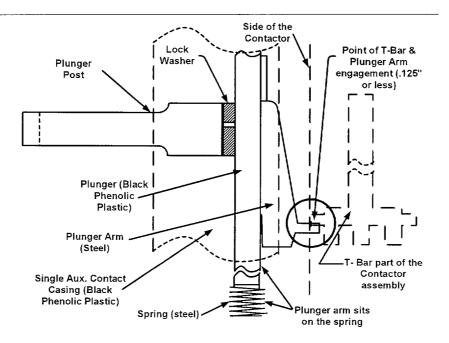
Figure 1

A BWR licensee experienced a CR105X auxiliary contact failure to change state. Troubleshooting revealed the auxiliary contact was stuck open. During repair, an auxiliary contact plunger arm was found disengaged from the T-Bar (see Figure 1), which caused the contact to fail to change state. The cause of the disengaged plunger arm and loose plunger post was determined to be a missing lock washer.

The CR105X auxiliary contacts sold as kits contain the lock washer; however, the instruction provided for customer installation did not contain instructions on where to install the lock washer or the required torque. Assemblies shipped from the factory containing an auxiliary contact may not have the lock washer installed. Without installation of the properly torqued lock washer the plunger arm may disengage from the T-Bar causing the contact to fail to change state.

GE-NE recommends that all CR105X auxiliary contacts be inspected. GE-NE records do not indicate that there is a high incident of failure due to the loosening of the plunger post. Based on the infrequent occurrence of this event, GE-NE recommends inspection of installed CR105X auxiliary contacts at the next available outage. CR105X auxiliary contacts in stores should be inspected prior to use. The inspection should include following:

- Visually verify that the lock washer is installed between the plunger post and the plunger. There should be no gap between them.
- If the lock washer is missing, either install a new lock washer or replace the auxiliary contact with a new one containing a lock washer.
- 3 If the plunger arm is determined to be loose, tighten to 8-15 in-lbs.
