Subject: Borg-Warner 3" and 4" Swing Check Valves

10 CFR PART 21 NOTIFICATION

(Reference No. CFRN-9301)

Texas Utilities, Comanche Peak Steam Electric Station.
Basic Component: 4-inch 150# Bolted Bonnet Swing Check Valve
BW/IP Part No. 75580
TU Tag Nos. 2CC-0697 & 2CC-0693

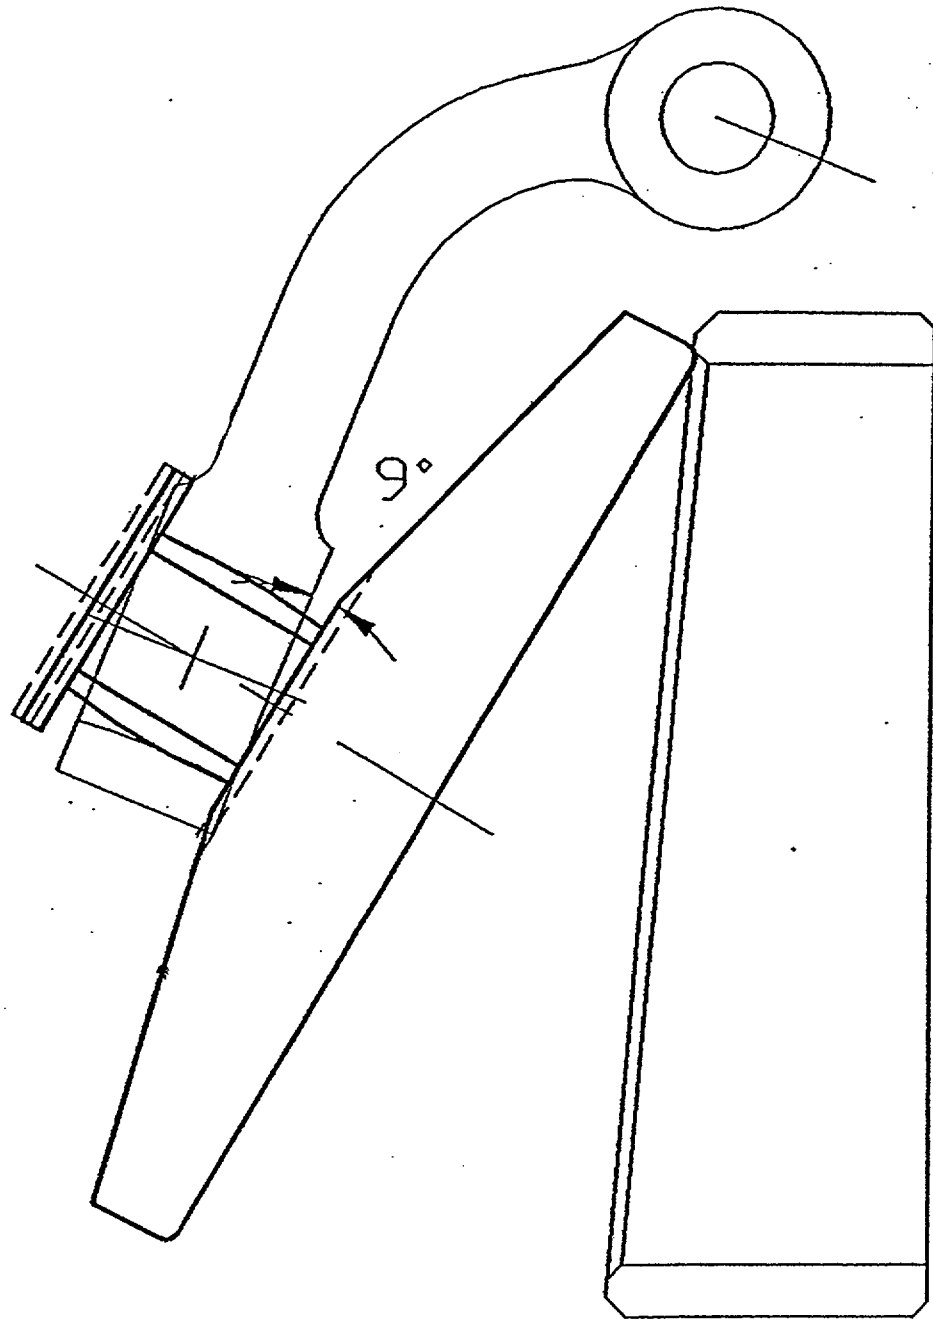
Required Angle of Disc Rotation and Axial Gap for Interference

Valve 2CC-0697 did not fully close during pre-operational testing. Radiographs taken at the time of failure show the disk positioned at approximately 21° from the full closed position. The valve was disassembled. The top of the disk was found to be lodged under the seat lip preventing full closure. Valve 2CC-0693 subsequently failed testing in a similar manner. Both valves are located in the Component Cooling Water return lines from the Reactor Coolant Pump Motor Coolers and do not serve an active safety function. However the failure mechanism could apply to other valves that do provide a safety function.

Evaluation of the basic component by BW/IP indicates the root cause of the failure to close is due to the configuration of the attachment weld between the disk to the stud. Prior to 1977, this weld was placed on the back surface of the stud and extended into the bushing bore. In disks manufactured after 1977, the weld was recessed into the back surface of the disk and a final machine cut made to assure a flush surface.

On May 31, 2001, Arizona Public Service Co. advised Flowserve that they recently encountered the same problem on a 4"-1500# pressure seal swing check valve. Because of this, Flowserve decided it would be prudent to notify or re-notify all customers who purchased 3" or 4" swing check valves or disc assemblies in 1977 or earlier of the potential problem. We recommend the valves be inspected at the earliest convenient time and if evidence of interference is found, replace the disc assembly. The enclosed sketch depicts the potential problem if there is excessive disc angular movement.

Licensees with valve installations effected by this notice should install a new disk component or refurbish the existing disk.
