# Penetration #1 Weld Profile

# **CAUSE ANALYSIS and STATUS**

# What Was Found

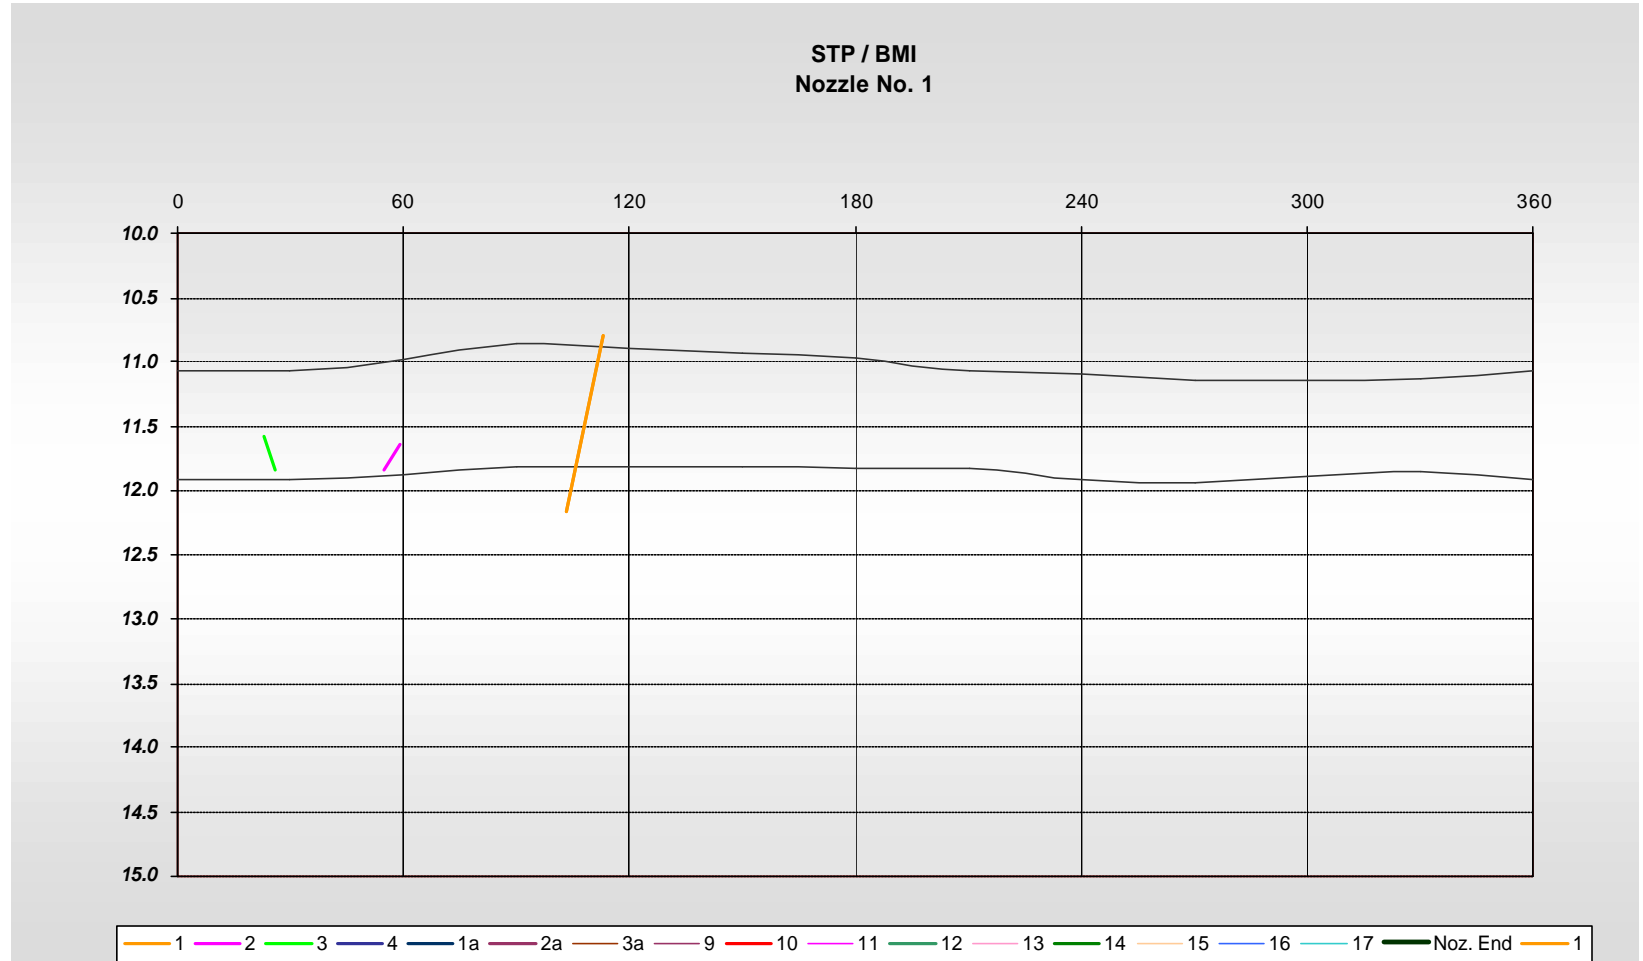
# Penetration #1 Leak Path

- Bobbin coil eddy current on penetration ID
  - Penetration #1 displayed a tube ID surface-breaking flaw
  - Penetration #46 displayed a tube ID sub-surface flaw
  - Two other reference penetrations displayed no flaws
- Array coil eddy current on J-Groove weld
  - Penetration 1, 46, 33 & 5 others scanned
  - No flaws identified

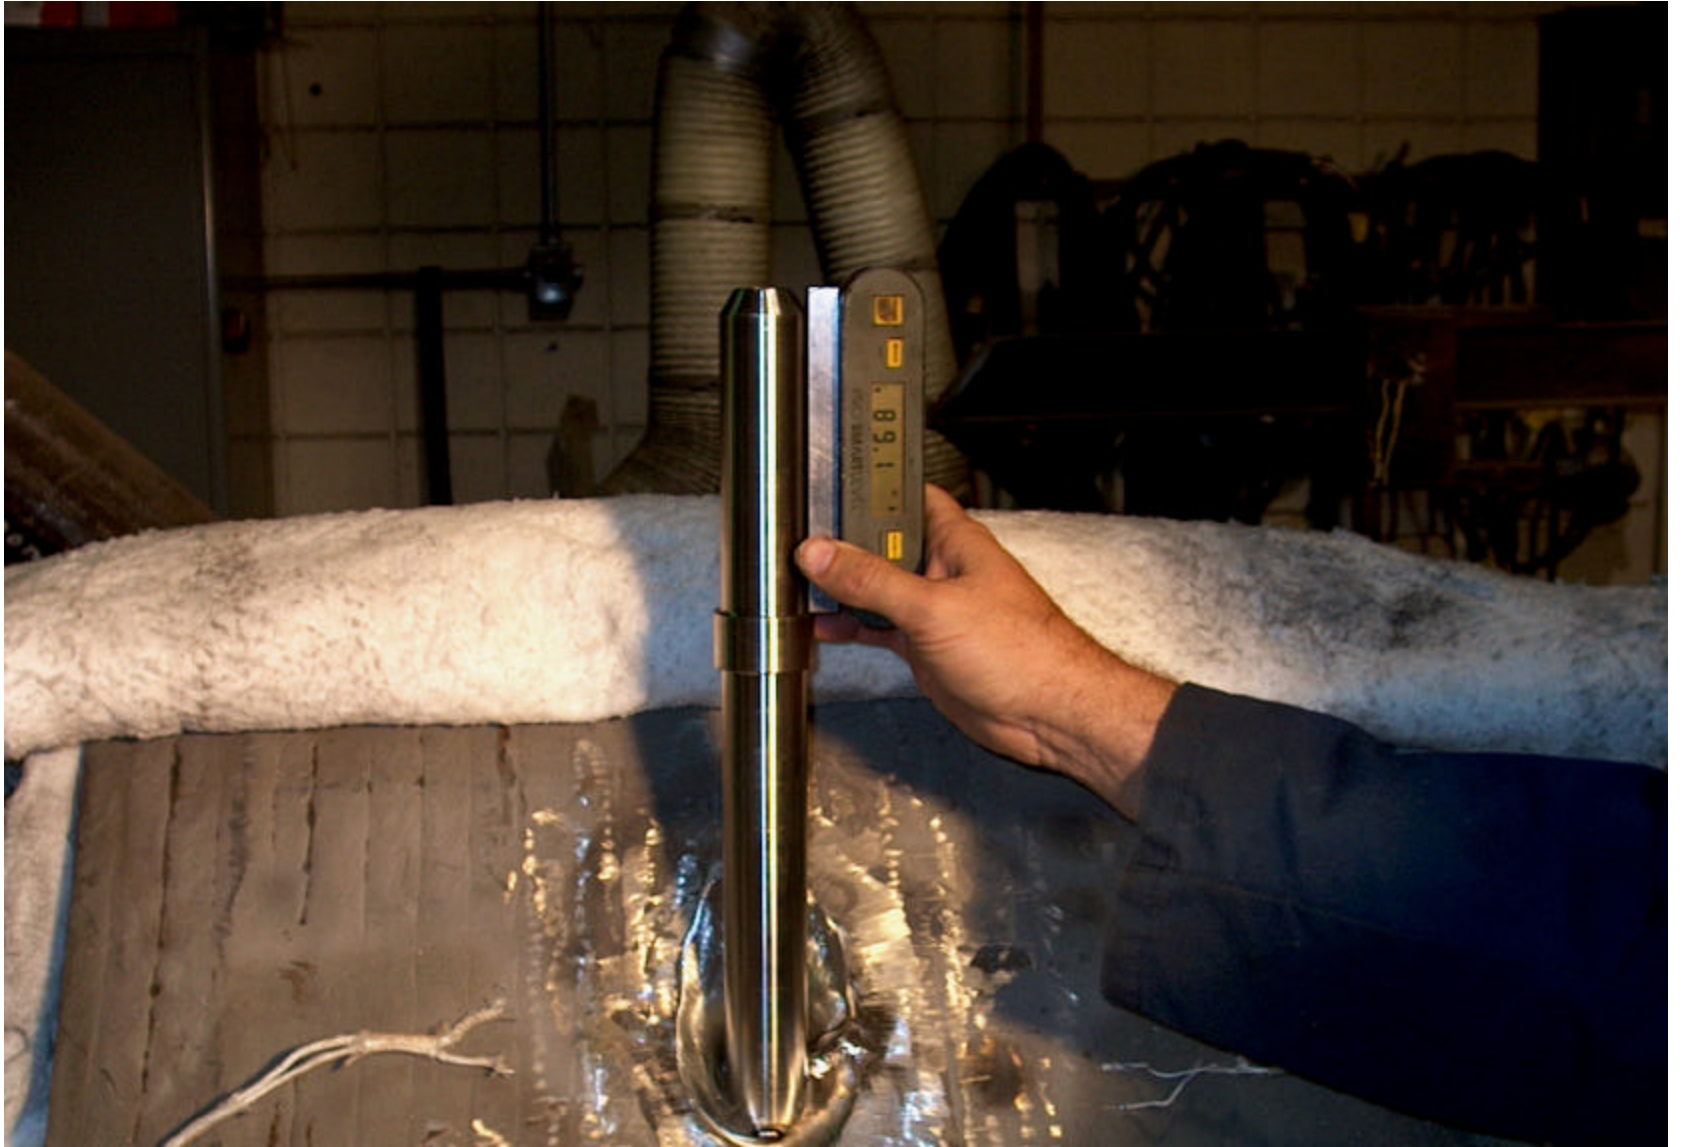
# Tube Coldworking Not a Likely Contributor

1976 Combustion Engineering Nuclear  
Fabrication Practice 101-3-0 states:

5.8.1 REMINDER: Use the bull's eye level and alternate welds as necessary to insure alignment

5.8.4 Cold straighten, as necessary, all tubes which are out of alignment
