Bottom Mounted Instrument Guide Tube Condition

April 12 - residue found on two of the 58 Bottom Mounted Instrumentation (BMI) penetrations.

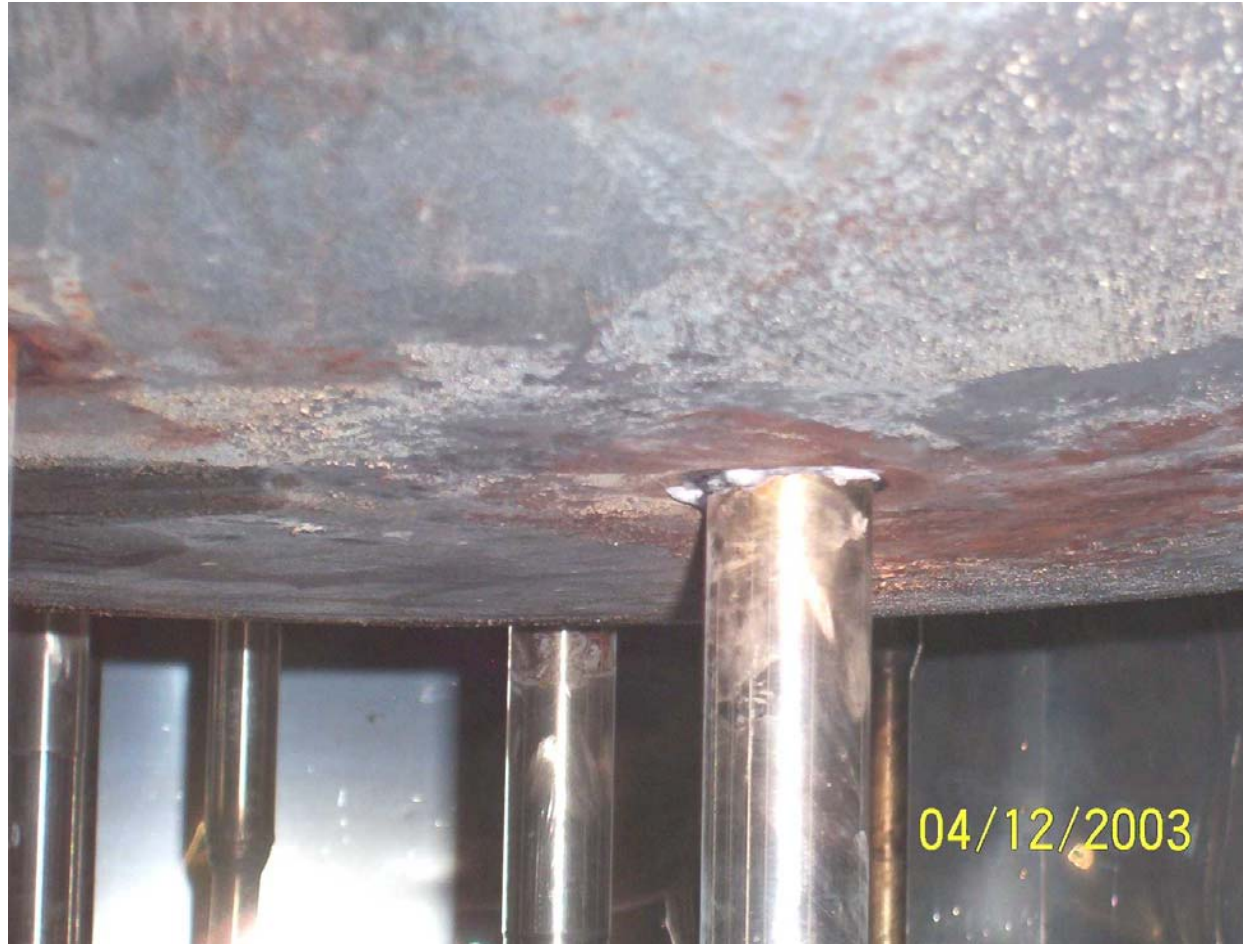
A small amount of residue had accumulated approximately 90 degrees around the guide tubes at vessel Penetrations #1 and #46.

The quantity of residue found on Penetration #1 is equivalent to about half of an aspirin (approximately 150 mg).

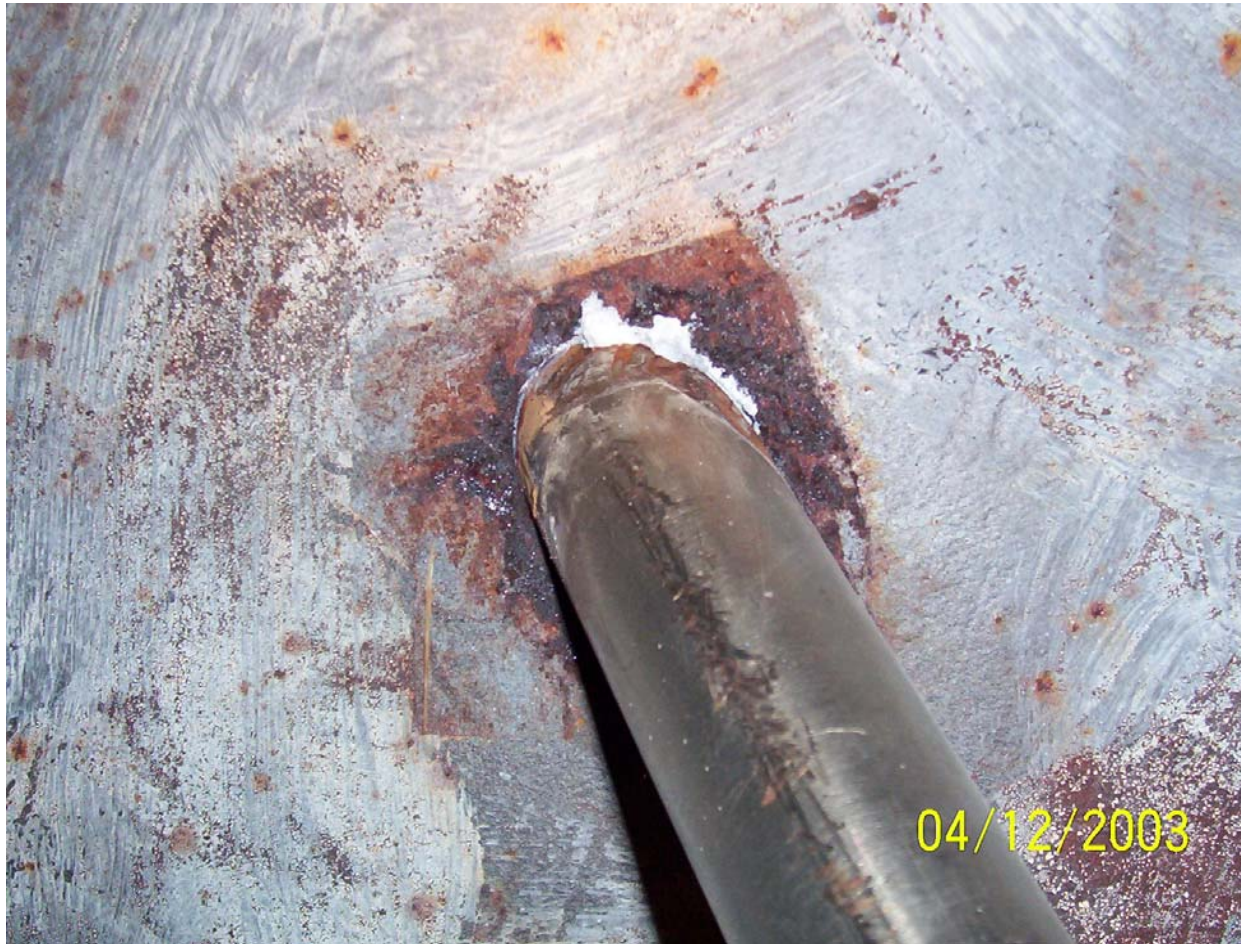
Penetration #46 had about 3 milligrams of residue.
