SEQUOYAH NUCLEAR PLANT (SQN) - UNIT 2 ITEM 5 RESPONSE TO NRC BULLETIN 2001-01, "CIRCUMFERENTIAL CRACKING OF REACTOR PRESSURE VESSEL HEAD PENETRATION NOZZLES," DATED AUGUST 3, 2001 (TAC No. MB2660) - UNIT 2 ITEM 2 RESPONSE TO NRC BULLETIN 2002-01, "REACTOR PRESSURE VESSEL HEAD DEGRADATION AND REACTOR COOLANT PRESSURE BOUNDARY INTEGRITY," DATED MARCH 18, 2002 (TAC No. MB4579)

TENNESSEE VALLEY AUTHORITY
SEQUOYAH NUCLEAR PLANT (SQN)
UNIT 2

THIRTY-DAY, AFTER PLANT RESTART, RESPONSE TO:
NRC BULLETIN 2001-01, "CIRCUMFERENTIAL CRACKING OF REACTOR PRESSURE
VESSEL HEAD PENETRATION NOZZLES"

NRC BULLETIN 2002-01, "REACTOR PRESSURE VESSEL HEAD DEGRADATION AND
REACTOR COOLANT PRESSURE BOUNDARY INTEGRITY"

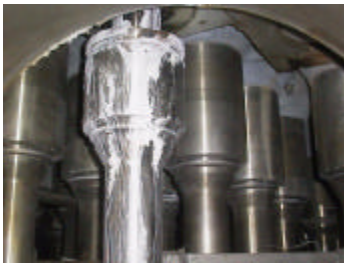
One area of concern was located at CRDM No. L-15 (CRDMP No. 75) which is an outer peripheral penetration. A Conoseal mechanical joint leak was identified at CRDM No. L-15. The leakage path extended to the penetration interface at the head and continued down the RPV head onto the flange. The characteristics of residue and corrosion product indicates that the leakage had occurred sometime prior to plant shut

down. There was no evidence of leakage at the penetration to RPV head interface. Figures 11, 13, and 15 show the as found condition.

Figure 11 - CRDMP No. 75
L-15 Conoseal Leakage Path at CRDM
Column (As Found)

The leakage condition at CRDM No. L-15 (CRDMP No. 75) that resulted from the Conoseal mechanical joint was entered into the TVA corrective action program and evaluated under TVA's BWC Program. As part of the corrective actions taken, the boron residue and corrosion product was removed from the CRDM column (accessible areas), RPV head penetration area, RPV head, and flange area. Residue was sufficiently removed on the CRDM column so as to not mask any critical areas (e.g. canopy seal weld area, bi-metallic weld, head penetration, etc.) for future evaluations for leakage. Figures 12, 14 and 16 show the cleaned, as left, condition. The corrosion on the RPV head, as a result of CRDM No. L-15 leakage, was superficial and had no indication of material degradation after removal. This location is on the outer periphery of the RPV head and is inspected each refueling outage. The inspection is required by site procedure to monitor for penetration leakage. The root cause of CRDM No. L-15 leakage was indeterminate. The most likely causes are either: 1) foreign material was present that did not cause a scratch or sealing surface flaw, or 2) the connecting clamp was insufficiently torqued during previous reassembly. Neither cause could be confirmed from the evidence at hand, and both appear to have sufficient steps in place in the reactor reassembly procedure to prevent recurrence.

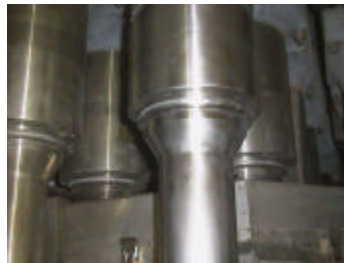
Figure 12 - CRDMP No. 75
L-15 Conoseal/CRDM Column
(After Cleaning)
