NATIONAL TRANSPORTATION SAFETY BOARD

RAILROAD ACCIDENT REPORT

**COLLISION INVOLVING TWO NEW YORK CITY
SUBWAY TRAINS ON THE WILLIAMSBURG BRIDGE
IN BROOKLYN, NEW YORK
JUNE 5, 1995**

Abstract: This report explains the collisions of two New York City Transit subway trains on the Williamsburg Bridge in Brooklyn, New York on June 5, 1995. One person was killed and 69 people were treated at area hospitals for minor injuries sustained in this accident. The total estimated damage exceeded \$2.3 million.

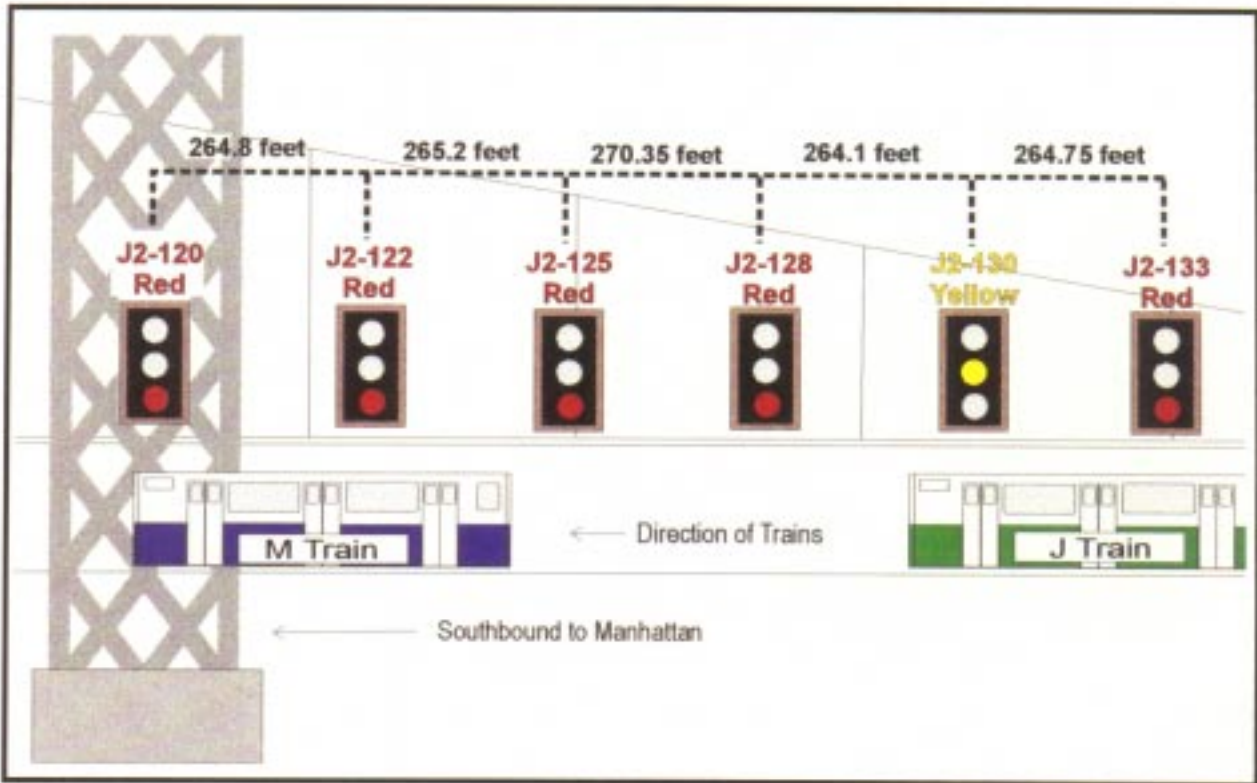
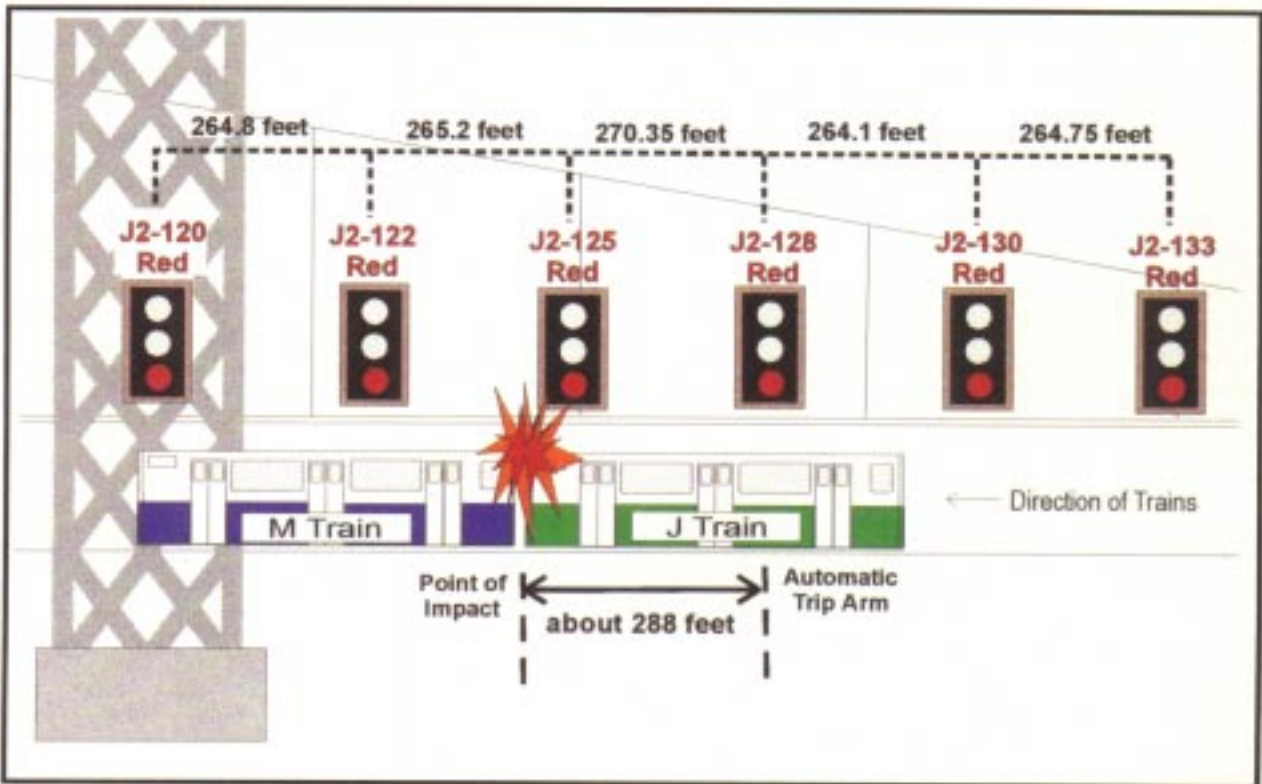
Figure 2 — (Top) The M train was stopped at Signal J2-120 when the J train proceeded past a yellow caution light at Signal J2-130 traveling about 34-36 mph. (Bottom) Although the automatic trip arm at red Signal J2-128 properly activated the emergency braking of the J train, it failed to stop within the 270-foot-long block and struck the rear of the M train, which was 16 feet beyond Signal J2-125.

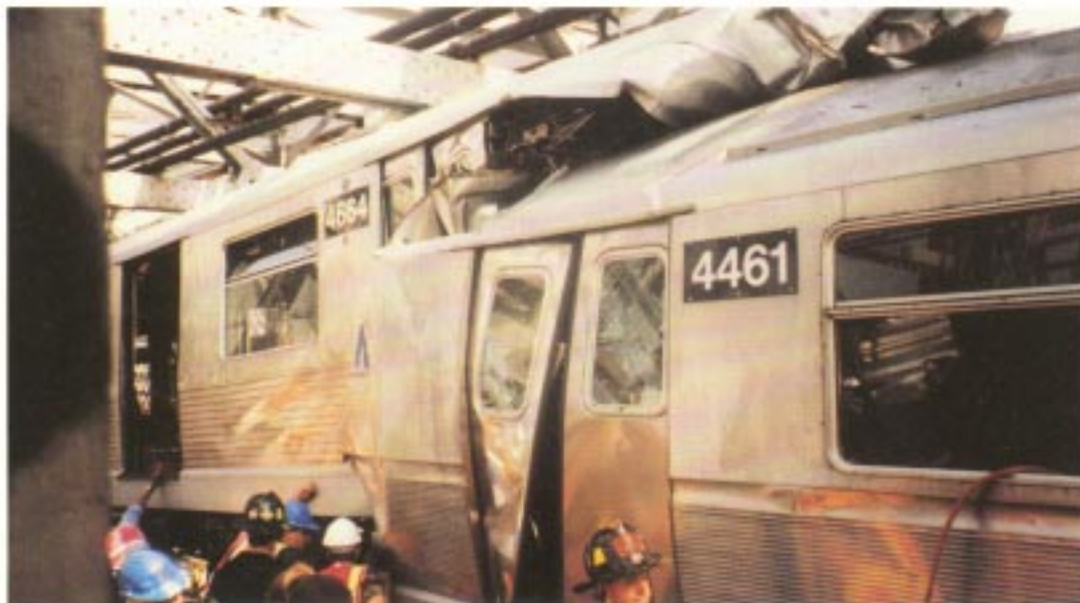
None of the 16 cars from the two trains derailed from the impact, but the lead car of the J train penetrated the rear car of the M train resulting in extensive damage to these two cars (figure 3) and the fatal injury of the J train operator. When the off-duty train operator on the J train noticed smoke coming from the front end, he instructed other passengers to run from the car and then assisted in evacuating people from the train. Within 5 minutes of the collision, a bystander called the New York Police Department (NYPD) 911 dispatcher, reporting that a train collision had occurred on the bridge. The NYPD immediately notified the Fire Department of New York (FDNY) and dispatched police and rescue personnel to the scene. Initial emergency responders arrived on scene within 5 minutes of the 911 notification call. They arranged to have a transit bus and 47 ambulances transport 55 injured passengers and crewmembers to 11 area hospitals. Several individuals with minor injuries either were treated and released at the scene or sought treatment elsewhere. Additional information about the response effort appears in the *Survival Factors* section of this report.

Figure 3 — The accident site.

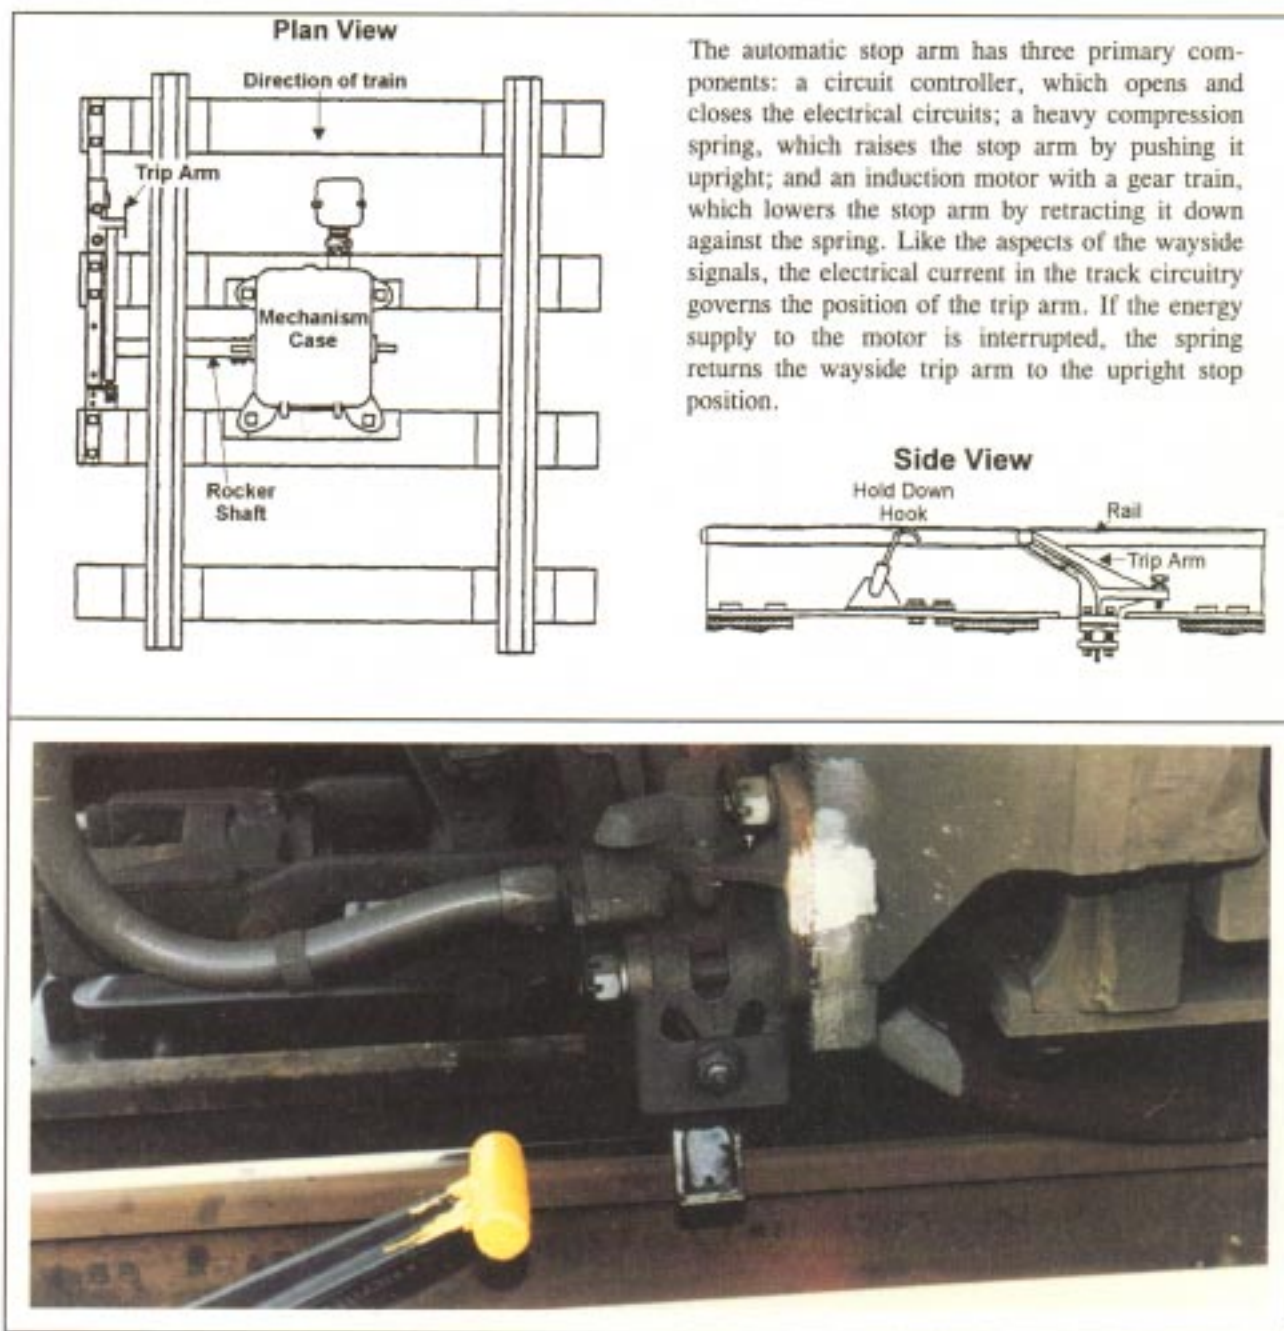
Investigators examined the trip cock arm on the No. 1 end of car 4461 and observed a small amount of yellow paint near the end of the arm. They measured the distance of the trip cock arm to the rail and determined that the arm was about 1-1/4 inches above the rail, which was within the NYCT standard. Investigators had the trip cock assembly removed and taken to the NYCT Coney Island Pneumatic Shop, where new and rebuilt trip cocks are qualified

Figure 5 — Top illustrations show plan and side view of a wayside trip arm. Photograph shows a lowered trip arm (painted yellow) in front of a train trip cock.

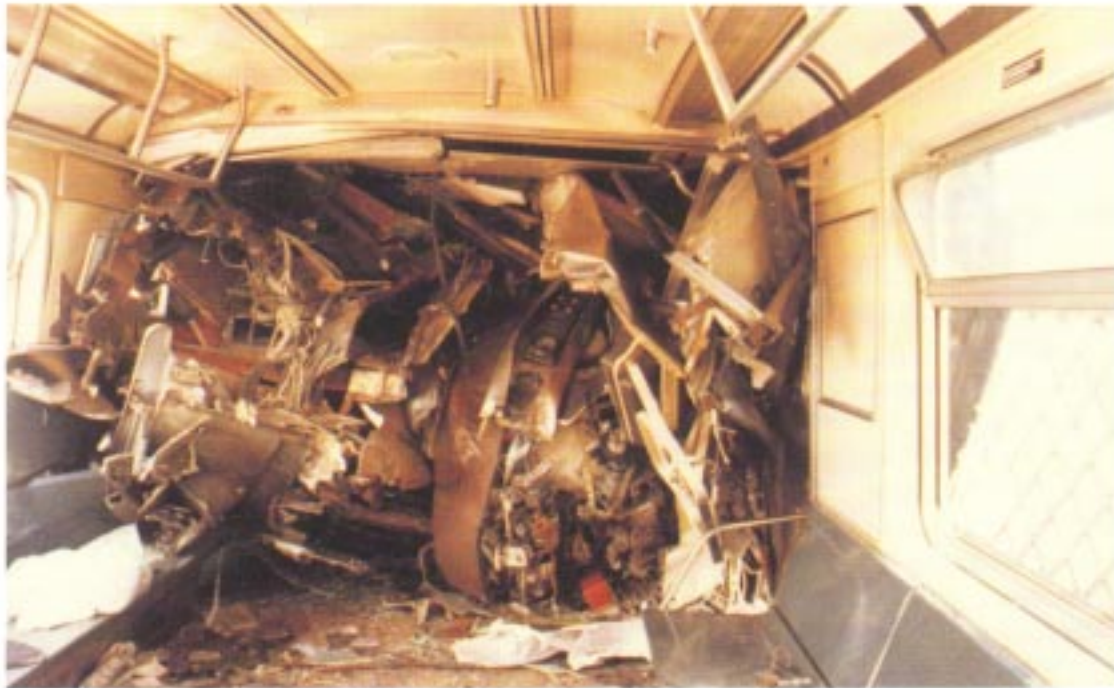
Wreckage — The lead car of the J train, 4461, partially telescoped about 17 feet into car 4664. The rear truck of car 4664 had been knocked off its center casting and had been moved forward about 7 feet, raising the car body about 6 feet into the air. The front end and operating compartment of car 4461 had collapsed inward (see figure 7). A summary of the damage to the individual cars follows.

J train damage — All eight cars suffered some degree of damage. The lead car, which struck the rear car of the M train, experienced massive carbody intrusion on the operator's cab end. The anticlimber and front structure was pushed in about 7 feet. The interior floor was penetrated, and had buckled upward and inward. The entire end of the car was essentially destroyed up to the horizontal cross member over the center pin. The front seat opposite the operator's cab was totally crushed. The operator's cab was totally crushed with no

Figure 7 — Interior damage to the lead car of the J train.

survival space remaining, and the rear wall of the cab was displaced backward. The remaining cars suffered damage to the draft gear (yoke and drawbar) and related parts, cracked bonnets, and bent anticlimbers (flanges).
