RAILROAD ACCIDENT REPORT

DERAILMENT OF BURLINGTON NORTHERN AND
SANTA FE RAILWAY COMPANY INTERMODAL FREIGHT
TRAIN S-CHILAC1-31, CRISFIELD, KANSAS
SEPTEMBER 2, 1998

**NTSB/RAR-00/01
PB2000-916301
Notation 7271
Adopted July 17, 2000**

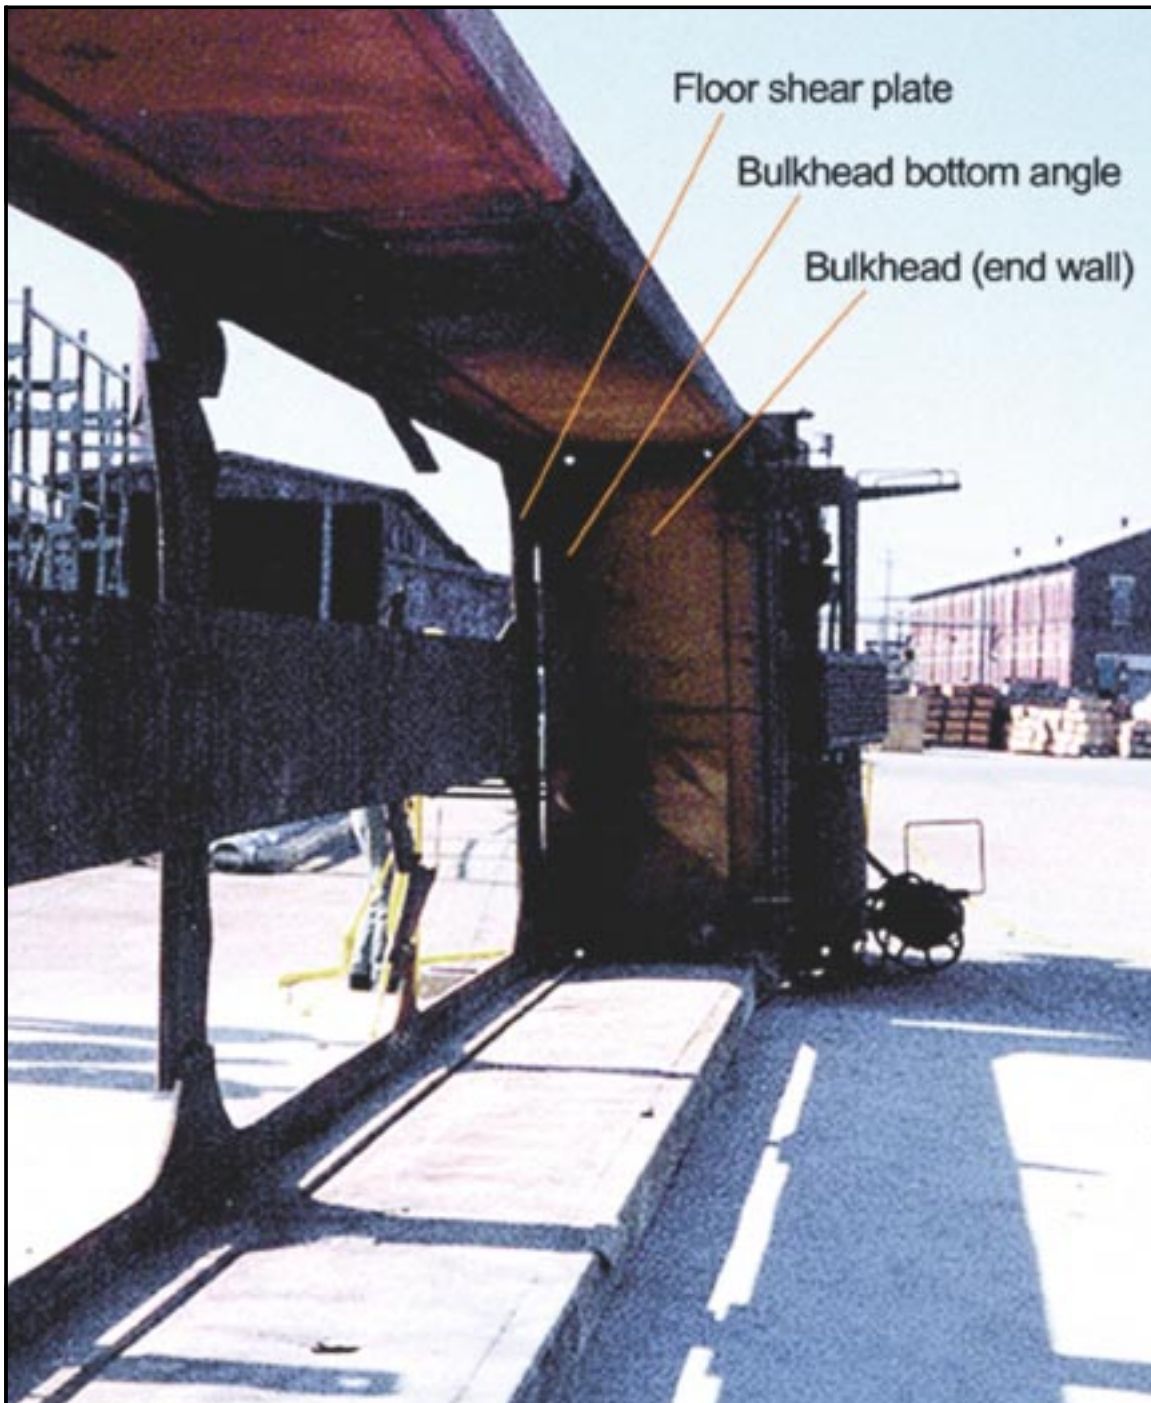
Figure 3. Separation between the floor shear plate and bulkhead bottom angle on DTTX 72318 (car as viewed lying on side)

Safety Board investigators visually examined the car and found a lateral fracture at a weld between the floor shear plate and the bulkhead bottom angle, at the leading end of the car's B platform.¹¹ In this area, the floor and end wall, or bulkhead, of the car meet at a right angle. The bulkhead bottom angle is attached between the floor shear plate and bulkhead face plate, as shown in figure 11. It contains drain holes in the bottom corners between the floor shear plate and sidewalls. Corner post angles are attached between the bulkhead face plates and the left and right sidewalls. All components are attached to each other with fillet welds.

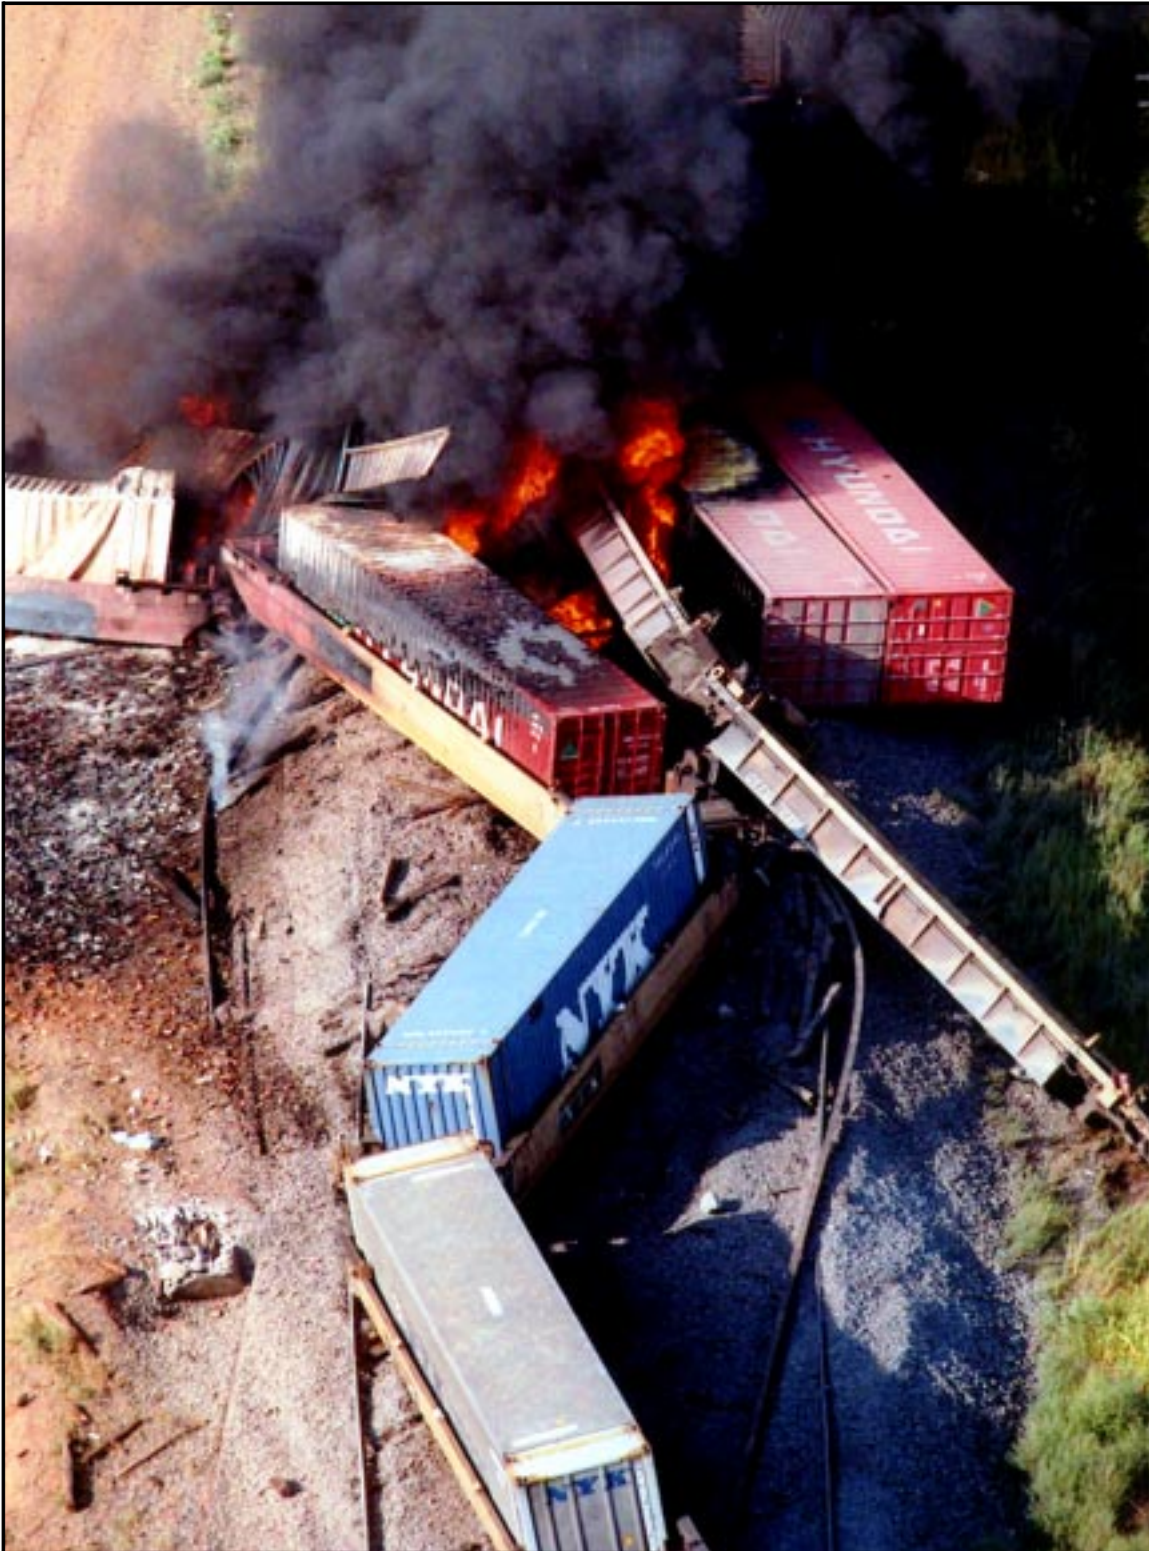
Figure 5. Aerial view of DTTX 72318 (photograph by *The Wichita Eagle*)

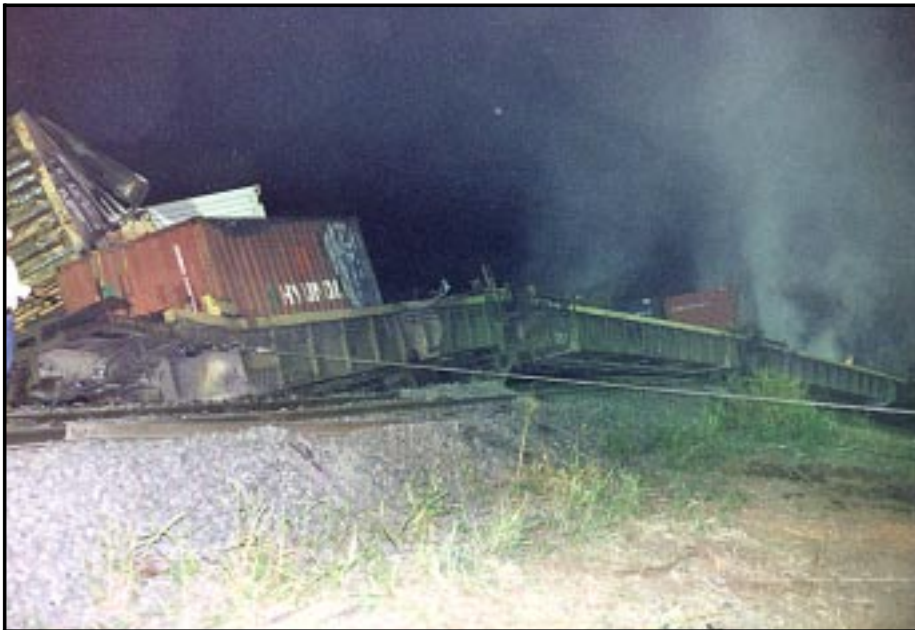
Figure 6. Five-platform car DTTX 72318 shortly after the Crisfield derailment

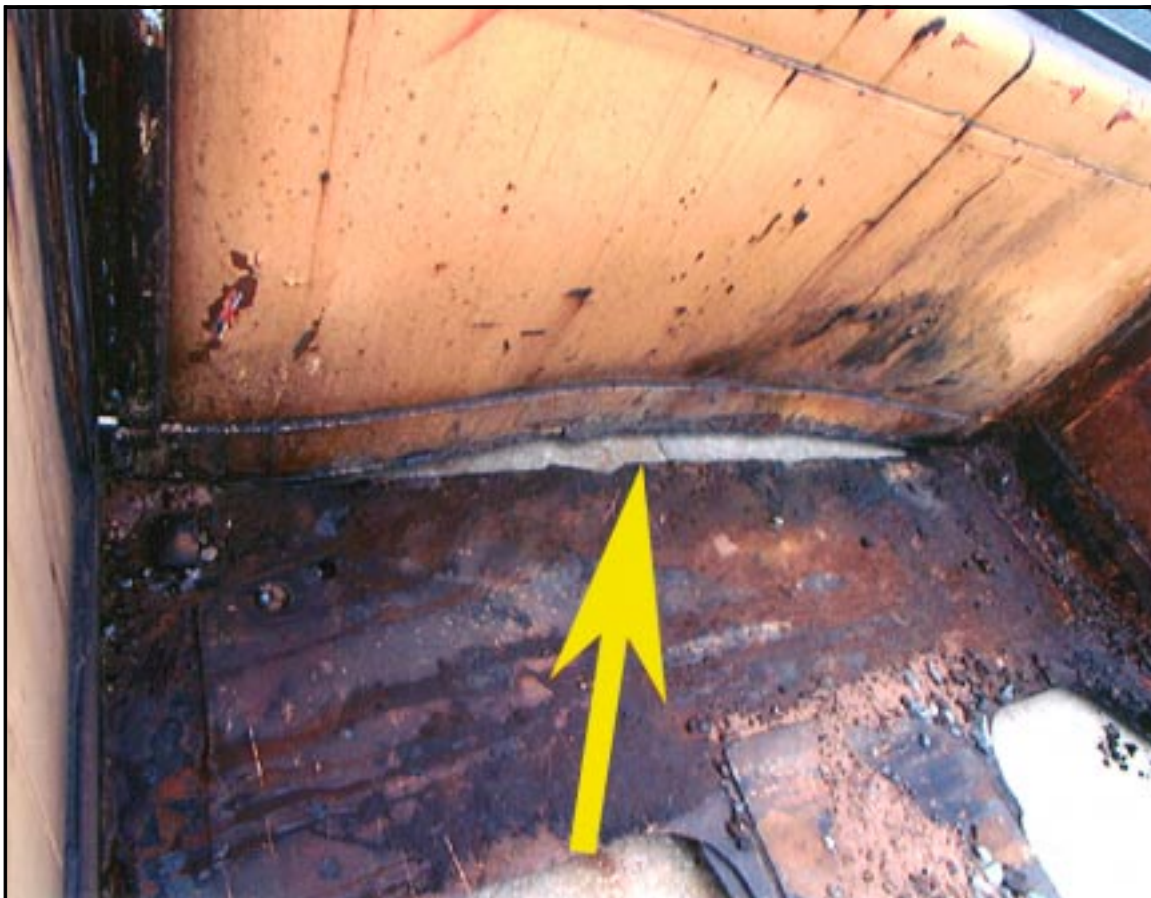
As viewed from inside the car, the fracture, for the most part, followed the toe of the weld on the floor-shear-plate side and penetrated completely through the floor shear plate. The sliver-shaped lateral fracture was about 92 inches long and about 4.8 inches at its widest point, longitudinally. (See figure 12.)

Figure 12. Gap as viewed from above car's platform

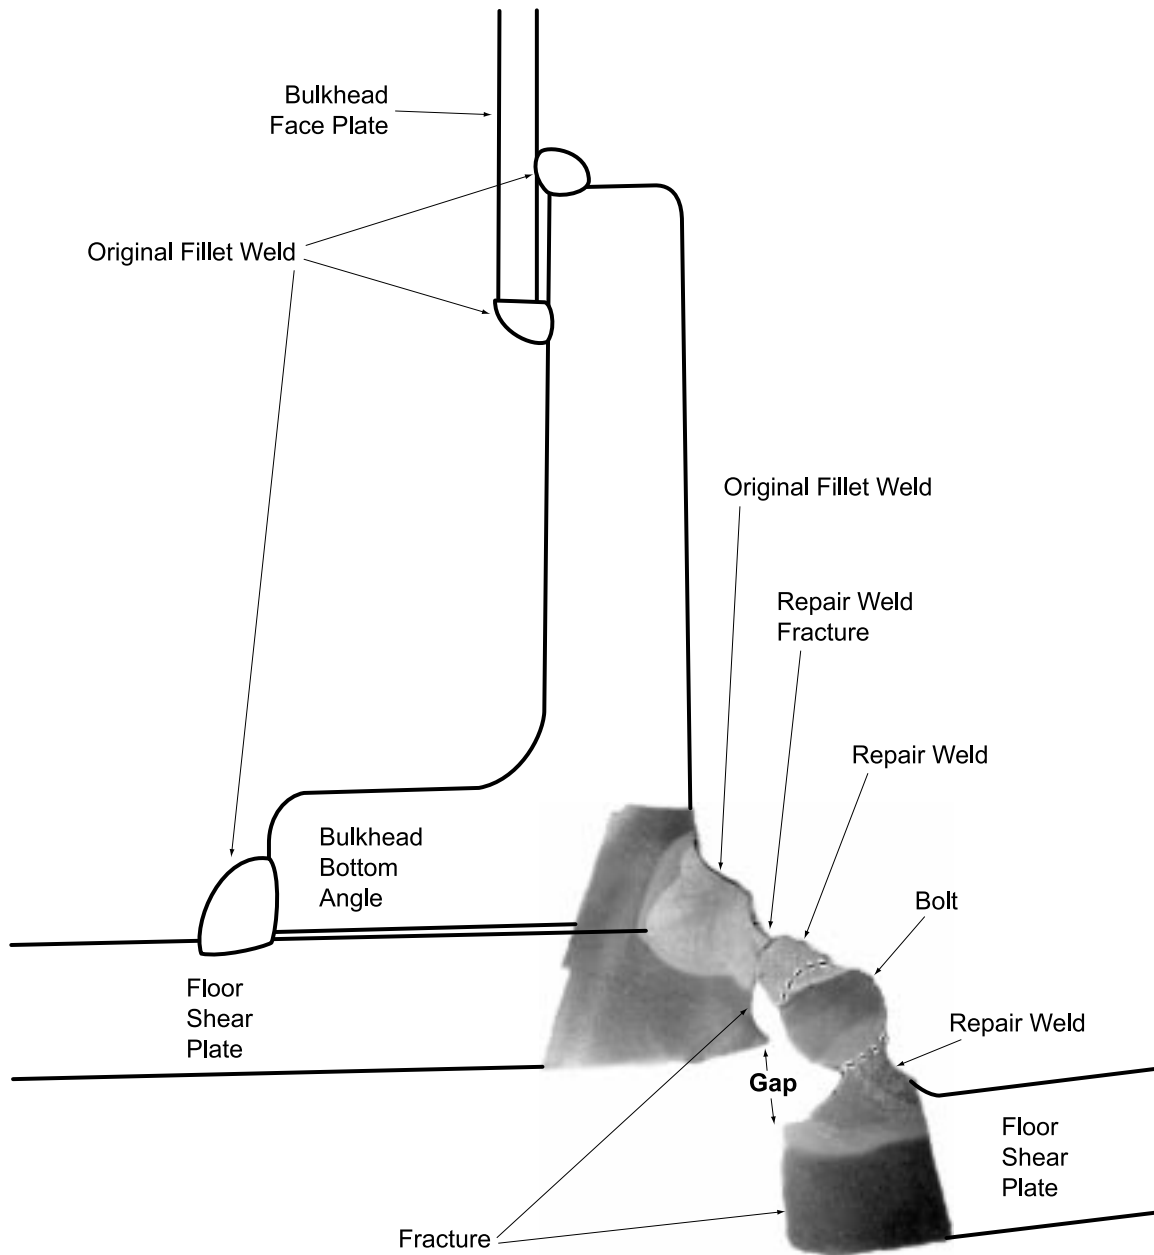
to the midpoint between the sidewalls. At some time, an 8-inch-long bolt had been welded between the floor shear plate and bulkhead bottom angle as filler metal to bridge the original 20-inch-long crack in the floor shear plate. (See figures 13 and 14.) The weld on one side of the bolt had been attached directly to the face of the fatigue fracture, and the downward deformed floor was not straightened or made flush with the mating bulkhead bottom angle. This weld repair had left an air gap (vertically about 0.3 inch) between the bottom of the bulkhead bottom angle and the upper surface of the floor shear plate. Furthermore, the thickness of the weld that bridged the gap between the bolt and fractured floor shear plate was about 0.2 inch, which was much less than the thickness of the floor shear plate (0.5 inch). The repaired area on the inside portion of the car had been covered with paint. The fracture faces remained exposed at the bottom side of the car.

Figure 13. Cross-section of the bolt (bound by dashed lines) welded between the floor shear plate and bulkhead bottom angle of DTTX 72318. (Sketch of the surrounding structure was added for orientation purposes and is not to scale. Bolt section photographed at 1.8X magnification.)

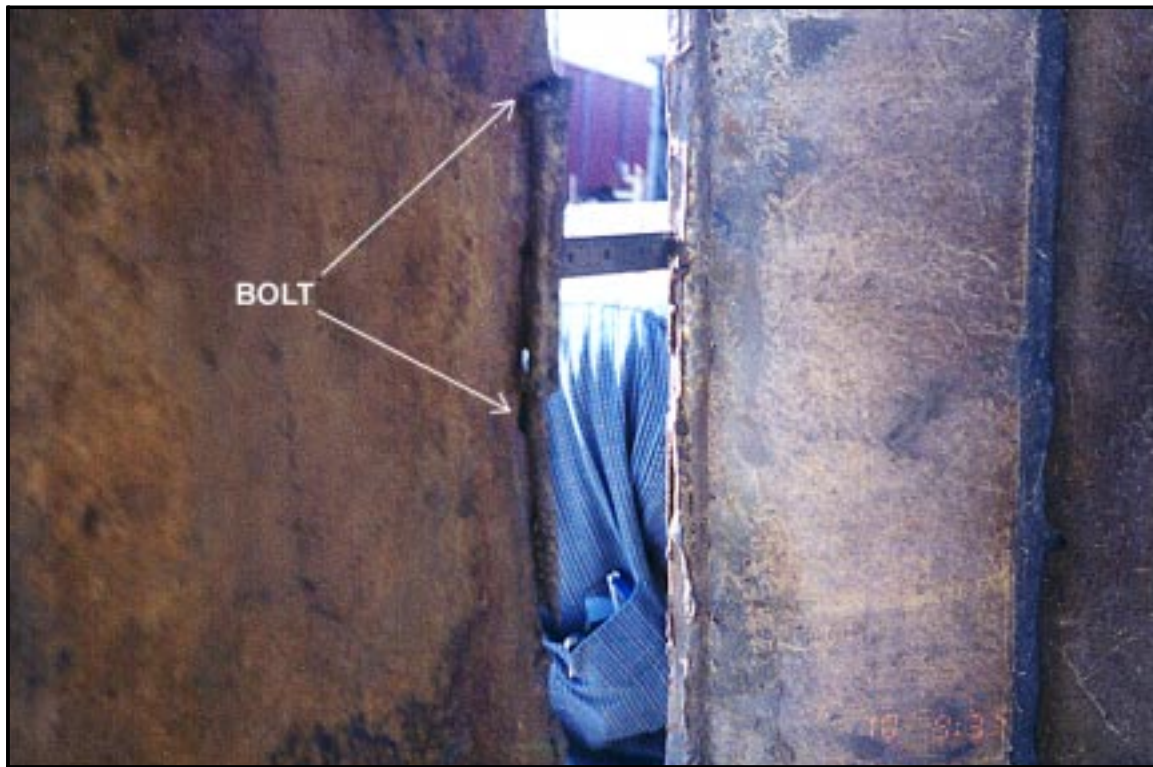
According to the Thrall Assistant Vice President, Product Engineering,¹² such a repair was “not proper” because it did not restore the floor shear plate to its original strength and condition. DTTX 72318 repair records did not state where the repair had been done or who had done it. In addition, DTTX records indicated that TTX Company had not been billed for the repair.

Figure 14. Bolt used to make improper repair to DTTX 72318

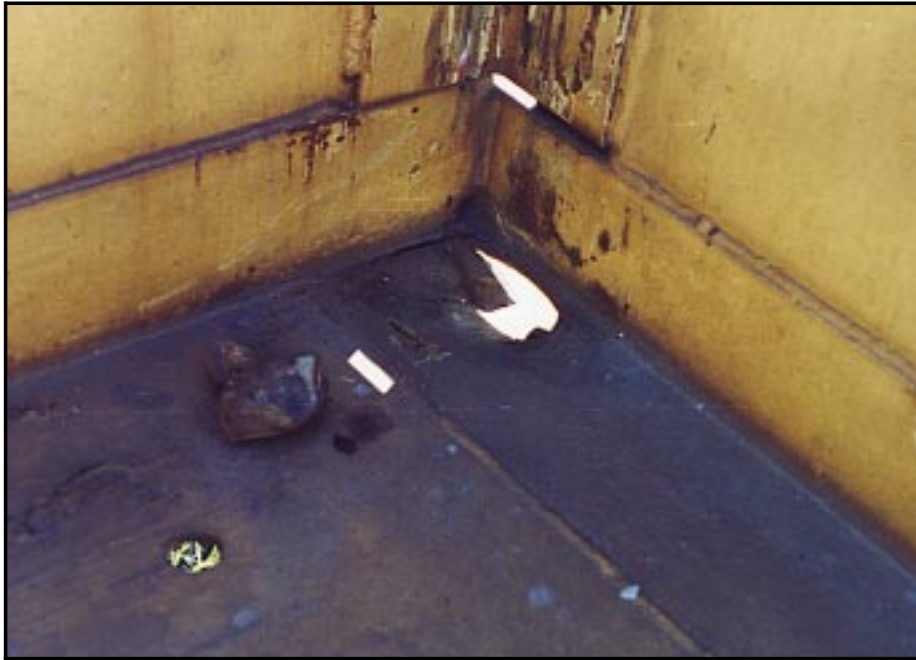
Figure 15. Damage caused by foreign objects to the platform floor of a Thrall double-stack car (two depressions and a hole). The larger depression (closer to hole) contains the imprint of a loose IBC.

bulkhead bottom angle. Five more cars with such cracks were found during inspections in Chicago; Memphis, Tennessee; Oakland, California; and Chehalis, Washington.²⁴ In every case, the UP found evidence of damage by a foreign object. According to the AAR, the UP Mechanical Department informed the AAR, Thrall, and TTX Company of its inspection results and of its concern that a safety problem existed. (See figure 15 for a representative example of a damaged Thrall car.)
