National Transportation Safety Board  
Washington, D.C. 20594

Highway Accident Brief

**Accident No.:** HWY-98-SH-010  
**Accident Type:** Highway-rail grade crossing collision  
**Location:** Grantsville, Utah  
**Date and Time:** December 3, 1997; 5:30 p.m.  
**Vehicle 1 (V1):** 1996 Kenworth tractor with a double semitrailer hauling potash  
**Vehicle 2 (V2):** Freight train  
**Injuries:** 1 minor injury

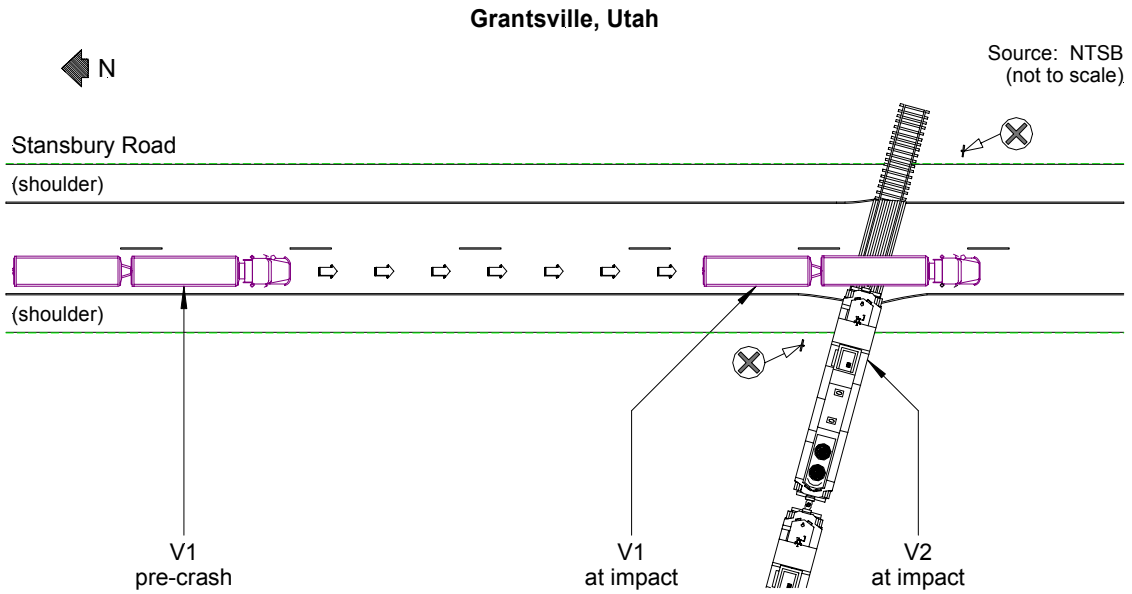
**Figure 1.** Accident diagram.

The truckdriver stated that he saw the train when he was about 120 feet away from the passive grade crossings on Stansbury Road. (See figure 1.) He said that he believed he would jackknife the truck if he tried to stop and decided to accelerate in an attempt to get across the tracks before the train arrived. The train struck the right side of the first semitrailer. At impact, the first trailer detached from the tractor and severed into three pieces. The second trailer detached from the front trailer and wrapped around the front of the locomotive, rupturing the fuel tank of the locomotive. One train crewmember sustained minor injuries.

The National Transportation Safety Board determines that the probable cause of the accident was the truckdriver's poor judgment in attempting to cross the tracks before the train arrived.
