National Transportation Safety Board
Washington, D.C. 20594
Railroad Accident Brief

Railroad Accident Number: ATL-00FR-004
Rail System: Metropolitan Atlanta Rapid Transit Authority (MARTA)
Train: MARTA train 103
Accident Type: Train striking technicians fouling the track
Location: Near MARTA Avondale Station in Decatur, Georgia
Date and Time: February 25, 2000, at 8:13 a.m.
Fatalities/Injuries: One fatality and one serious injury

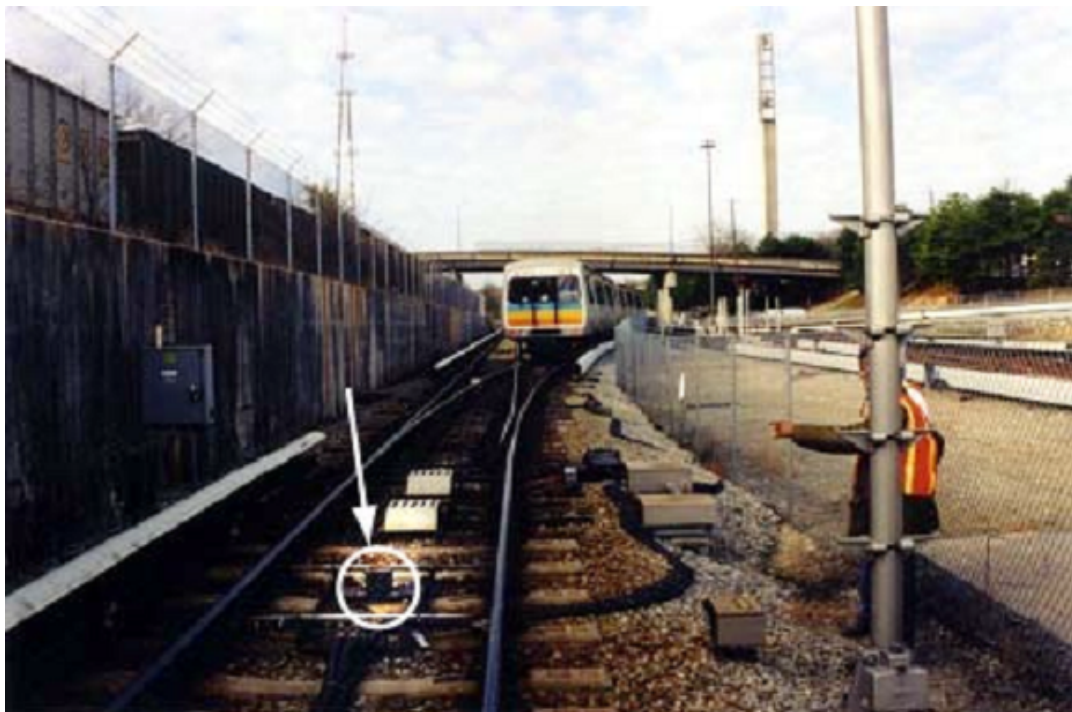
About this time, the technicians were at a relay box between the rails about 1,000 feet east of Avondale Station, about 27 feet past the switch where the middle track converged with the main track. (See figure 2.) While at this location, they unlatched and removed the relay box cover. The technicians had not placed flagging devices to warn train operators of their presence, nor had they placed shunts on the rail to activate the signal system as a warning for approaching trains.

Figure 2. Train approaching the accident location from Avondale Station. The relay box that the technicians had opened is circled and indicated by the arrow.
