# Uncontrolled Movement, Collision, and Passenger Fatality on the Angels Flight Railway in Los Angeles, California February 1, 2001

## Railroad Accident Report NTSB/RAR-03/03

**NTSB/RAR-03/03  
PB2003-916303  
Notation 7575  
Adopted August 5, 2003**

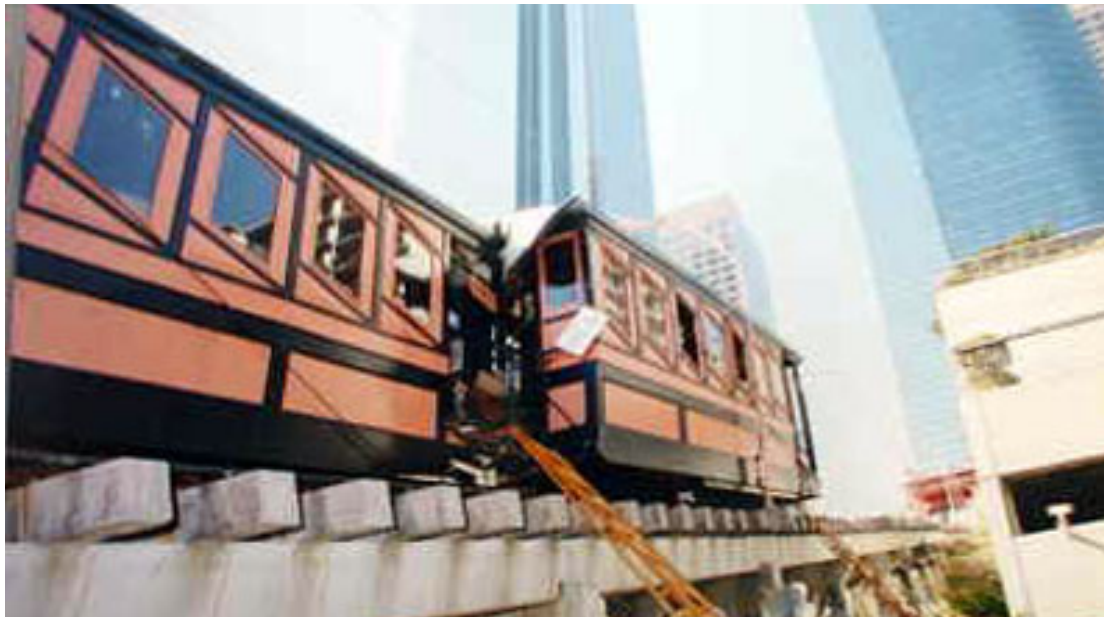
**Figure 3.** Position of cars after collision.

The runaway car derailed during the crash; the struck car did not. The derailment marks and the dispersal of debris after the collision indicated that both cars moved about 20 feet downward from the point of impact.

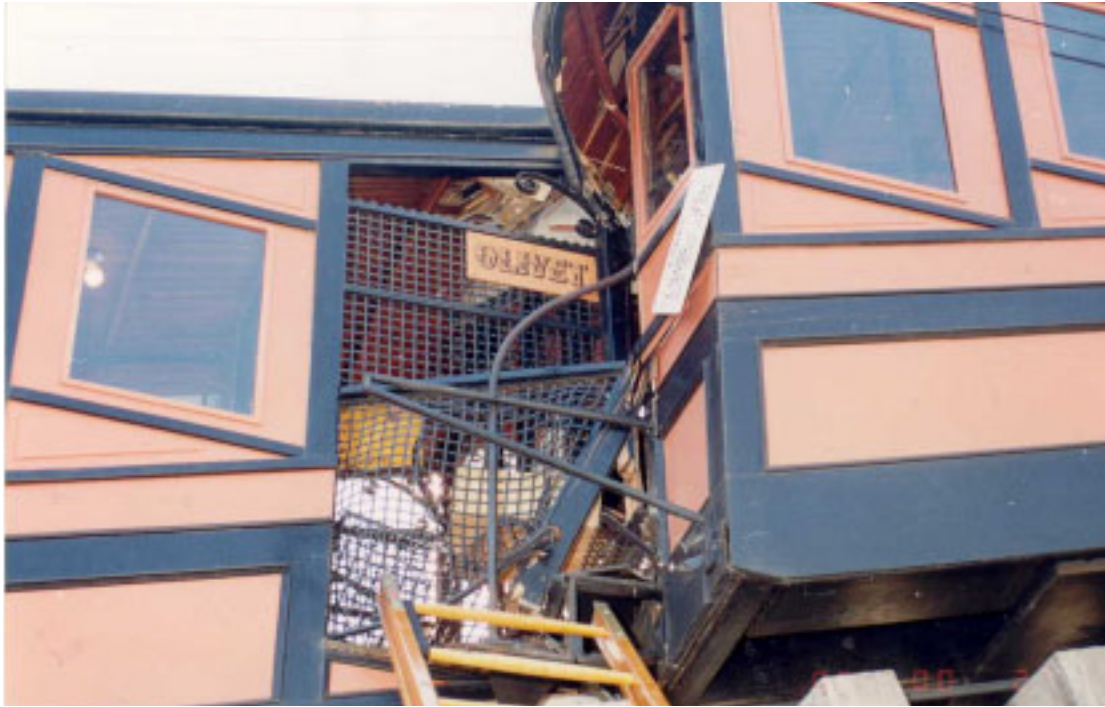
**Figure 6.** View of some of the exterior damage to cars.

The lower inboard quarter of the runaway car struck the upper inboard quarter of the stationary car. Approximately 4 feet of each car was crumpled. (See figures 6 and 7.)

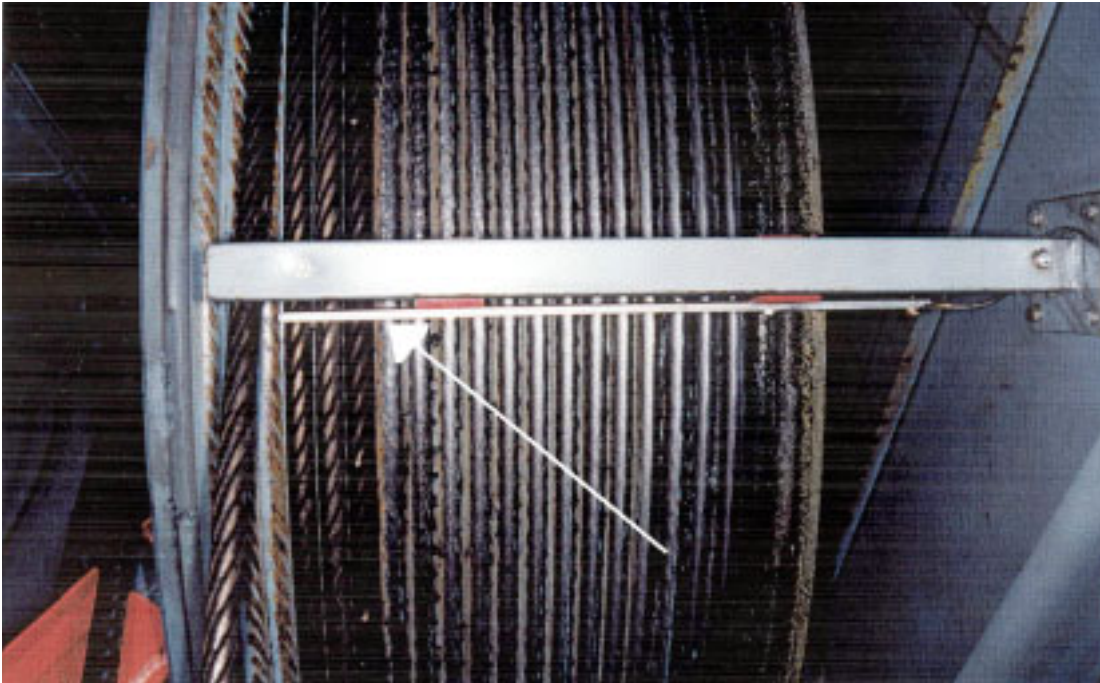
**Figure 11.** Deropement device.

Both of the Angels Flight cable drums were equipped with switches intended to activate the system brakes to stop the funicular in the case of deropement. (See figure 11.) The switches contained pressure-sensitive edges and were mounted directly above the surface of each haul cable when it was stored on its respective drum. Because the deropement switches did not extend all the way across the drum's surface, the outboard haul cable coils could derope without triggering the deropement switch, as occurred with the *Sinai* drum in this accident.

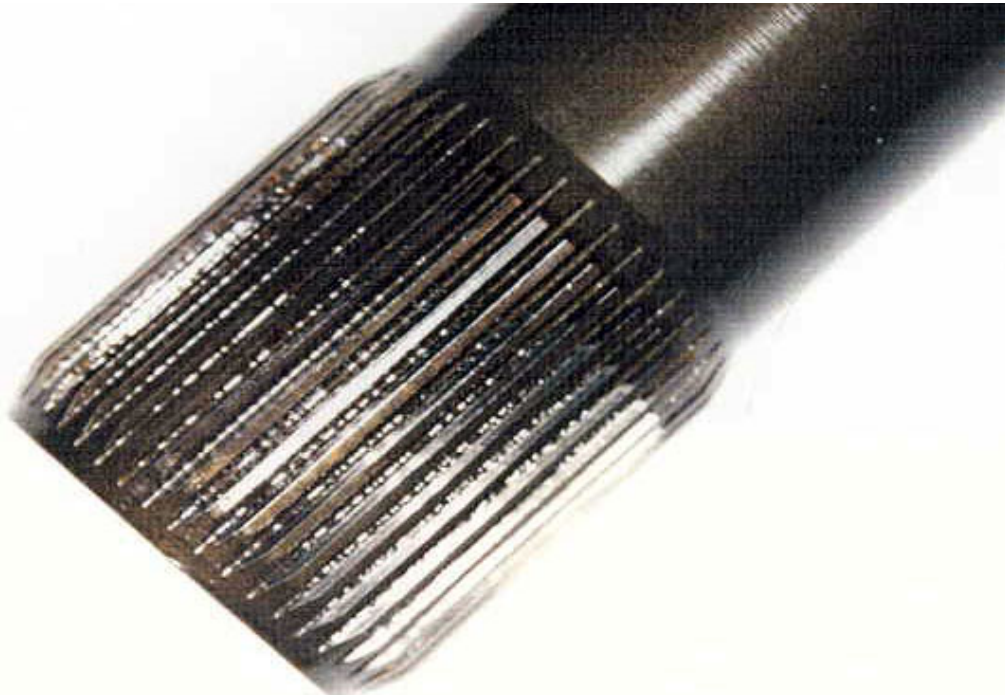
**Figure 12.** Splined end of *Sinai* axle shaft that engaged the planetary gear receiving hub.

**Axle Shafts and Splines.** The Caterpillar-manufactured axle shafts for both the *Sinai* and the *Olivet* sides were found to be in good condition. For the *Sinai* car, metal shavings were found on the surface of the axle shaft, and the splines of the end of the axle shaft that engaged the planetary gear were slightly worn but otherwise intact. (See figure 12.) The outside diameter of the *Sinai* shaft, measured at the splines that mated with the receiving hub splines, was 2.912 inches. The outside diameter for the *Olivet* shaft at the corresponding splines was 2.917 inches.

Both axle shafts were subjected to Rockwell C hardness tests.<sup>13</sup> The average Rockwell C hardness for the *Olivet* shaft was 57 and for the *Sinai* shaft, 60. These hardness levels are near the higher end of the range measured for steel and indicate that the axle shafts were subjected to a hardening heat treatment to maximize their load-bearing capacity.

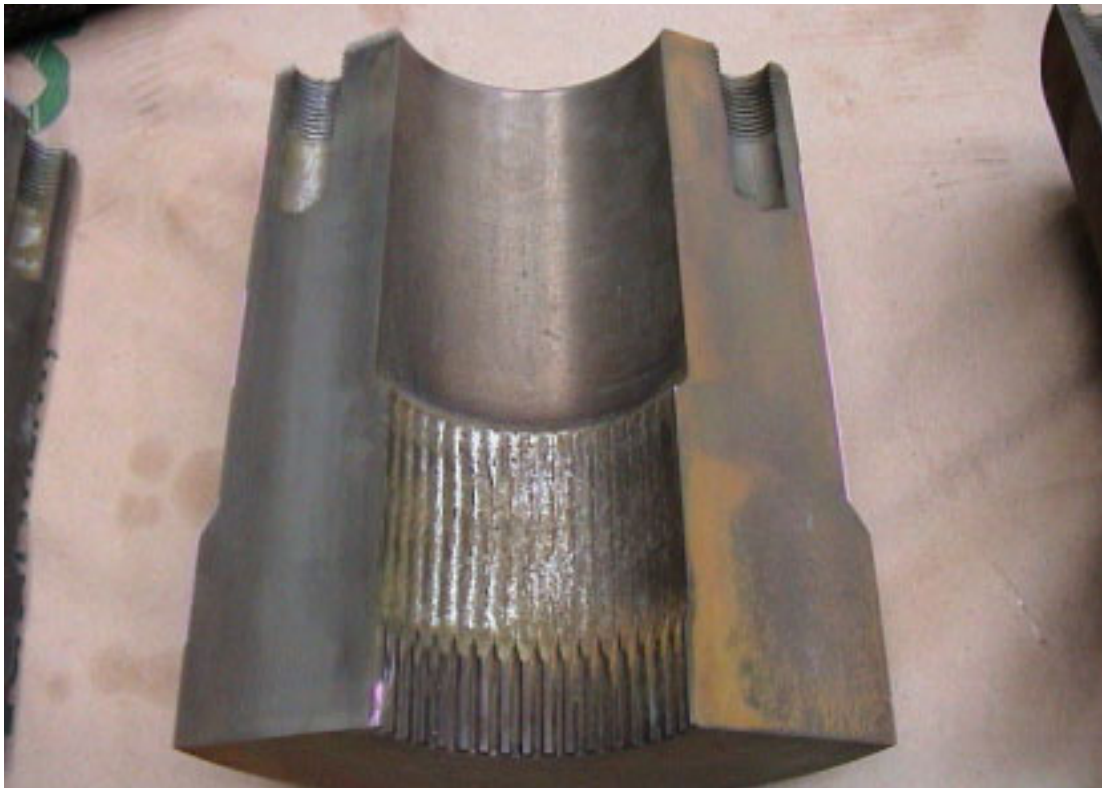
**Figure 13.** Section of planetary gear receiving hub showing stripped splines.

**Sinai Receiving Hub and Splines.** The Yantrak-supplied receiving hub for the *Sinai* planetary gear was pressed out of the gear and then sectioned by electron discharge machining. The splines that mated with those of the axle shaft were found to be stripped, thereby preventing the interlocking of the planetary gear with the cable drum. (See figure 13.) Thus, the *Sinai* car's cable drum had effectively become disconnected from the drive mechanism, and it became freewheeling. The metal shavings removed from the surface of the *Sinai* shaft were consistent with the metal of the sheared female splines of the planetary gear receiving hub with which the *Sinai* axle shaft splines mated. The sectioned piece from this receiving hub was polished using standard metallurgical techniques and then examined under an optical microscope. The microstructure was found to consist of ferrite and pearlite typical of an unhardened steel. The sample of the receiving hub was then subjected to hardness testing at a variety of locations through its cross section, both near and away from the spline teeth. The hardness of the steel was between 78.0 and 80.5 on the Rockwell B scale for softer metals and was consistent throughout the piece. The receiving hub's average Rockwell B hardness of 79 is typical of a nonheat-treated, soft steel. Thus, the *Sinai* receiving hub was softer than the axle shaft.

investigated further, through a gearbox teardown, for example, they may have discovered the damage in the *Sinai* car's planetary gear hub splines.
