**Derailment of Northeast Illinois Regional
Commuter Railroad Train 519 in
Chicago, Illinois
October 12, 2003**

Railroad Accident Report
NTSB/RAR-05/03

**NTSB/RAR-05/03
PB2005-916303
Notation 7615A
Adopted November 16, 2005**

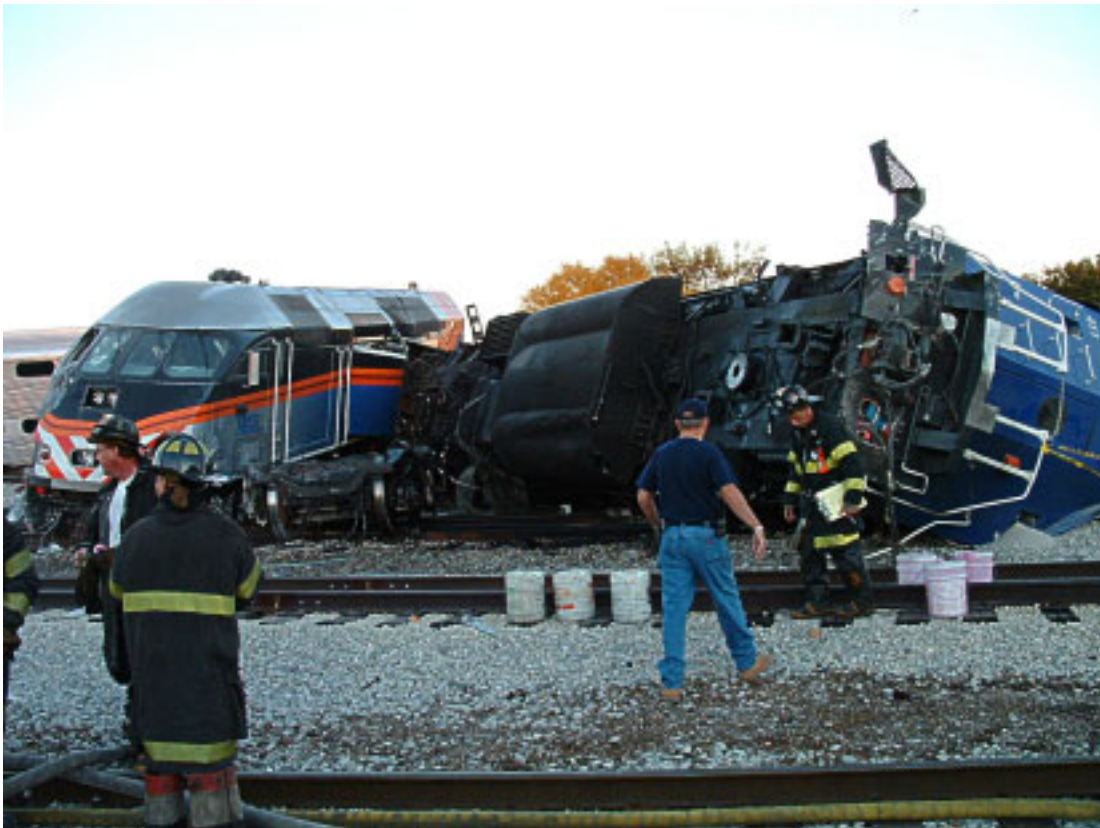
automatically as the train derailed. The locomotives and cars separated. Both locomotives and all five of the passenger cars derailed, striking a Metra passenger-equipment wash building on track 6 at Metra's 47th Street Yard. The lead locomotive overturned onto its right side, facing south. The trailing locomotive derailed upright, facing north adjacent to the lead locomotive. The derailed passenger cars remained upright and parallel to the track structure. (See figure 2 for a photograph of the derailed locomotives and figure 3 for a photograph of the derailed passenger cars.)

Figure 2. The lead locomotive (on its side) and second locomotive at their final resting positions.

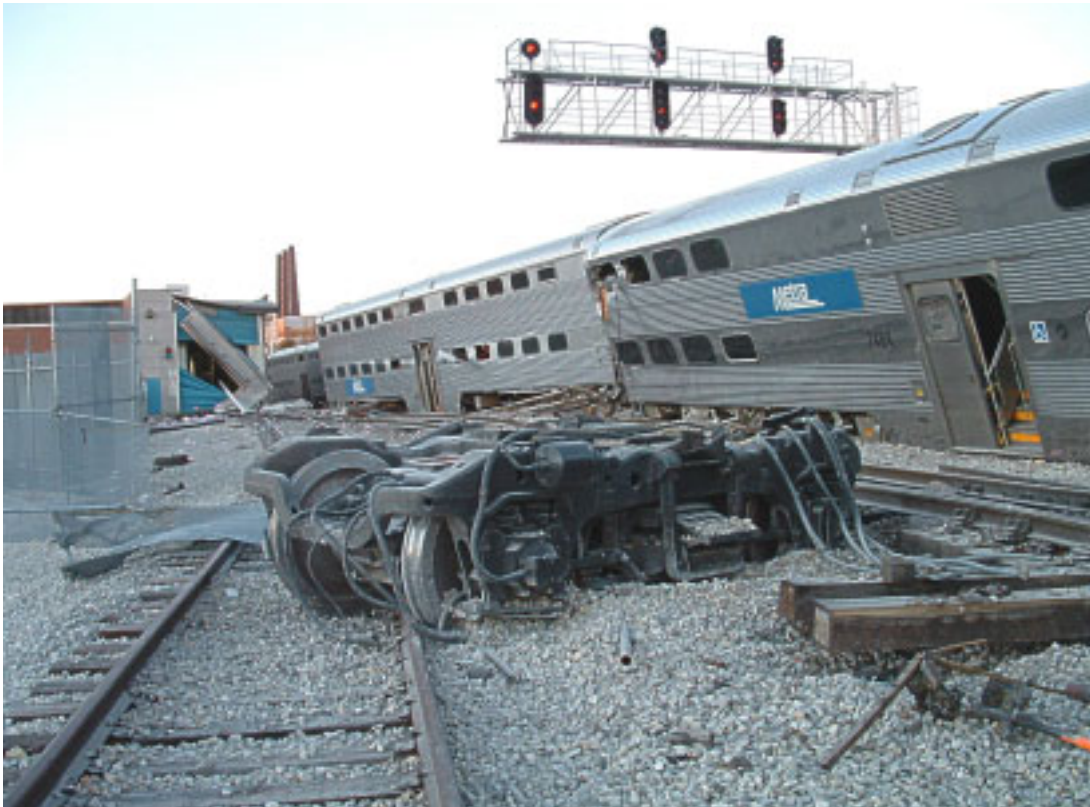
Figure 3. All five passenger cars derailed but remained upright. The trucks from the lead locomotive dislodged (foreground).
