# National Transportation Safety Board

## Railroad Accident Brief

**Accident No.:** DCA-04-FR-006  
**Location:** Carrizozo, New Mexico  
**Date:** February 21, 2004  
**Time:** 7:54 a.m. mountain standard time<sup>1</sup>  
**Railroad:** Union Pacific Railroad  
**Property Damage:** \$1,964,543  
**Fatalities:** 2  
**Injuries:** 0  
**Type of Accident:** Collision

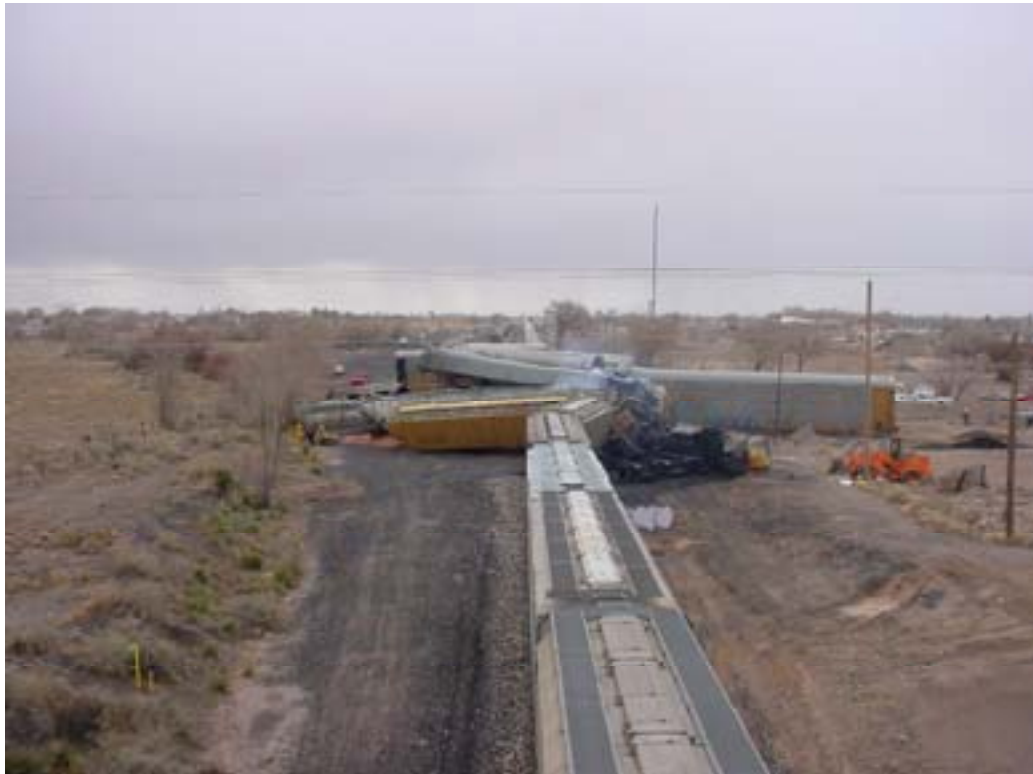
**Figure 1.** Overpass view of wreckage.

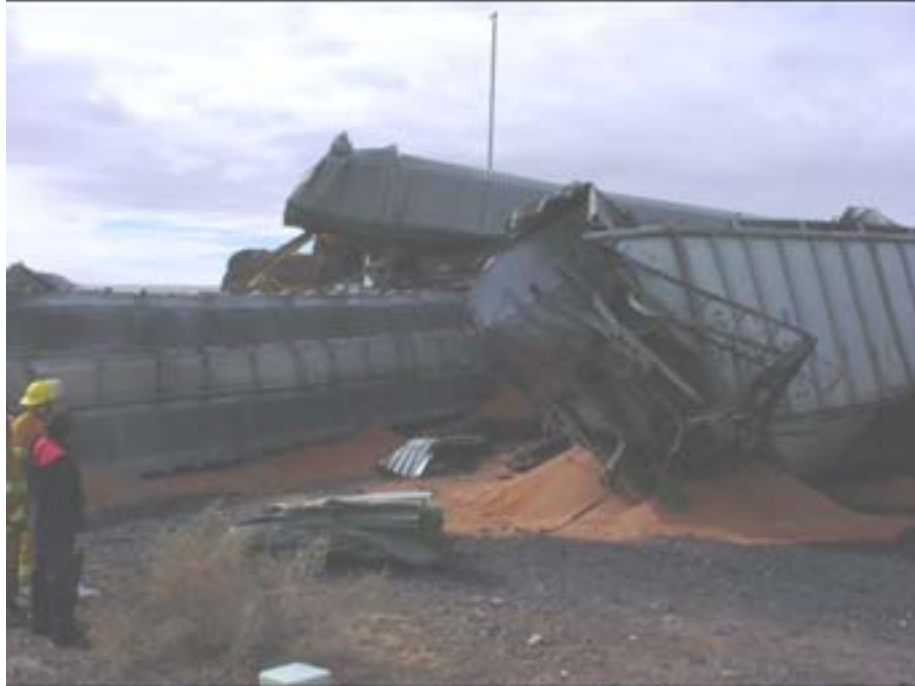
**Figure 2.** Wreckage of two Union Pacific Railroad freight trains.
