## AIRCRAFT ACCIDENT REPORT

UNCONTAINED ENGINE FAILURE/FIRE  
VALUJET AIRLINES FLIGHT 597  
DOUGLAS DC-9-32, N908VJ  
ATLANTA, GEORGIA  
JUNE 8, 1995

**Adopted: July 30, 1996**

**Notation 6579A**

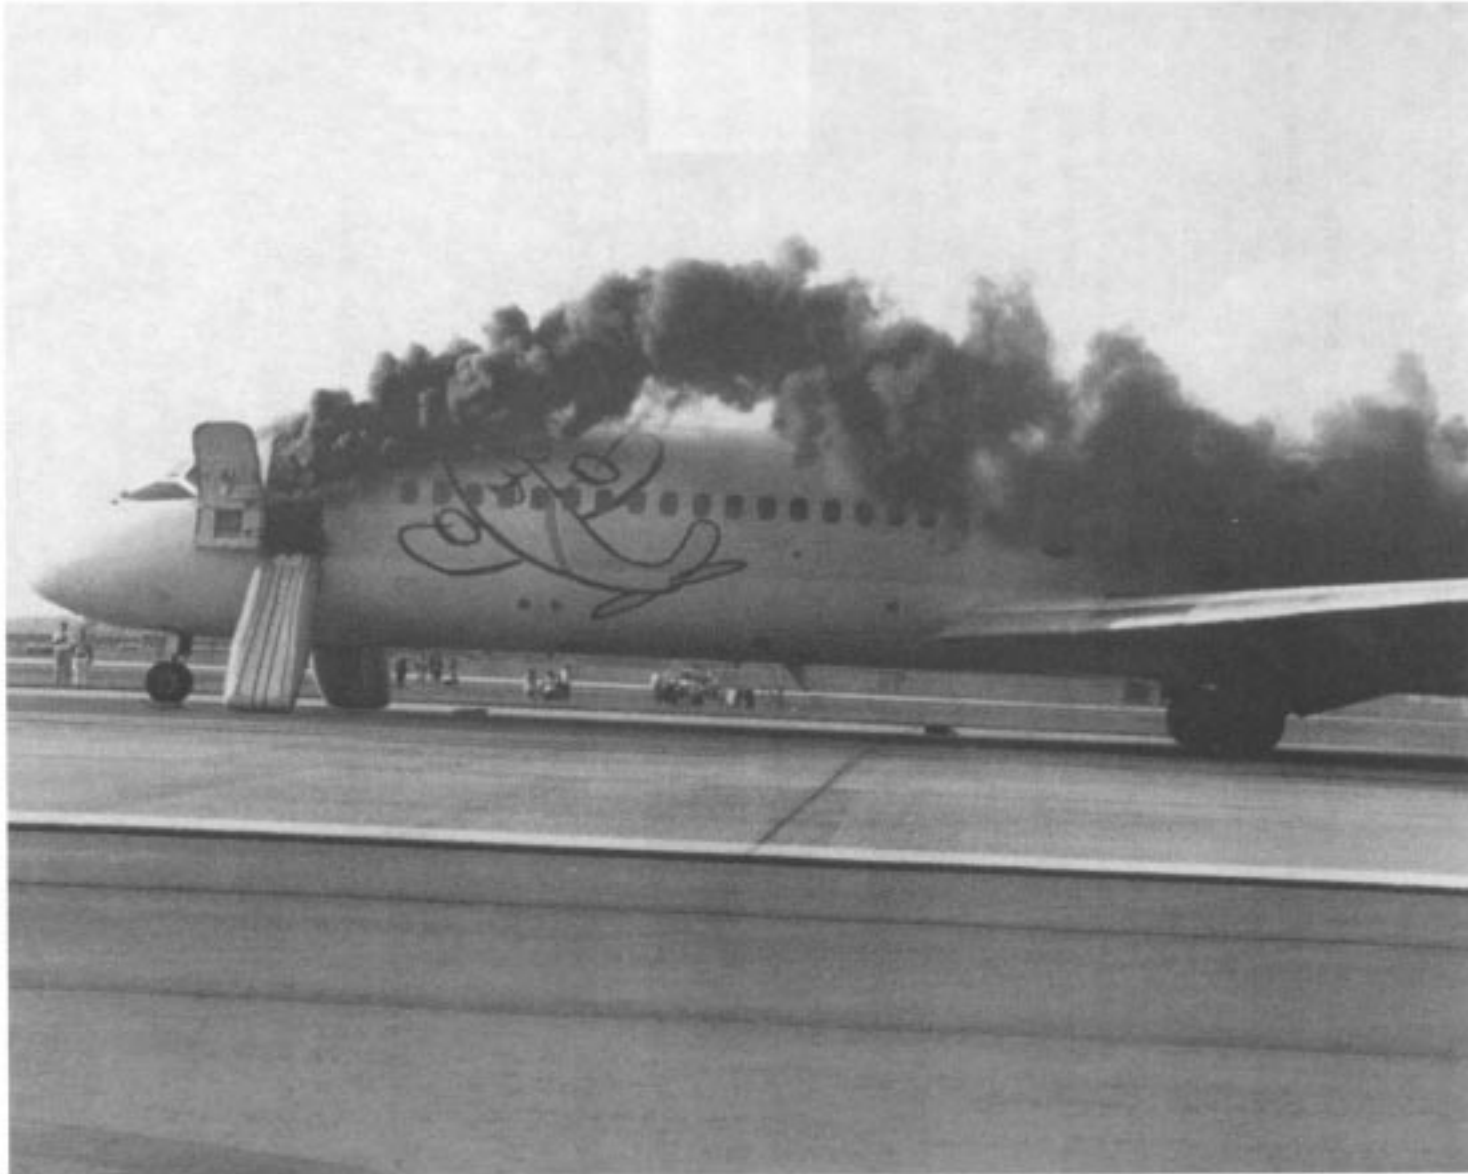
The fuselage was destroyed by fire, which gutted the interior, burned through the roof of the forward cabin area of the airplane, and consumed most of the cabin overhead. There was substantial exterior damage with circumferential outward tearing of the right engine cowl and engine case in the plane of rotation of the right engine 7<sup>th</sup> stage high pressure compressor (HPC) disk. There was also shrapnel damage to the fuselage and left engine cowl.

Figure 3—Photograph of flight 597 after uncontained engine failure

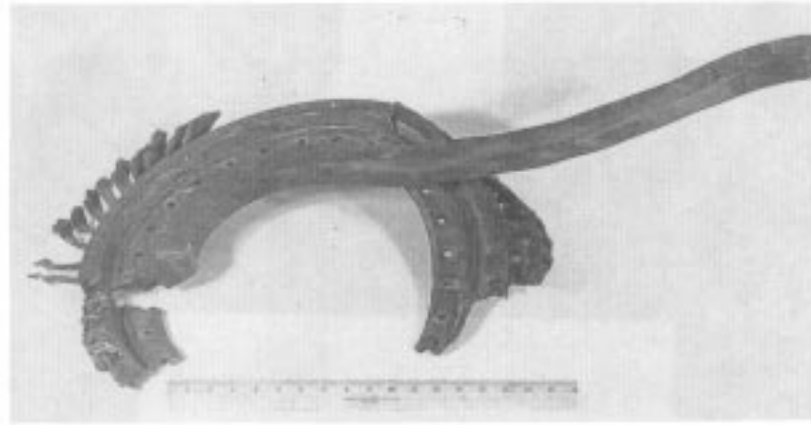
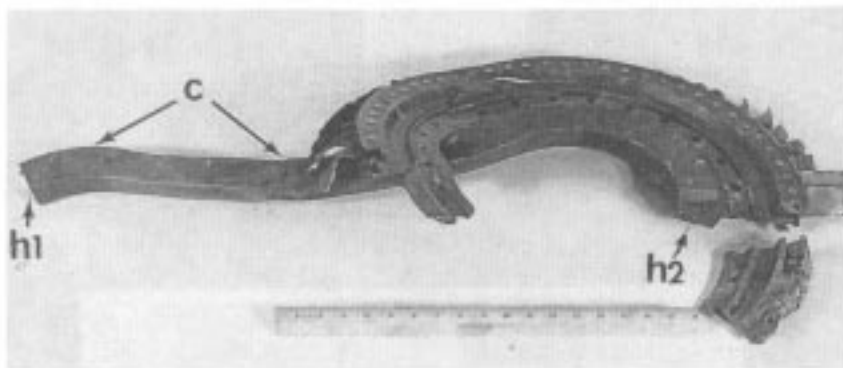
The larger piece of the recovered disk was fractured circumferentially (see arrows "c," figure 4), which is typical of overstress. About ¼ of the disk outward (toward the rim) of the bore was separated and not recovered. There was a radial fracture of the disk bore at the position shown by arrows "h1" and "h2" in figure 4. Examination of these fractures showed that they were matching overstress separations and therefore accounted for the complete separation of the bore section of the disk.

Figure 4—Overall views of 7<sup>th</sup> stage compressor disk as received

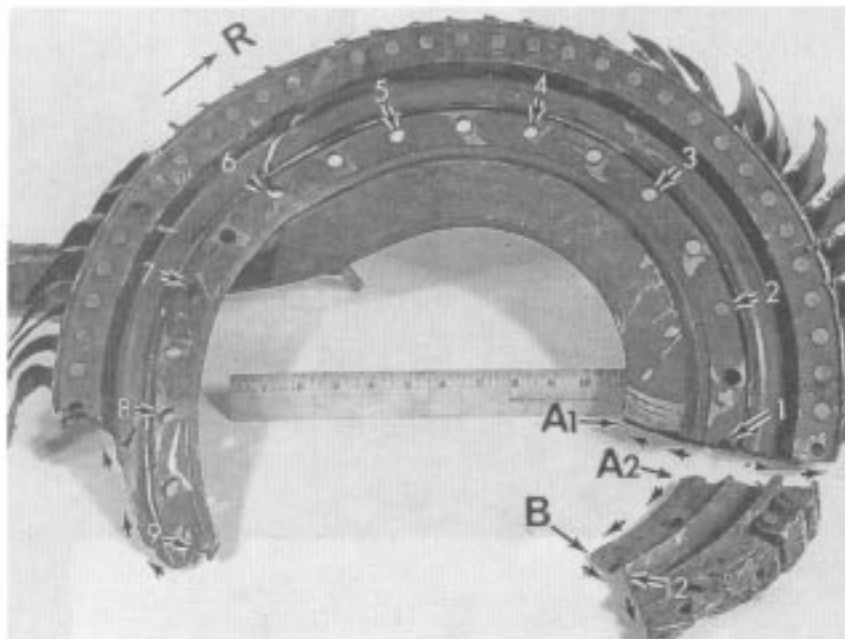
Figure 5 shows the aft face of the two recovered pieces situated relative to each other by fracture matching. The SR holes are shown by arrows "1" through "9" and arrow "12" in figure 5. The SR hole numbering was arbitrarily begun at the radial fracture plane indicated by arrows "A1" and "A2" in figure 5 and progressed sequentially counterclockwise looking forward around the disk (as shown in figure 5). The missing section of web would have contained SR holes "10" and "11" in the above numbering sequence, and three tierod holes.

Figure 5—View looking forward showing bulk of the 7<sup>th</sup> stage compressor disk

Fatigue cracking was also evident radiating outboard from other SR holes, indicated by arrows "4," "6," "8," "9," and "12" in figure 5. The largest of these fatigue cracks was 5 mm (0.20 inch) outboard from its respective hole. Most of the secondary cracks appeared to initiate at well-defined corrosion pits in the hole wall with the largest and deepest pit measuring 0.01-inch wide at the hole wall and being about 0.003-inch deep. Magnified examination of the cross section of the crack disclosed a surface deposit on the pit cavity wall and hole wall surfaces indicative of the nickel-cadmium plating.

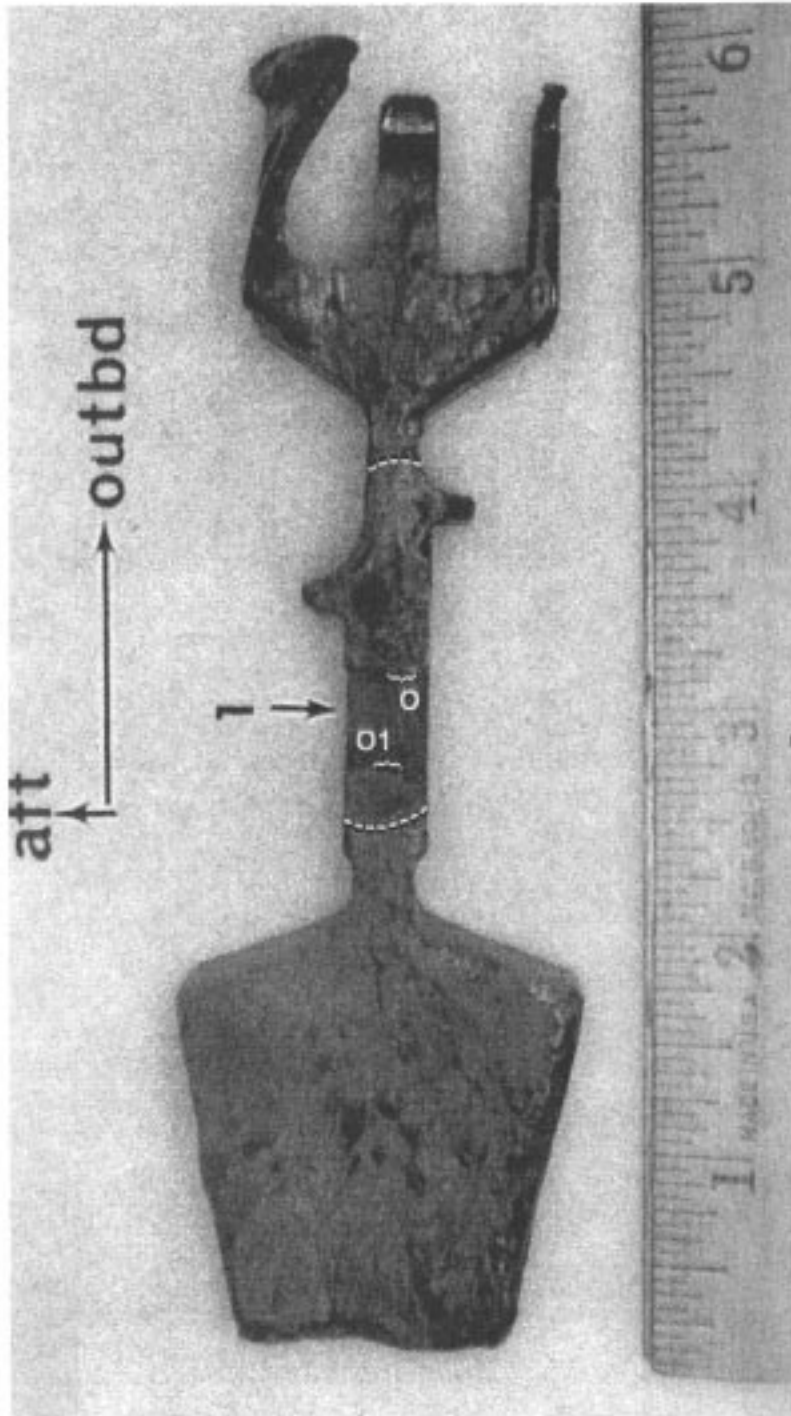
Scanning electron microscope (SEM) examination established that fatigue cracking originated from numerous pits in the hole wall and progressed radially inboard (toward the center of the disk) from SR hole "1," approximately 6.9 millimeters (mm) (0.27 inch). SEM examination also showed evidence of fatigue cracking outboard (toward the rim) from SR hole "1" that measured 22.25 mm (0.88 inch). Figure 6 shows the fracture surface containing the primary fatigue crack.

Figure 6—Fracture surface containing the primary fatigue cracking

Visual and SEM examinations of the outboard fracture surface from SR hole "1" showed extensive post-fracture smearing that obliterated most of the microscopic fracture features on the fracture surface. However, some undamaged fracture areas were found that indicated an origin area at the outboard wall of SR hole "1." Features outside of the smeared region up to a distance of about 3 mm (0.12 inch) showed a granular appearance with no evidence of striation development. At this point, fatigue striation development was noted that continued outboard approximately 22.25 mm (0.88 inch) from SR hole "1."

Striation spacing measurements of the fracture surface of SR hole "1" were attempted but hampered by the smearing in the fracture surface. The striation spacing in the granular type fracture regions near the origin were possibly unresolvable or nonexistent. Striation spacings outside of the granular fracture regions and smearing for the outboard fatigue crack from SR hole "1" averaged about 2 microns (0.002 mm) from about 3 mm to the terminus at 22.25 mm. This indicated that at least 9,500 striations (19 mm/0.002 mm per striation) were present along this fatigue region.

The 0.88-inch fatigue crack outboard from SR hole "1" was the longest fatigue region at any of the SR holes. The crack lengths from each side of the hole combined with the diameter of the SR hole (0.410 inch) gave a calculated overall crack length of 1.56 inch for SR hole "1" at the time of disk separation.
