**NATIONAL TRANSPORTATION SAFETY BOARD
WASHINGTON, D.C. 20594**

Marine Accident Brief No. DCA03MM028

Vessel: U.S. Passenger Vessel *Safari Spirit* O.N. 631818, 105 feet long (LOA), 24.5 feet wide, 6.5-foot draft, 190 gross tons (domestic), 231 gross tons (International Tonnage Convention [ITC]), uninspected, built in 1981

Accident Type: Grounding and sinking

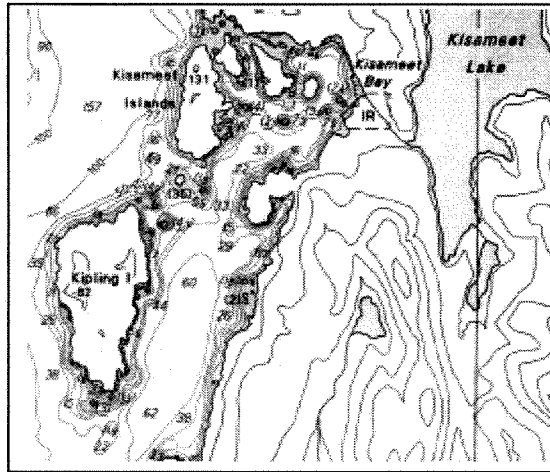
Figure 2. Actual-size portion of Canadian Chart No. 3936 showing Kisameet Bay.

The chart shows much more navigable water south of the submerged rock and continuing on west into Fisher Channel, which was the vessel's intended course to open water. The master stated that he used Canadian Chart No. 3936, which has a 1:40,000-scale, for navigation in and around Kisameet Bay. Canadian Chart No. 3936 is the most up-to-date chart for Kisameet Bay. However, the suitability of the scale for the intended area is less than ideal when compared with the 1:20,000-scale insets available on the same chart for similar geographic inlets and bays. The probability of error in measuring distances of scale is greater on a 1:40,000-scale chart than on a 1:20,000-scale chart.

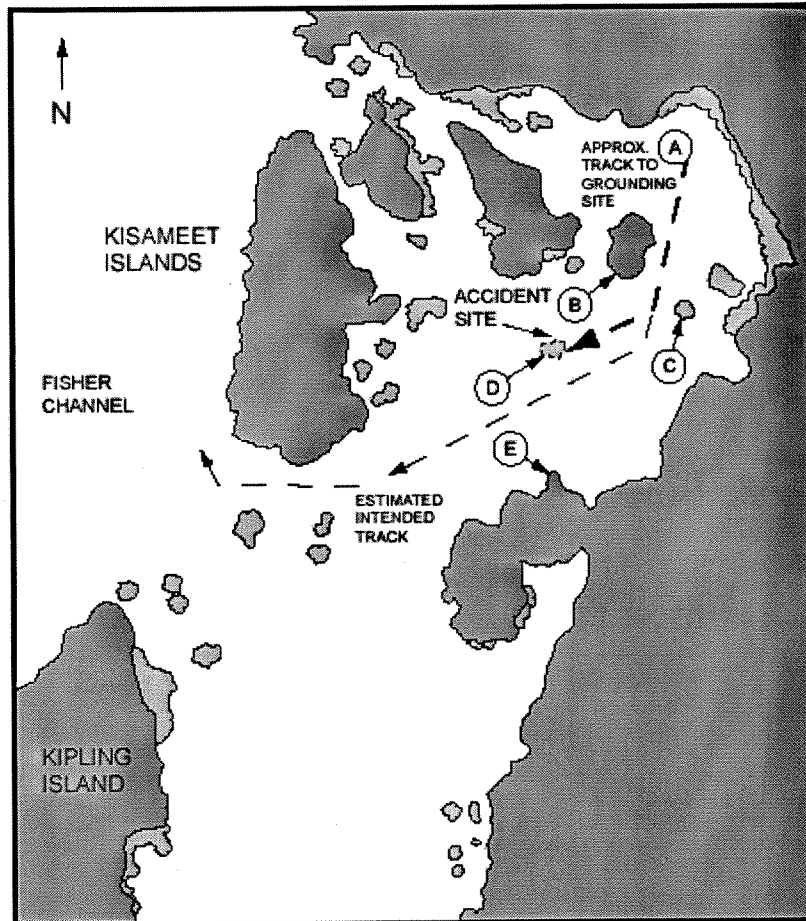
The master stated that on his outbound transit of the bay, he used the variable range marker (VRM⁴) capability of the radar to gauge his turn to avoid the submerged rock. (Item D on figure 3.) Using his copy-machine enlargement of Canadian Chart No. 3936, he selected a single reference point, the islet southwest of his anchored position, and estimated the distance between its southern point (B) and the south side of the

submerged rock (D). He then set the VRM distance equal to that estimated distance plus 120 feet, for a total distance of 0.15 nautical miles. He said that he did not select a second reference point and do comparable distance estimates, which he could have used on the VRM radar to check his range accuracy. Rather, he proceeded on a heading toward point E until his VRM ring tangent indicated the small islet was astern and about north-northeast of the *Safari Spirit*. He then turned to starboard and put the vessel on what he estimated was a west-southwest course to pass south of the submerged rock D.

Figure 3. The above illustration represents an enlargement of the Kisameet Bay area that is about three times the size of Canadian Chart No. 3936. The *Safari Spirit* was anchored at A. The master gauged his turn using one reference point, the islet designated B. A small exposed rock that is east of the islet is designated C, and the submerged rock on which the vessel grounded is designated D. The point of land that the master used to judge the vessel's initial heading is designated E.

Shortly after making the course change, the master said that he noted the vessel's depthsounder indicated that the water depth was 70 feet. About 30 seconds later, about 0725 local time, the *Safari Spirit* struck the submerged rock D. Crewmembers and passengers alike said that the yacht smoothly rode up on the rock, with no rough or violent vessel motion, and then became hard aground.

The master's intention was to come right to a southwesterly heading when the preset VRM tangent crossed the radar presentation of the south end of the island and then continue to open up or increase the distance away from the island. The master used a prominent point of land at the south end of the bay (point E, figure 3) to maintain the vessel's track line to the south. With the cursor on this prominent point, he navigated away from his anchored position and maintained this south-southwesterly course on the prominent radar bearing while he continued between the two visible obstructions (the islet and the visible rock). However, the master was using only point E to maintain the vessel's heading.

The master could have used additional methods of navigation to safely navigate the vessel out of the bay. He could have set his radar's VRM to a range from the prominent point at the south end of the bay. By determining the distance from another radar range, he would have had an additional reference that he could have used to fix⁹ his vessel's position in order to pass safely clear of the submerged rock. The *Safari Spirit* master had predetermined a safe distance for passing the hazard by using his chart and then setting his VRM. He could have done the same for at least one, possibly two, other references. By comparing these references, ideally the two radar ranges previously mentioned, he would have seen that the preset numbers did not match and could have delayed the turn to the southwest or slowed his vessel to reassess the vessel's position.

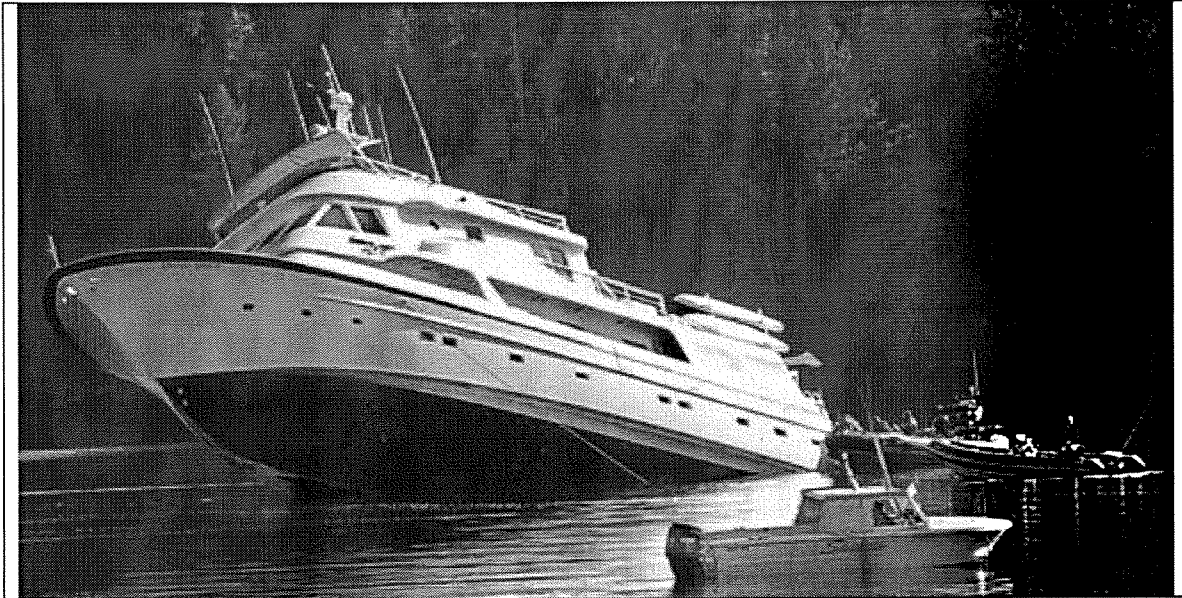
The master stated that while the passengers were in their cabins retrieving their belongings, the vessel suddenly, and unexpectedly, listed hard over on its starboard side (figure 4). He then ordered everyone to evacuate the vessel at once. As they returned to

Figure 4. According to crewmembers, the *Safari Spirit* listed to starboard at an angle of about 35° when it shifted on the submerged rock. Photograph courtesy of Shearwood Marine.
