**Capsizing of New York State-Certificated Vessel
Ethan Allen, Lake George, New York
October 2, 2005**

Marine Accident Report

NTSB/MAR-06/03

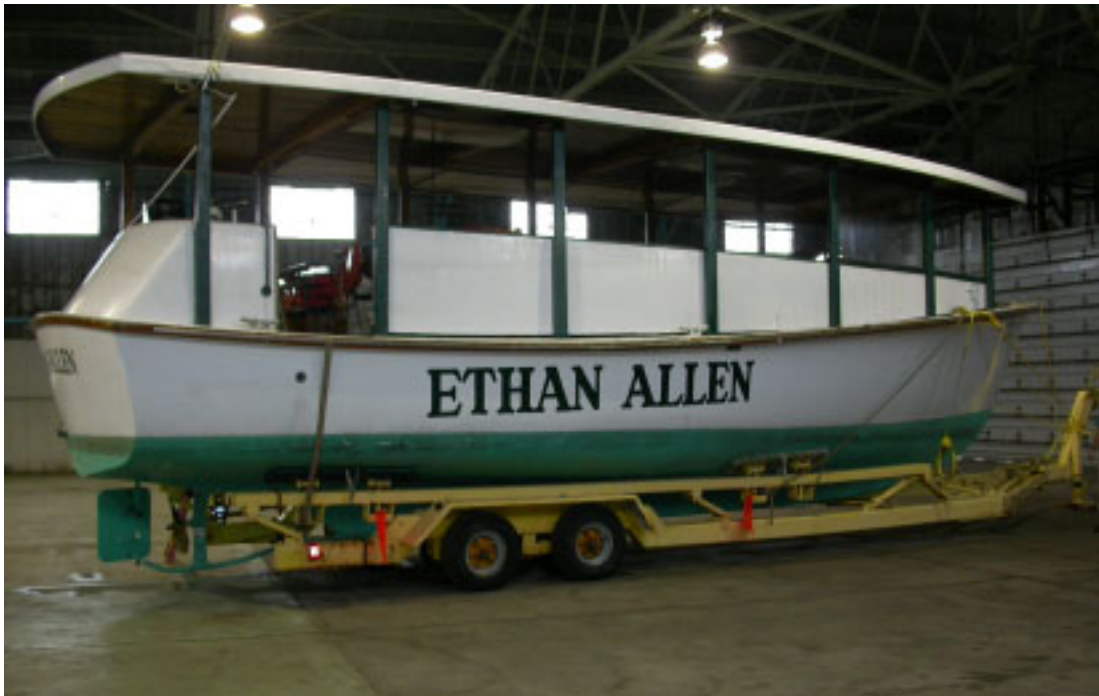
Figure 1. The *Ethan Allen*, shown above after the accident, was a New York State-certificated public vessel, a category of powered vessels that is permitted to transport passengers or freight for commercial purposes solely on state waters.

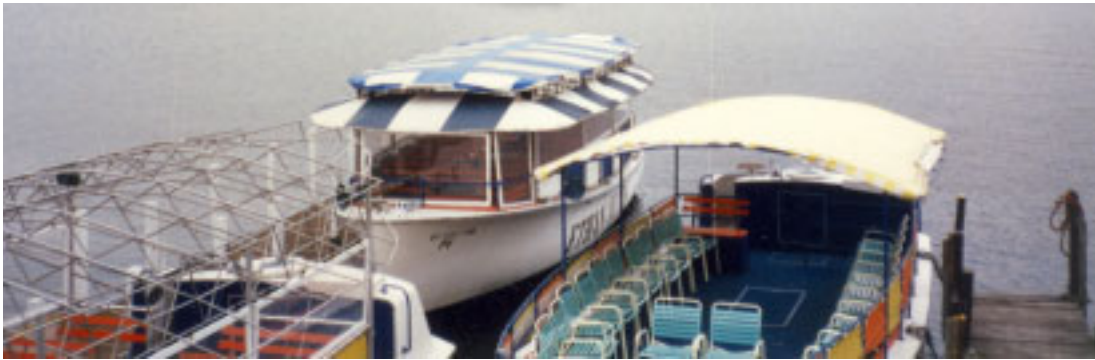
The wooden canopy that Scarano Boatbuilders installed was about 15 inches lower than the metal and canvas canopy it replaced, providing a smaller lateral surface area¹⁷ than the previous canopy.

Figure 4. This circa 1980 photograph shows the canopies and metal framework on the *de Champlain* (foreground left), the *Ethan Allen* (foreground center), and the *Algonquin* (foreground right).

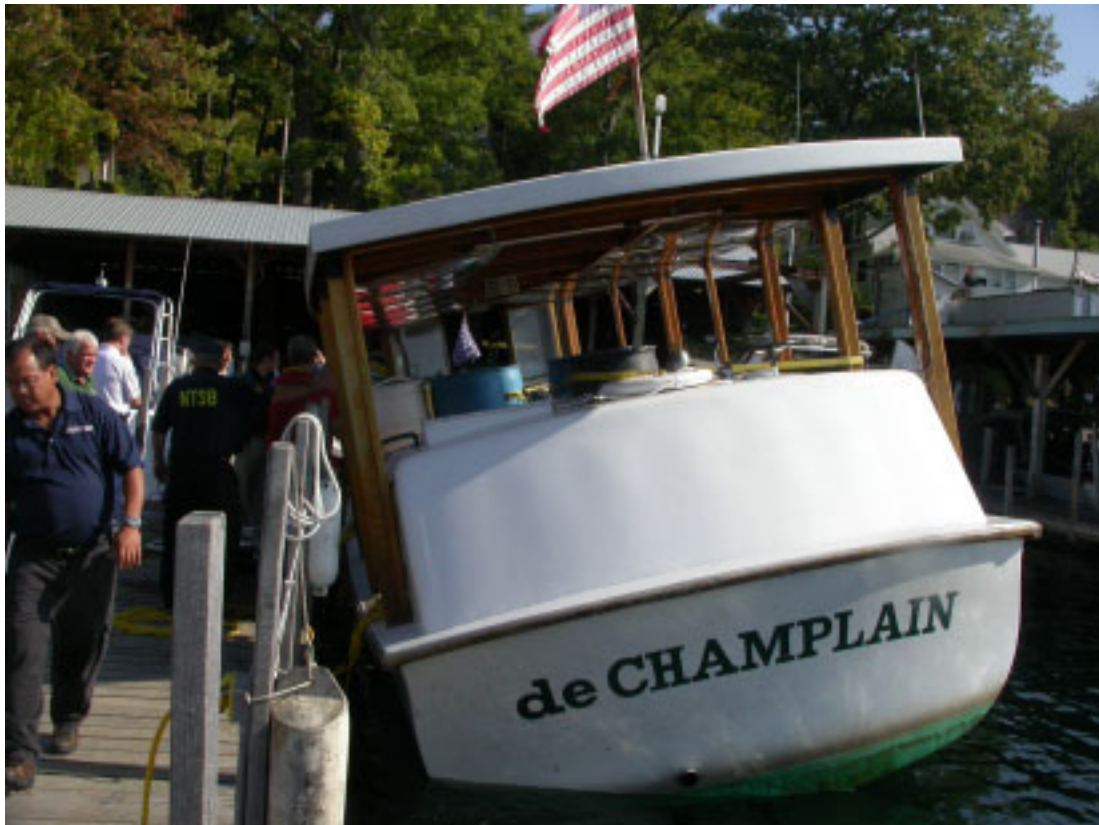
Figure 5. *De Champlain* after on-site stability assessment was terminated.

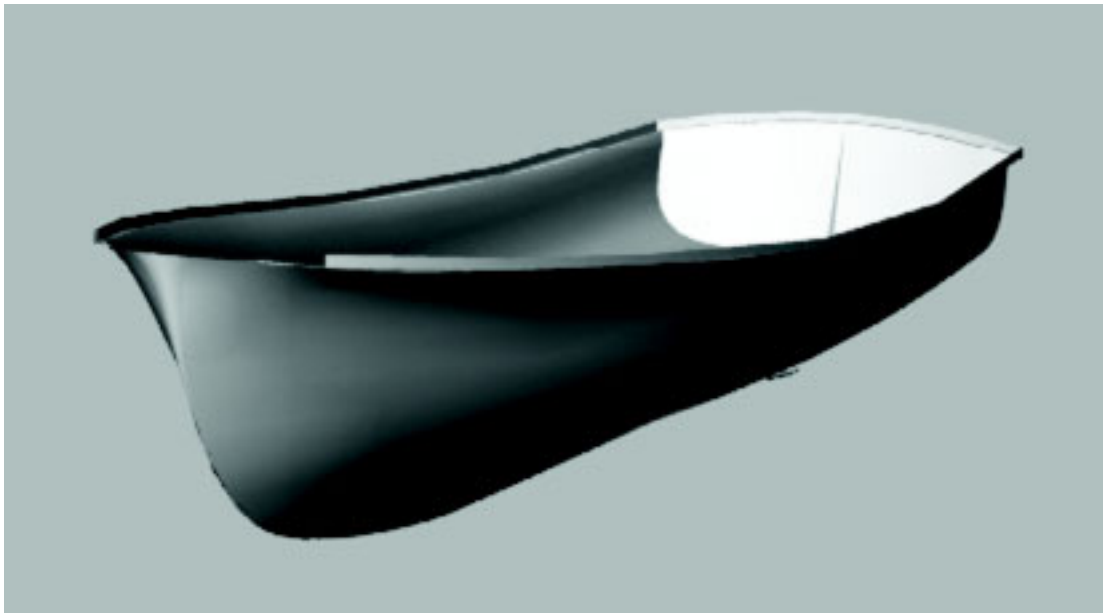
Figure 6. Computer-generated *Ethan Allen* hull form.
