National Transportation Safety Board

Marine Accident Brief

Accident No.: DCA-03-MM-032
Accident Type: Boiler rupture
Vessel: Bahamas-registered passenger vessel S/S *Norway*
Location: Piers 1 and 2, Miami, Florida
Date: May 25, 2003
Time: 0637 eastern daylight time¹
Owner/Operator: Norwegian Cruise Line
Property Damage: \$20-\$23 million
Complement: 911 crew
2,135 passengers
Fatalities/Injuries: Passengers: none
Crew: 8 fatalities; 10 serious injuries; 7 minor injuries

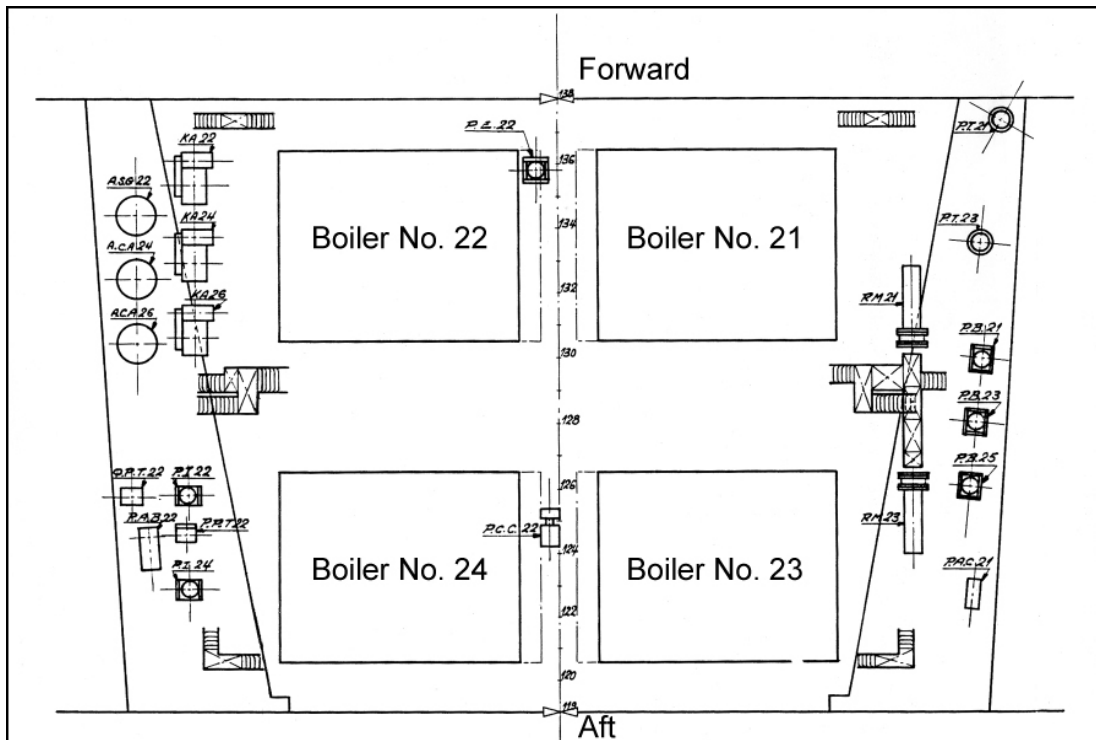
Figure 5. Layout of *Norway's* aft boiler room, where boiler No. 23 ruptured (from copy of original drawing of *S/S France* boiler arrangement provided by NCL). Boilers were numbered to indicate whether they were in the forward (1) or aft (2) boiler room. Thus, No. 23 indicated the third boiler in the aft boiler room. The forward boilers were removed when the *France* was overhauled and renamed the *Norway*.

Boiler No. 23, located on the starboard side of the boiler room, had ruptured. The boiler contained about 20 tons of water operating at a temperature of about 528° F under a pressure of about 60 bar (870 pounds per square inch [psi])¹⁰. In the normal atmospheric pressure of the aft boiler room (14.7 psi), the pressurized hot water rapidly expanded in volume about 1,260 times into steam.¹¹ The expanding steam, mixed with smoke, soot, and debris, swept through the engineering spaces, fatally injuring four

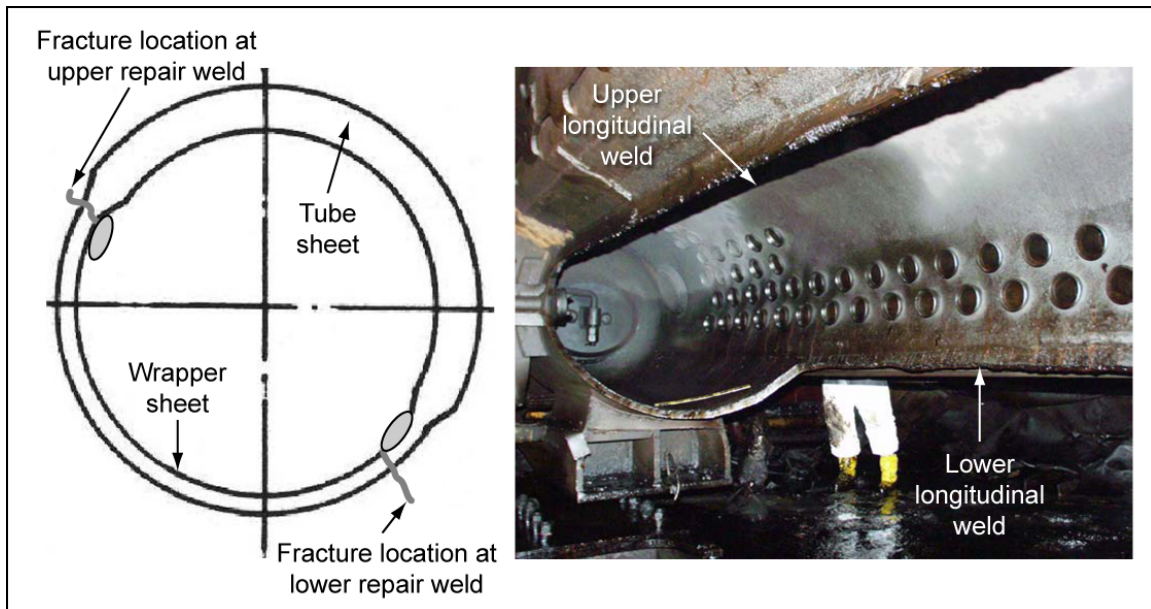
The entire waterwall header, including the caps (“dished heads”), was about 16.5 feet long. The cylindrical portion of the header was about 13 feet long. The fracture along the upper longitudinal weld extended about 11 feet, and the fracture along the lower longitudinal weld extended about 8 feet. The weld repairs were approximately 1.5 inches wide along almost the entire length of the original longitudinal weld seams. The fractures along the weld seams were connected by overstress fractures through the wrapper sheet. The header's upper longitudinal fracture had dark areas, indicating preexisting cracks that extended from the inner surface through about 40 percent of the wall thickness toward the outer surface of the header.

Figure 8. Schematic (left) showing location of fracturing along the longitudinal welds, and partial view (right) of damaged waterwall header, looking aft. The waterwall header was constructed by longitudinally welding together two half-cylinders and then welding caps (dished heads) on either end. The two half-cylinders were of different thicknesses. During the manufacture of the header, the tube sheet was tapered down to the wrapper sheet and the two were welded together at the bottom of the tapered region. The header fractured where weld repairs had been made along the original longitudinal welds joining the tube sheet and the wrapper sheet.

The header's lower longitudinal fracture surface also had dark areas, again indicating the presence of preexisting cracks from the inner surface through about 60 percent of the wall thickness. The preexisting crack region extended along the length of the fracture. Investigators observed isolated thumbnail-shaped regions, indicative of metal fatigue, at both ends of this fracture. The weld repair region contained both longitudinal and transverse cracks not observed in other areas of the boiler. The transverse cracks varied from 0.5 to 2 inches long.

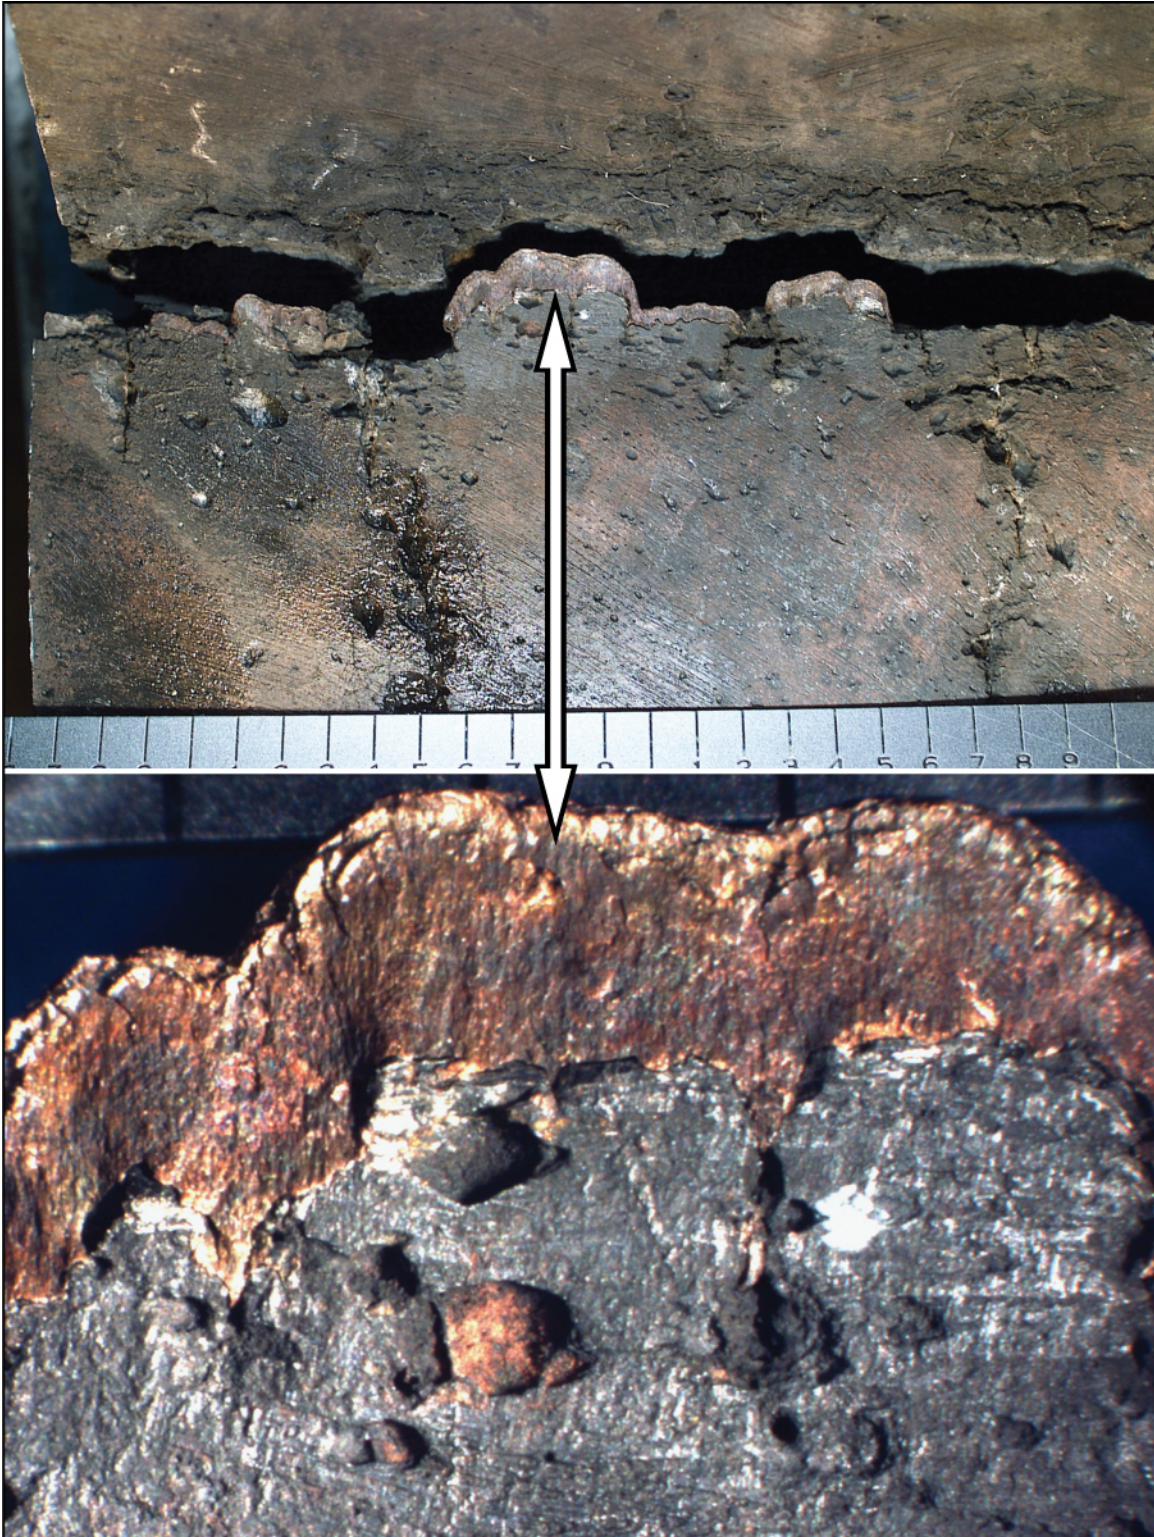
Figure 9. View of matching fracture halves (above) and enlarged image of copper nuggets (below) at the edge of the fracture. Arrow points to area of enlarged image.

Investigators determined the elemental composition of the copper fragments to be almost pure copper, with a wrought (hammered) structure similar to the composition of hammered copper refrigeration tubing. The inside surface of the nuggets had transverse marks associated with grinding, consistent with the copper material having been ground flush with the inner diameter of the header after being introduced into the open crack. Investigators considered the possibility that the copper had entered the boiler as the result of chemical reactions such as deposition induced by excess hydrazine.⁴⁶ They discounted this mechanism as the source because of the mechanical features and shape of the copper nuggets.
