Weather Encounter and Subsequent
Collision into Terrain
Bali Hai Helicopter Tours, Inc.
Bell 206B, N16849
Kalaheo, Hawaii
September 24, 2004

NTSB/AAR-07/03

Aircraft Accident Report

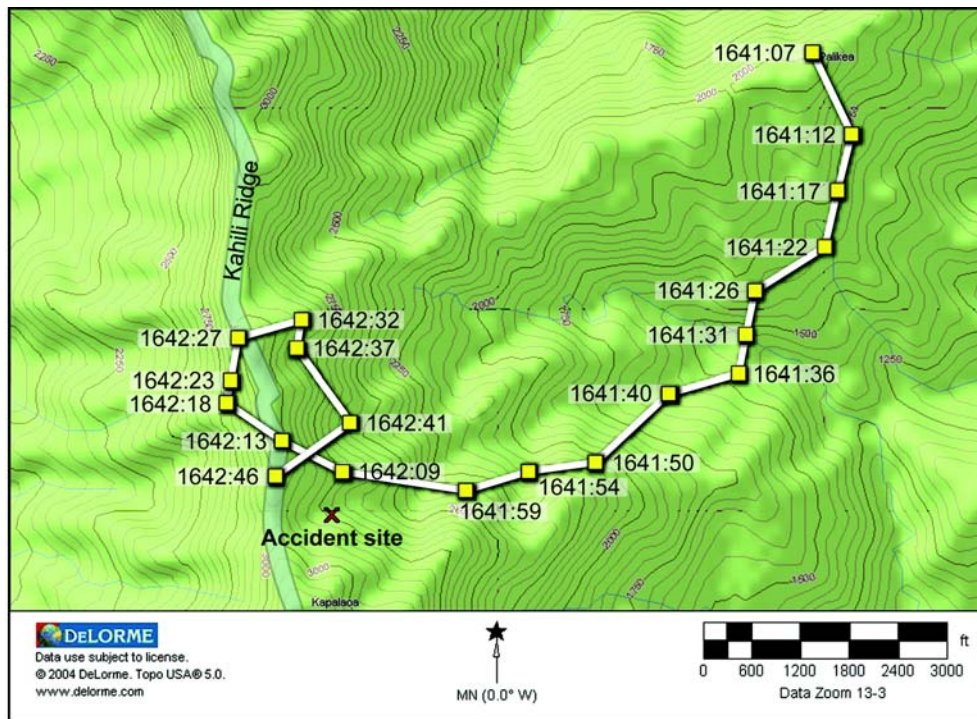
thereafter, the helicopter tracked west toward a pass at the top of Kahili Ridge, then crossed Kahili Ridge. About 1642, the radar track depicted the helicopter on the west side of Kahili Ridge as it turned toward the north. The helicopter's ground track then made a 180° clockwise turn toward the south and crossed back to the east side of the Kahili Ridge in a zigzag pattern before it was lost from radar at 1642:46. The wreckage was located on the east side of Kahili Ridge about 200 feet below the top of the ridgeline and southeast of the last radar return.⁹

Figure 2. Radar data for the last 2 minutes of the accident flight plotted over a topographical map.

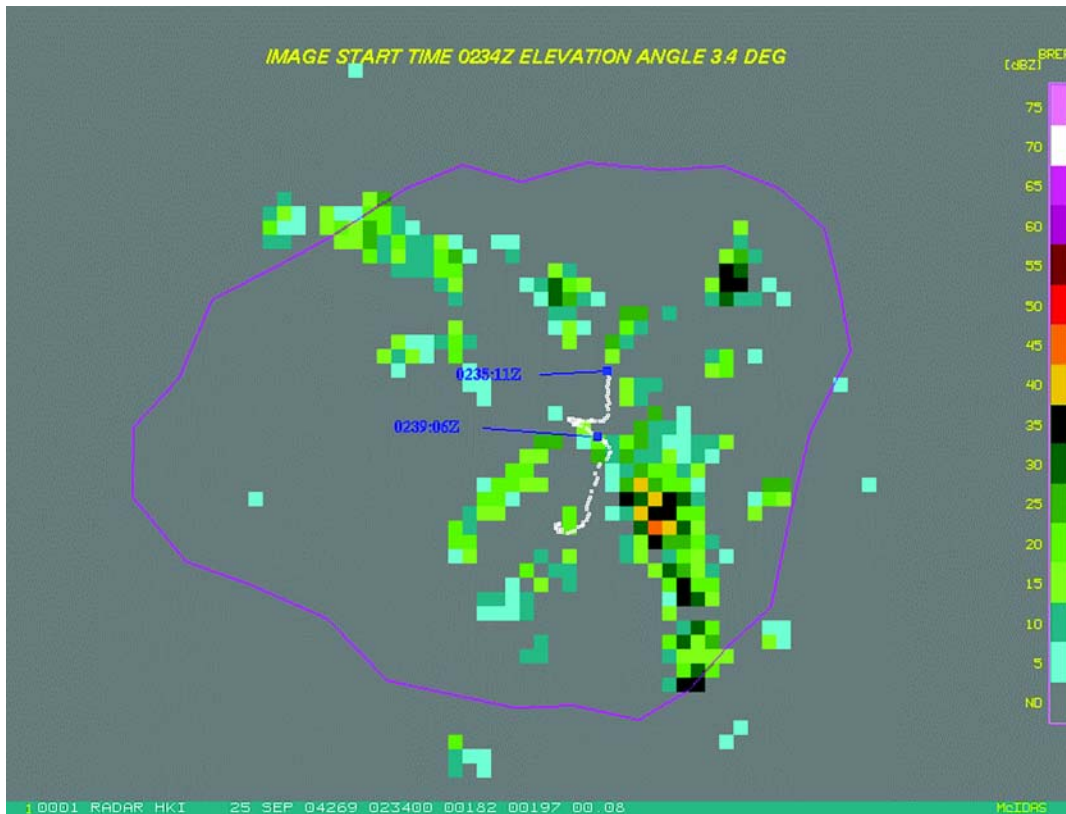
(msl). The weather radar echo intensities are represented in decibels (dBZ) (see color bar on the right side of each figure). In the figures, the ground track of the accident flight from 1635:11 to 1642:46 is plotted in white, and selected radar plot times are noted in blue.

Figure 3. Weather radar at 1634.

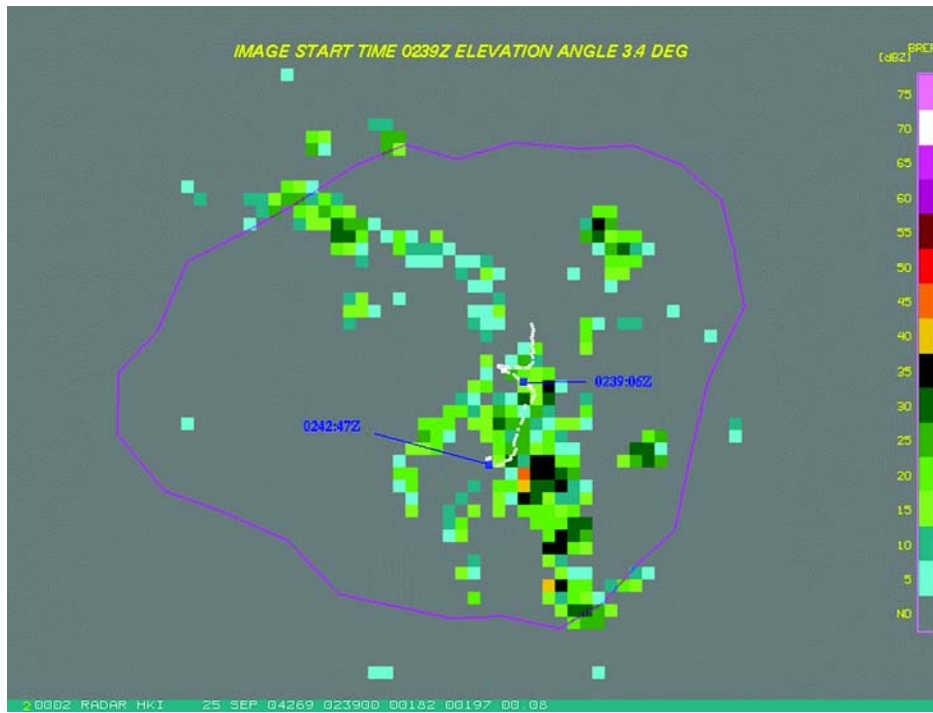
Figure 4. Weather radar at 1639.

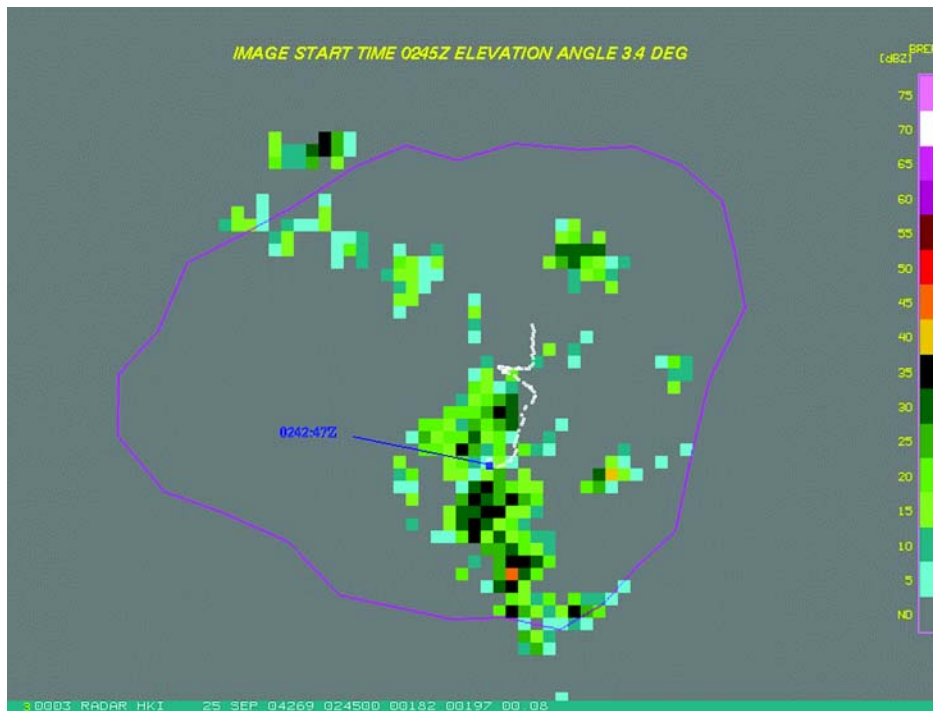
Figure 5. Weather radar at 1645.
